***Optimum Locations for the Benefits of Green  
Infrastructure (GI) on the NMDOT Transportation  
System  
May 2025***

*Prepared for:  
New Mexico Department of Transportation  
Albuquerque, NM*

*Prepared by:  
GeoSystems Analysis, Inc.  
8601 Paseo Alameda NE; Suite B  
Albuquerque, NM 87113*

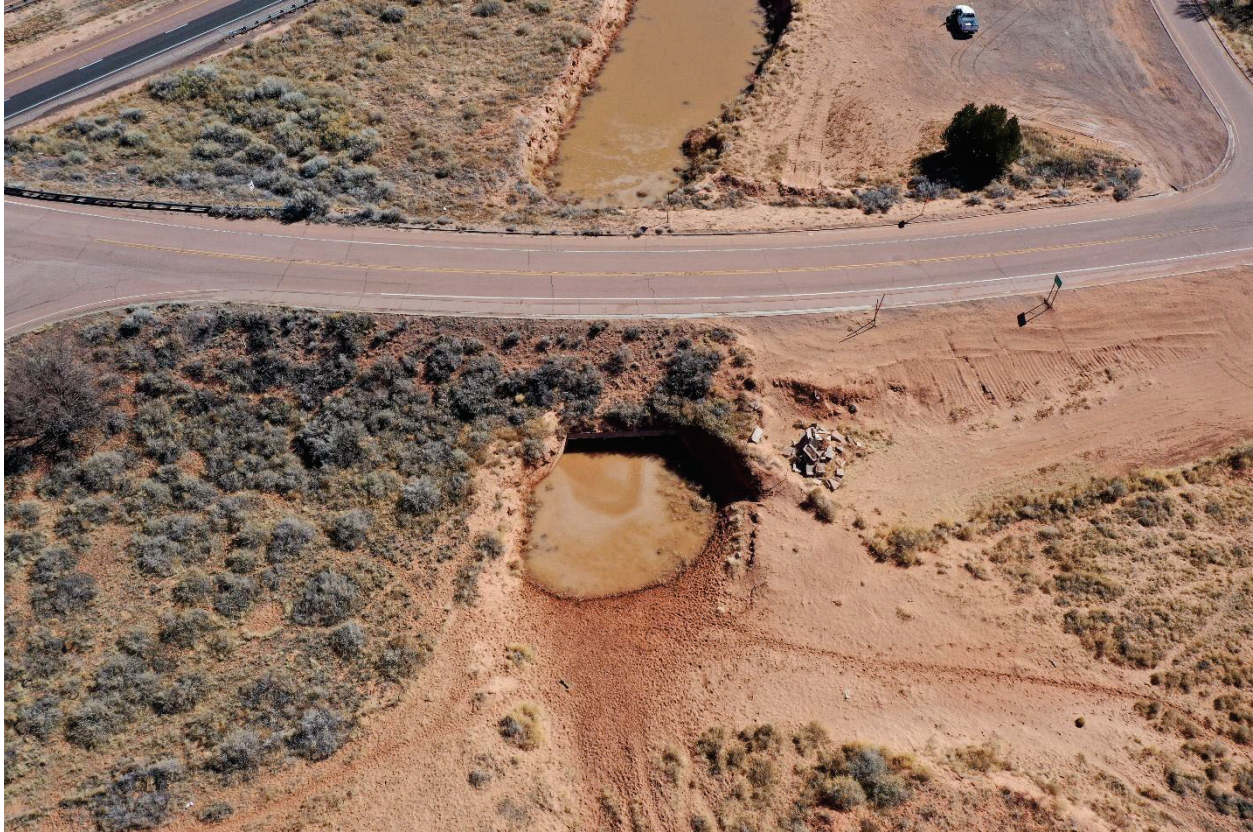
*Figure 1 – An example of a maintenance problem area, where ponding and erosion are evident.*

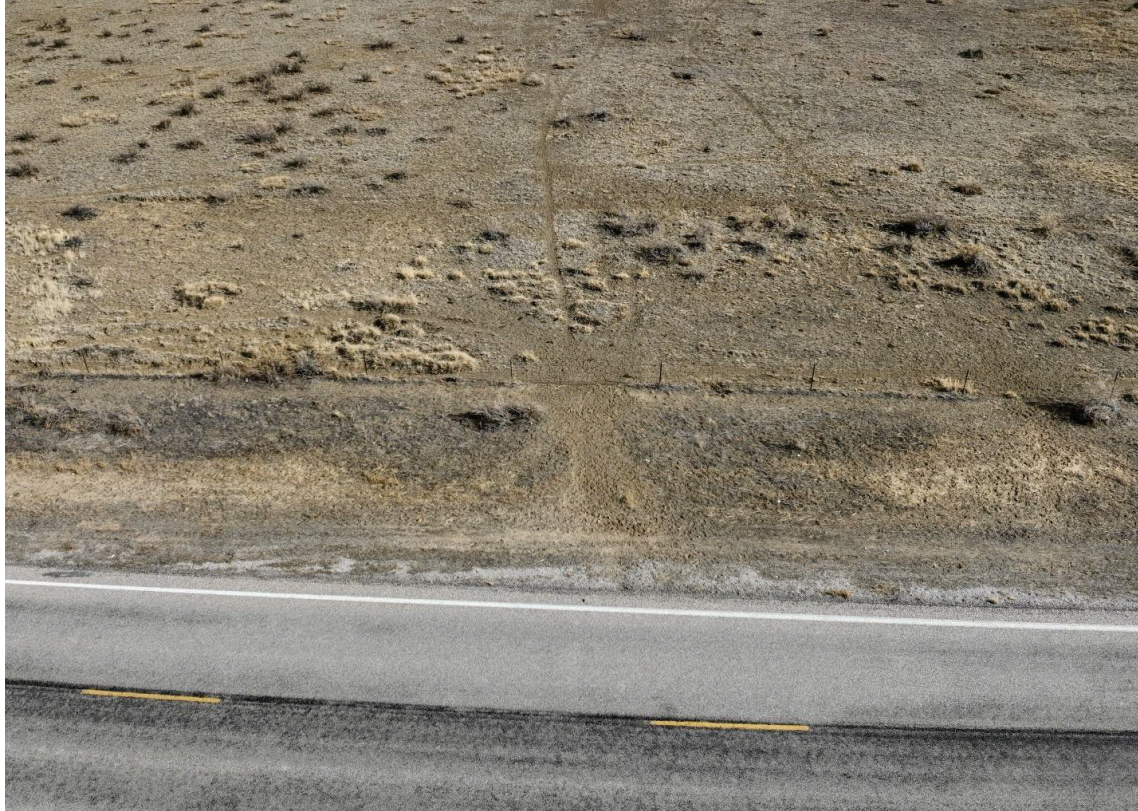
Figure 10 - An example of a wildlife crossing observed in a rural area in District 6.

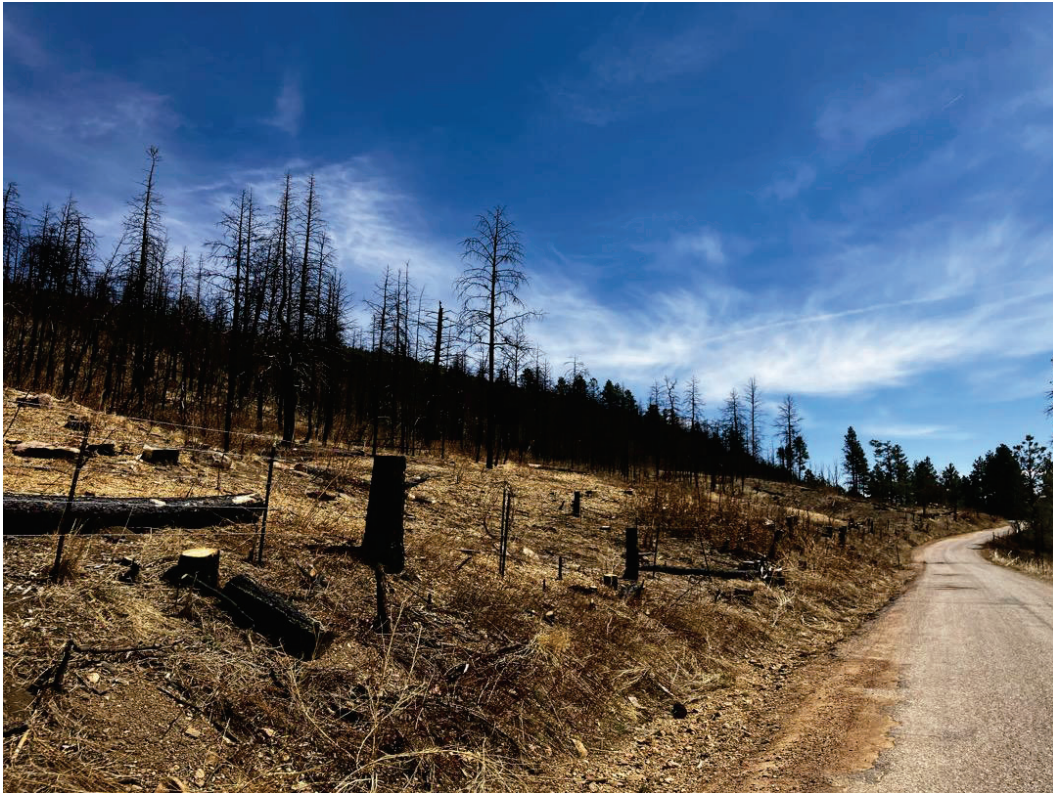
Observation ID: S48\_Ob1

For example, Site S48, the highest-ranked site overall, displayed severe post-fire flooding and erosion, and is situated in an area flagged for both habitat connectivity and flood vulnerability. Similarly, Site S11 exhibits substantial maintenance concerns within an environmentally sensitive context, suggesting strong potential for GI to provide both functional and ecological benefits. In contrast, lower-ranked sites tend to feature either fewer observed issues or are locations with limited environmental co-benefits.
