Comparing Resistivity and Conductivity in Metal Culverts

Final Report

Agua del Sol Consultants, LLC
PO Box 92797
Albuquerque, NM 87199

Report R924020

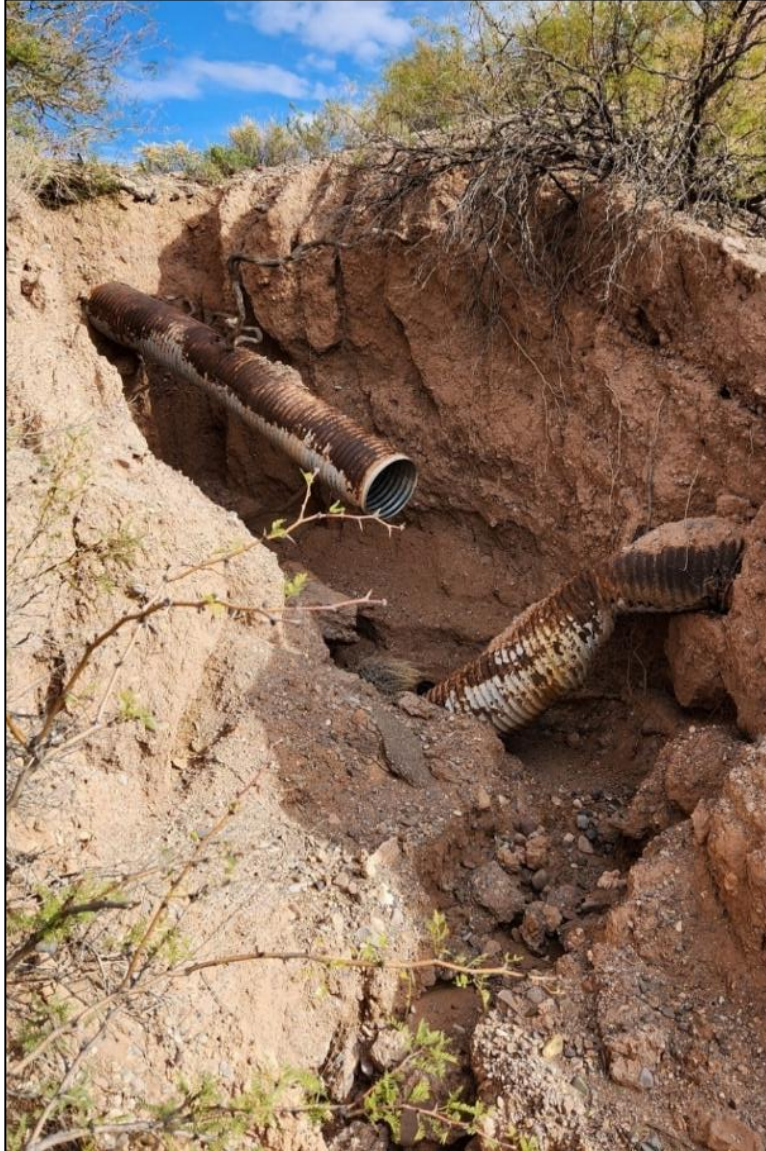
This culvert was visited on 11/05/2025, but no data were collected at this location. As seen in **FIGURE 4** below, this culvert has completely failed, creating a roughly 20-25-foot-deep gouge in the interstate's eastern embankment. Using Google Earth images, it appears that this culvert drains the median between north and southbound I-25, but was buried in sediment sometime between Jan 2013 and Nov 2014. No evidence of the median drain was found during the site visit. Additionally, it appears that this culvert failed due to top-down erosion from I-25 runoff coming down the hill to the north, with evidence of erosion in an August 2009 Google Earth image.

FIGURE 4: Culvert on I-25 (NB) MP 77.19.

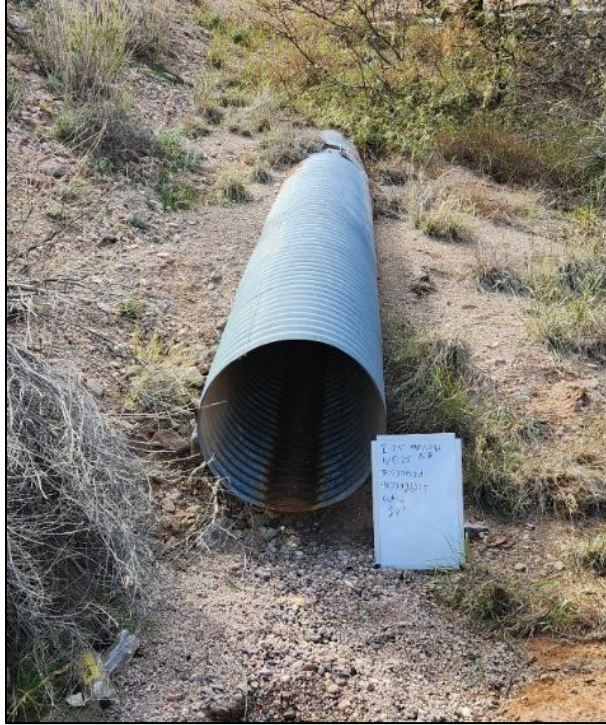
This culvert was visited on 11/05/2025 and is located on northbound (NB) I-25. This culvert had visible corrosion on the bottom inside and slight corrosion on the top outside when in contact with the surrounding soils as seen in **FIGURE 5**, **FIGURE 6**, and **FIGURE 7** below.

FIGURE 5: Culvert on I-25 (NB) MP 107.86, outlet side.

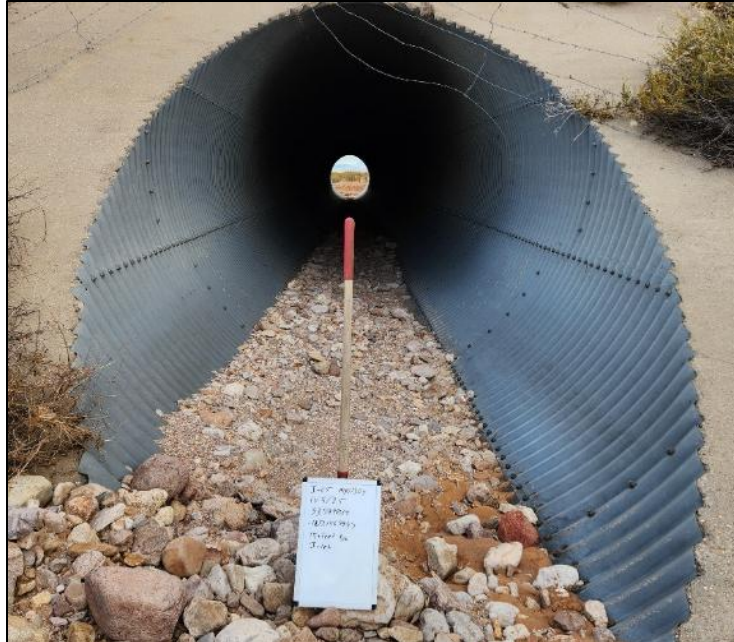
FIGURE 9: Culvert on I-25 MP 113.04, inlet side.

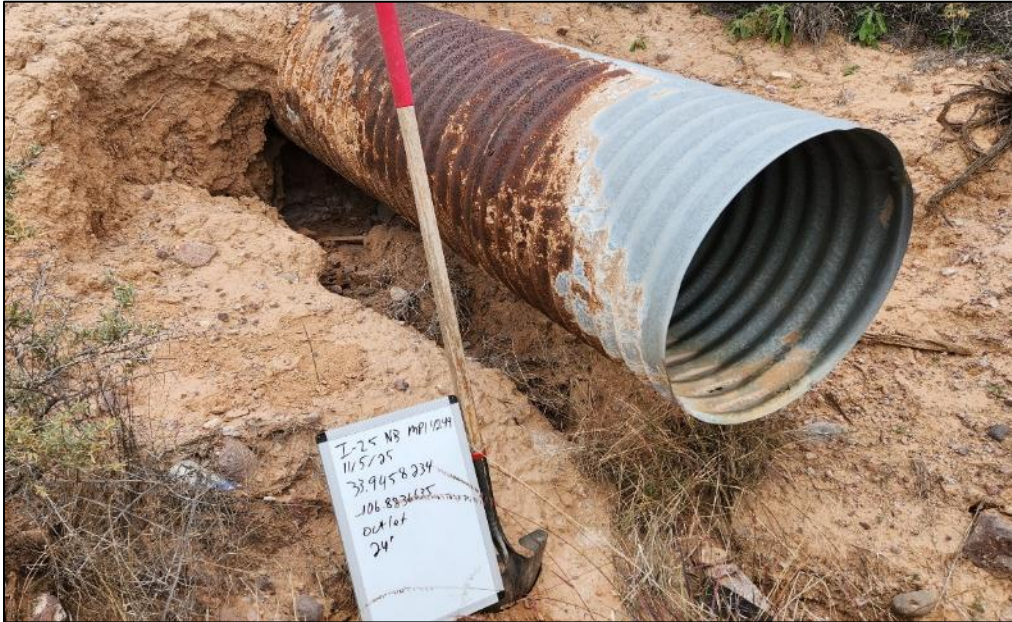
This culvert was visited on 11/05/2025. This culvert had significant visible corrosion on the outside, **FIGURE 12** and **FIGURE 13**. There was no corrosion present on the inside portion of the outlet that was not in contact with the soil, **FIGURE 12** and **FIGURE 14**, but further in, there is significant corrosion throughout the inside where the culvert is in contact with the surrounding soils (**FIGURE 15**). The pitting corrosion is clearly seen in **FIGURE 13** and **FIGURE 15** below.

FIGURE 12: Culvert on I-25 (NB) MP 142.49, outlet side.

This location had significant corrosion in locations that used to be covered by the surrounding soil and locations in current contact with the surrounding soil. The presence of soils with greater than 7.3 pH indicated that corrosion on the soil side will govern in this location, as seen in **FIGURE 12** and **FIGURE 13** above. With the soil’s resistivity being greater than 2000 ohm-cm at this location and no visible inside-out corrosion on this culvert, the corrosion potential due to the soil’s resistance values is negligible.

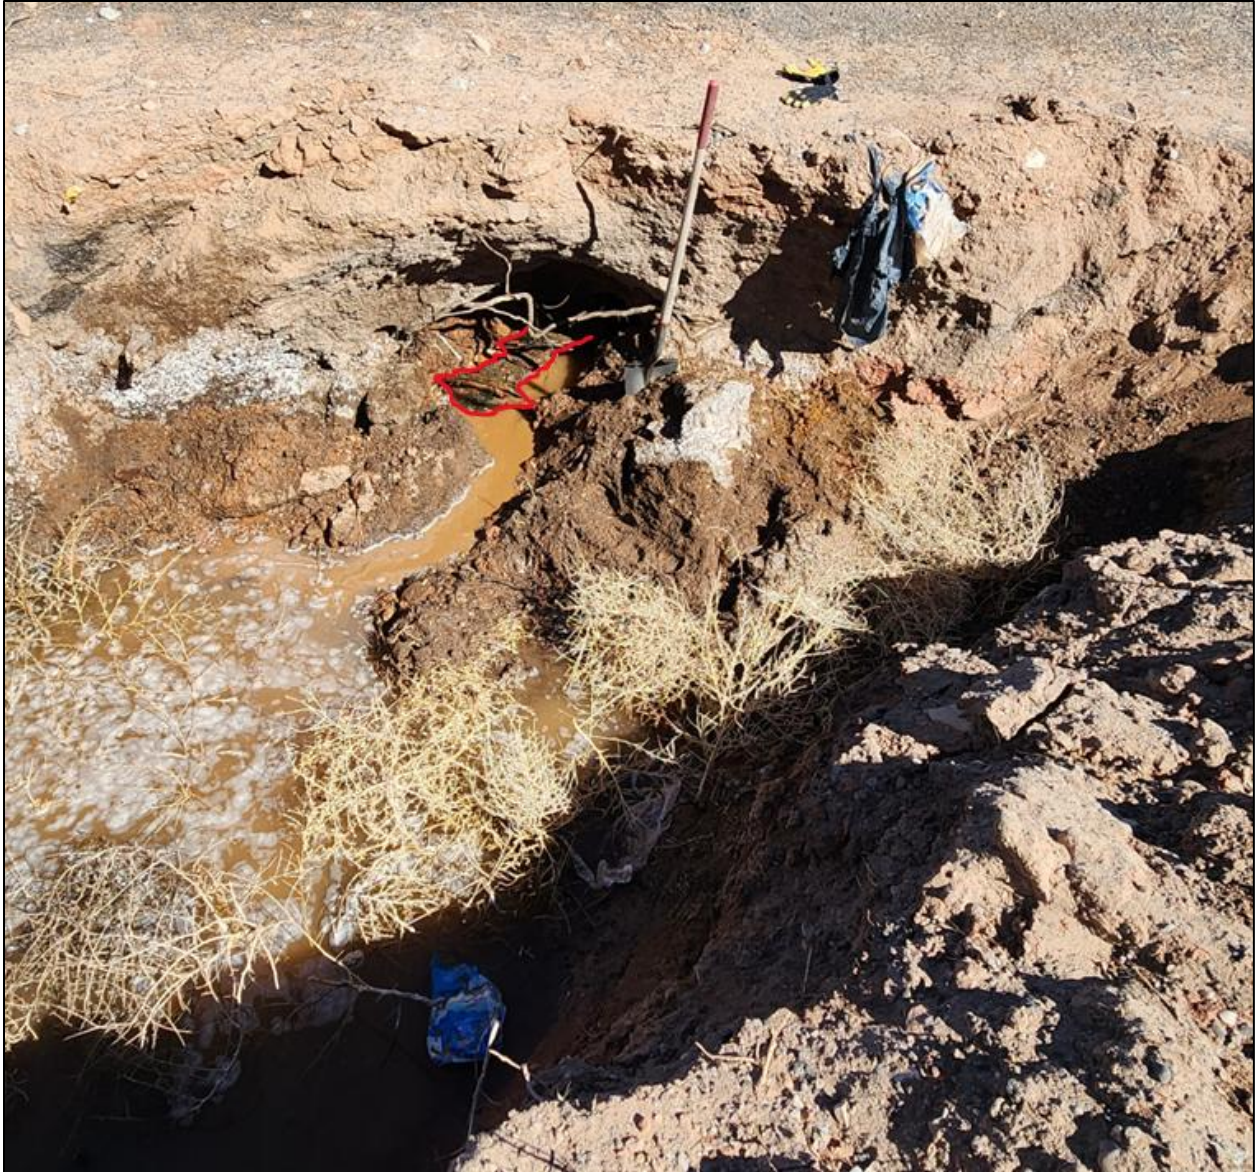
FIGURE 20: Image of 24" (estimated) outlet with a red line highlighting the only metal remaining of culvert between Exit 264 offramp and I-25.

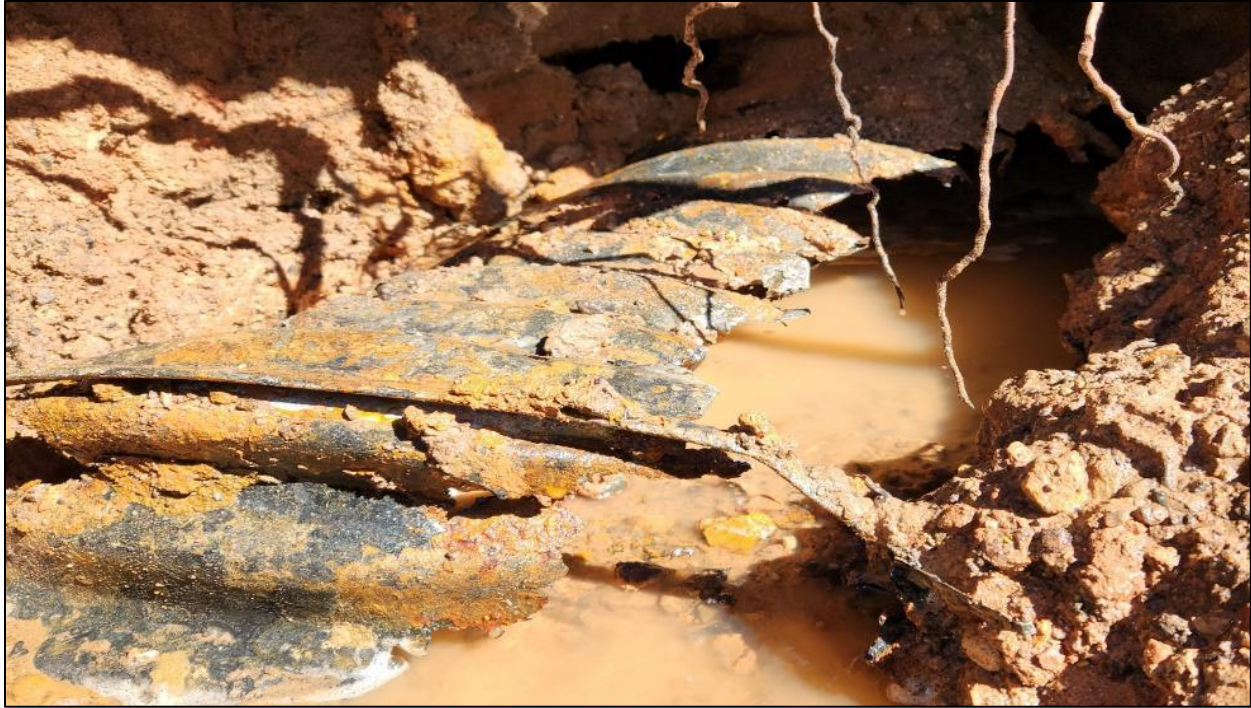
FIGURE 21: Close-up image of the near fully corroded second culvert outlet from culvert between Exit 264 offramp and I-25.

No culvert thickness measurements were taken, as both inlets were inaccessible (under the grate and buried below 6-10 feet of tumbleweeds) and the outlet was nearly fully corroded with minimal metal remaining and below a 4-foot-tall trench wall that was actively collapsing.

The higher pH in addition to the lower resistivity values suggest that this location has a very high potential for culvert corrosion, as seen in the nearly fully corroded away culvert in **FIGURE 21** above. This location had similar pH values as the nearby 78" culvert 0.25 miles away, but the soils' resistivity, based on results of CTM-643 tests at both locations, was over 10 times less. This large difference in resistivity could be attributed to this location's higher potential of road salt runoff, located at the downslope of a large hill that frequently requires salting and deicing in the winter months. A future visit to this site is suggested once the tumbleweeds have been removed and following a long, dry period to allow for the soil to dry, permitting access to the second culvert's inlet and outlet.

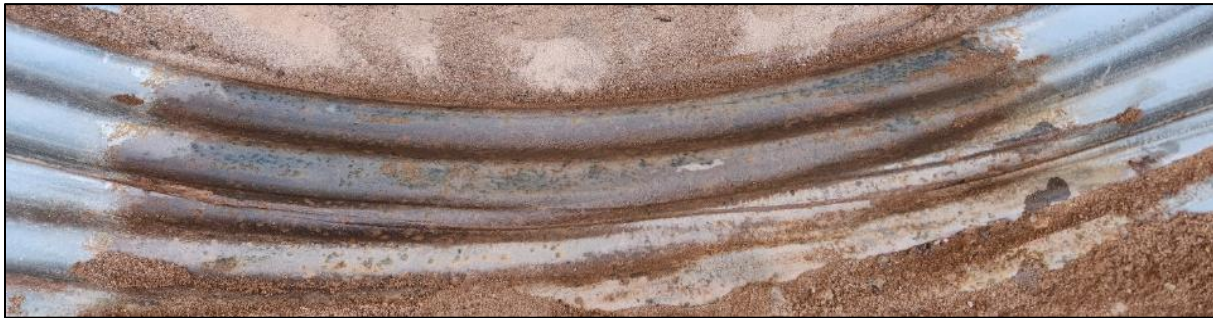
The 78" culvert south of the Cochiti exit that goes under the frontage road east of I-25 and under both lanes of I-25 was visited on 9/25/2024 and then again on 3/25/25. Approximately the first foot of the culvert is 12-gage, 0.1046" thick and the remaining length of the culvert is 16-gage, 0.064" thick. The image below, **FIGURE 22**, is looking into the inlet (west side of I-25). The only location where the outside of the culvert was accessible was at the outlet, which was completely corroded over, but no pitting or holes was observed, **FIGURE 24** below. There was approximately 9 inches of sandy soil on the bottom of the culvert on the inlet side. The culvert had minimal corrosion on the bottom, mostly appearing as scale buildup, **FIGURE 23**.

FIGURE 23: Slight corrosion on the bottom of the culvert underneath the sandy soil present on I-25 MP 264.2.

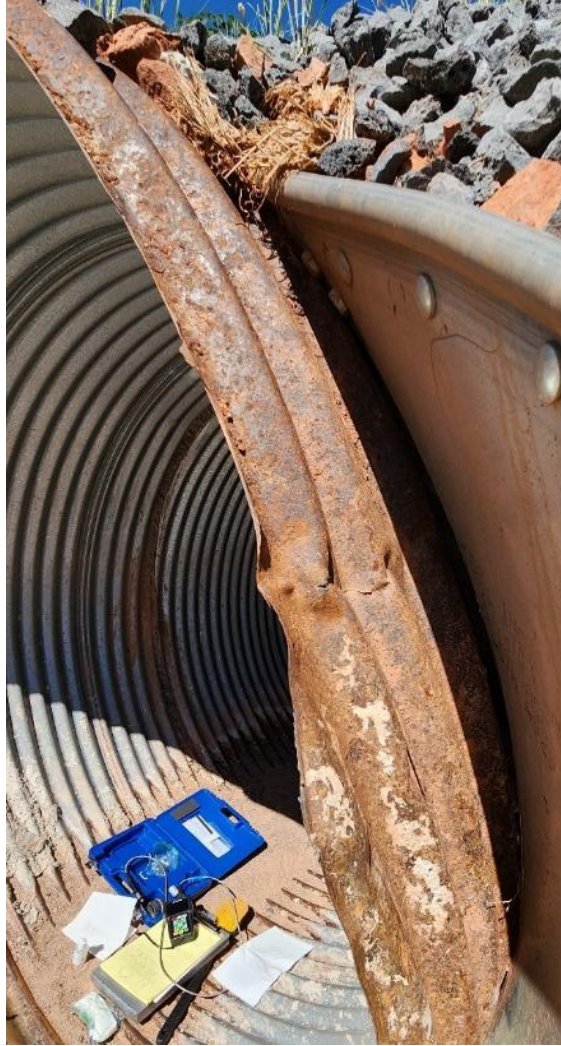
FIGURE 24: Outside of the outlet showing extent of corrosion on I-25 MP 264.2 culvert.

The greater than 7.3 pH values at this location indicate that soil-side corrosion will govern, which matches what was observed in the field. The similar resistivity values (average: 6,577 ohm-cm) between the side-bank soil samples with the CTM-643 test and the in-situ 4-pole resistivity tests (average: 7,115 ohm-cm) conducted on 9/25/24 have a significantly closer agreement than the soil samples collected on 9/25/24 with the CTM-643 test (average 15,265 ohm-cm). This similarity indicated that the soil samples collected on 9/25/24 were insufficient in fully representing the locations' soil characteristics.

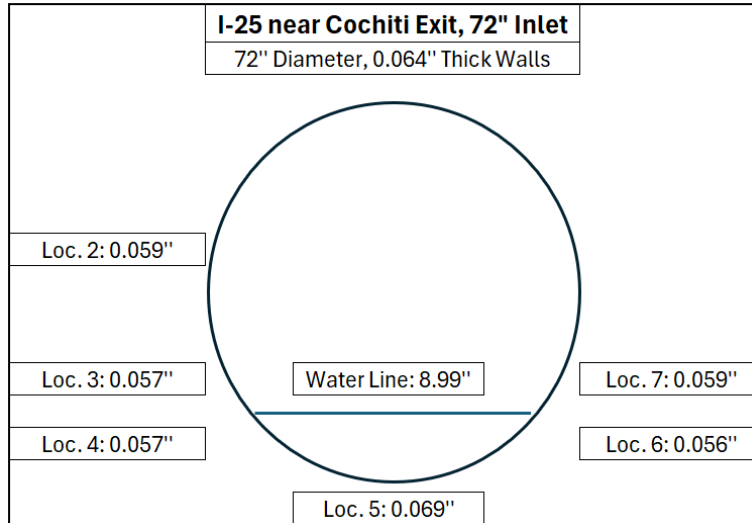
No exterior culvert was accessible that did not have any corrosion present to take an uncorroded measurement, but based on the ultrasonic measurements taken, it is estimated that the culvert is 16 gage, 0.064" thick. Both the inlet and outlet measurements followed the same pattern: thicker walls above the waterline, thinner walls below the waterline, and thickest measurement on the bottom due to scale buildup as seen in **FIGURE 25** below.

FIGURE 25: Diagram of inlet wall thickness measurements taken on I-25 MP 264.2.

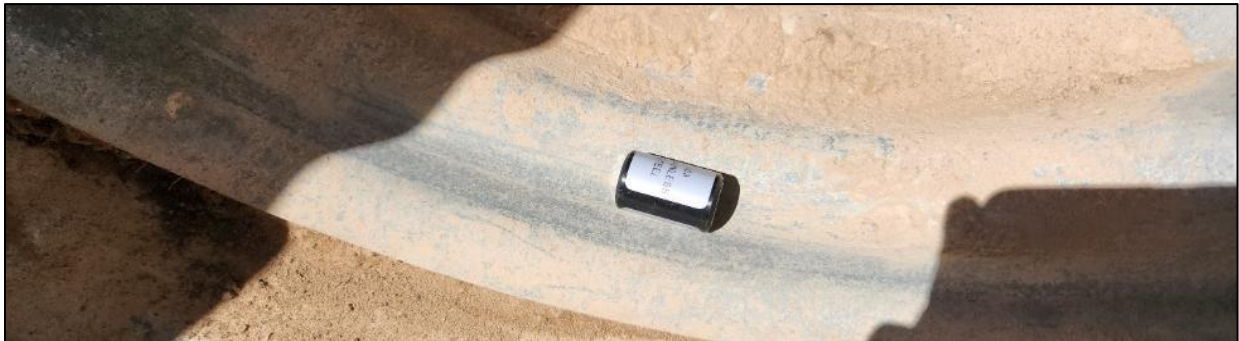
This 24" culvert under the southbound lane of I-25 is located east of Cerrillos road overpass by 1.2 miles and was visited on 9/25/2024. The image below, **FIGURE 27**, is looking into the inlet (facing north between the south bound and north bound lanes of I-25). There was approximately 2 inches of loamy soil on the bottom of the culvert on the inlet side. The culvert had no corrosion present on the inside, as seen in **FIGURE 28**.

FIGURE 28: No corrosion was present on the inside of the I-25 (SB) MP 278.7 culvert.

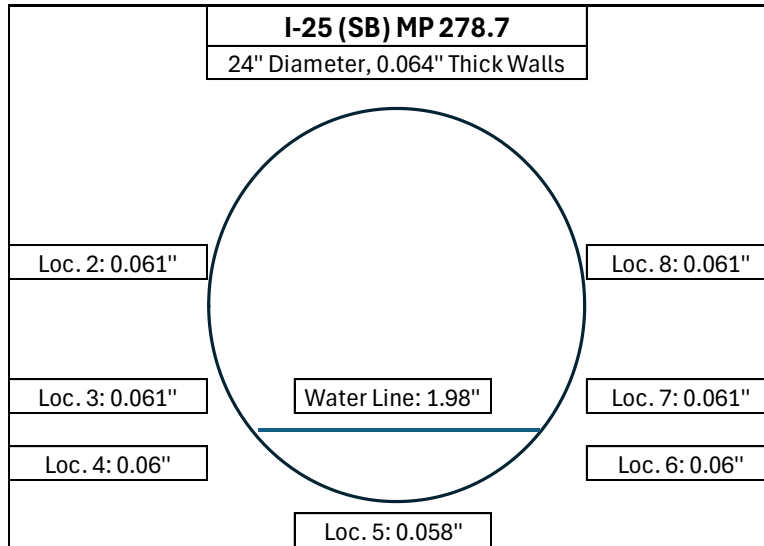
A value of 0.0581 inches was measured on an uncorroded exposed location with a micrometer, indicating a 16-gage thickness, which has a standard thickness of 0.064 inch when galvanized coated and an uncoated thickness of 0.0598 inches. Based on the ultrasonic thickness measurements taken 1 foot in from the end of the culvert, there appears to be very little corrosion on the outside of the culvert, **FIGURE 29** below.

FIGURE 29: Diagram of inlet wall thickness measurements taken on the I-25 (SB) MP 278.7 culvert.

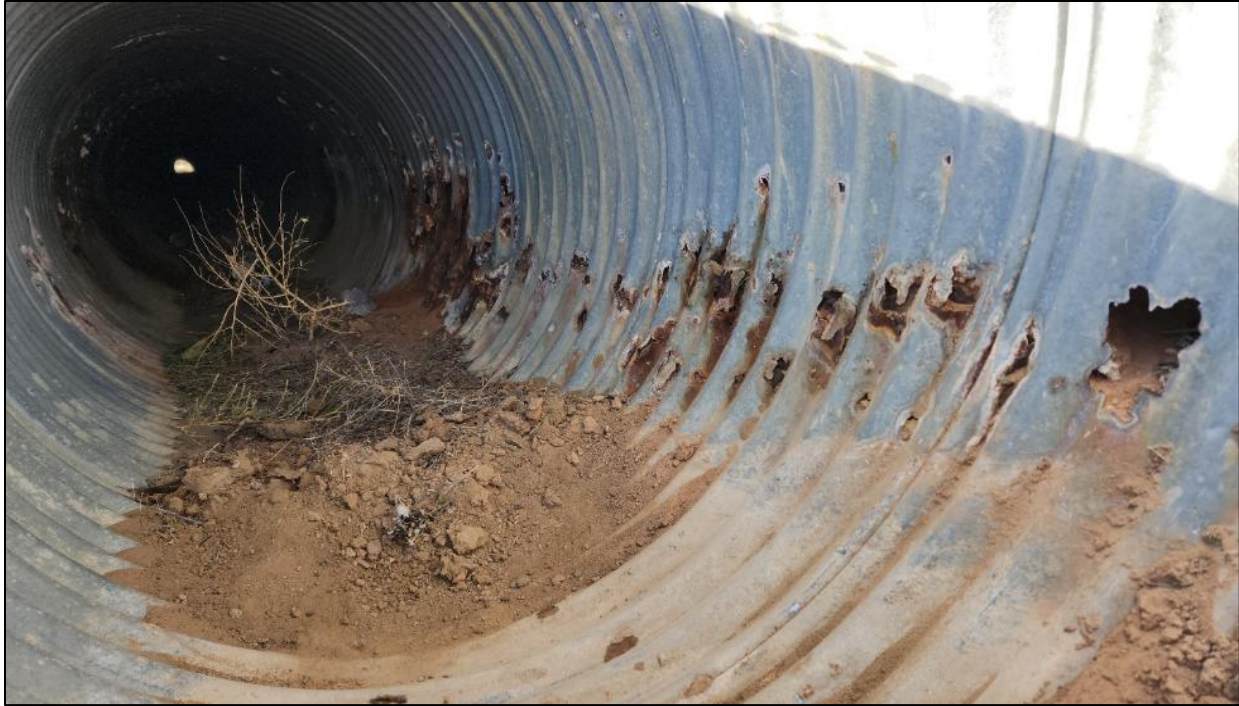
Locations 3 and 4 and locations 6 and 7 showed, on average, the most metal loss due to corrosion, with these regions having the most perforations on all three culverts, as shown in **FIGURE 34** and **FIGURE 35** below for Culverts A and B. In all occurrences of observed corrosion, the corrosion began on the outside of the culvert, with little to no corrosion on the inside of the culvert.

FIGURE 34: Culvert I-40 MP 121 A showing the extent of corrosion roughly 1/3 up the side of the culvert.

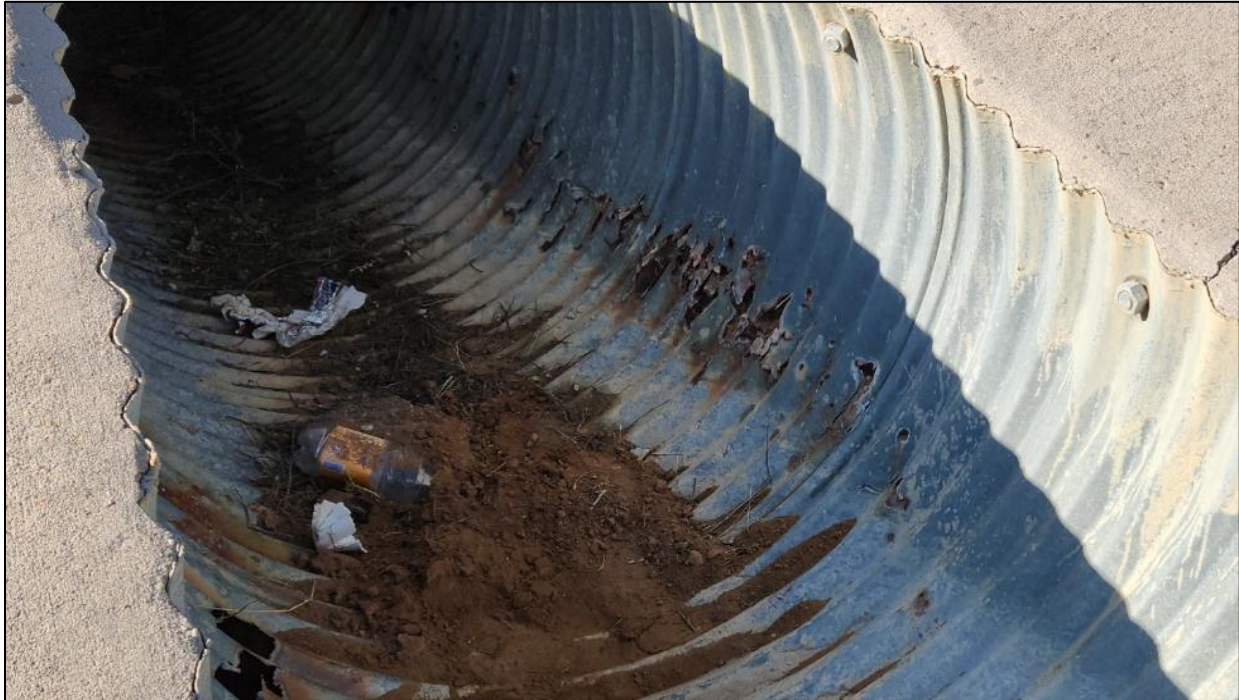
FIGURE 35: Culvert I-40 MP B showing the extent of corrosion roughly 1/3 up the side of the culvert.

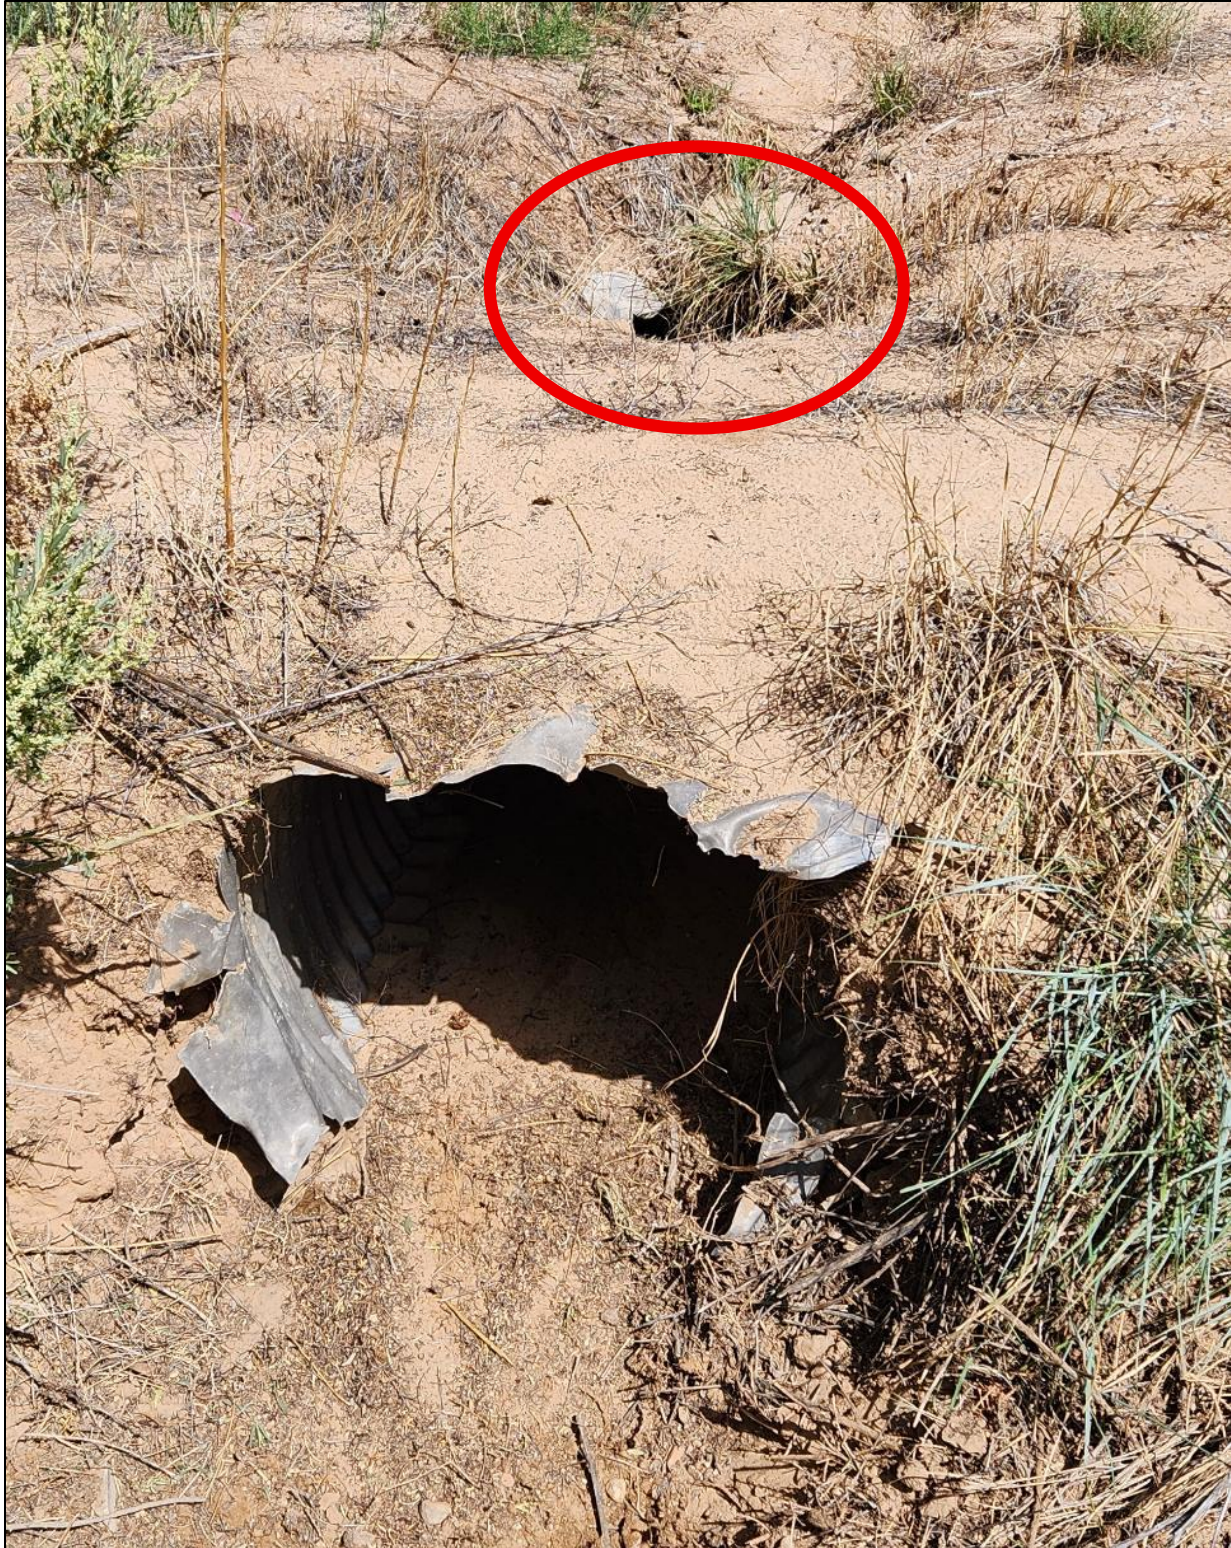
FIGURE 60: Inlet side after removal of brush with collapsed section of the culvert circled in red, NM 117 MP 55 culvert.

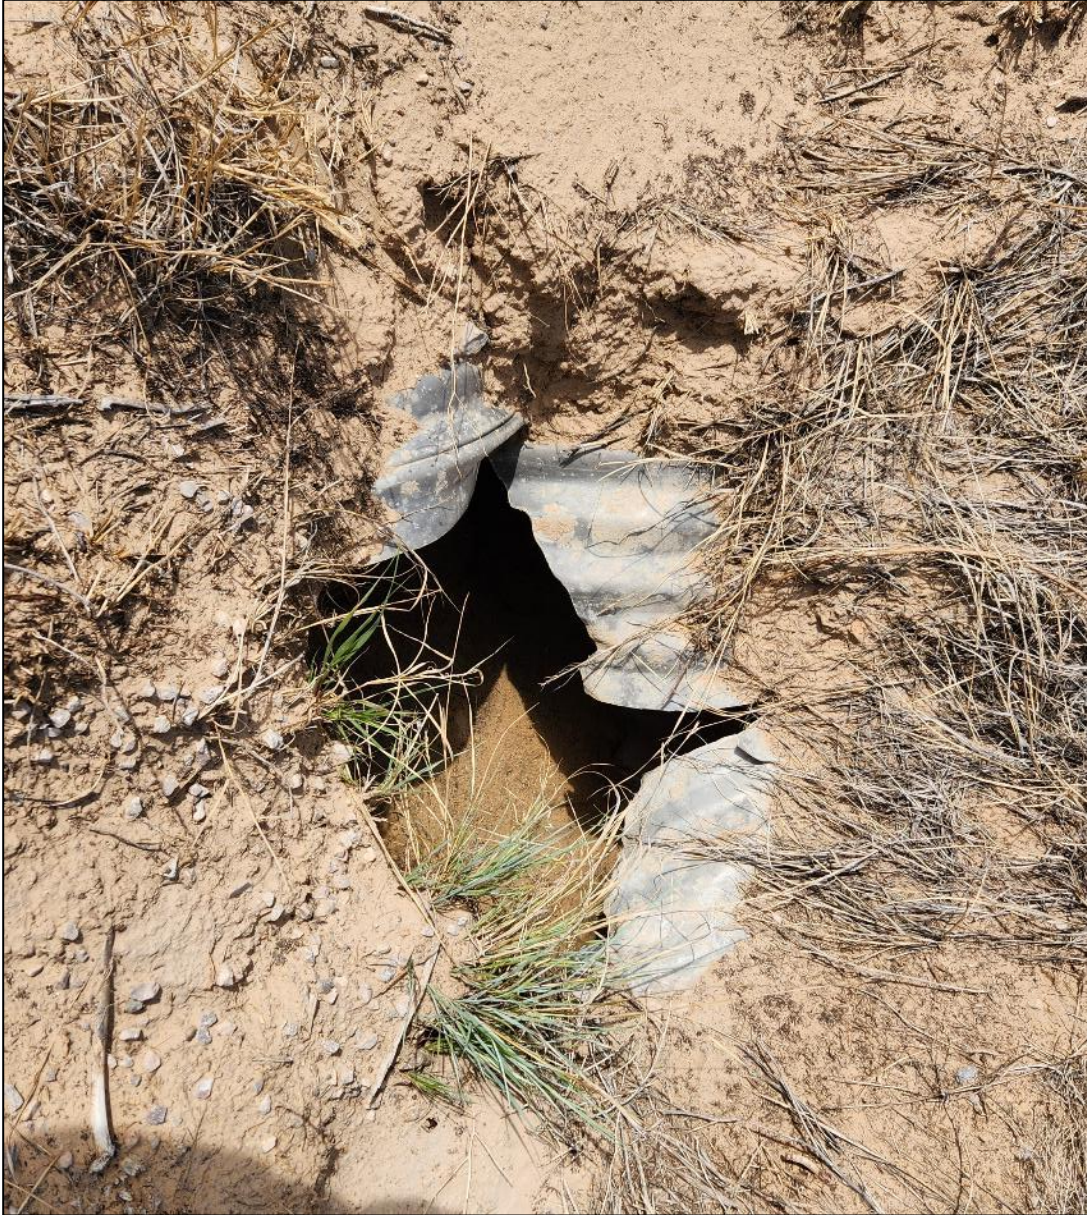
FIGURE 61: Close-up of collapsed culvert, roughly 3' by 2', NM 117 MP 55 culvert.

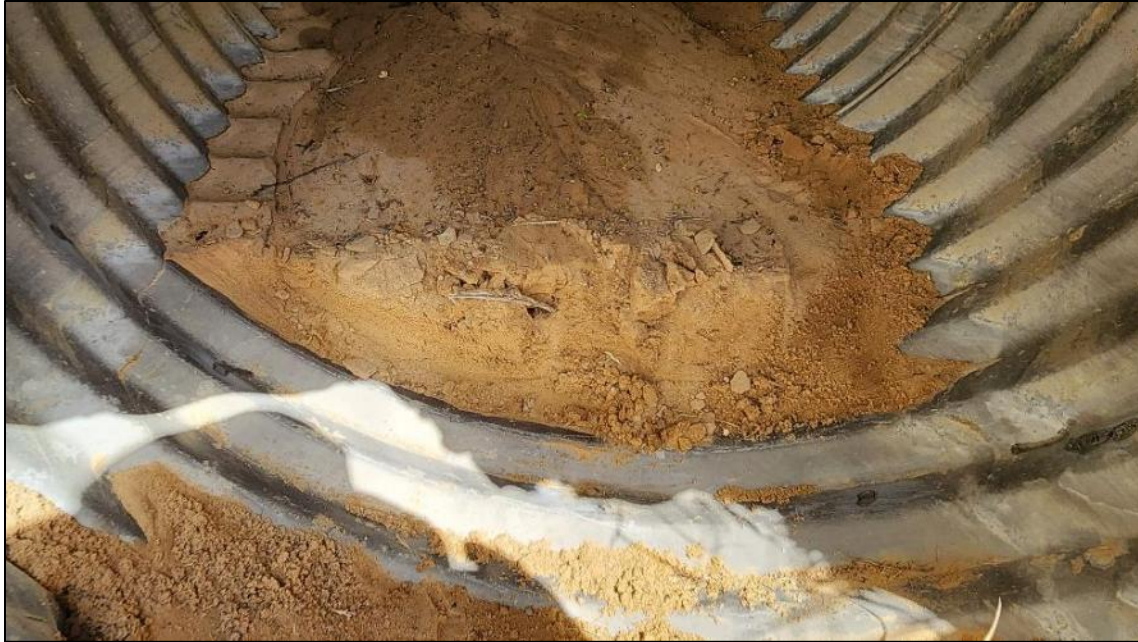
FIGURE 62: Location of ultrasonic thickness measurement, zero corrosion present, NM 117 MP 55 culvert.

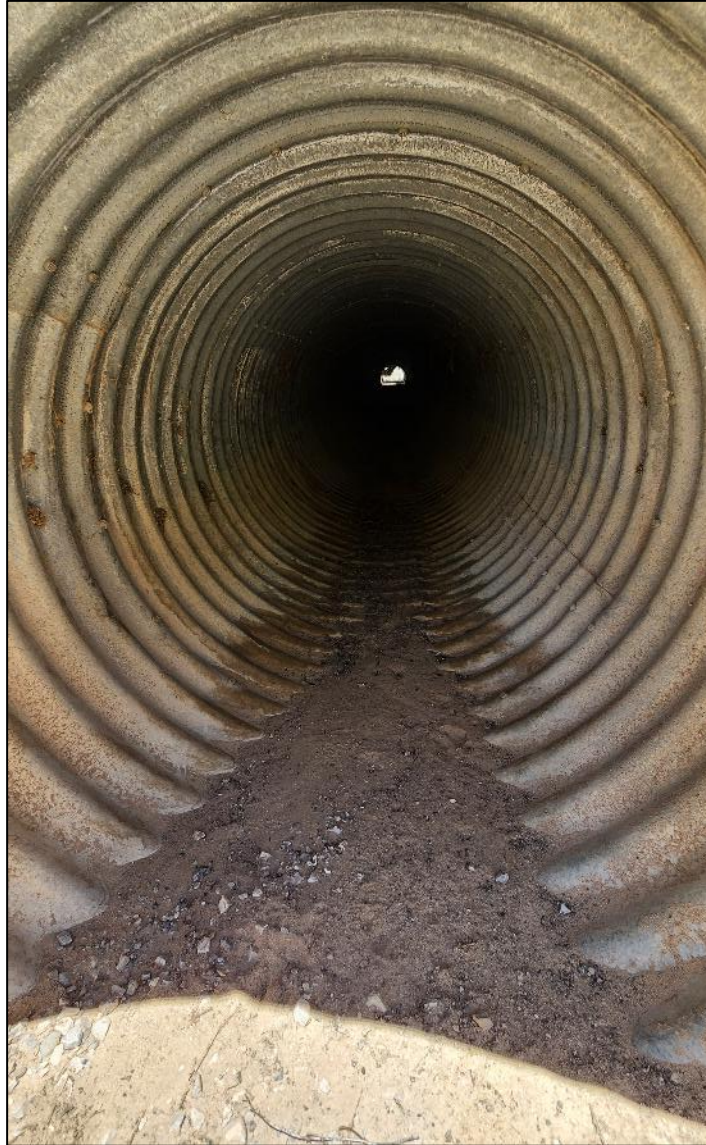
FIGURE 65: Inside of the inlet side of the culvert on NM 117 MP 55.8, indicating some slight corrosion on the bottom inside of the culvert.

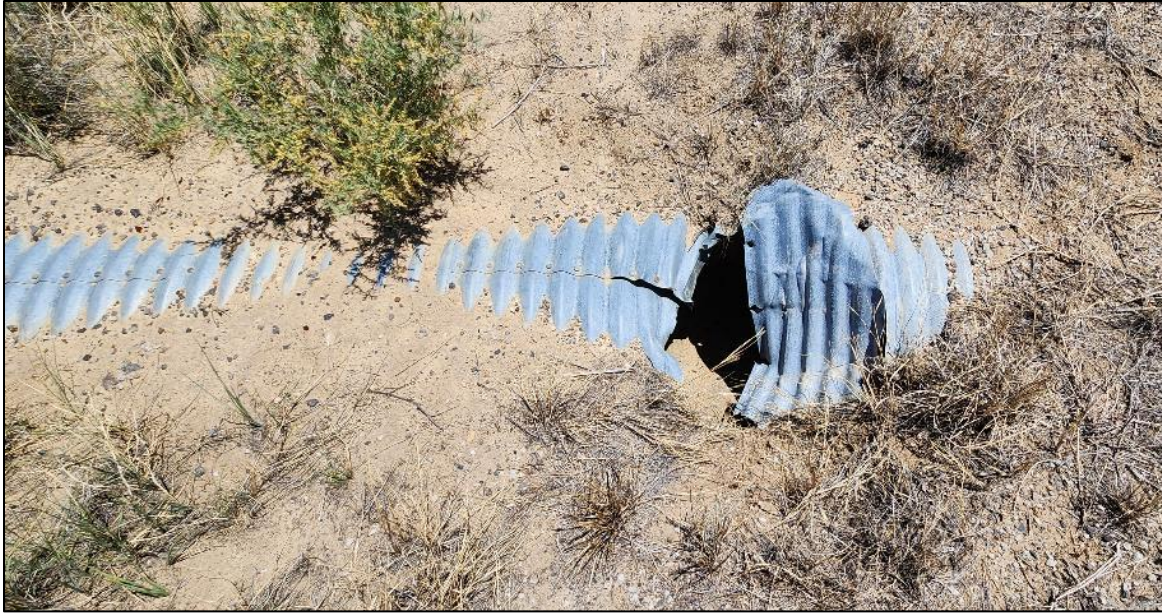
FIGURE 66: Outlet of culvert on NM 117 MP 55.8 showing collapsed location.

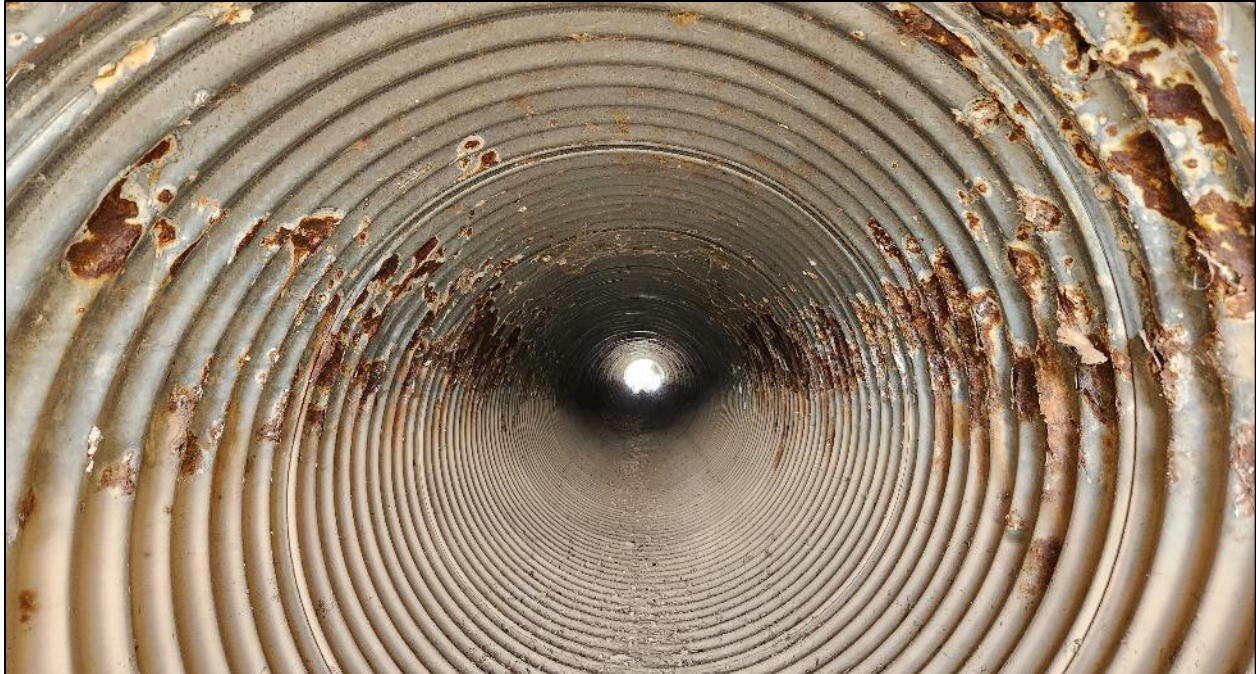
FIGURE 72: Culvert on NM 117 MP 57, inlet side, significant corrosion on the upper half of the culvert and minimal to no corrosion on the lower half.

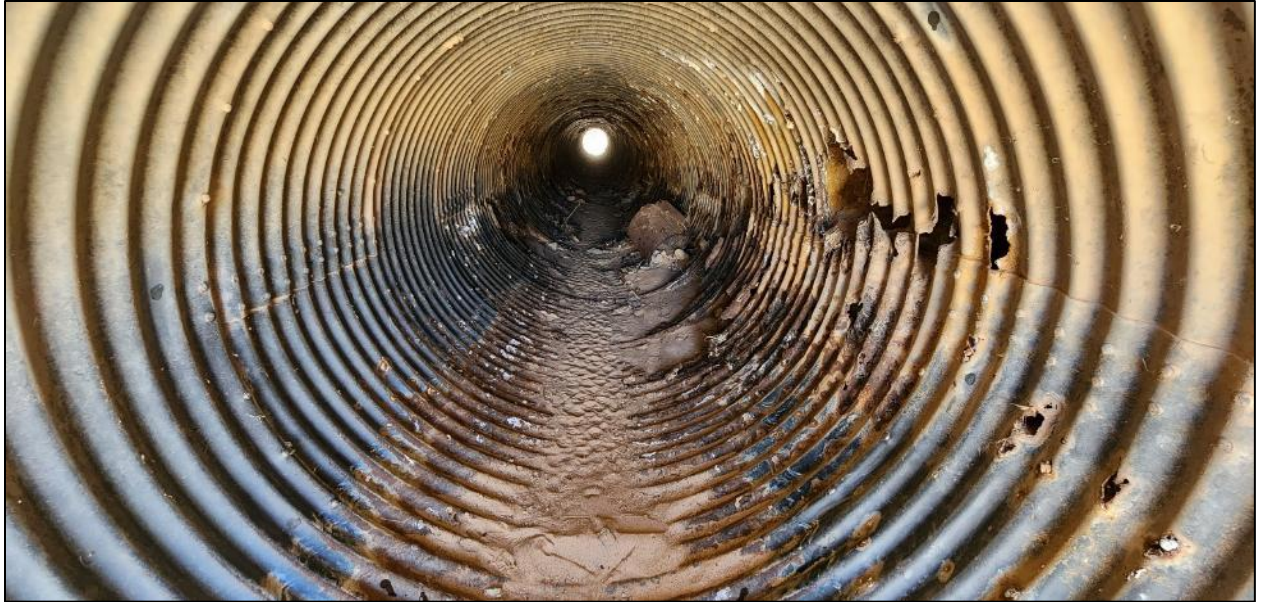
FIGURE 85: Culvert on NM 290 MP0.65, inlet side, approximately 10 feet in from the end. Image shows multiple large sections of the culvert's bottom missing in addition to a large hole halfway up the right side.

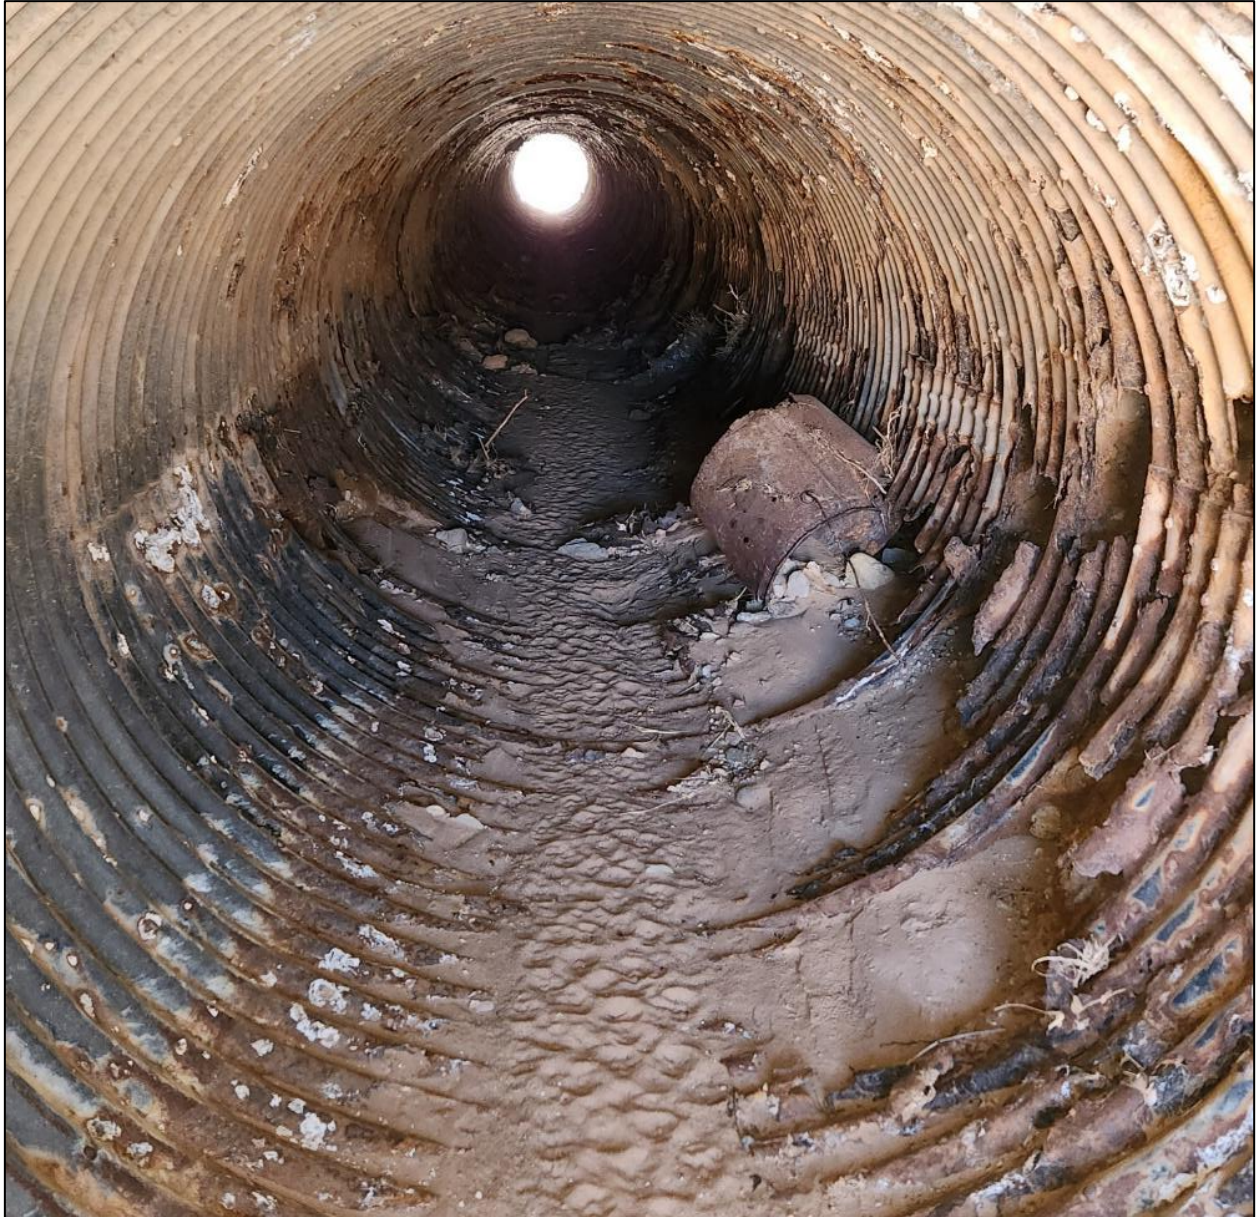
FIGURE 86: Culvert on NM 290 MP 0.65, inlet side, approximately 10 feet in from end. Image shows a zoomed-in view of the culvert's bottom where large sections are missing and what appears to be an old, metal bucket stuck in one of the corroded holes.

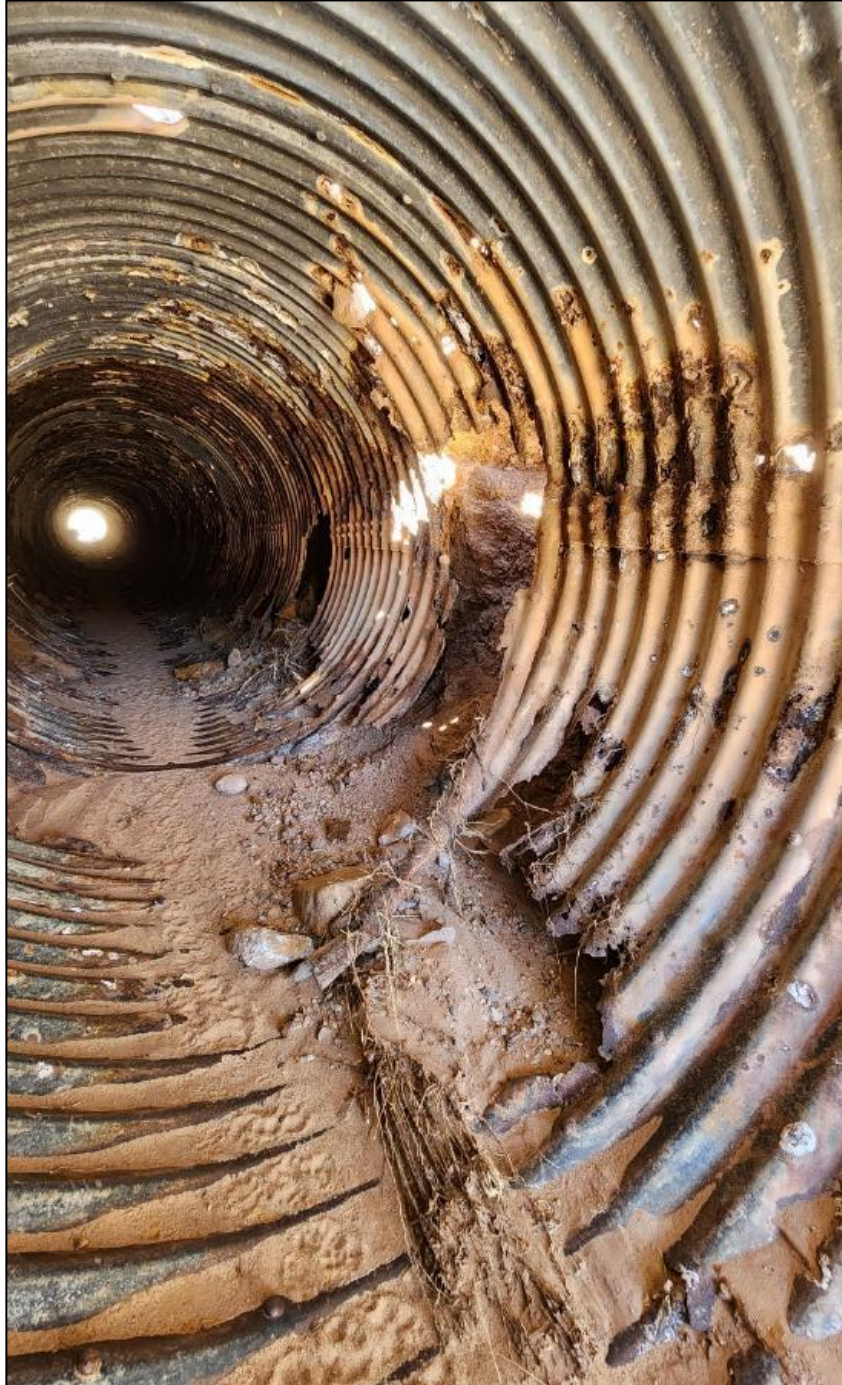
FIGURE 87: Culvert on NM 290 MP0.65, outlet side, approximately 10 feet in from end. Extreme corrosion with backfill being undermined during last flow event.

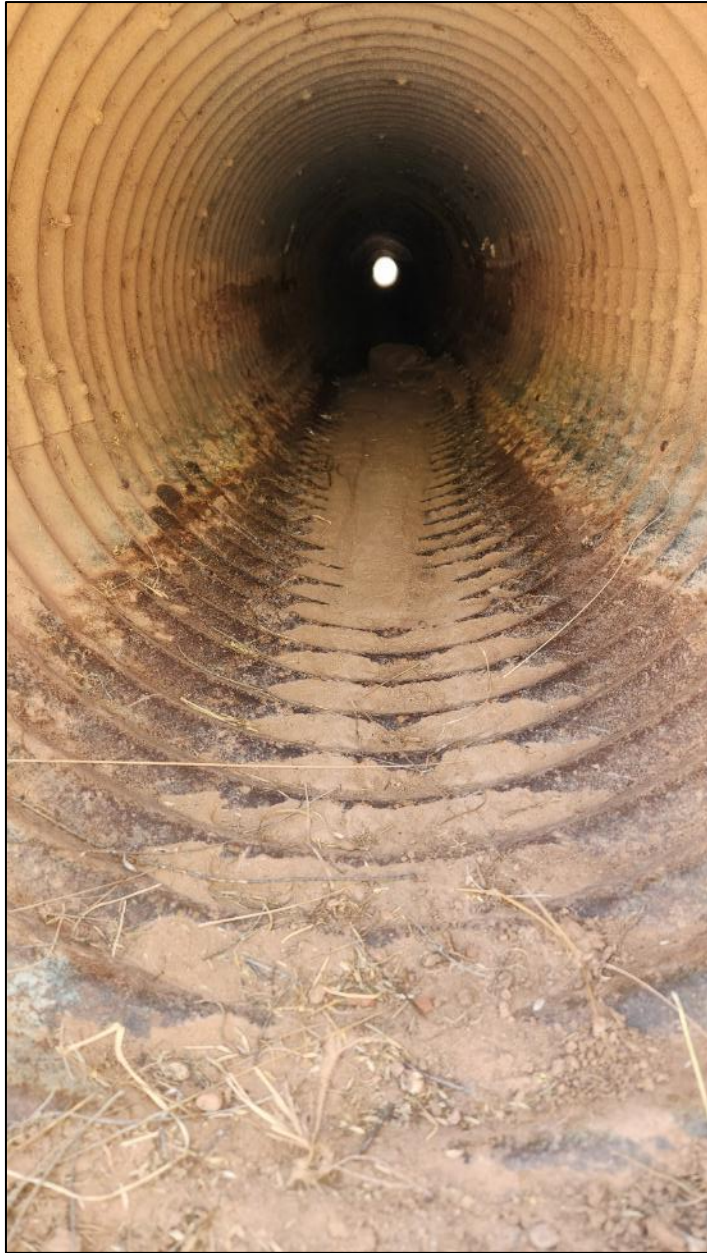
FIGURE 91: Culvert on NM 290 MP 0.91, inlet side showing corrosion on the inside bottom.

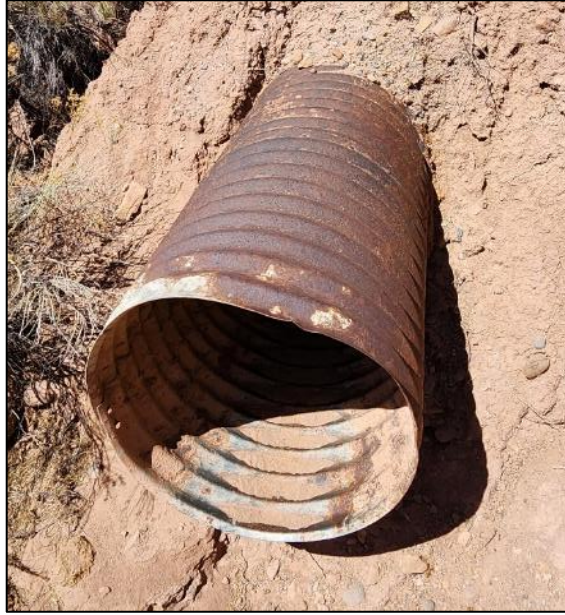
FIGURE 92: Culvert on NM 290 MP 0.91, outlet side with excessive outside corrosion.

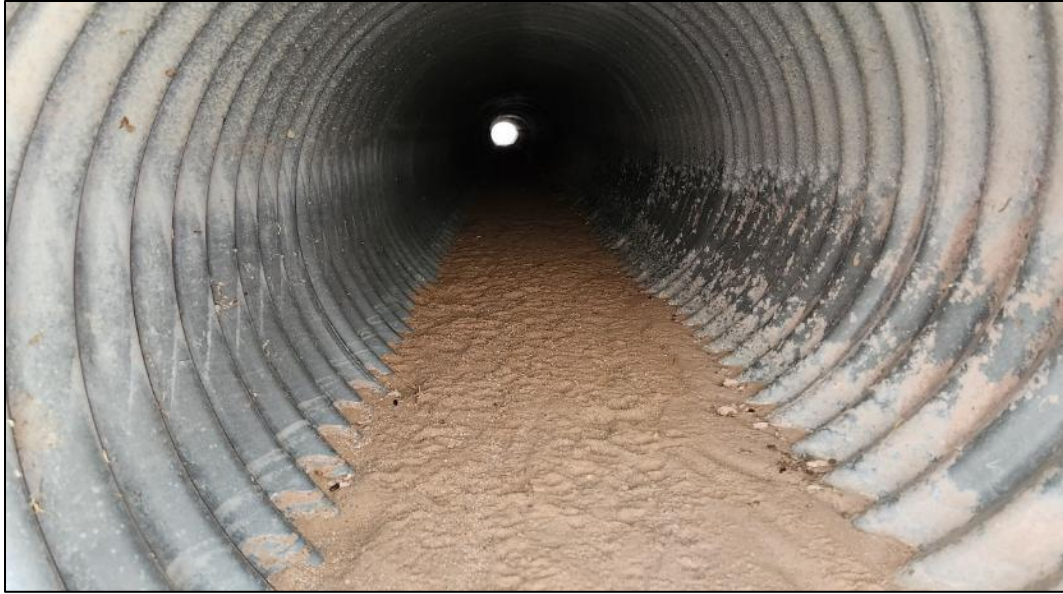
FIGURE 95: No corrosion present on the inside of the culvert on NM 290 MP 1.0.
