Comparing Resistivity and Conductivity in Metal Culverts

Final Report

Agua del Sol Consultants, LLC
PO Box 92797
Albuquerque, NM 87199

Report R924020

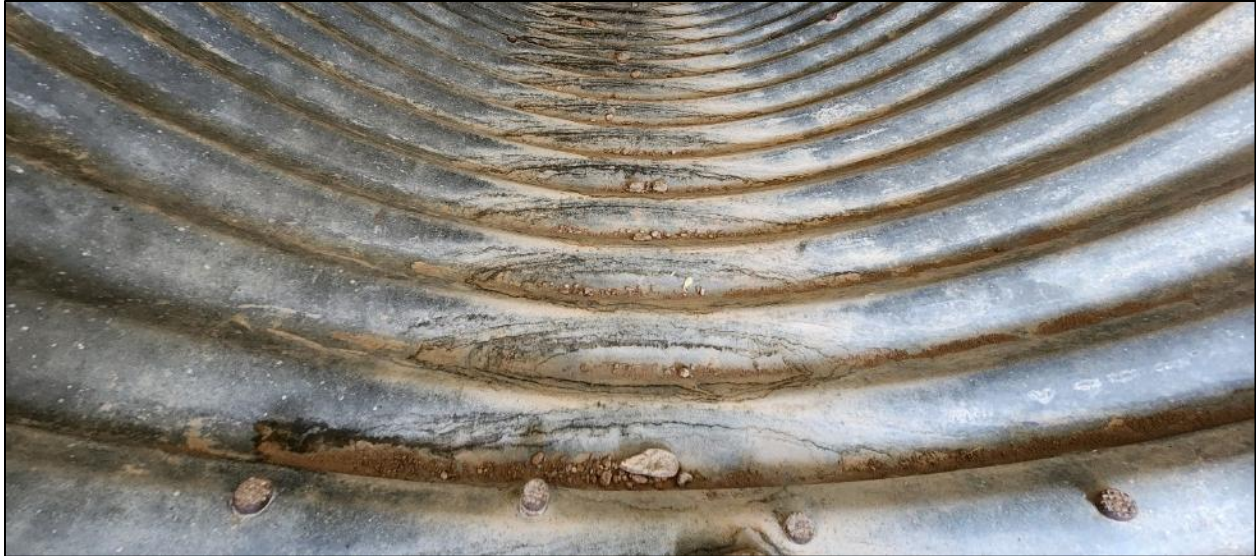
FIGURE 98: No corrosion was present on the inside of the culvert on US 60 MP 203.41.

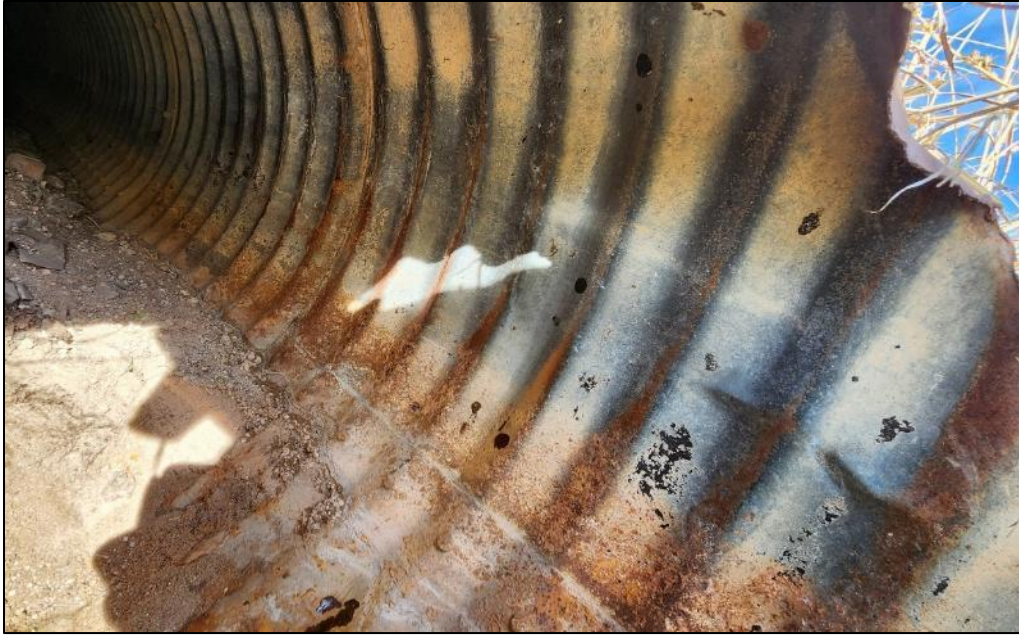
FIGURE 101: Considerable amount of corrosion on the inside of the culvert on US 60 MP 204.33.
