## Field Evaluation of Lightweight Noise Barriers and Development of Noise Barrier Inspection and Asset Management Program

**Final Report VTRC 26-R47**

**FIELD EVALUATION OF LIGHTWEIGHT NOISE BARRIERS AND DEVELOPMENT  
OF NOISE BARRIER INSPECTION AND ASSET MANAGEMENT PROGRAM**

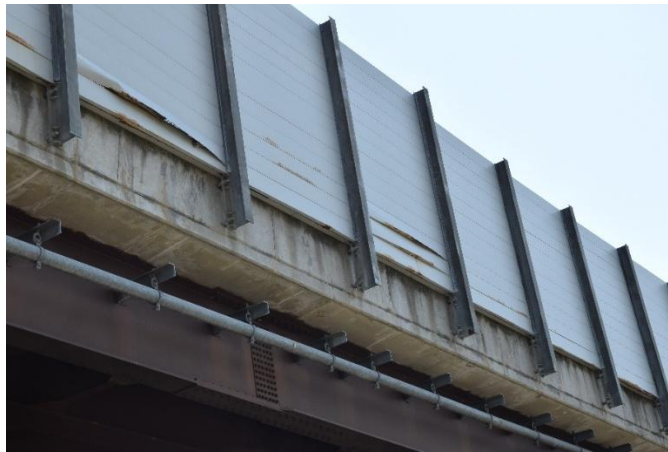
underperformed. Corrosion of some metal panel barriers has caused premature failures such as buckling, crushing, or panel slippage, leading to compromised noise reduction effectiveness and increased replacement costs. Figure 2 shows an example of this corrosion damage. In response, VDOT began using alternative lightweight materials, such as composites, acrylics, and PVC. Although these alternative materials have anecdotally performed well in terms of structural durability, a comprehensive field evaluation is required to determine the long-term durability of all lightweight material noise barriers in the VDOT inventory.

Figure 2. Example of Corrosion Damage on Metal Noise Barrier in Virginia

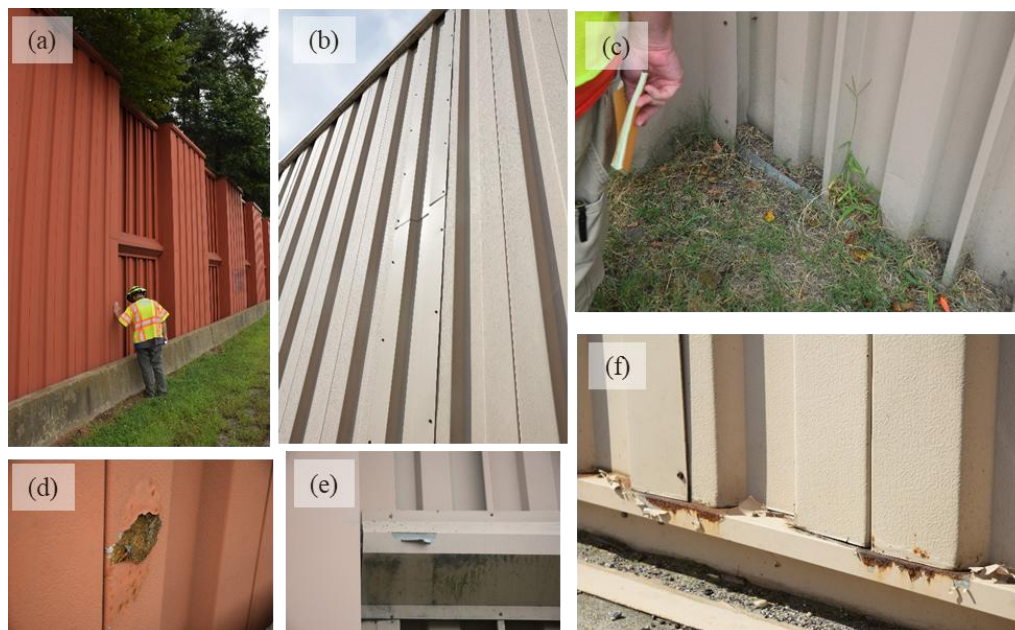
Noise barriers constructed with metal panels oriented vertically were used in ground-mounted and bridge-mounted applications. In general, these barriers appeared to be performing well from a corrosion standpoint. Most of these wall areas had intact coatings after many years of service. This observation is notable because two of these barriers were constructed in 1983 and 1991. Some localized coating failures had progressed to corrosion damage. Although the bases of the ground-mounted barriers appeared to exhibit good corrosion resistance, they could be susceptible to corrosion damage if poor drainage were to cause ponding at the base of the walls. The flashing at the base of the structure-mounted barriers showed more corrosion damage than the rest of the panels because of water and salt accumulation. Figure 5 shows representative photos of the condition of noise barriers with metal panels oriented vertically.

**Figure 5. Photos of the Condition of Noise Barriers Constructed with Metal Panels Oriented Vertically: (a) Overall Condition of Ground-Mounted Barriers; (b) Overall Condition of Bridge-Mounted Barriers; (c) Susceptibility to Corrosion if Ponding Were to Occur; (d) Minor Section Loss at Intermittent Locations; (e) Minor Coating Failure at Intermittent Locations; (f) Corrosion Damage at Base and Flashing of Bridge-Mounted Barriers**

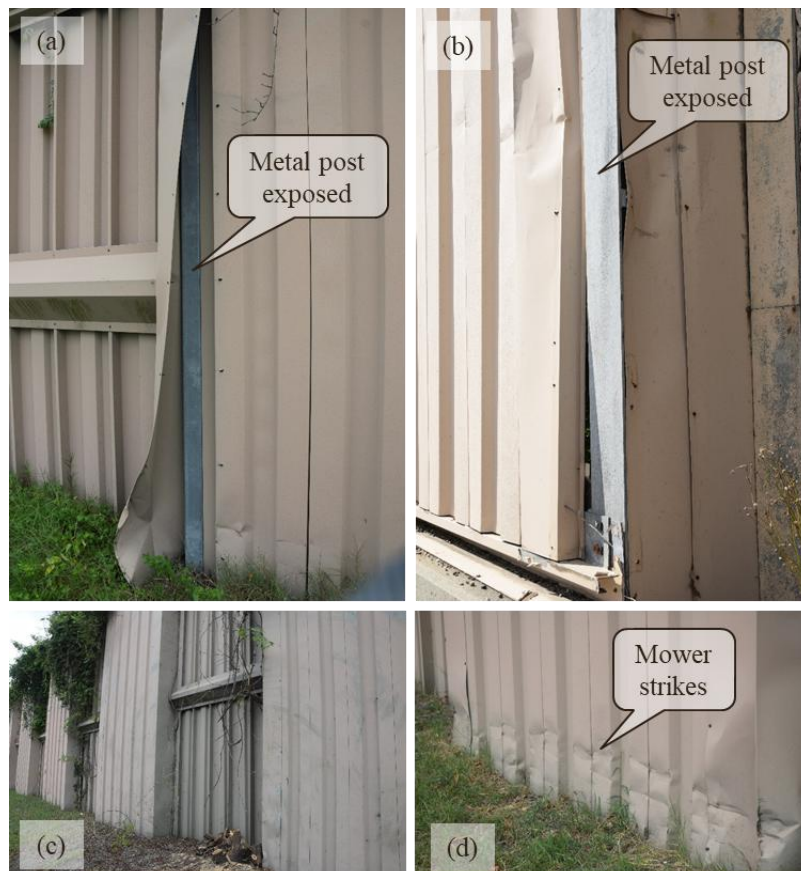
These types of panels also appeared susceptible to impact damage. Three of the inspected barriers had impact damage, likely from vehicle or mower strikes. These impacts had bent the metal panels, exposing the metal posts behind the panels. If not repaired, the exposed posts could experience accelerated corrosion because they were not coated with the same level of corrosion protection as the metal panels. In addition, these metal panels were susceptible to vegetation growth, which could cause accelerated deterioration in the future if not maintained. Figure 6 shows representative photos of this impact damage and vegetation growth.

**Figure 6. Additional Photos of the Condition of Noise Barriers Constructed with Metal Panels Oriented Vertically: (a) Impact Damage Leaving Metal Post Exposed on Ground-Mounted Barrier; (b) Impact Damage Leaving Metal Post Exposed on Bridge-Mounted Barrier; (c) Vegetation Growth; (d) Mower Impact Strikes on Ground-Mounted Barrier**

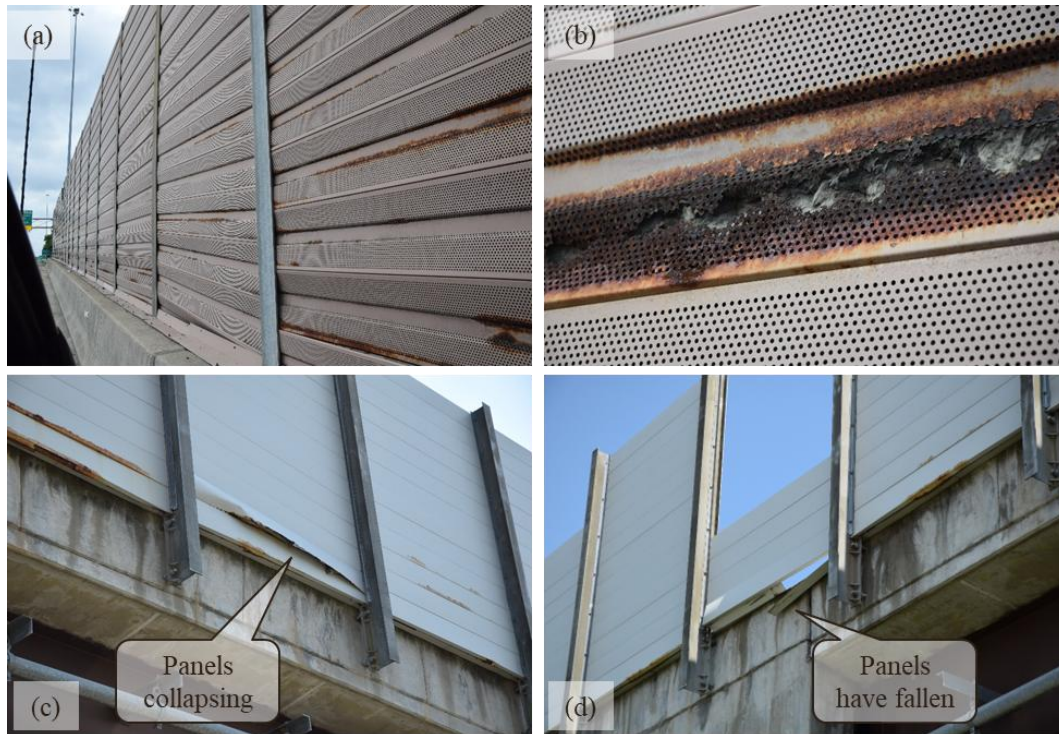
corrosion damage. Based on field observations, the rock wool in these barriers became saturated with salt spray, causing corrosion damage from the inside out. The weight of the saturated rock wool also contributed to some of these panels collapsing between their posts and falling to the ground below, clearly causing safety concerns. Figure 7 shows representative photos of these panels with corrosion damage.

**Figure 7. Photos of the Condition of Noise Barriers Constructed with Metal Panels Oriented Horizontally with Perforations: (a) Overall View from Roadway Side of Corrosion Present Throughout; (b) Closeup from Roadway Side of Corrosion Damage on Front Face of Panels; (c) Panels Collapsing Viewed from the Back Side; (d) Back Side View Showing Missing Panels that Have Fallen to the Ground**

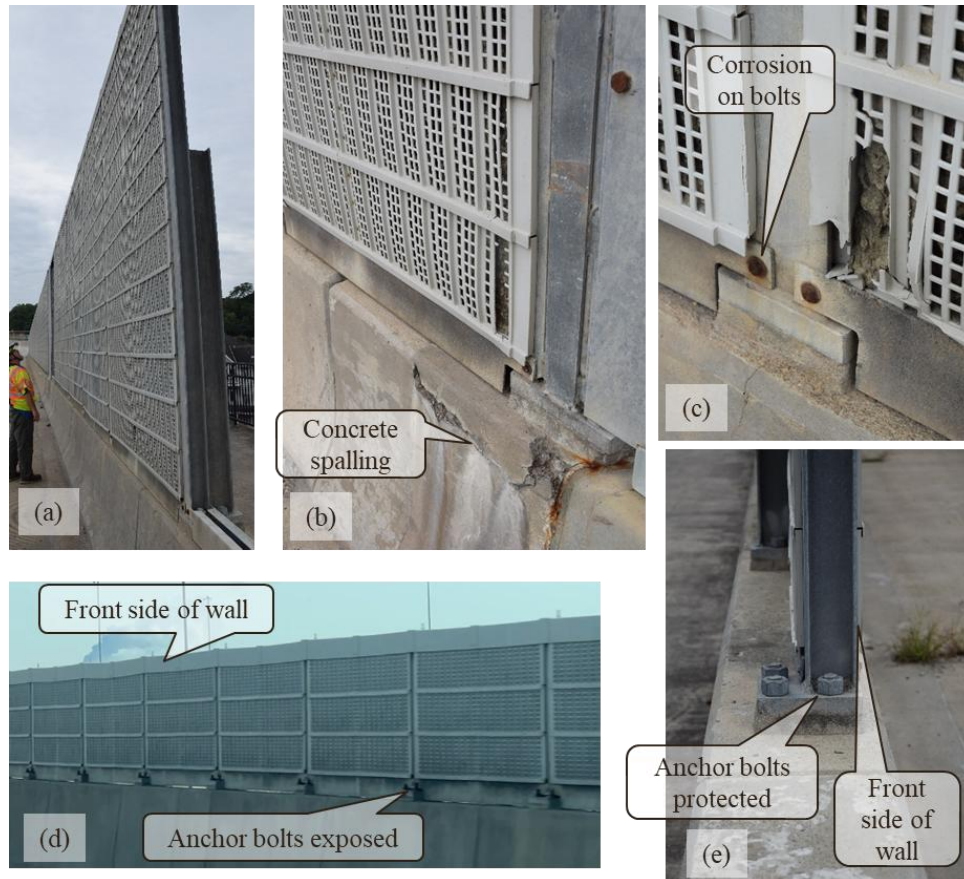
to the posts likely caused stress on the panels and resulted in this damage. Previous photos of the noise barrier suggested that these cracked locations had been present for about 12 years with no notable progressive damage. Therefore, this damage does not appear to warrant significant concern. Figure 8 shows photos that illustrate the damage present on the barriers constructed with composite panels.

**Figure 8. Photos of the Condition of Noise Barriers Constructed with Composite Panels: (a) Overall View with Barrier; (b) Closeup Showing Cracking at Intermittent Locations Near Panel-to-Post Connections and Concrete Spalling in the Barrier; (c) Closeup Showing Damage on Panels and Corrosion on Bolts Connecting Panels to Posts; (d) Exposed Anchor Bolts with Corrosion; (e) Anchor Bolts Protected from Salt Spray Showing no Corrosion**

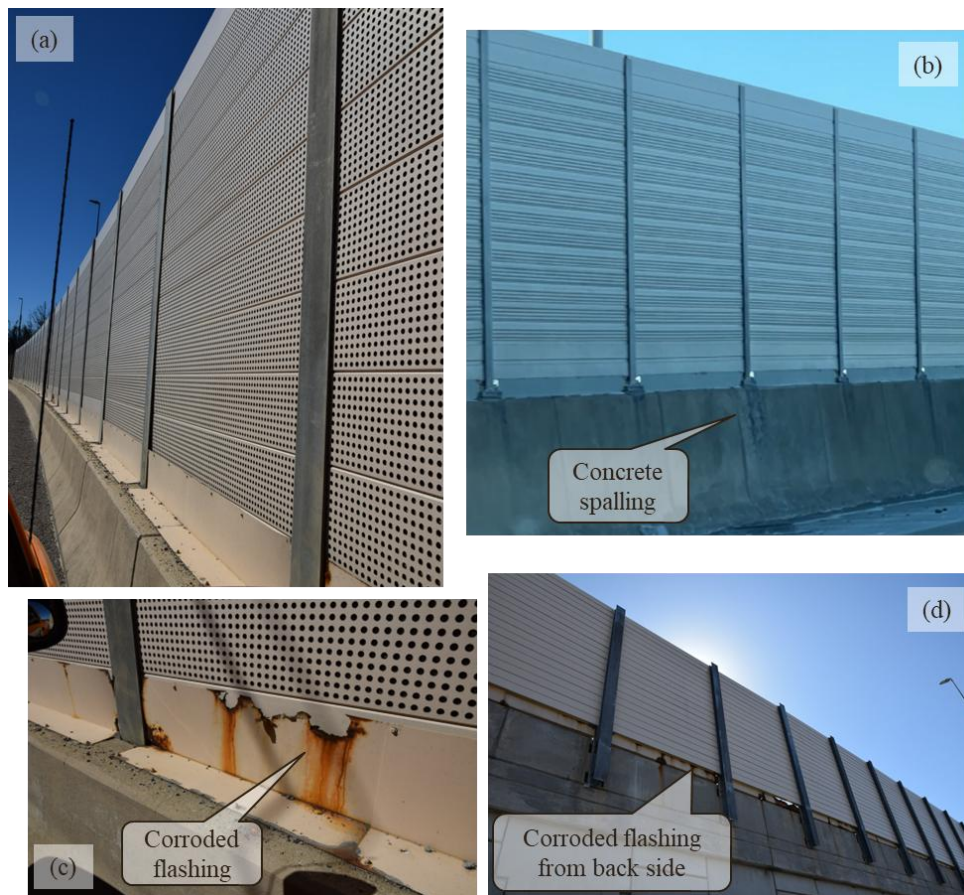
The PVC panel noise barriers observed were performing well with no deficiencies found on the panels. Figure 9 shows representative photos of these noise barriers. Some corrosion was observed on the metal flashing connected between the panels and concrete barrier. This corroded flashing could easily be replaced if necessary. The two PVC panel noise barriers visited had two different designs for anchor connections. In the noise barrier with vertical anchor bolts connecting the posts to the concrete barrier, spalling was present in many locations. No corrosion was observed at the horizontal bolted connections between the posts and concrete barrier because these connections were protected from salt spray. However, as noted previously, these connections are extremely difficult to inspect.

**Figure 9. Photos of the Condition of Noise Barriers Constructed with Polyvinyl Chloride Panels: (a) Overall View of Barrier; (b) Concrete Spalling in Concrete Barrier at Post Connections; (c) Corroded Flashing at Panel Base; (d) Back Side of Noise Barrier Showing Post Connections and Corroded Flashing**

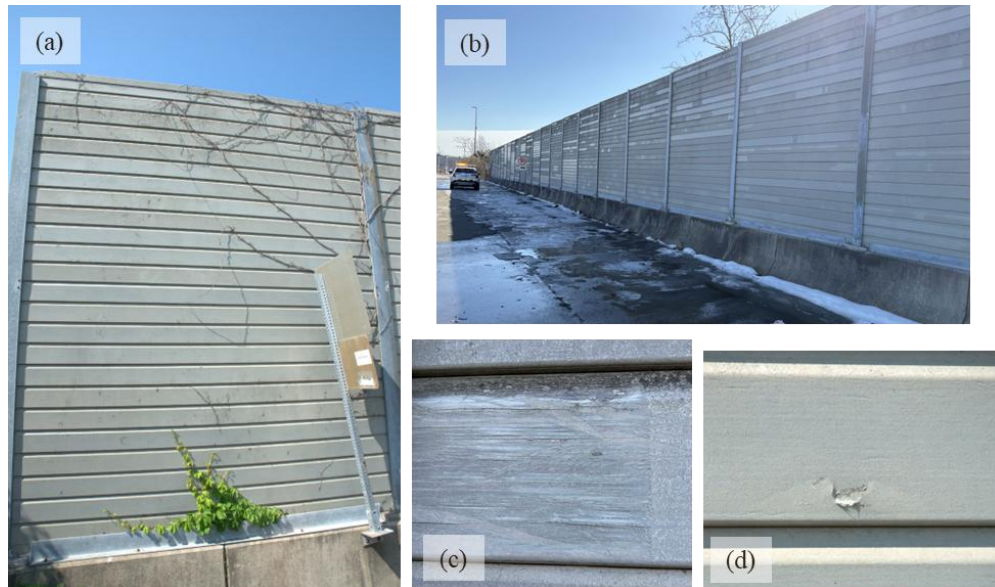
Noise barriers constructed with fiberglass panels also performed well, with only minor deficiencies found on the panels. These deficiencies included very small amounts of deterioration and one instance of impact damage. In some instances, vegetation growth occurred on the noise barriers, but it did not appear to have caused any damage yet. The vertical anchor bolts connecting the posts to the concrete barrier were performing well with no visible corrosion. This condition was likely because they were on a road with less traffic relative to some of the other noise barriers inspected, so they were subject to less salt spray. Figure 10 shows representative photos of the condition of fiberglass panel noise barriers.

**Figure 10. Photos of the Condition of Noise Barriers Constructed with Fiberglass Panels: (a) Single Panel with Vegetation Growth; (b) Overall View; (c) Closeup of Deterioration; (d) Closeup of Impact Damage**

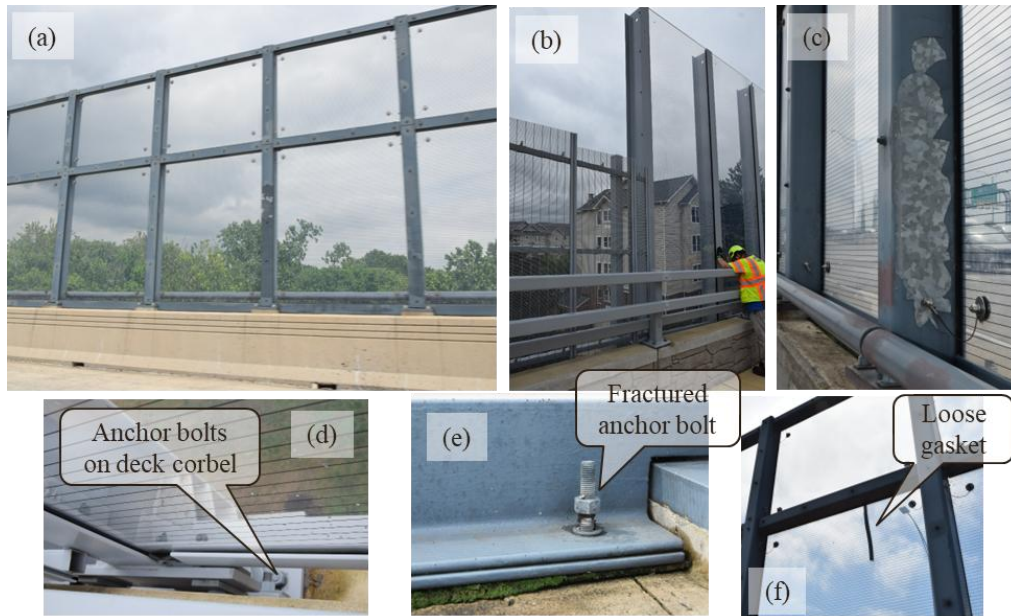
On the noise barriers with acrylic panels, the panels appeared to be performing well overall. Figure 11 shows representative photos of the condition of acrylic panel noise barriers. The acrylic portions of the panels did not appear to have any durability issues. Multiple gaskets, designed to be between the acrylic panels and metal posts or metal bracing, were either loose or missing in all three of the noise barriers inspected. Although these missing gaskets do not pose an immediate concern, they could increase the amount of vibration in the acrylic panels, potentially leading to deterioration in the future.

**Figure 11. Photos of the Condition of Noise Barriers Constructed with Acrylic Panels: (a) Overall View Showing Coating Failures on Metal Posts; (b) Overall View of Another Noise Barrier; (c) Closeup of Coating Failure on Metal Posts; (d) Anchor Bolts on Deck Corbel Showing Good Performance; (e) Fractured Anchor Bolt and Evidence of Trapped Moisture Between Panel and Concrete Barrier; (f) Closeup of Loose Gasket Between Panel and Metal Bracing**

The metal posts and bracing on these noise barriers appeared to be a duplex coating system, consisting of first galvanizing the steel and then applying a coating on top. On these steel posts and bracing members, many instances of coating failures were present and areas that had been recoated. This condition was especially true for the older noise barrier that was inspected. Two types of post connections were observed during these field visits. In the connections using vertical anchor bolts, some fractured anchor bolts and evidence of trapped moisture between the concrete barrier and metal bracing were observed. The other type of post connection consisted of horizontal bolts connecting the post to the back of the concrete barrier and vertical anchor bolts connecting the post to a concrete corbel. This connection was performing well in terms of durability because it was protected from salt spray. This type of connection also provides greater durability and redundancy than the other post connection types.

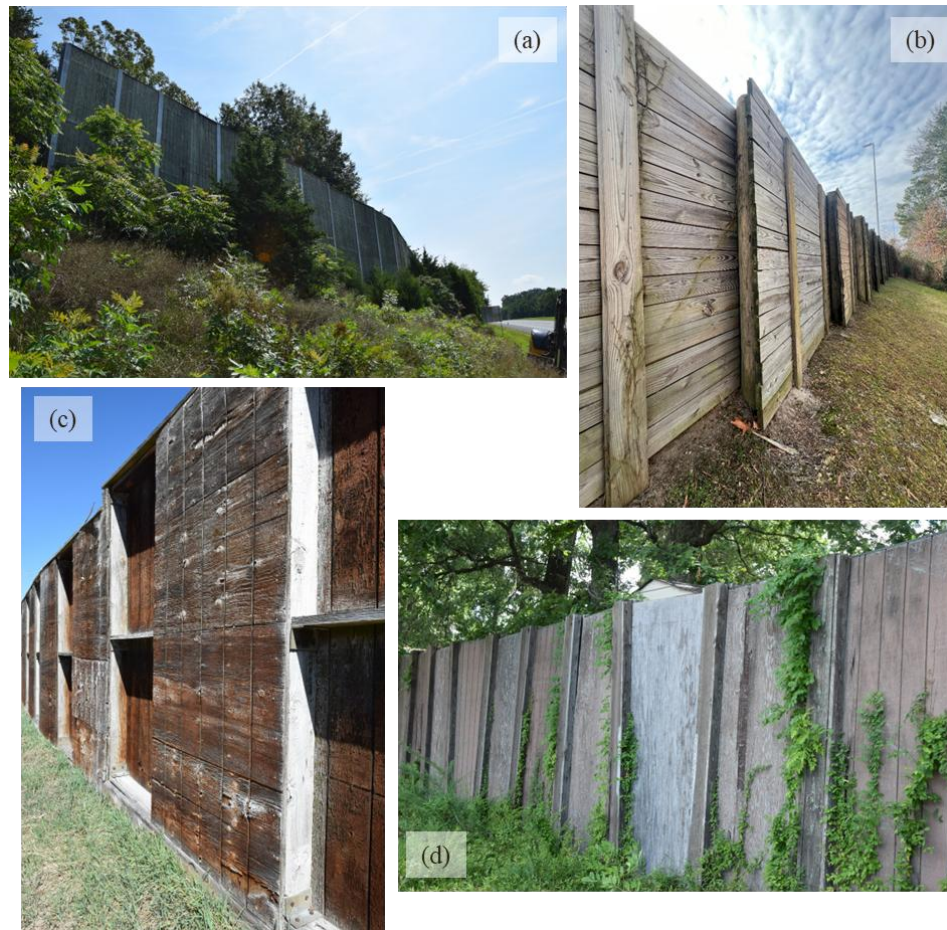
non-structural grade wood without preservatives. In addition, UV degradation was less notable in wood panels using waterproof structural adhesives than in those without. Furthermore, the wood panels appeared to be more susceptible to damage from vegetation growth than some of the other lightweight materials. Figure 12 shows representative photos of the condition of wood panel noise barriers inspected during the field evaluations.

**Figure 12. Photos of the Condition of Noise Barriers Constructed with Wood Panels: (a) Good Condition Noise Barrier with Metal Posts; (b) Good Condition Noise Barrier; (c) Old Noise Barrier in Good Condition; (d) Subpar Quality Wood Panel Noise Barrier in Poor Condition with Vegetation Growth and Flaking Wood**

Based on the field evaluations, lightweight wood panels constructed with structural grade, pressure-treated wood with structural adhesives and a UV-resistant treatment can be expected to achieve a service life of 50 years. In these cases, the good quality wood, adhesives, and treatments aid in protecting the panel from degradation caused by moisture and UV.

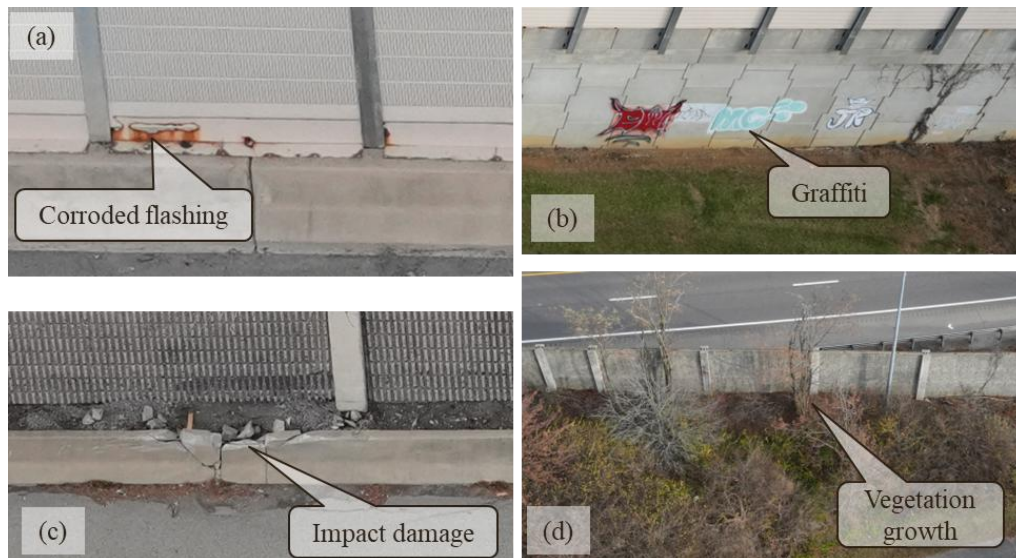
below the PVC noise barrier, impact damage on the concrete noise barrier and concrete barrier, and vegetation growth behind the concrete noise barrier.

**Figure 20. Screenshots of Colorized Mesh Model of Noise Barriers at Christiansburg Site: (a) Corroded Flashing at Base of PVC Noise Barrier; (b) Graffiti on Retaining Wall Below PVC Noise Barrier; (c) Impact Damage on Concrete Noise Barrier and Concrete Barrier; (d) Vegetation Growth Behind Concrete Noise Barrier. Photos were taken with a 61 megapixel camera at either 180 or 250 feet above ground level. PVC = polyvinyl chloride.**

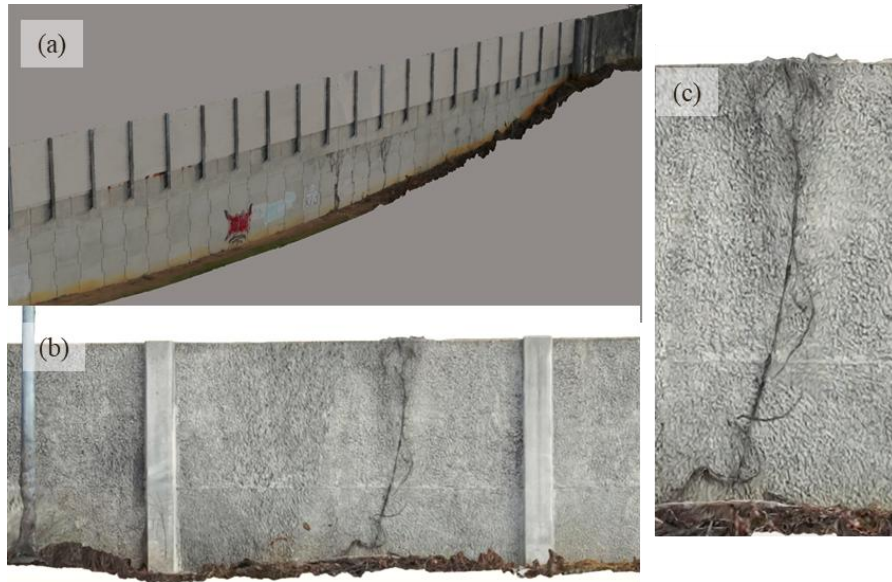
**Figure 21. Screenshots of Colorized Mesh Model at Christiansburg Site: (a) Overall View of Polyvinyl Chloride Noise Barrier; (b) Overall View of Vine Growth Along Back Side of Concrete Noise Barrier; (c) Closeup of Vine Growth on Concrete Noise Barrier**

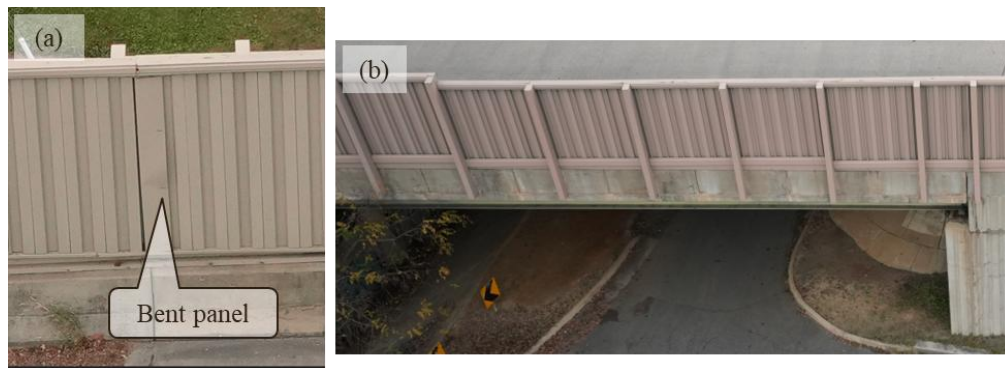
Figure 24 and Figure 25 show screenshots of the colorized mesh model of the metal noise barrier at the Fredericksburg site. Figure 24a shows that the bent panel on the noise barrier was captured through the UAS data, demonstrating its effectiveness at capturing condition data. Figures 24 and 25 display the high-resolution data that could be used to evaluate other noise barriers with potential damage.

**Figure 24. Screenshots from Colorized Mesh Model of Metal Noise Barrier at Fredericksburg Site: (a) Bent Panel on Front Side of Noise Barrier; (b) Back Side of Noise Barrier**
