DOT/FAA/CT-83/42  
NASA-TM-85654

# Structural Response of Transport Airplanes in Crash Situations

November 1983

Final Report

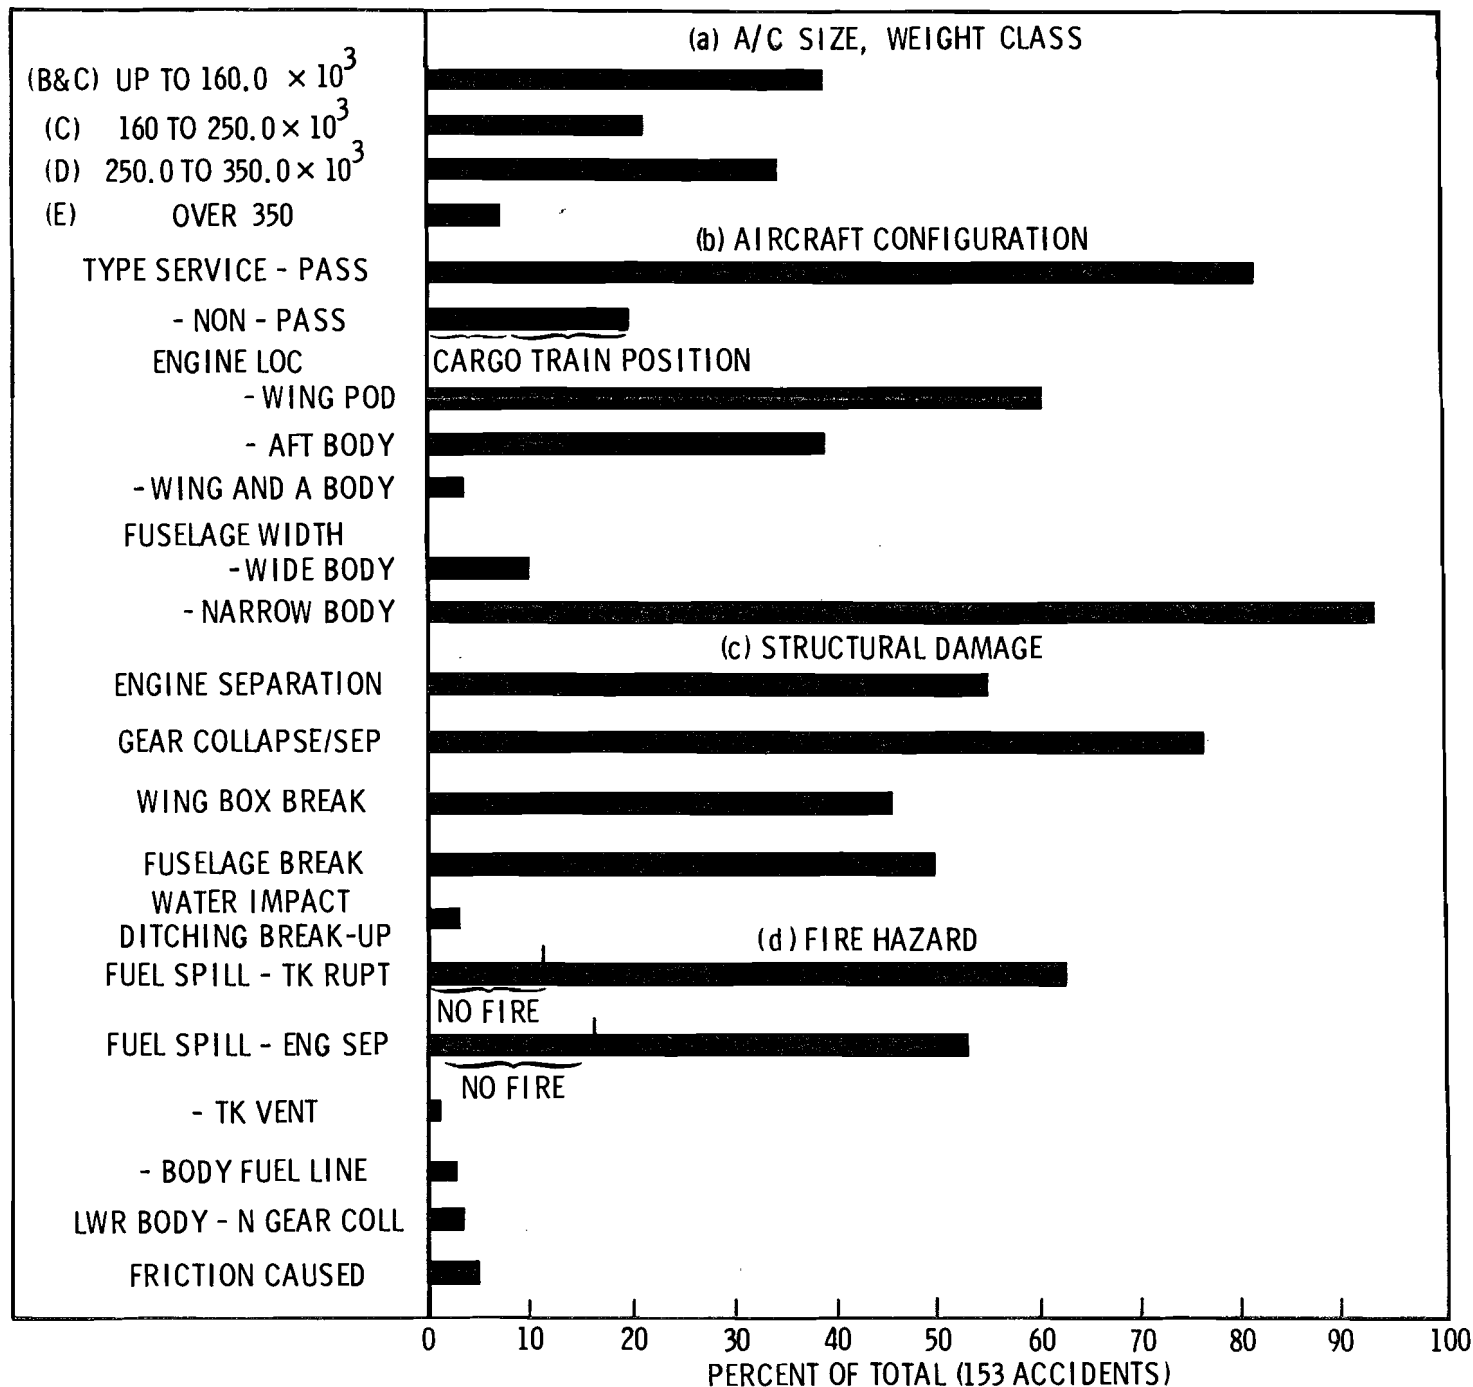
FIGURE 2. - AIRCRAFT SIZE AND CONFIGURATION

By referring to figure 2b, approximately 20% of transport airplane accidents involve non-passenger service. Non-passenger service was further divided into cargo, training, and positioning flights. As regards cargo service, a review of the accident data shows some cases where cargo shift during the accident increased the hazard to the flight crew. (A notable instance is an accident where cattle pens broke loose during an overrun and blocked the cockpit door). Training accidents most frequently involve engine-out takeoff attempts. These accidents involve extreme yaw and roll angles with ground strikes of wings, engines or aft fuselage. Some accidents involve touch-and-go landing practice.

In figure 2c it may be seen that engine separation occurred in 55%, landing gear collapse or separation occurred in 75%, wing box breaks occurred in 45%, fuselage breaks occurred in 48%, and water ditching impact breakup occurred in 3% of the accidents. The separation of an engine and the breaking of a wing box imply fuel spills. In some instances a fuselage break in an aircraft with aft mounted engines also caused a fuel spill. The wide body long haul aircraft have main body landing gear that transfer high impact loads to the fuselage structure. Water ditching impact breakup is considered separately from fuselage breaks because in general the forces involved are different.

In figure 2d engine placement was observed to affect the fire hazard. In particular, aft body location is associated with the breaking of engine fuel lines and body fuel lines. Wing pylon mounted location had, in addition to fuel line breaks, the rupturing of wing fuel tanks due to pylon/engine separation. The engines mounted

internally in the wings with wing pod fuel cell tanks exhibit engine fires. The wing pod cell tanks have separated due to high accelerations and have contacted external objects. The associated fire hazard was tank rupture.

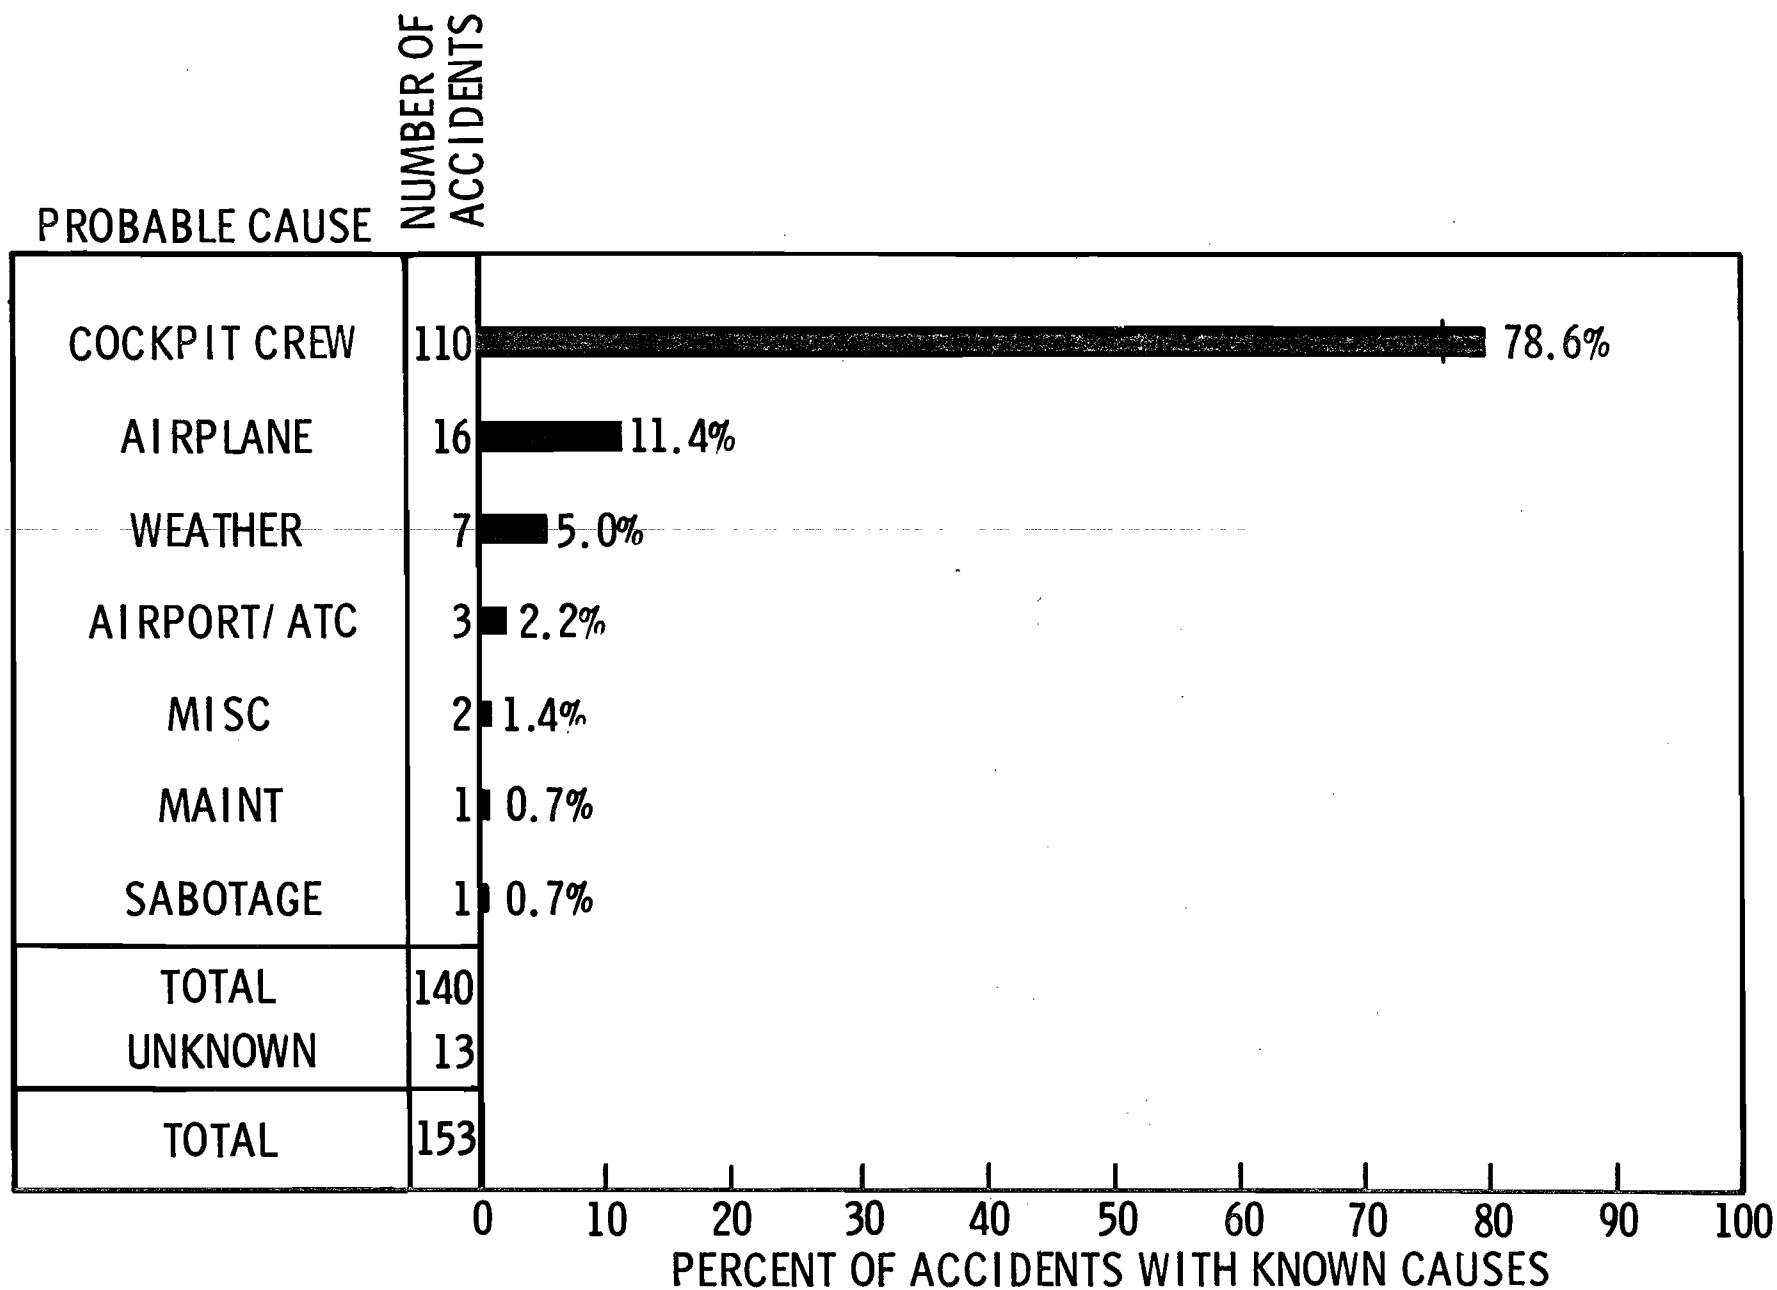
FIGURE 7. - PROBABLE CAUSE OF ACCIDENTS

The probable cause of accidents is presented in figure 7 (ref. 19). "Probable cause" is based on the determination of the accident investigation team. For 13 accidents the cause is unknown. For 140 cases where cause has been determined 76.4% of the cases are attributed to the cockpit crew, 11.1% to the airplane, 5% to weather, 2.1% to the airport/air traffic controller, 1.4% to miscellaneous, 0.7% to maintenance, and 0.7% to sabotage.

The aircraft was the cause of the accident in 11% of the cases. Landing gear systems and support structure were involved in 7 accidents. Failures involved brakes, wheels, tires, and structure. Engine disintegration, thrust loss, and thrust reversers were involved in 6 accidents. Flight instrumentation was involved in 2 accidents and ground spoilers and elevator trim tab were each involved in 1 accident. From these data it may be concluded that a large percentage of the accidents can be attributed to human error such as pilot and ground control assistance. Such items as ground proximity warning, wind shear detection, automated landing and navigation systems, and advanced integrated systems for pilot assistance offer the best hope for eliminating most accidents in the "avoidable" category. Improved ground control and reduction of hazards on and around airports is another area for improved safety. The avoidance of collisions between aircraft and with ground vehicles should be attainable. Reduction of hazards such as drainage ditches, poles, trees, columns, outbuildings and birds from airports is a matter of concern. In addition the overrun areas for runways could be improved to reduce the severity of accidents in these areas.

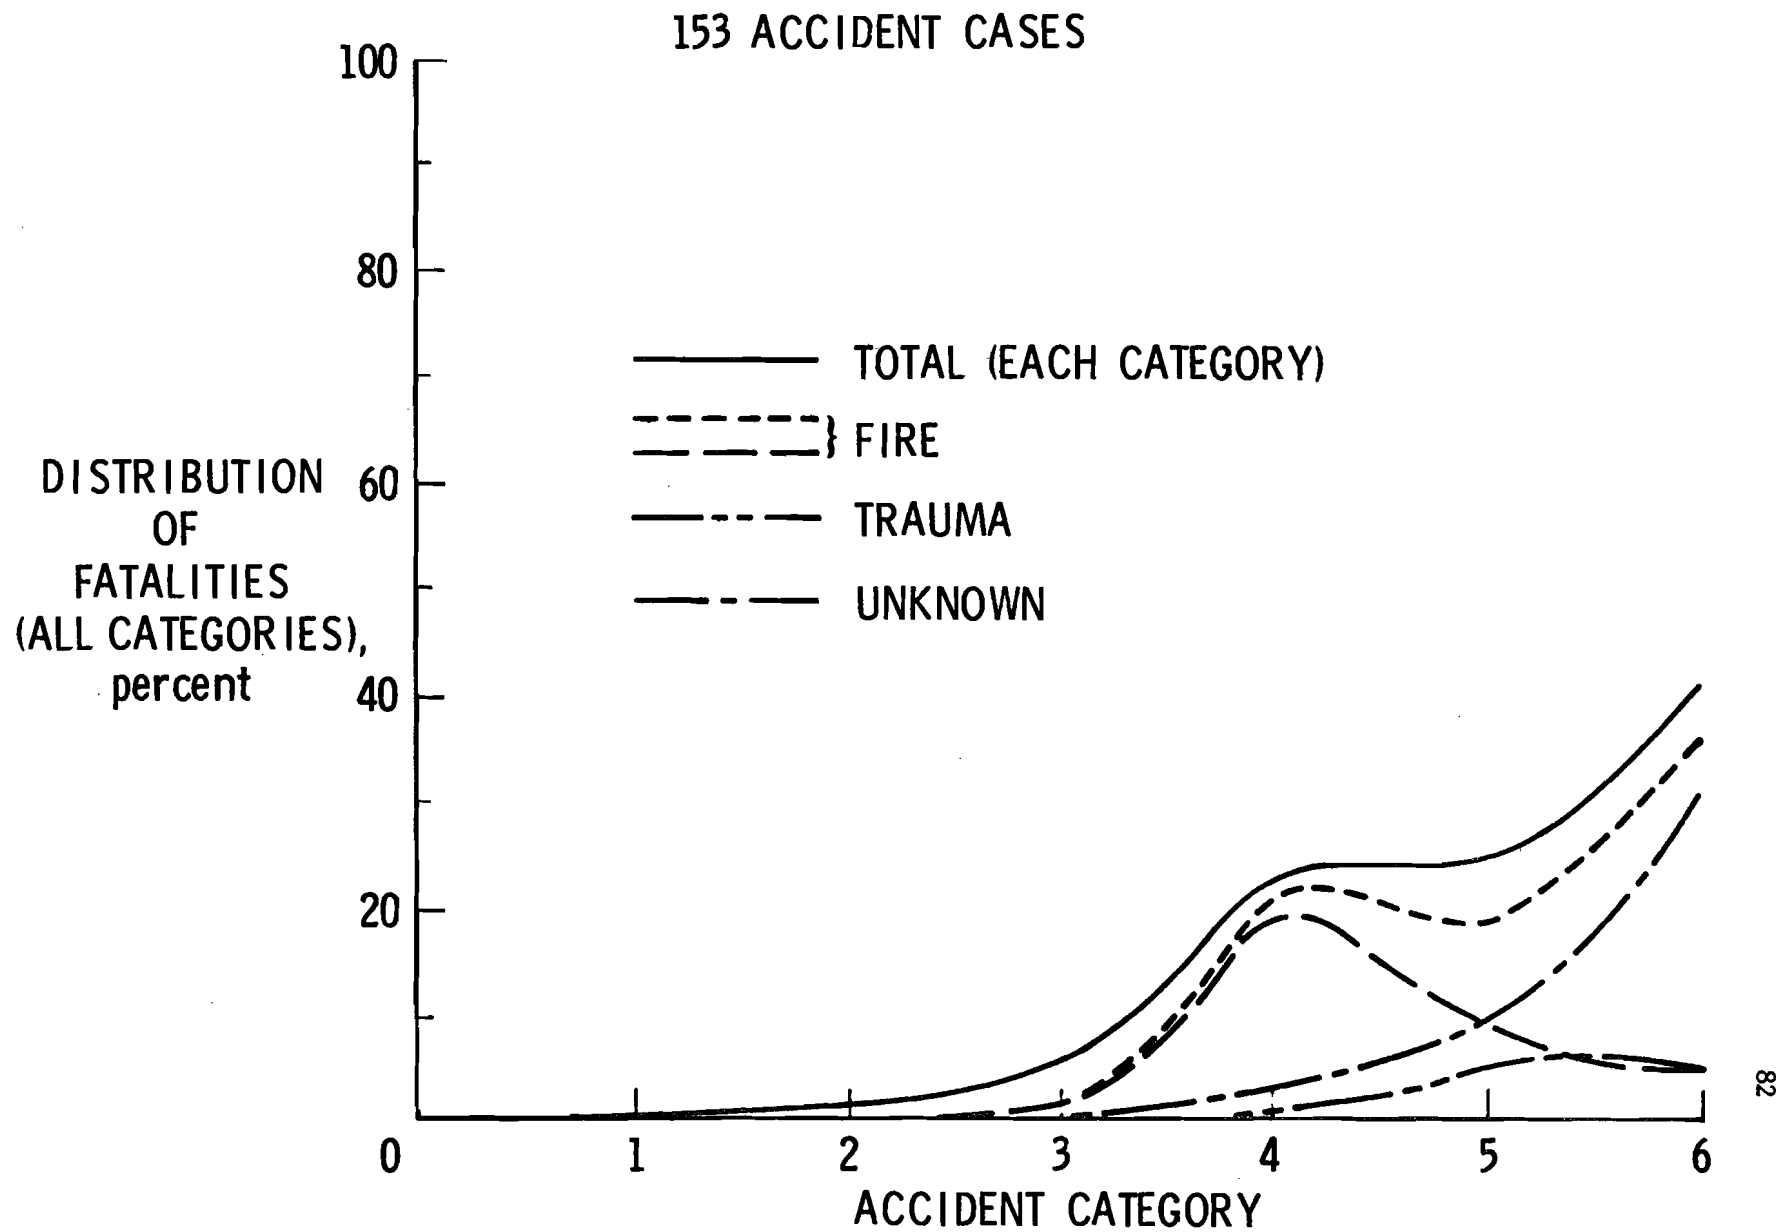
FIGURE 10. - DISTRIBUTION OF FATALITIES AS A FUNCTION OF ACCIDENT CATEGORY

The 153 well-documented accidents in the data base have been grouped by category and are summarized in table 12 and figure 10, from which some general observations may be made. First as regards overall survivability, fire presents the greatest hazard. Known fire fatalities outnumber known trauma fatalities by 2.8:1. (This is in contrast to the results presented in figure 8(b) for domestic accident data only.) The foreign accident data reflects the same fire to trauma fatality ratio (approximately) as given here. Fire hazard is most severe for accidents having major fuel spills due to rupturing of fuel tankage (categories 4, 5, and 6). Trauma fatalities occur mostly in categories 5 and 6 which involve severe fuselage breaks. Little structural or detailed information is available on several accidents in which a large percentage of the occupants perished. Deep water impact accidents represent less than 10% of the study data base. Water impact usually results in severe damage to the lower fuselage, often accompanied by class 2 breaks in the fuselage and separation of wings, engines, and landing gear. In some cases many occupants drowned after evacuating the aircraft. In other cases the high fatality rate was due to inappropriate action of the cabin crews after the aircraft came to rest.

Last, as might have been anticipated, the overall survivability generally decreases as the major structural damage to the aircraft increases. For categories 5 and 6, known fatalities due to fire and to trauma appear in almost equal numbers. These categories also have the largest percentages of undefined fatalities. The dashed line in figure 10 is an extension of the fire fatalities curve if one adds all of the undefined fatalities to the fire fatalities.

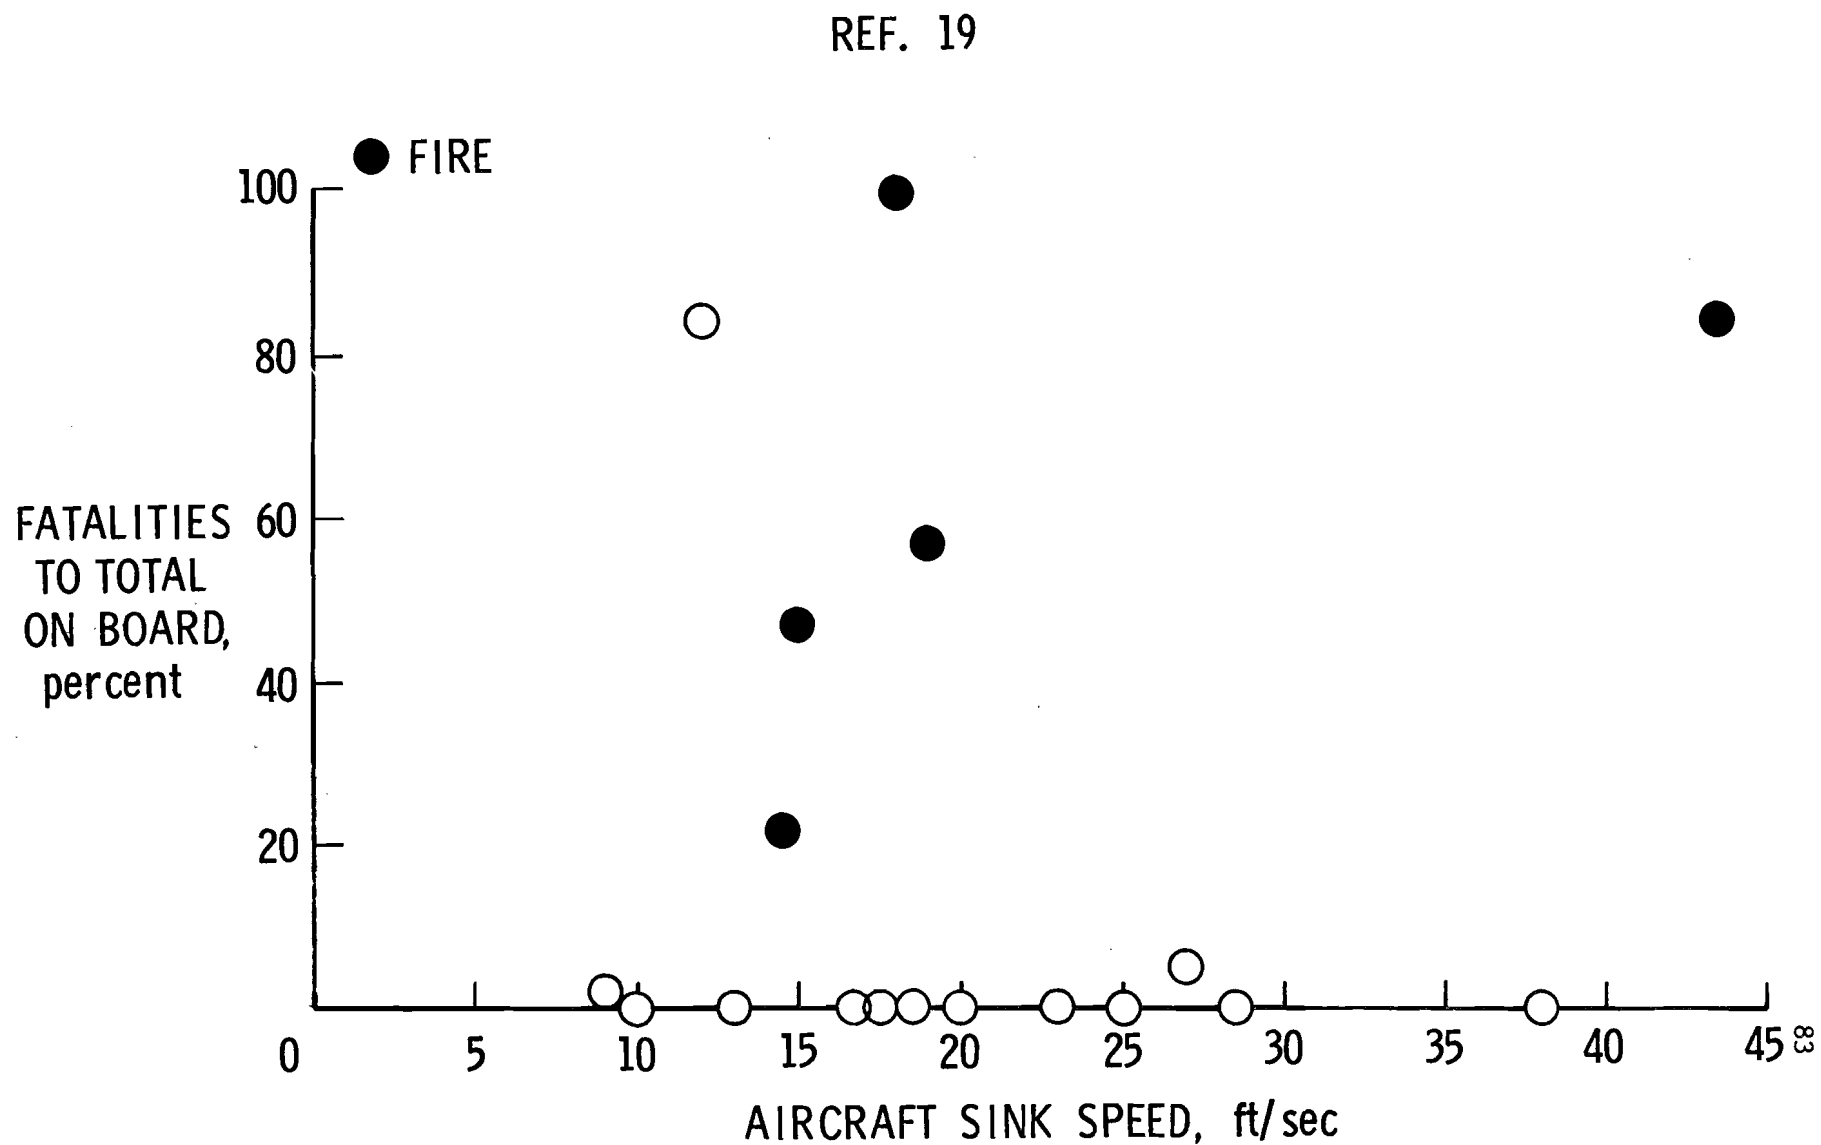
FIGURE 11(A). - FATALITIES AS A FUNCTION OF SINK RATE; REF. 19

To further explore the effect of rate of descent on fatalities a graph of fatalities as a percentage of total onboard for air-to-surface approach accidents, as a function of sink rate, is plotted in figure 11. In figure 11(a) the data from ref. 19 is presented, in 11(b) the data from ref. 20, and in figure 11(c) the data from ref. 21. Recognizing the fact that following initial impact, subsequent hazards may be encountered such as impact into columns, ditches or other obstructions the data plotted in figure 11 should only be viewed as indicating a trend. Furthermore, the accidents in which a large percentage of the fatalities are fire related are shown as solid symbols. Reviewing the solid and open symbol data for all three data bases indicates a general increase in trauma-related fatalities occurring at aircraft sink speeds of approximately 25 fps and above. This trend shows an inherent structural capability of the airframe to provide a good measure of load attenuation in the vertical direction. In figure 12(a), (b), (c) the percent injury to total onboard is plotted as a function of sink rate for the same air-to-surface approach accidents as in figure 11. Again, the accidents involving a high percentage of fire-related fatalities are shown as solid symbols. The data exhibit no apparent trend indicating that injury-causing mechanisms may be more local in nature than global. The accident data does show injuries occurring at a sink speed of 10 fps and above which coincidentally is approximately the landing gear design sink speed.
