DOT/FAA/CT-85/25

# **Seat Experiment Results Full-Scale Transport Aircraft Controlled Impact Demonstration**

Mark R. Cannon  
Richard E. Zimmermann

July 1986

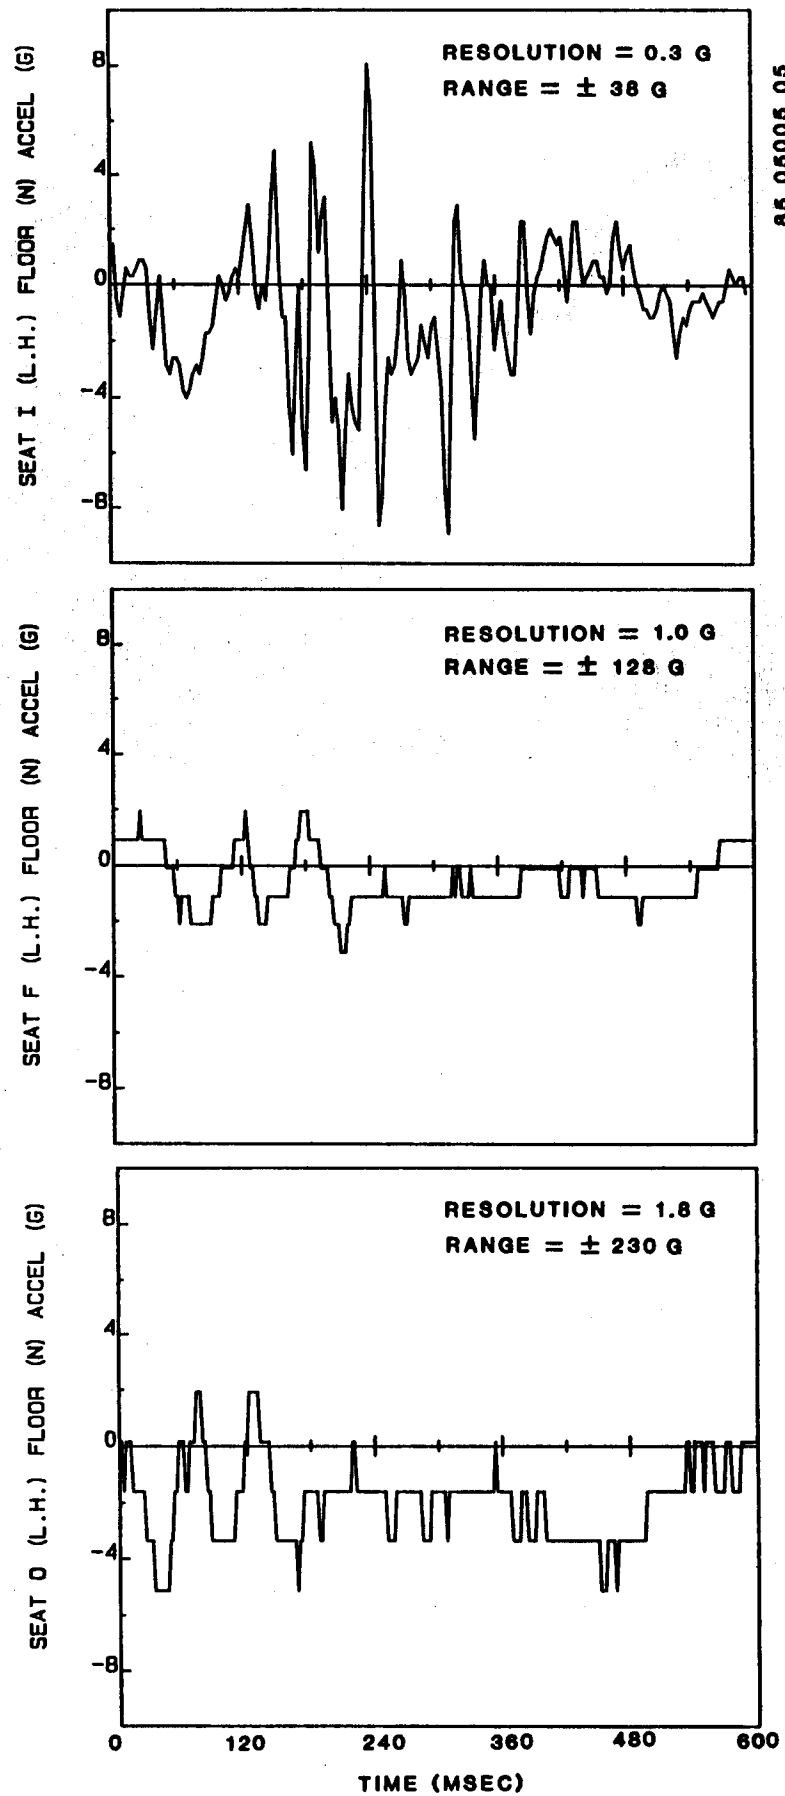
After the CID data was made available for analysis, it was discovered that this instrumentation ranging procedure was not consistent. Figure 38 is an example of this. Three acceleration plots from floor-mounted vertical accelerometers are shown with the smallest measurable G and the resulting ranges. Similar occurrences were found throughout the seat and dummy data. This does not invalidate the data, but it does require an explanation in the Data Interpretation section concerning the inaccuracies inherent in the CID data.

Figure 38. Example of inconsistent CID data ranging.

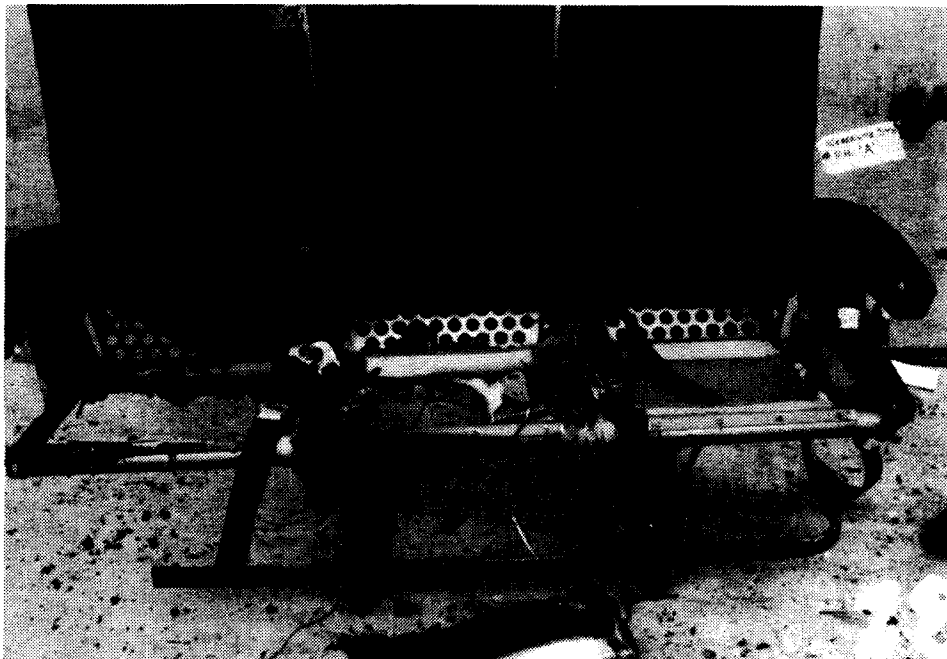
Figure 57. Damage to seat A/R.

SEAT A/R. The fire caused the underfloor structure in front of the seat and in the aisle to collapse, leaving the seat tilted forward and toward the aisle. Fire damage extended to melting two of the plasticized seat pans, burning the upholstery off the seat backs and scorching the food trays. There was no impact-related damage (figure 57).

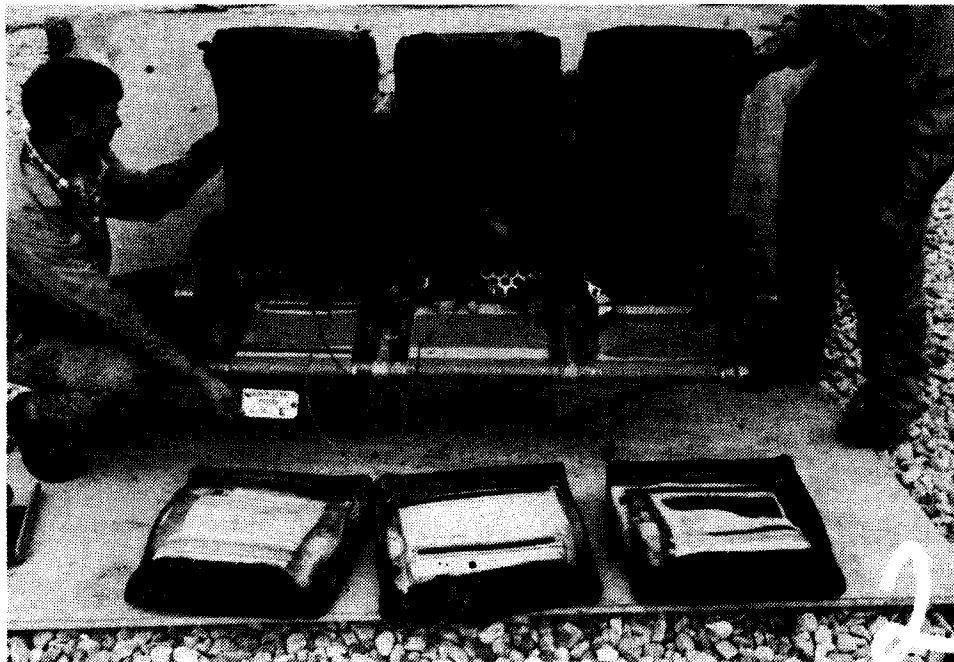
Figure 58. Damage to seat E/L.

SEAT E/L. This seat was across the aisle from seat A/R and was found in a similar orientation, due to the floor collapsing. It also sustained similar fire damage; one of the plasticized seat pans had melted and the upholstery was blackened (figure 58).

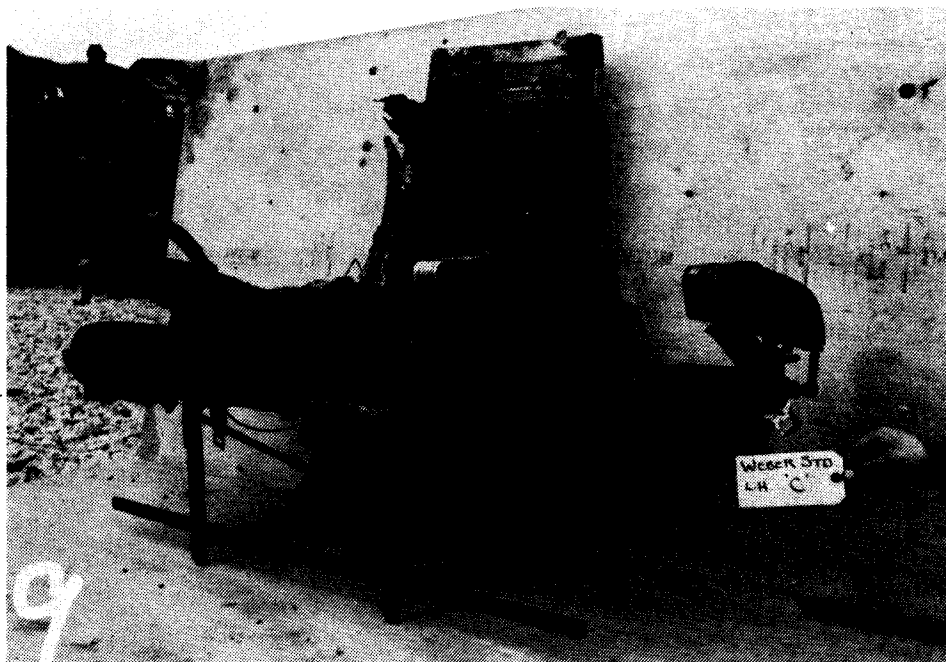
Figure 59. Damage to seat C/L.

SEAT C/L. No damage from the impact was sustained by the seat. However, the fire destroyed both outboard and inboard seat backs and part of the center one (figure 59).

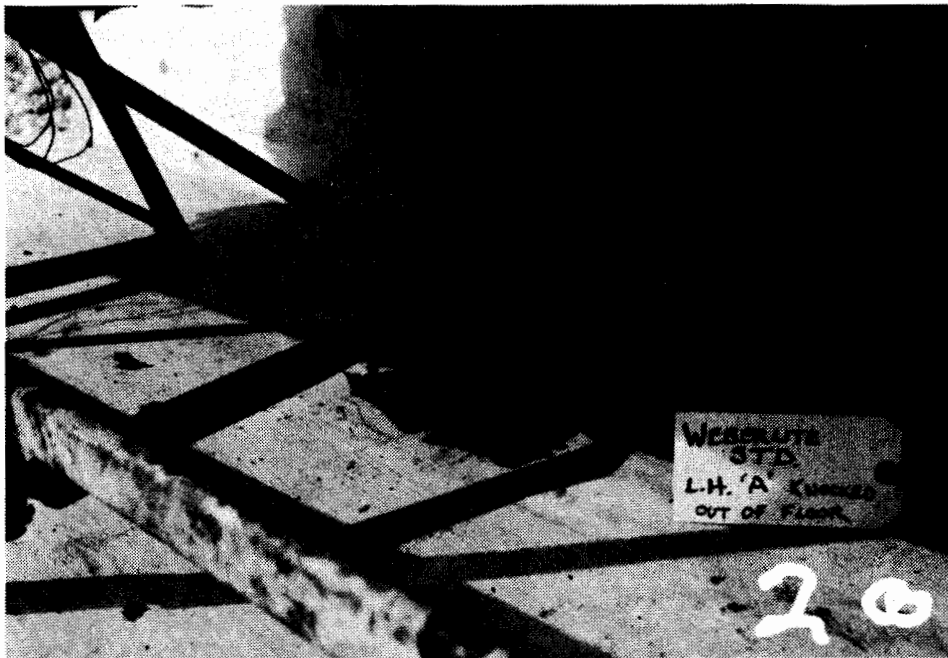
Figure 72. Floor track attached to rear outboard leg of seat A/L.

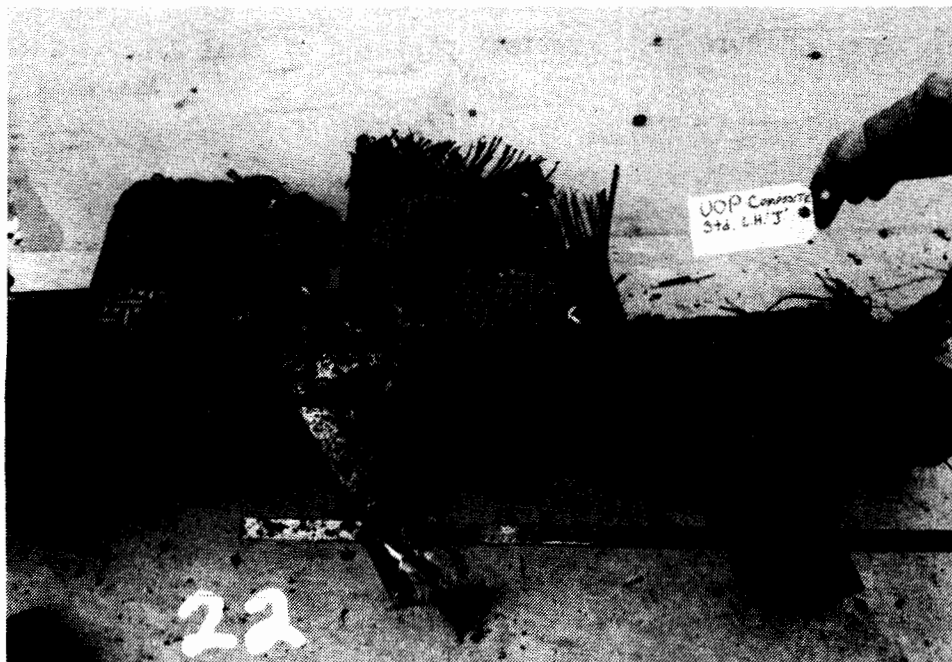
Figure 82. Deformed legs of seat J/L.
