DOT/FAA/CT-85/33

# **Galley and Overhead Compartment Experiment Results - Full-Scale Transport Controlled Impact Demonstration**

Roger M. Lloyd  
RMS Technologies, Incorporated  
Trevose, Pennsylvania

December 1985

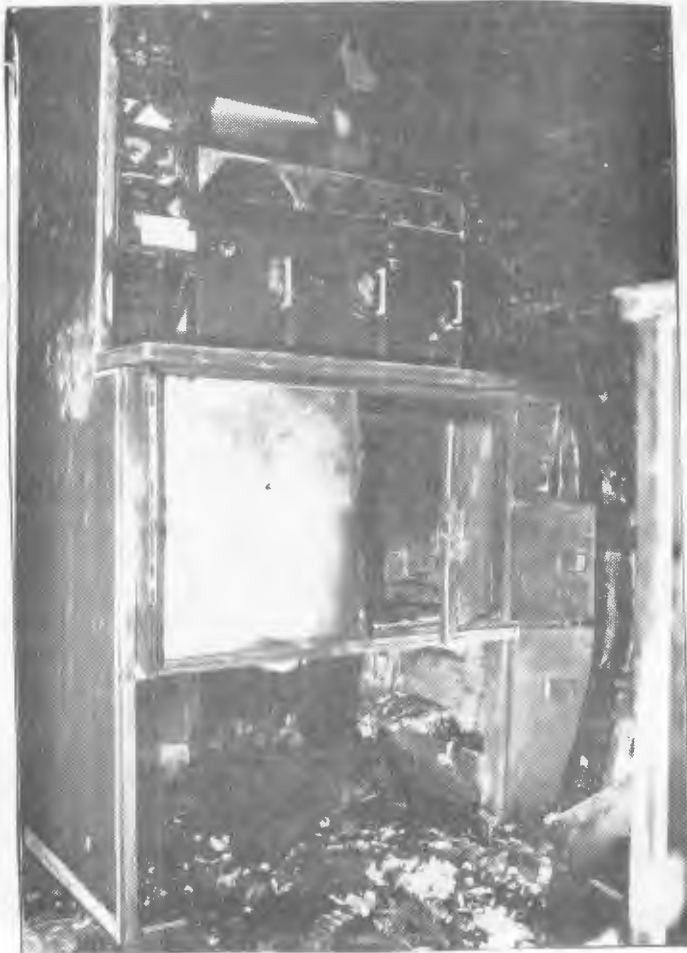
Both of the galley modules withstood the crash impact forces with no structural damage except for post-impact damage caused by the fire crew when they used fire axes to get to the simulated hazardous material containers. These containers, located in the bottom of the forward galley, started to burn due to the entry of fire from the lower cargo compartment (figure 24). The inboard studs of the aft galley floor attachment became disengaged from the floor track when the floor collapsed due to fire and the weight of the DAS located at about the same station on the other side of the aircraft. Neither the track nor the studs were broken or deformed as may be seen in figures 25 through 27. The studs may not have been adequately tightened or the floor could have shifted enough to allow the studs to disengage from the track. However, both galleys remained attached to the airframe and the supports did not appear to be overly stressed. There were no popped rivets or deformed structures.

FIGURE 24. FORWARD GALLEY POST-CRASH

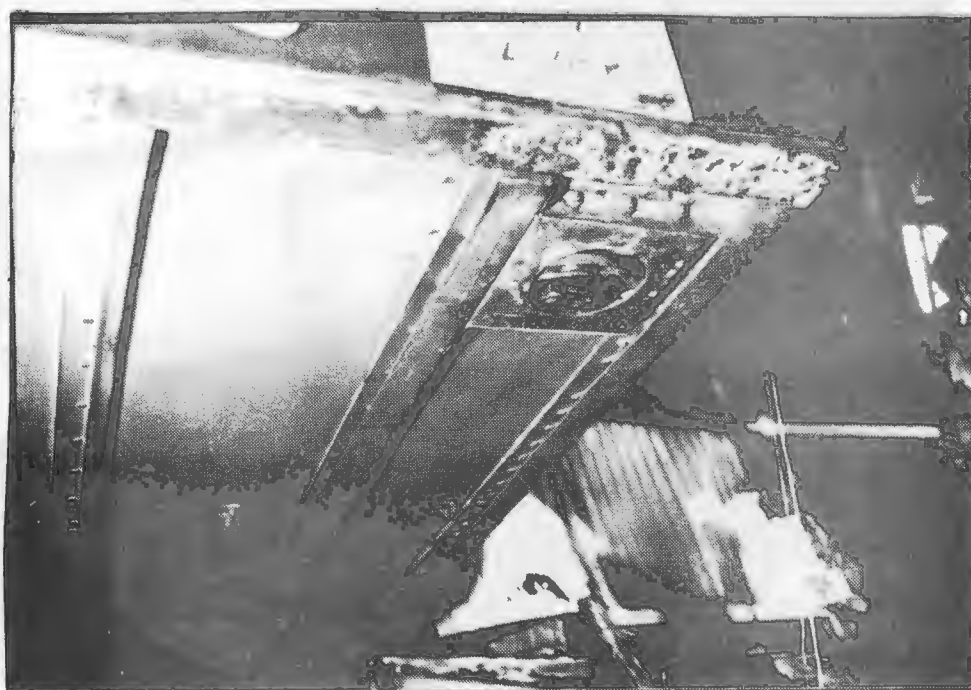
Post-crash examination of the two experimental galleys revealed no structural damage or spillage of the interior contents. The condition of both galleys and their contents indicated that they were exposed to fire but not to the extent of the overhead compartments. The experimental hazardous material containers in the forward galley showed no indication of structural damage caused by the crash impact loads. There was, however, damage caused by the subsequent use of fire axes. The inboard aft galley floor attachment studs became disengaged from the floor track, while neither the studs nor the track were broken or deformed. It was believed that the studs may not have been adequately tightened or that floor deformation (resulting from the fire) could have allowed the studs to pop out.

FIGURE 26. AFT GALLEY FORWARD TRACK STUD

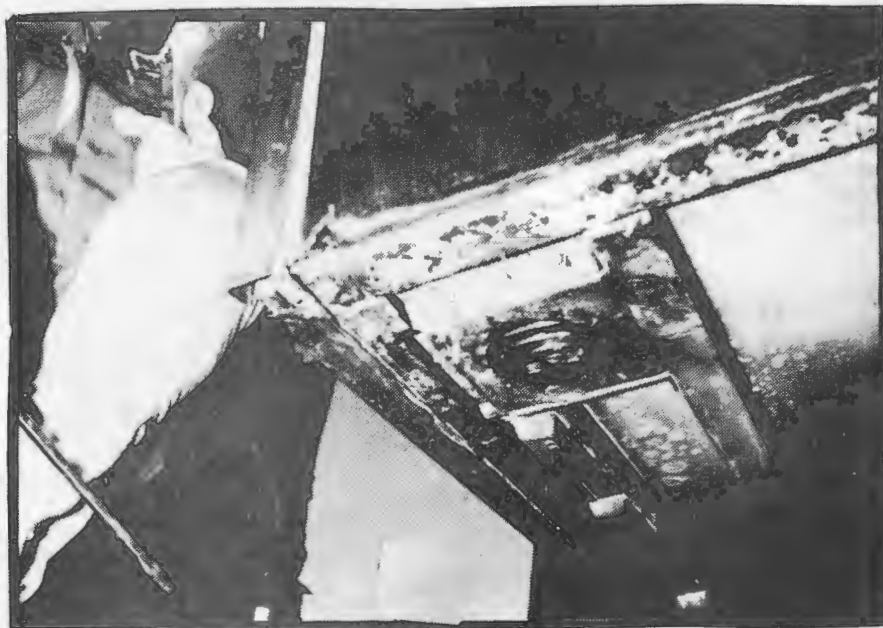
FIGURE 27. AFT GALLEY AFT TRACK STUD

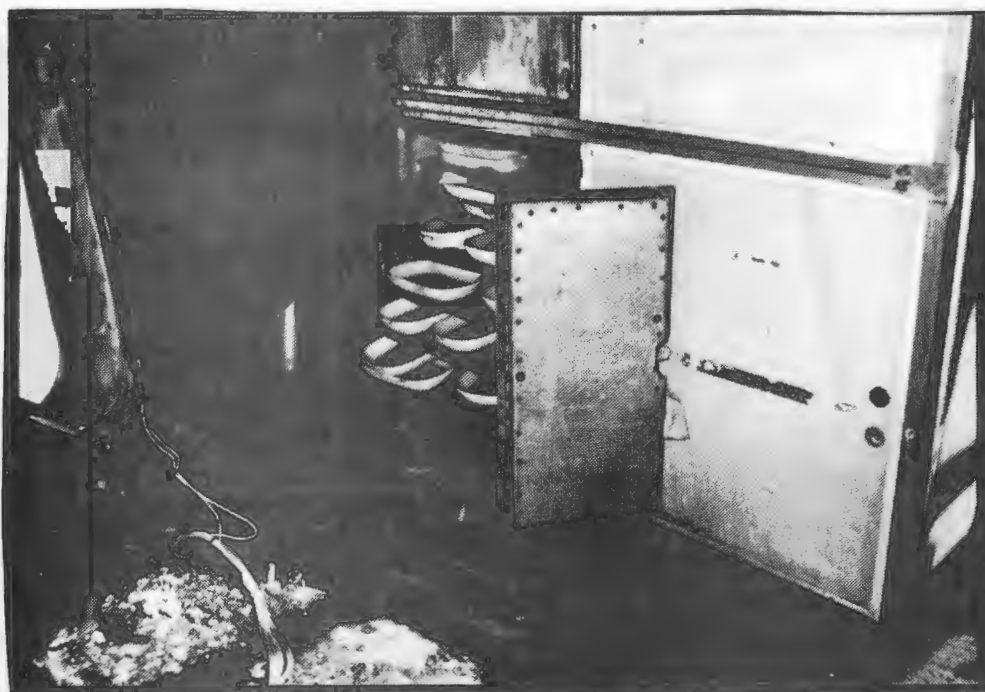
Post-test examination of the galley modules also revealed that the interior latching devices and exterior sliding galley restraint doors, performed satisfactorily without loss of interior contents and equipment. The galley interior and container equipment showed evidence of smoke residue due to the fire. Also, minor chips on some of the dishes were noticed. The forward galley performed equally well. Notwithstanding that the hazardous material packages were ignited by the lower cargo compartment fire and that some of the packages were damaged by the fire crew, there appeared to be no evidence of prior impact damage to the forward galley or interior contents (see figures 28 through 30).

FIGURE 28. AFT GALLEY CHINA POST-CRASH

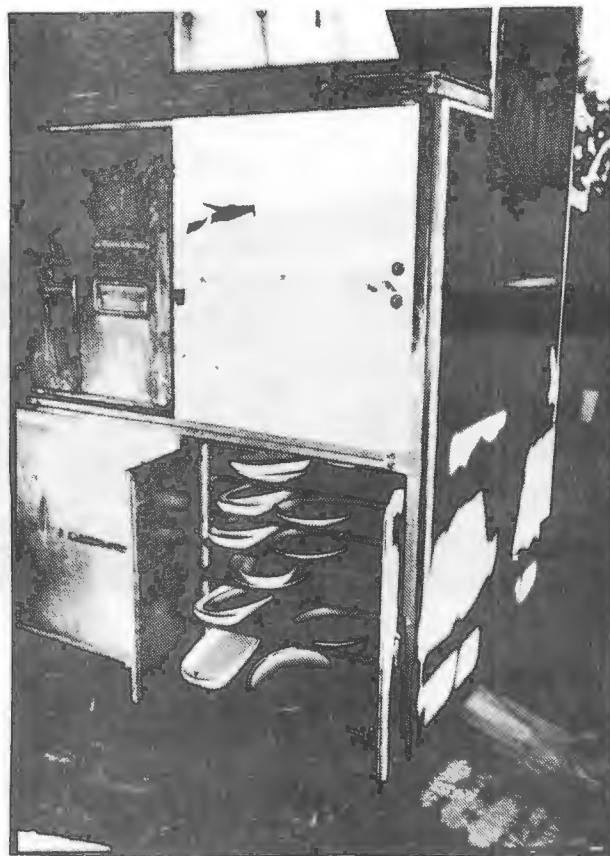
FIGURE 29. AFT GALLEY CHINA, TRAYS POST-CRASH (LOWER)

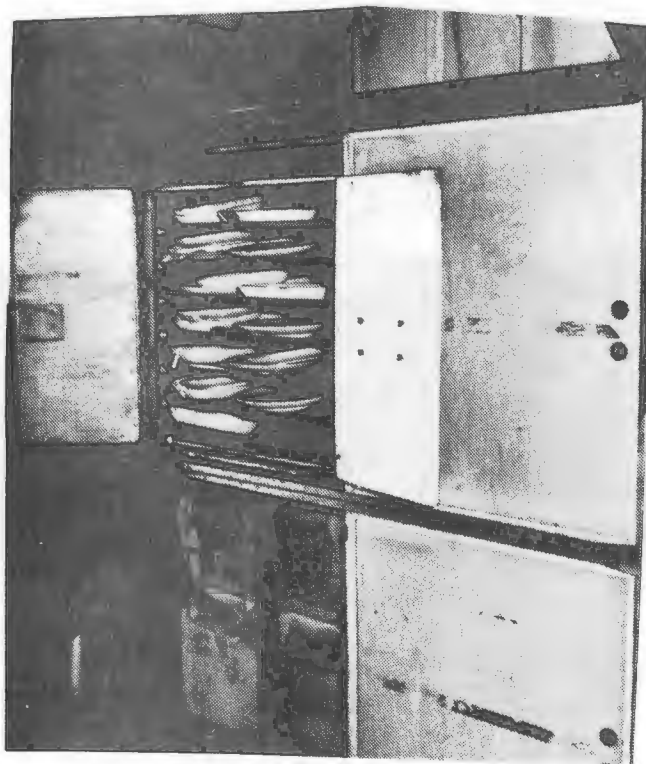
FIGURE 30. AFT GALLEY CHINA, TRAYS POST-CRASH (UPPER)

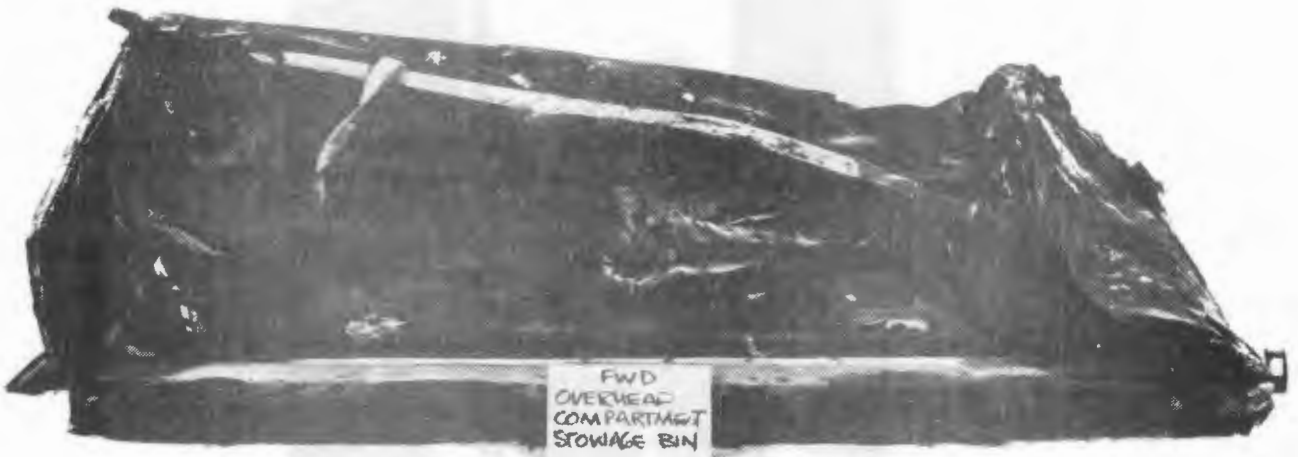
remained in place during the crash and slide out. However, both compartments were found in the lower cargo area severely damaged by fire when the aircraft was entered after the crash. As may be seen in figure 31 and 32, the compartments were heavily damaged by fire. There are some questions about the failures of the support links. The remains of the support links were examined by the metallurgy laboratory at the Naval Air Development Center, Warminster, PA., to determine if the failures were due to the heat from the fire and/or if they could have failed structurally during the crash. The laboratory report is included as Appendix A to this report. The laboratory results concluded that all of the failures were due to the fire. However, there is some evidence indicating that some of the support links may have broken during the initial impact, while not to the extent that would have allowed separation of the compartments.

FIGURE 31. FORWARD OVERHEAD COMPARTMENT POST-CRASH

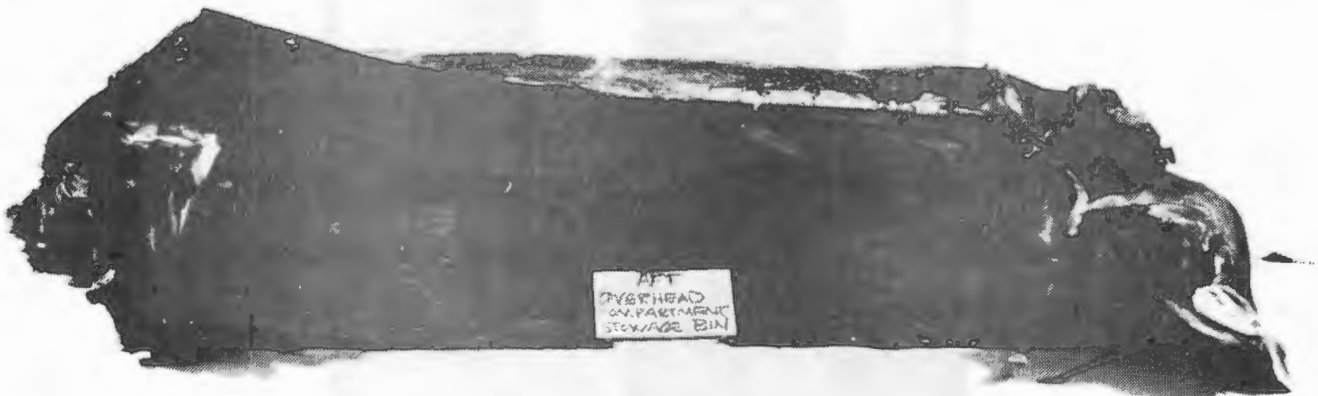
FIGURE 32. AFT OVERHEAD COMPARTMENT POST-CRASH

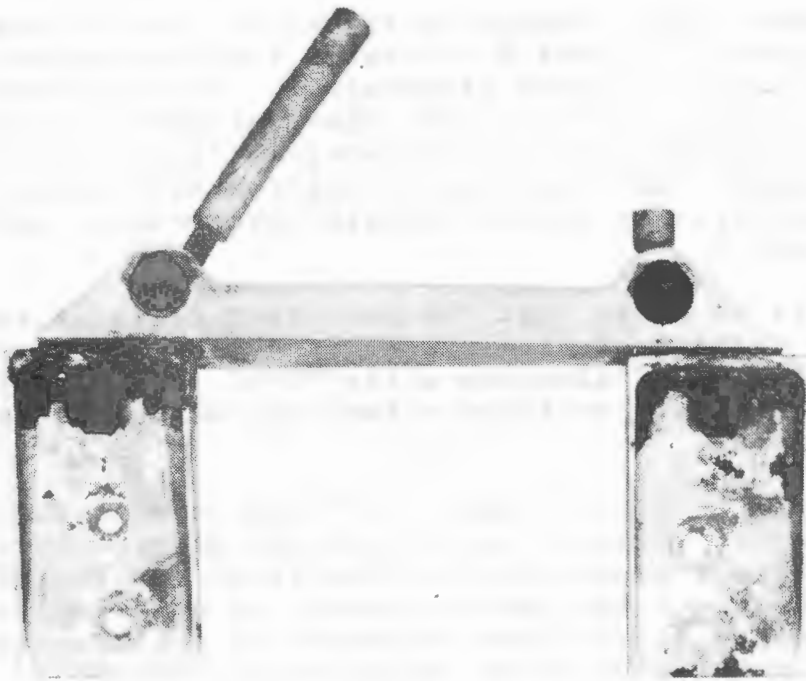
Visual/Macroscopic Examination: The remnants of seven support links were arranged in their relative positions in order to assess the loading and sequence of failure, as shown in Figures 1, 2, 3, and 4. Three links fractured in a plane perpendicular to the axial direction of the links through the holes in the unthreaded area. One link fractured in the same manner through the two small holes in the threaded area. In addition, two links failed through the eye-bolt attached to the threaded link. One of the seven links did not fail. The fractures in the failed links were relatively smooth and flat, as shown in Figure 5.

Analysis of Results: The results of this investigation indicate that the probable cause of failure in the six broken links was due to overheating caused by the fire after impact. Evidence of incipient melting at the grain boundary in all samples indicates that these support links were subjected to a temperature very close to the melting point of the material.

FIGURE A-1. FORWARD BIN, AFT UPPER SUPPORT BRACKET

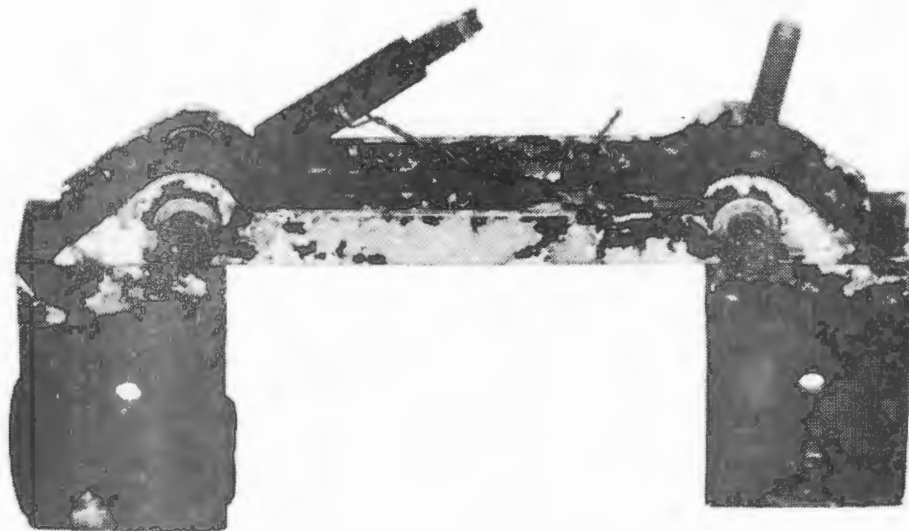
FIGURE A-2. FORWARD BIN, FORWARD UPPER SUPPORT BRACKET

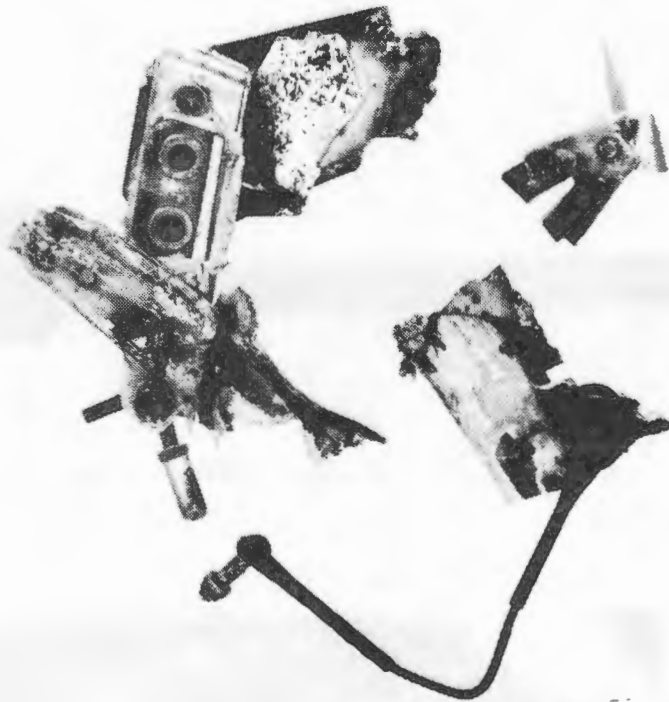
FIGURE A-3. AFT BIN, AFT UPPER SUPPORT BRACKET

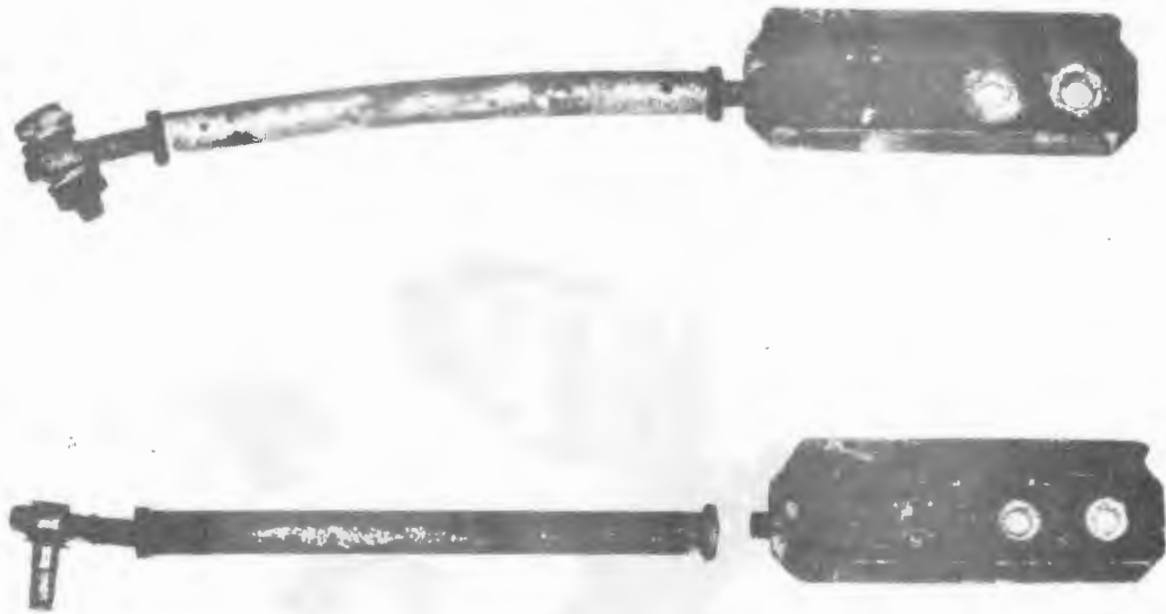
FIGURE A-4. AFT AND FORWARD LOWER SUPPORT LINKS

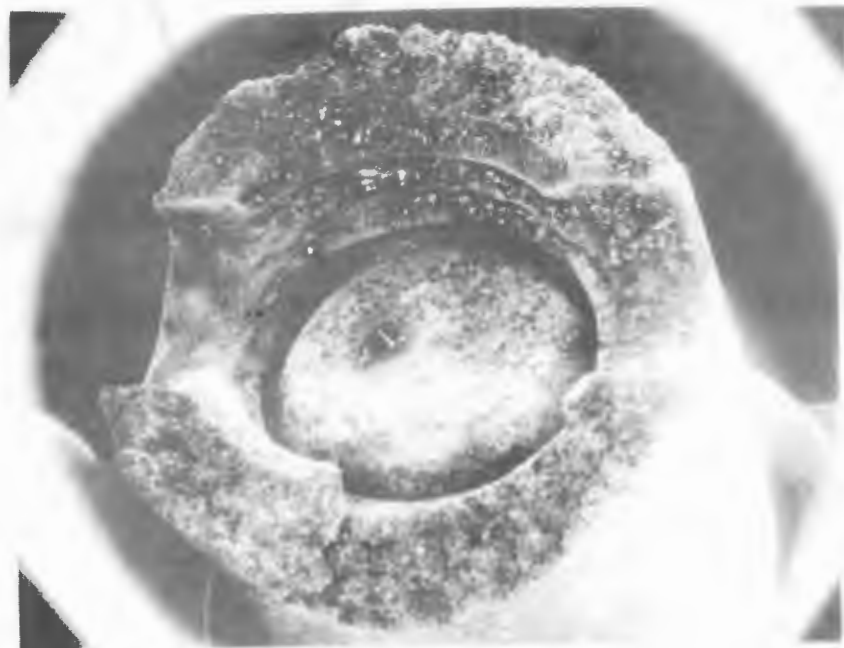
FIGURE A-5. TOPOGRAPHY OF FRACTURE SURFACE

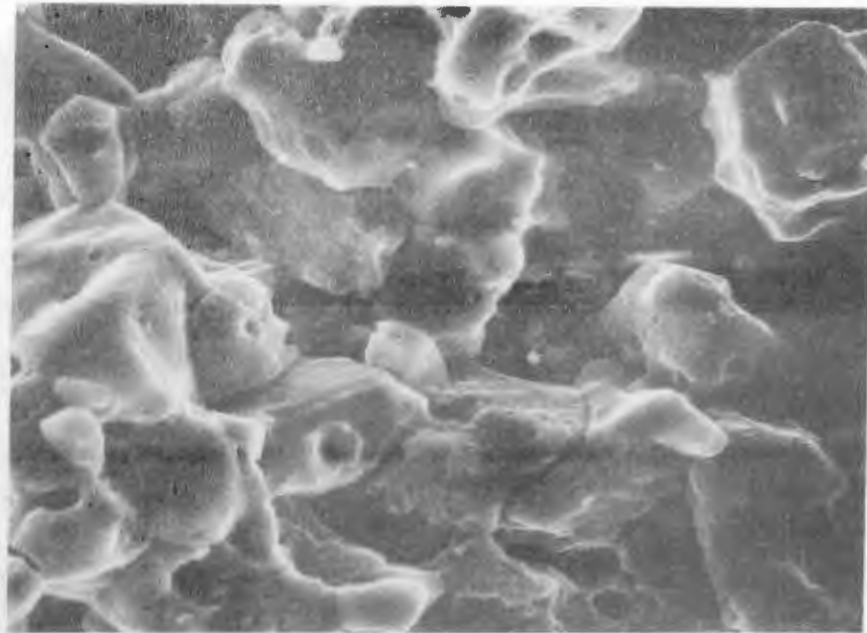
Microscopic Examination: A scanning electron microscopic (SEM) examination of the fracture surface was conducted to characterize the fracture mode involved in the failure. In most of the samples, significant fractographic features could not be discerned due to the presence of excessive amounts of oxidation products on the fracture surfaces, as shown in Figure 5. However, scanning electron microscopic examination of one sample relatively free of oxidation products revealed what appeared to be intergranular fracture, as shown in Figure 6. Subsequent metallographic examination of longitudinal sections in the area of fracture exhibits excessive grain growth and incipient melting at the grain boundary, as shown in Figure 7.

prominent shear lips as shown in Figure 8. The elongated dimple rupture as shown in Figure 8 indicates that the material failed in a ductile manner at room temperature. The elevated temperature failure was flat and intergranular as shown in Figure 9. Comparison of the test program failure with the crash failures revealed that the crash fractures have characteristics that were most similar to the elevated temperature failures, as shown in Figure 6.

FIGURE A-6. FRACTURE SURFACE OF FAILED LINK SHOWING INTERGRANULAR FAILURE

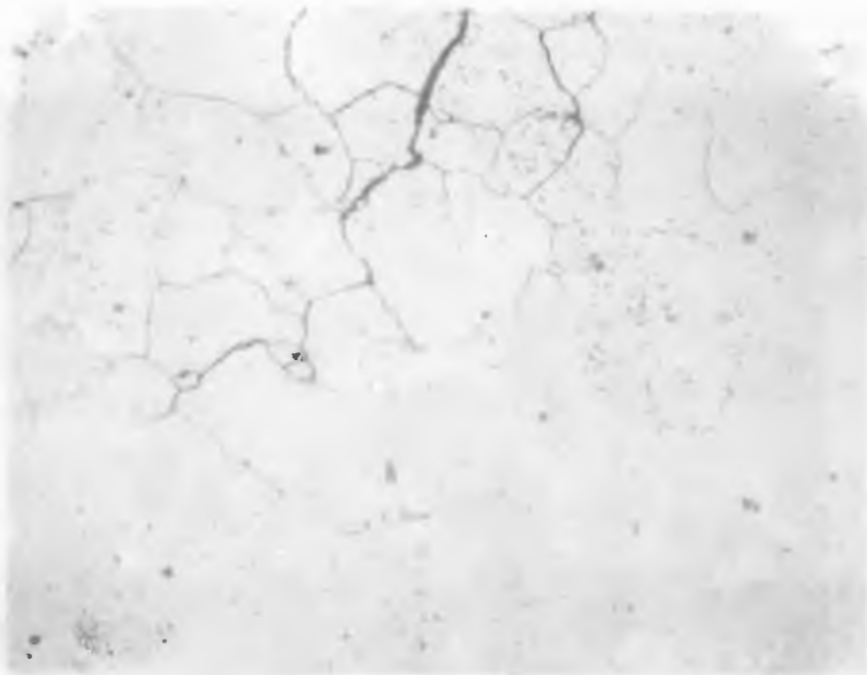
FIGURE A-7. MICROSTRUCTURE OF THE FAILED LINK SHOWING  
INCIPIENT MELTING AT GRAIN BOUNDARY
