DOT/FAA/CT-85/36

# **Crash Dynamics Program Transport Seat Performance and Cost Study Benefit Study**

Mark R. Cannon  
Richard E Zimmermann

Final Report

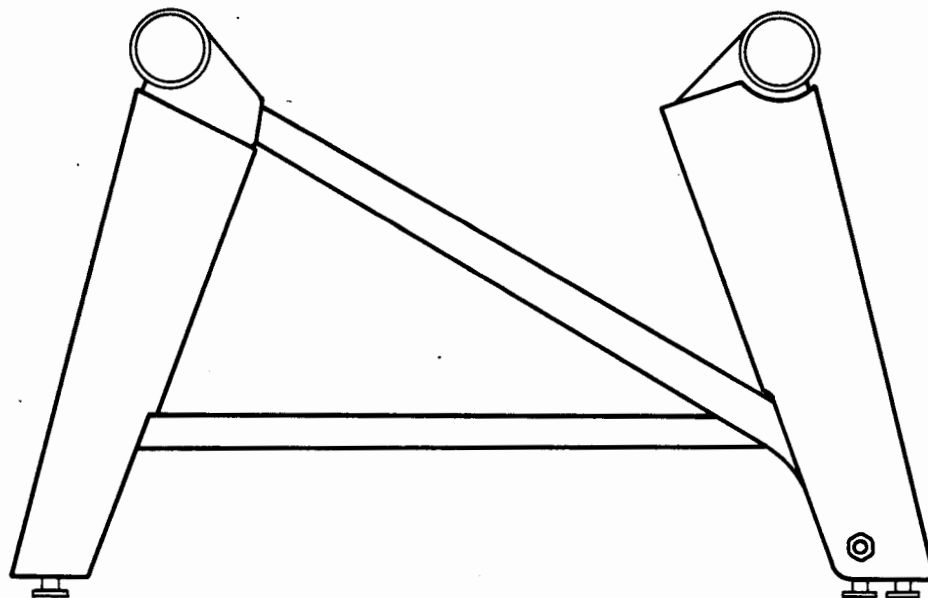
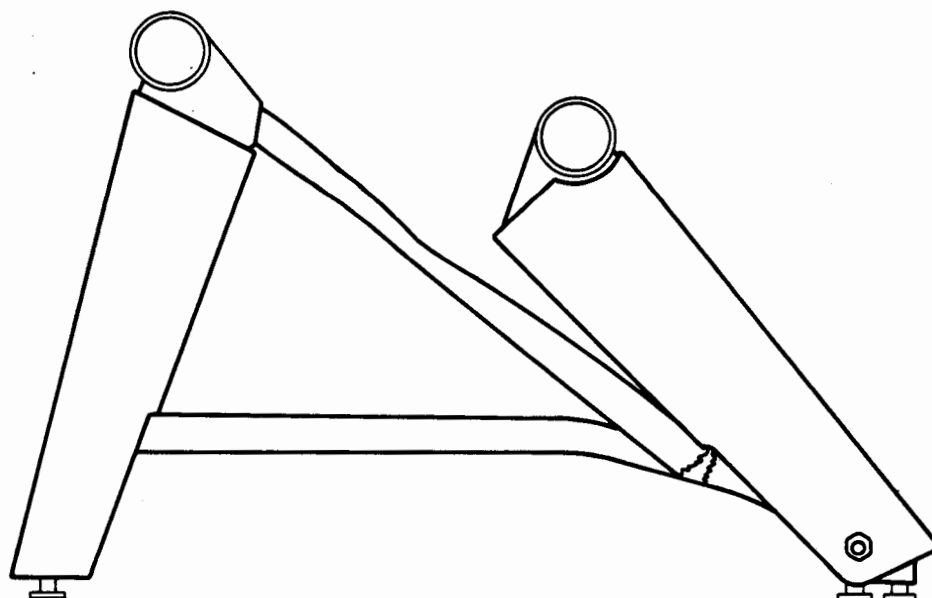
One of the seats used during the 1960's, the Hardman Model 8727, did not have energy-absorbing devices, but its sheet metal construction enhanced its performance under loading conditions. When subjected to a forward test, the sheet metal seat pan crushed and the rear legs rotated about their attachment points (figure 11), allowing the occupant to move forward while the deforming metal absorbed some of the energy.

Figure 11. Leg deformation of the Hardman 8727 seat after forward static test.

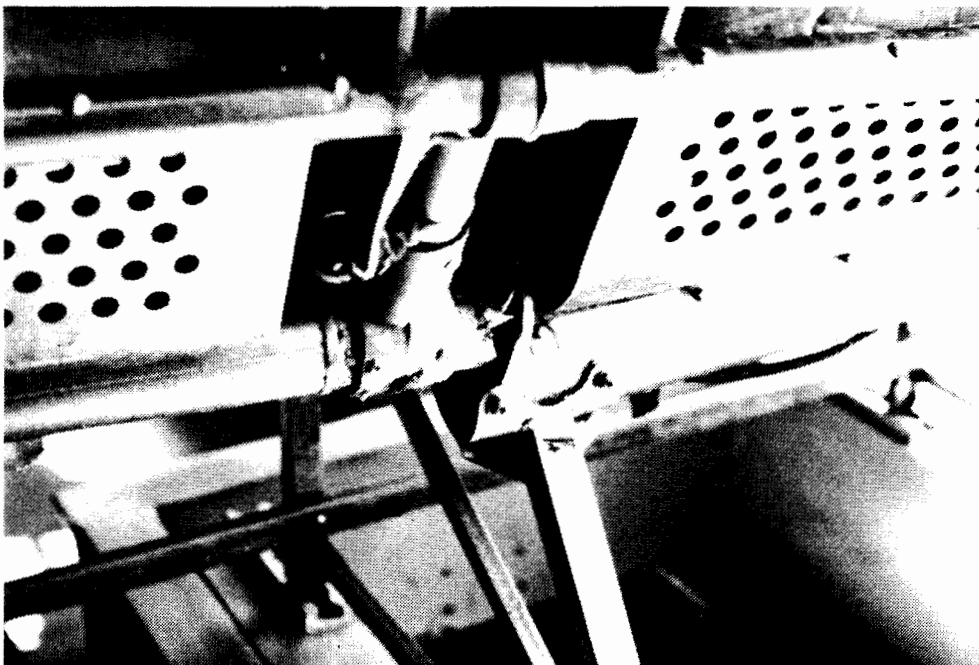
Results from the forward static tests showed the standard seat built in the early 1970's had an ultimate strength of 11.2 G, while one of the newer seats failed at 9.1 G. Failure locations of two of the standard seats are shown in figures 17 and 18. In figure 17, the rear lateral seat pan tube ruptured at the outboard rear leg attach point. The seat in figure 18 failed at the fitting which attaches the outboard rear leg to the seat pan tube.

Figure 17. Forward static test failure location of standard seat (Example 1).

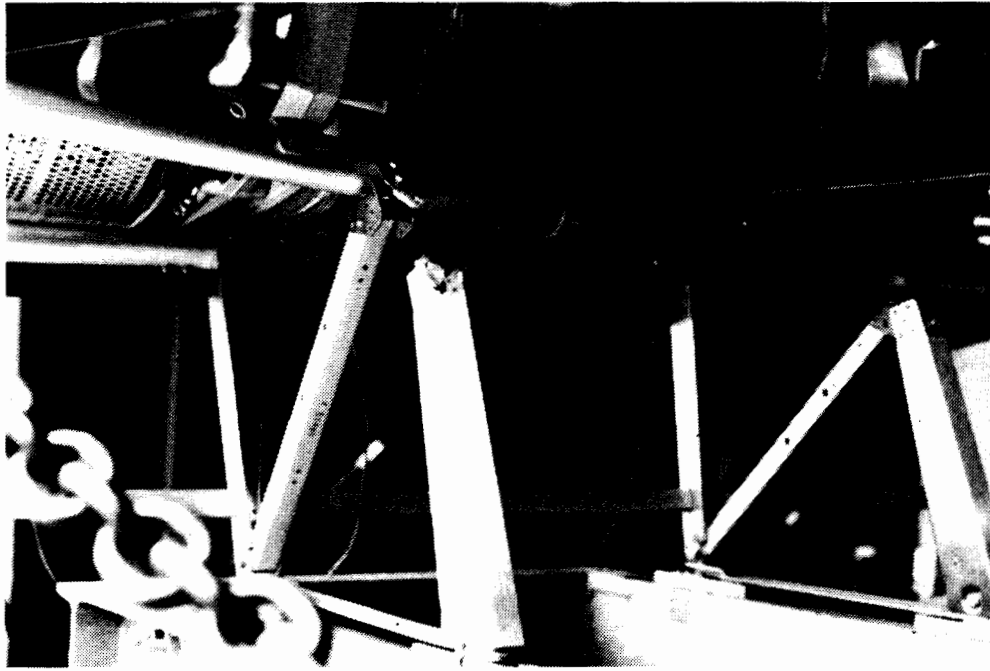
Figure 18. Forward static test failure location of standard seat (Example 2).

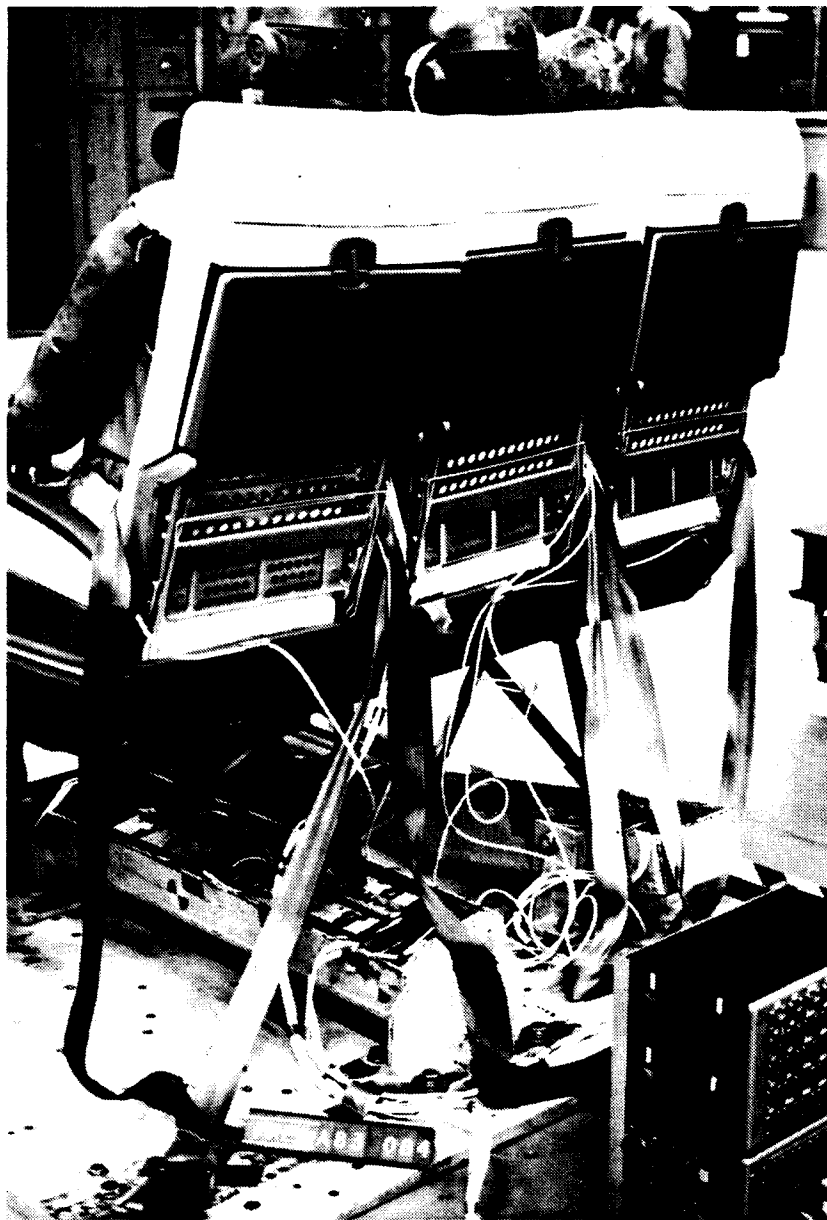
results were desired. To study the seats' reaction to floor deformation, the inboard track was pitched down 10 degrees and the outboard track was rolled out 10 degrees prior to the dynamic tests (figure 19). All of the standard seats failed the dynamic tests with floor deformation such that the seats became completely detached from the floor tracks on the test fixture (figure 20). Conversely, the modified seats remained affixed to the floor track and used only half of their available energy absorption capability (figure 21). After completion of the static and dynamic verification tests, new modified and standard seats were placed aboard the Boeing 720 CID aircraft (figure 22). Additional seat experiments were installed by NASA and the FAA. The NASA experiments consisted of a standard and modified triple passenger seat, and the FAA experiment was a new, state-of-the-art, composite, triple-passenger seat.

Figure 19. Floor deformation prior to dynamic testing.

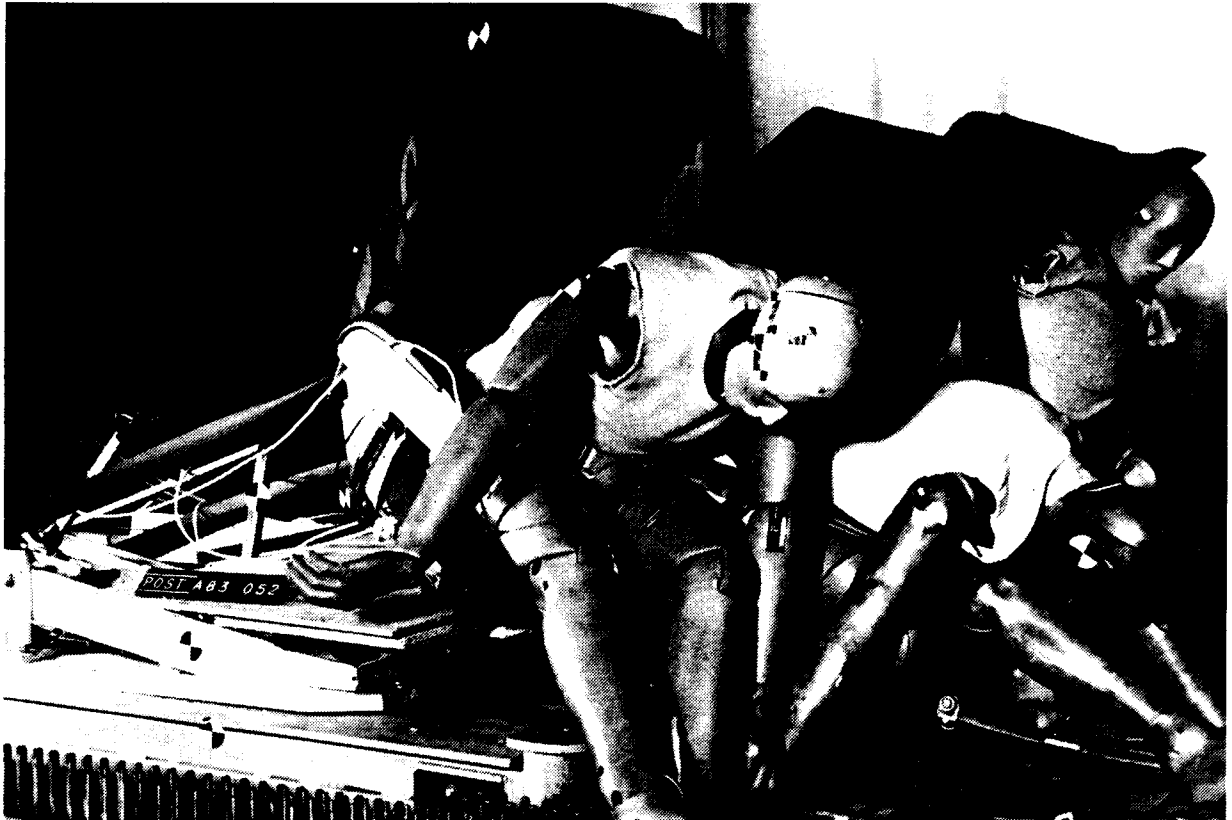
Figure 20. Standard seat after dynamic testing.

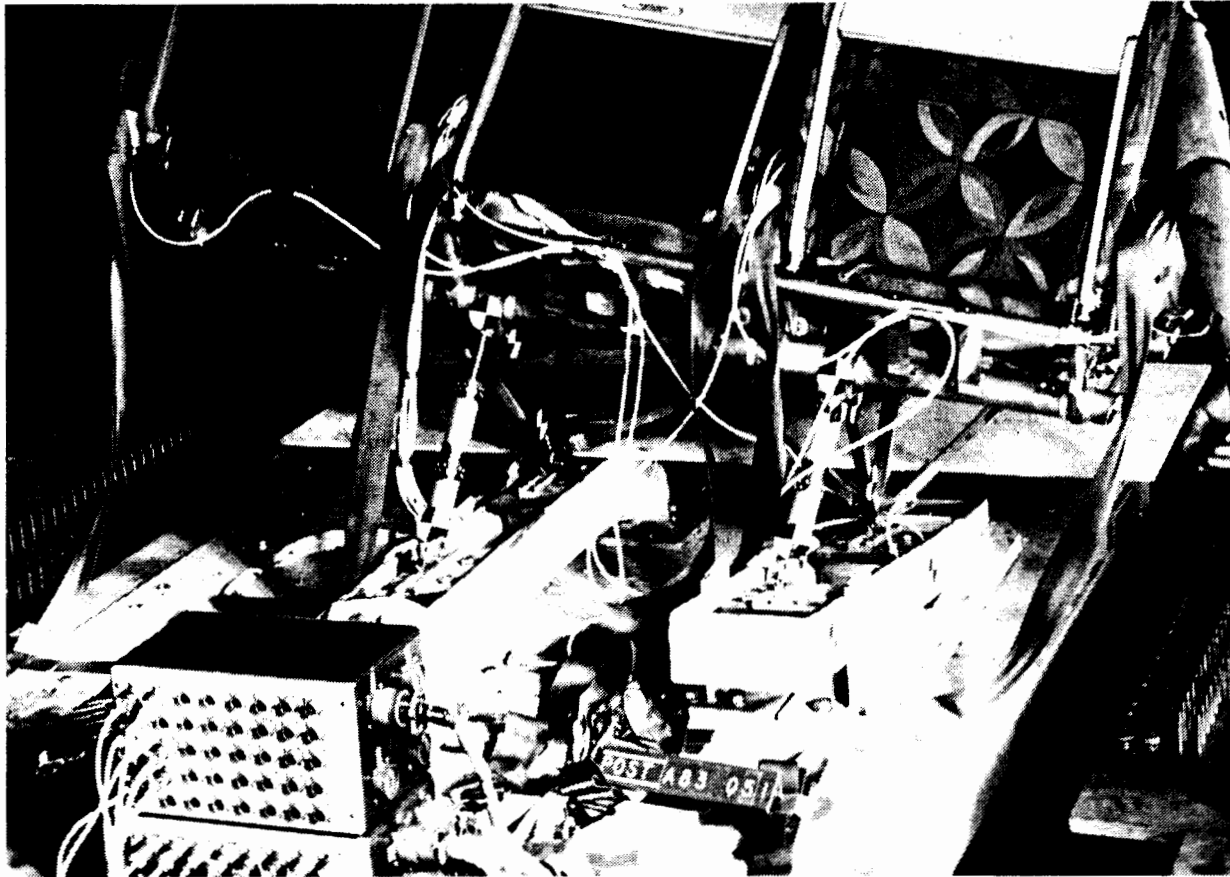
Figure 21. Modified seat after dynamic testing.
