DOT/FAA/CT-86/42

# Statistics on Aircraft Gas Turbine Engine Rotor Failures that Occurred in U.S. Commercial Aviation During 1981

March 1987

Final Report

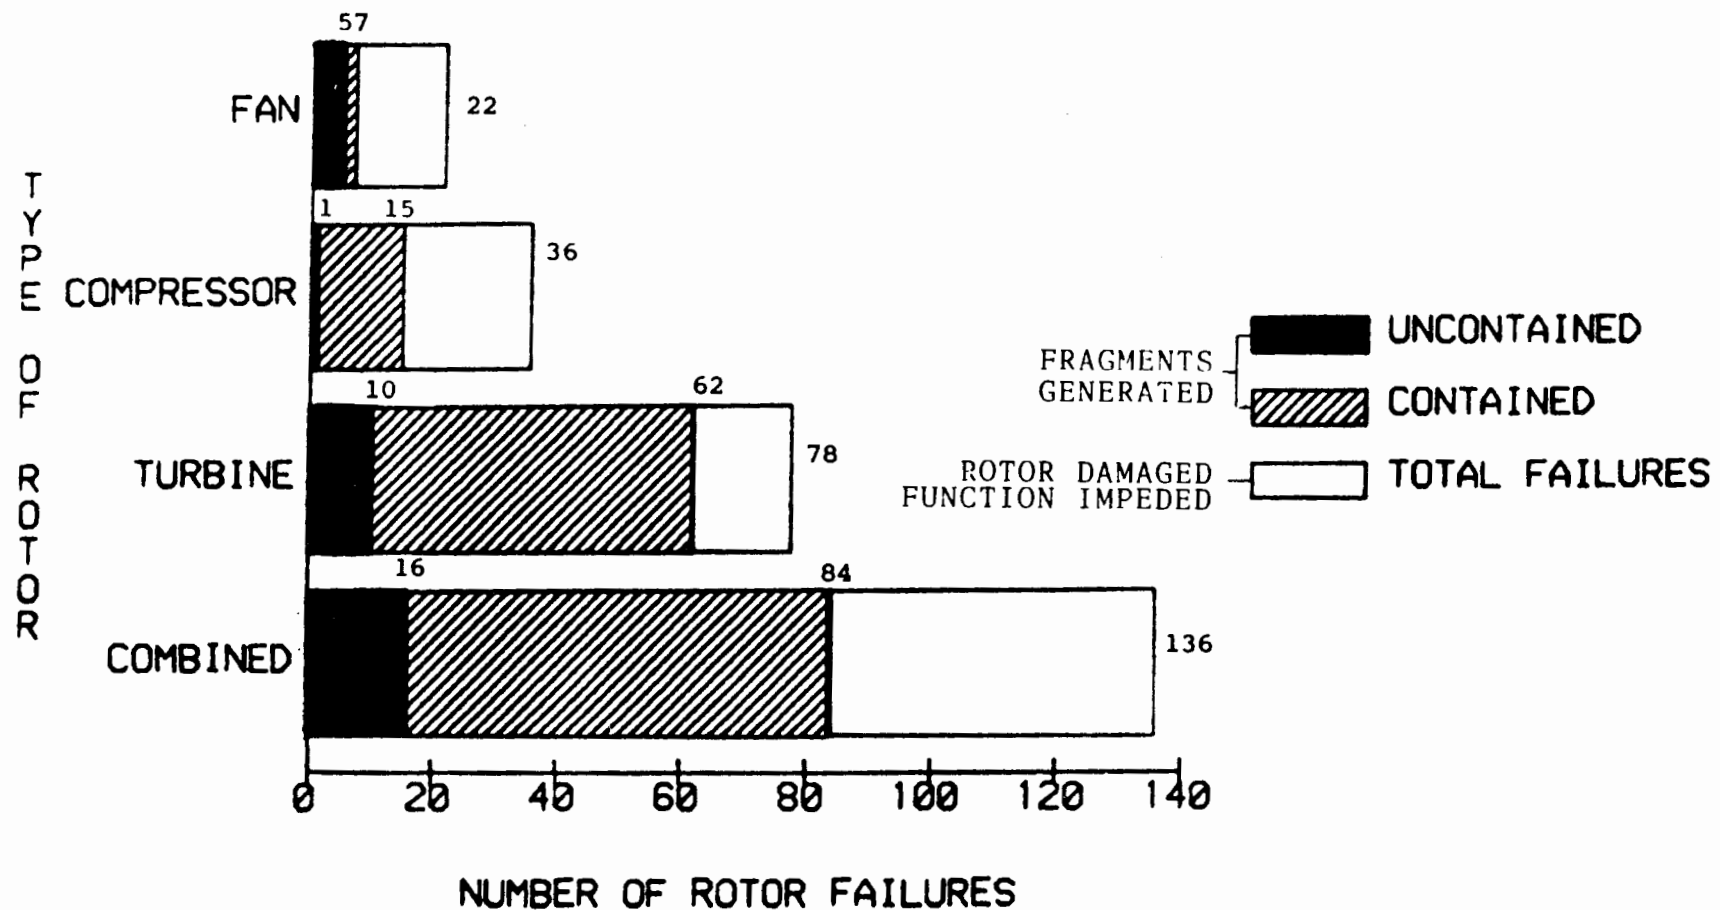
FIGURE 1: INCIDENCE OF ENGINE ROTOR FAILURE  
IN U. S. COMMERCIAL AVIATION 1981

a. Figure 1 shows that 136 rotor failures occurred in 1981. These rotor failures accounted for approximately 2.7 percent of the 5095 shutdowns experienced by the gas turbine powered U. S. commercial aircraft fleet during 1981. Rotor fragments were generated in 84 of the failures experienced and, of these, 16 (19.0 percent of the fragment producing failures) were uncontained. This represents an uncontained failure rate of 2.1 per million gas turbine engine powered aircraft flight hours, or 0.8 per million engine operating hours. Approximately 7.5 million and 20.7 million aircraft flight and engine operating hours, respectively, were logged by the U. S. commercial aviation fleet in 1981. Gas turbine engine fleet

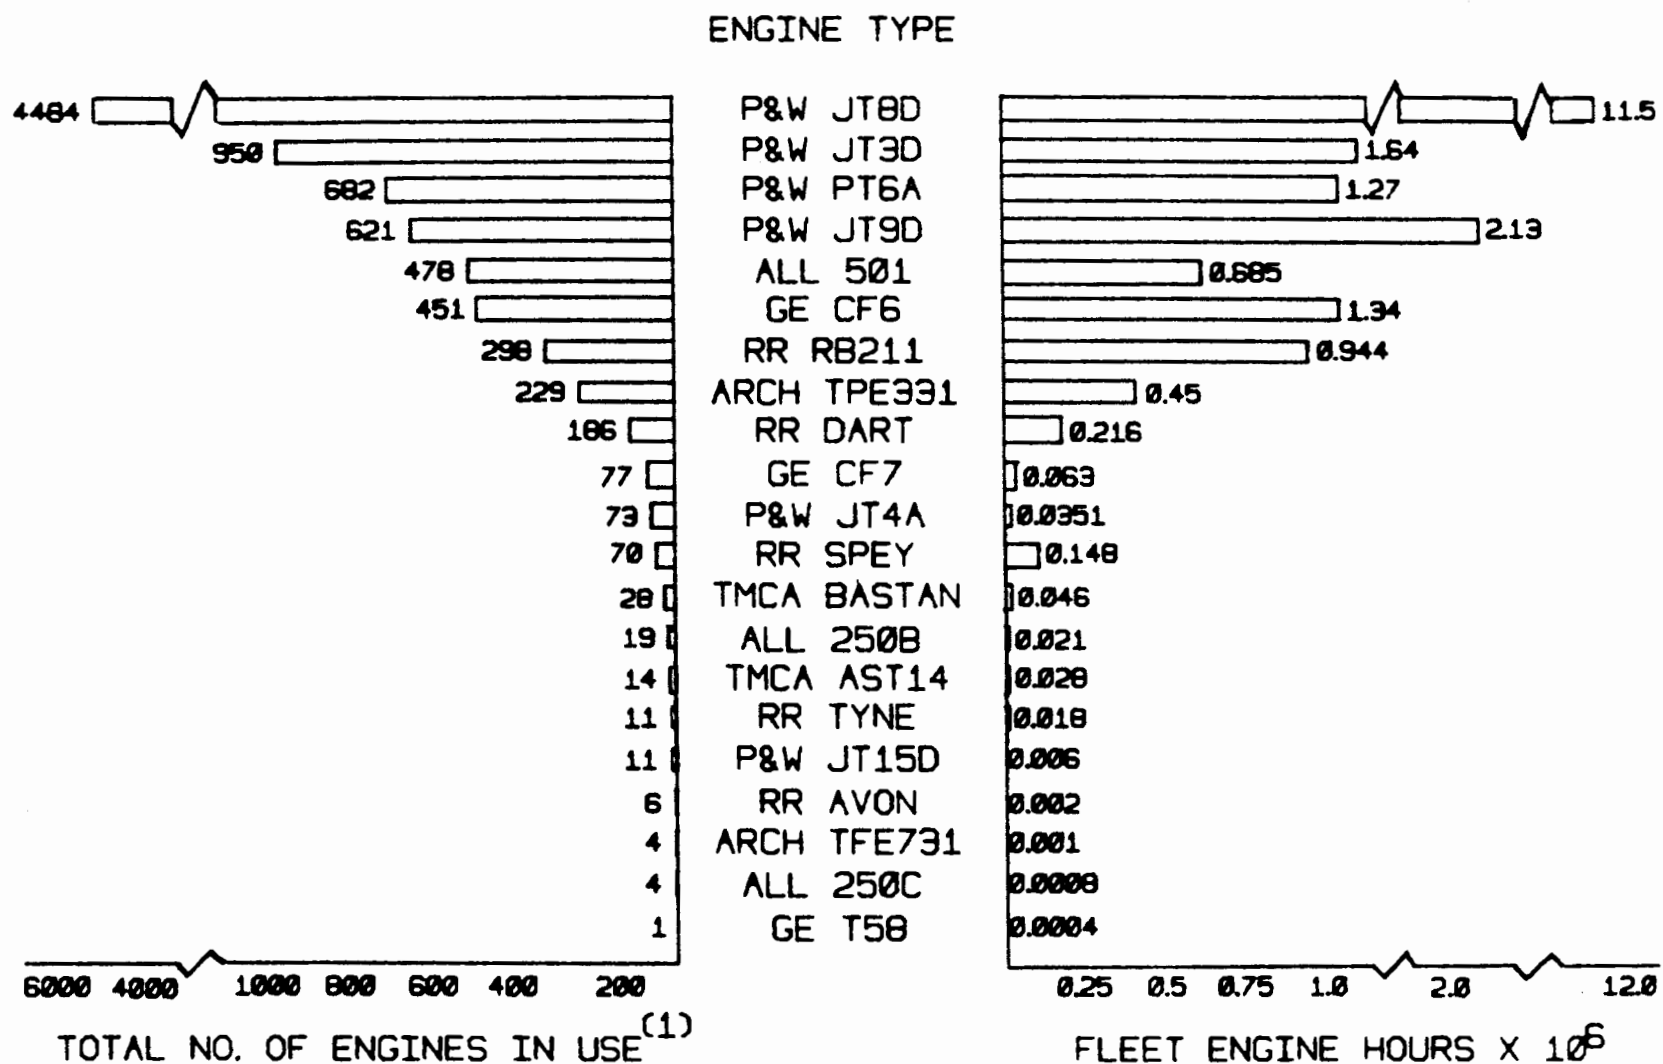
FIGURE 2: GAS TURBINE ENGINE FLEET OPERATING HOURS IN U.S. COMMERCIAL AVIATION ACCORDING TO NUMBER OF ENGINES IN SERVICE - 1981

operating hours according to the number and type of engines in use is shown in Figure 2.

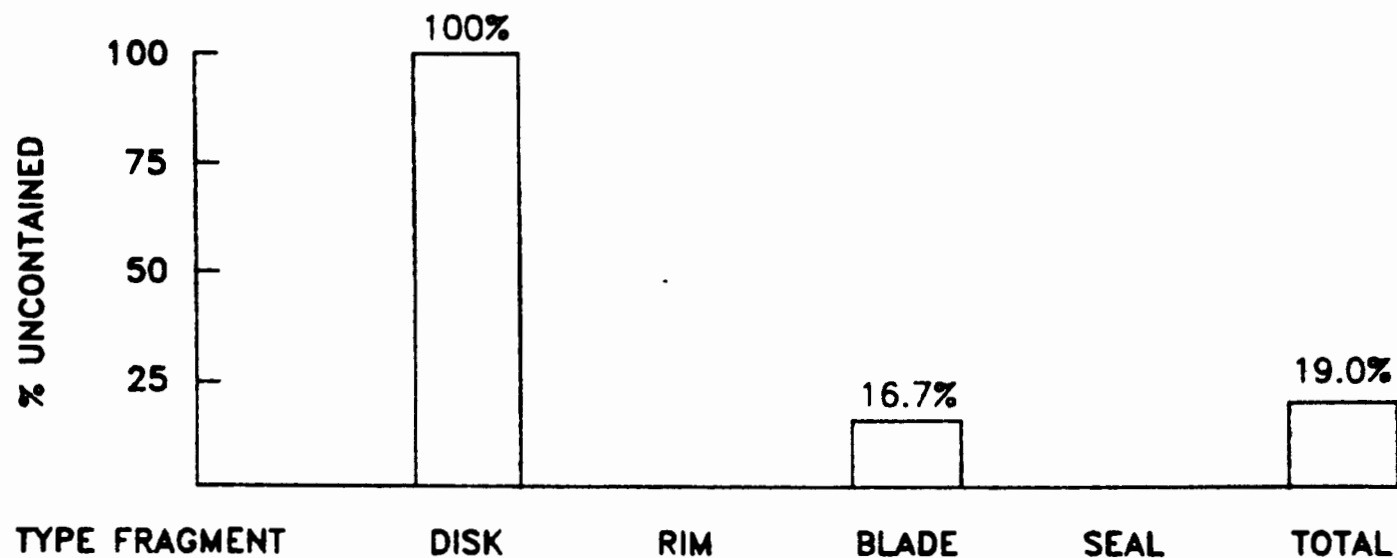
FIGURE 3: COMPONENT AND FRAGMENT TYPE DISTRIBUTIONS FOR  
CONTAINED AND UNCONTAINED ROTOR ENGINE FAILURES  
(FAILURES THAT PRODUCED FRAGMENTS) - 1981

b. Figure 3 shows the distribution of rotor failures that produced fragments according to the engine component involved (fan, compressor, turbine), the types of fragments that were generated, and the percentage of uncontained failures according to the type of fragment generated. These data indicate that:

(1) The incidence of turbine rotor fragment producing failures was approximately four times greater than that of the compressor rotor fragment producing failures; these corresponded to 62 (73.8 percent) and 15 (17.9 percent), respectively, of the total number of rotor failures. Fan rotor failures accounted for 7 (8.3 percent) of the fragment producing failures experienced.

(2) Blade fragments were generated in 78 (92.9 percent) of the rotor failures; 13 (16.7 percent) of these were uncontained. The remaining 6 (7.1 percent) rotor fragment failures were produced by disk, rim, or seal.

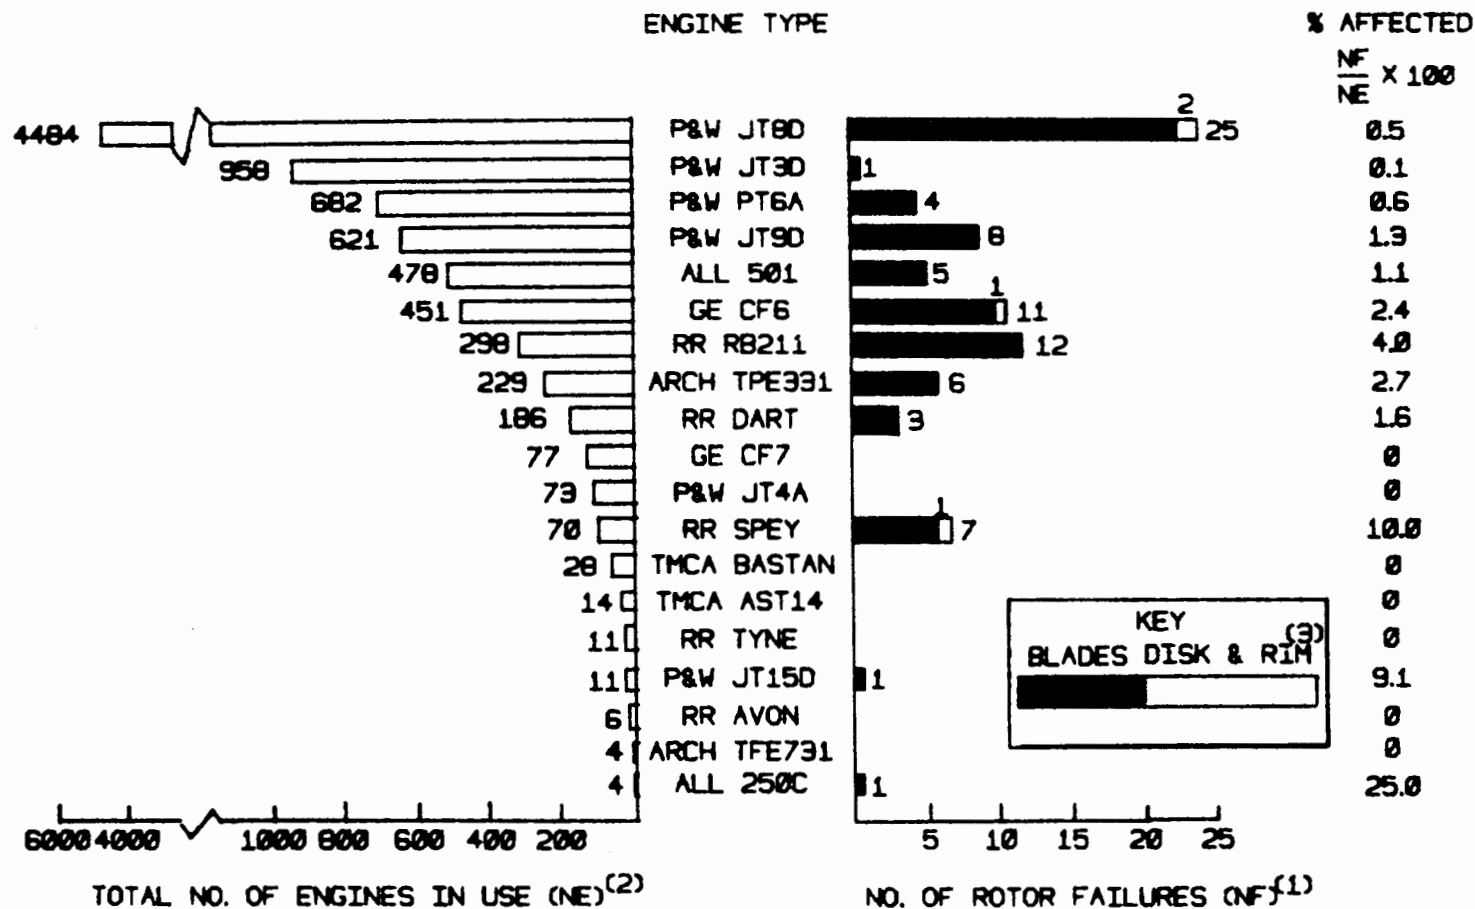
FIGURE 4: THE INCIDENCE OF ENGINE ROTOR FAILURE IN  
 U.S. COMMERCIAL AVIATION ACCORDING TO  
 ENGINE TYPE AFFECTED - 1981

c. Figure 4 shows the rotor failure distribution among the engine models that were affected, and the total number of the models in use.

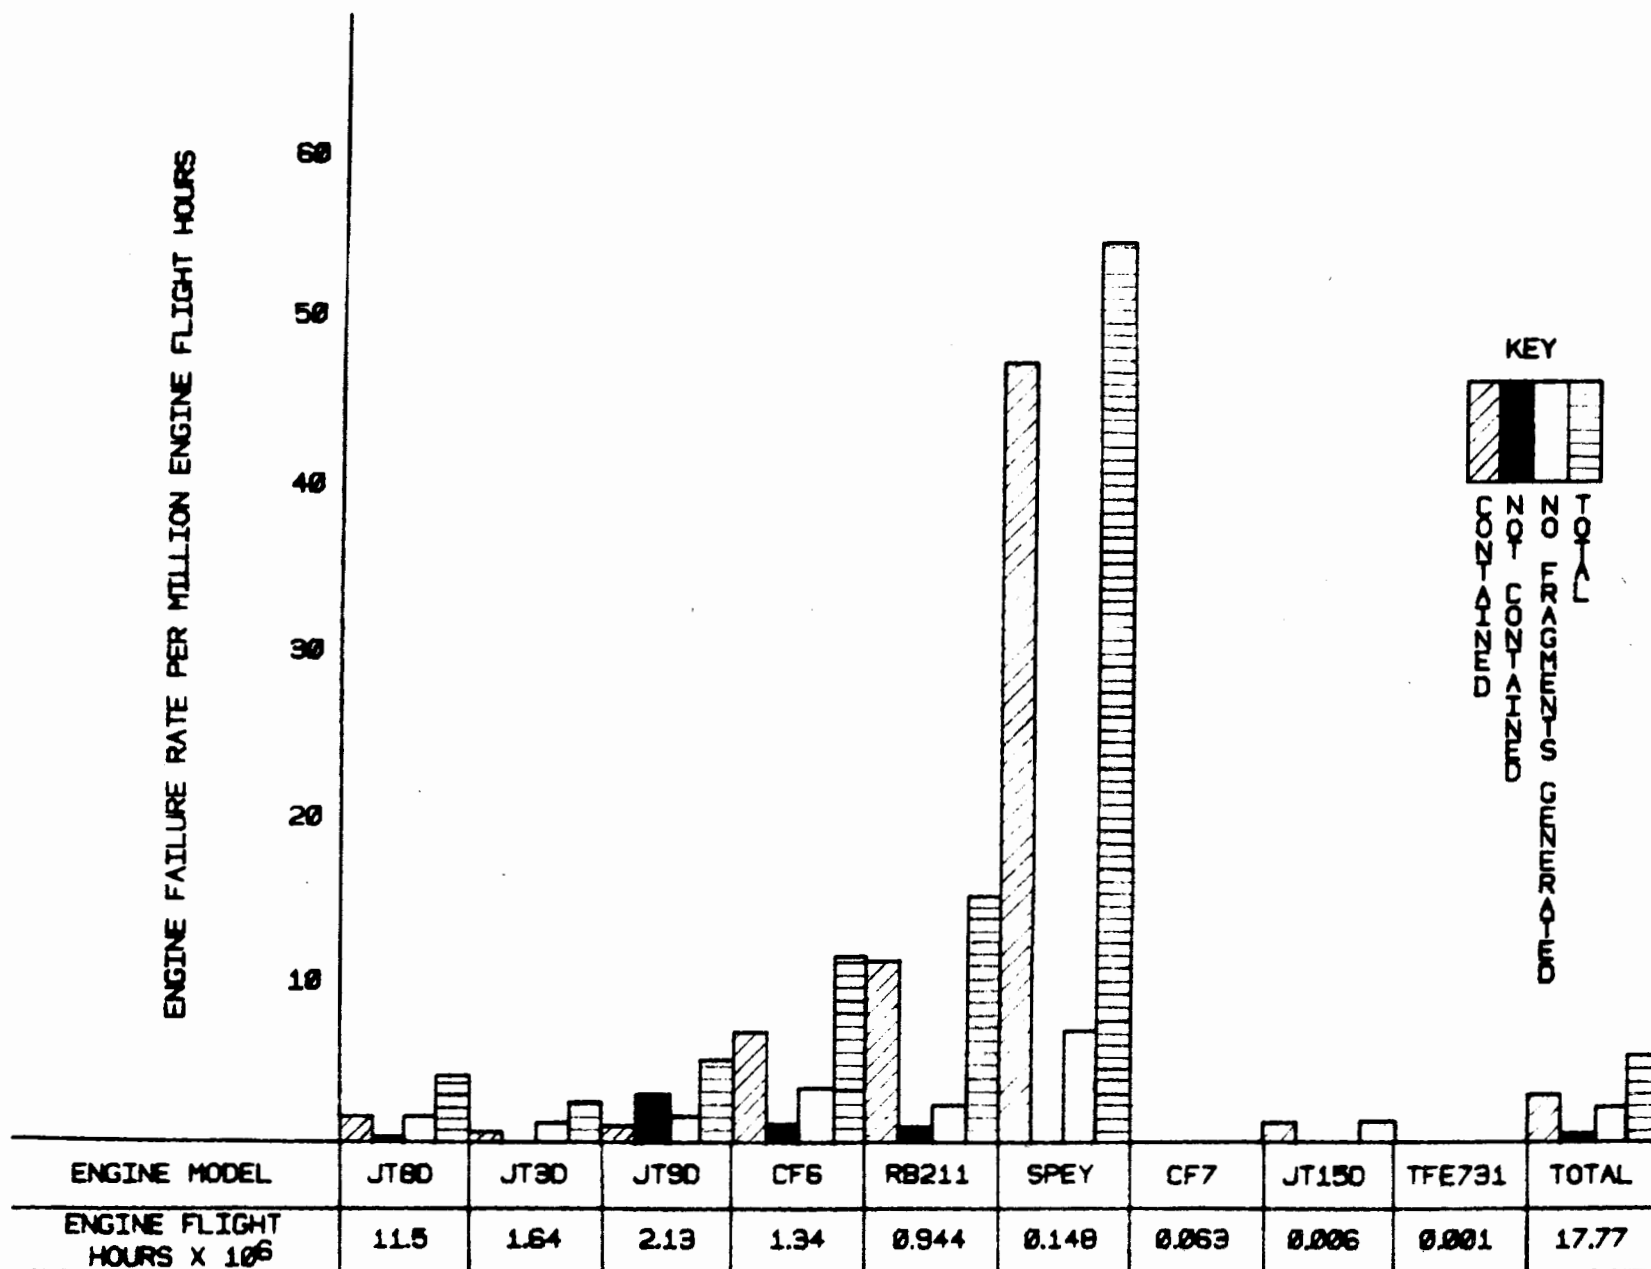
FIGURE 5: TURBOFAN ENGINE FAILURE RATE ACCORDING TO ENGINE MODEL - 1981

d. Figures 5, 6, and 7 illustrate engine failure rates per million engine flight hours according to engine model, engine type, and containment condition. The total engine failure rate per million engine type flight hours are: turbofan 5.7, turboprop 11.8, turboshaft 34.2, and turbojet 27.0. Total uncontained engine failure rates per million engine type flight hours were: turbofan 0.7 and turboprop 1.5. No uncontained rotor failures were reported for turboshaft and turbojet engines in 1981.

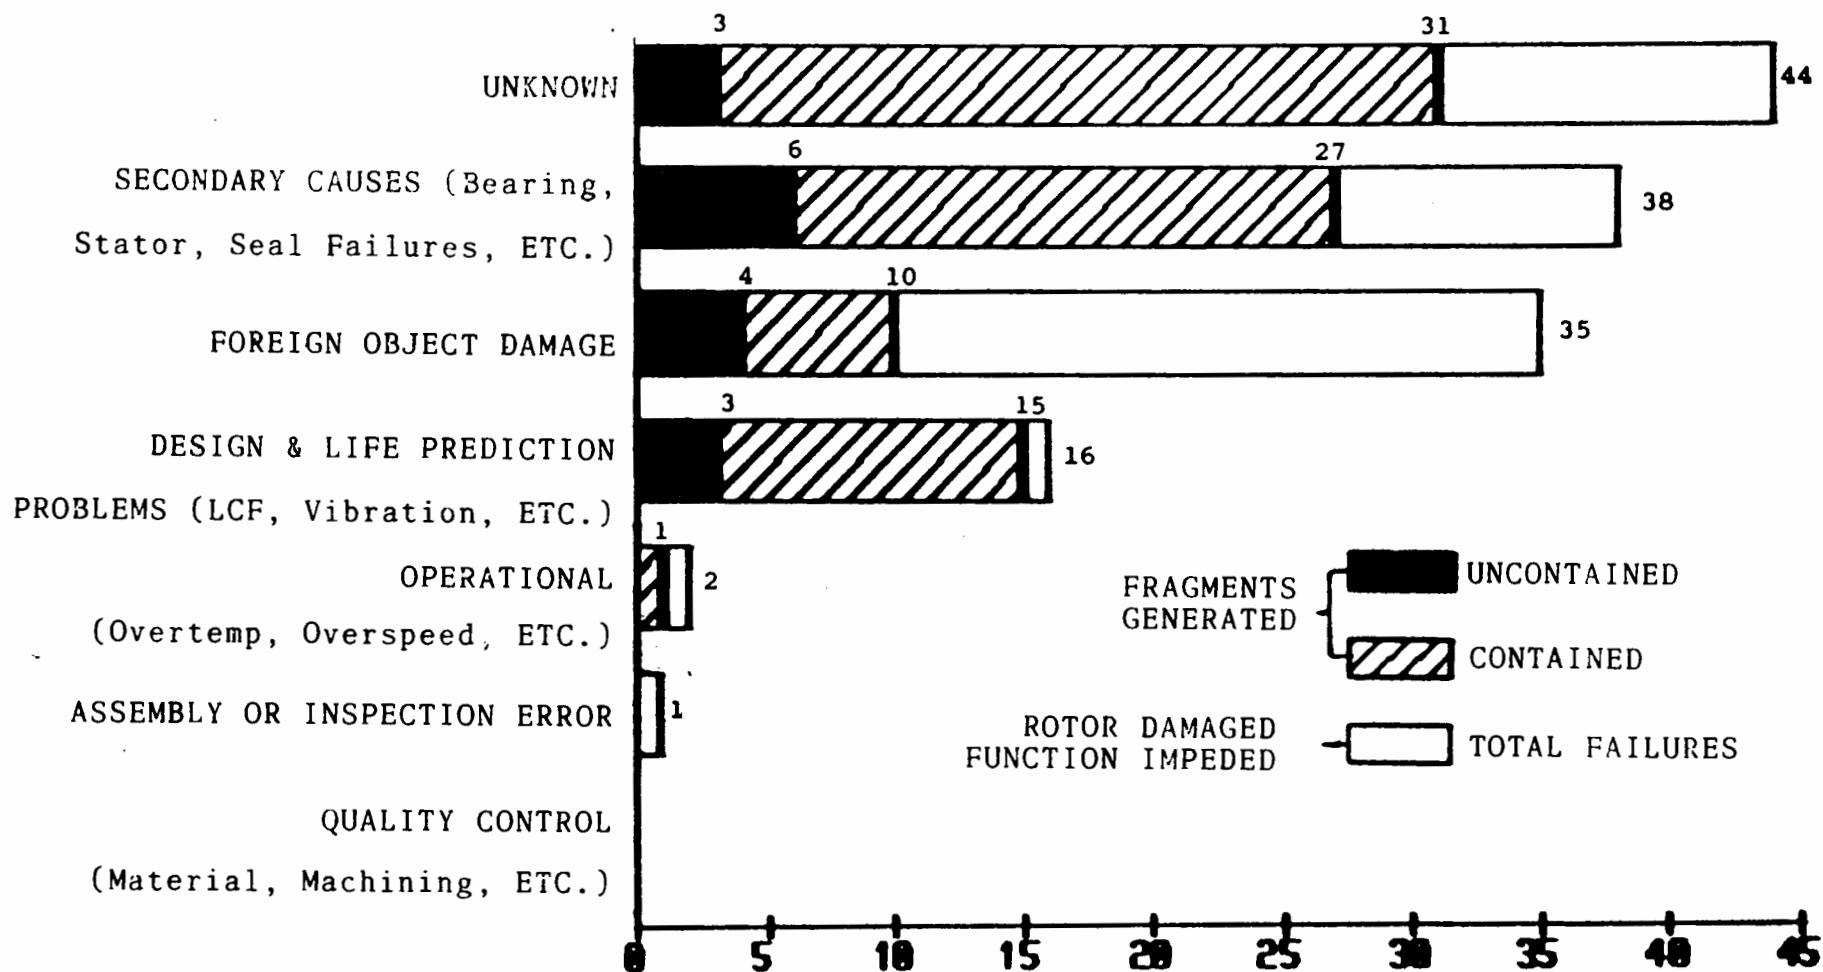
FIGURE 8: ENGINE ROTOR FAILURE CAUSE CATEGORIES - 1981

e. Figure 8 shows what caused the rotor failures to occur. Of the 92 known causes of failure (because of the high percentage of unknown causes of rotor failure, the percentages were based on the total number of known causes), the causal factors were: (1) Secondary Causes 38 (41.3 percent); (2) Foreign Object Damage 35 (38.0 percent); (3) Design and Life Prediction Problems 16 (17.4 percent); and Other 3 (3.3 percent).

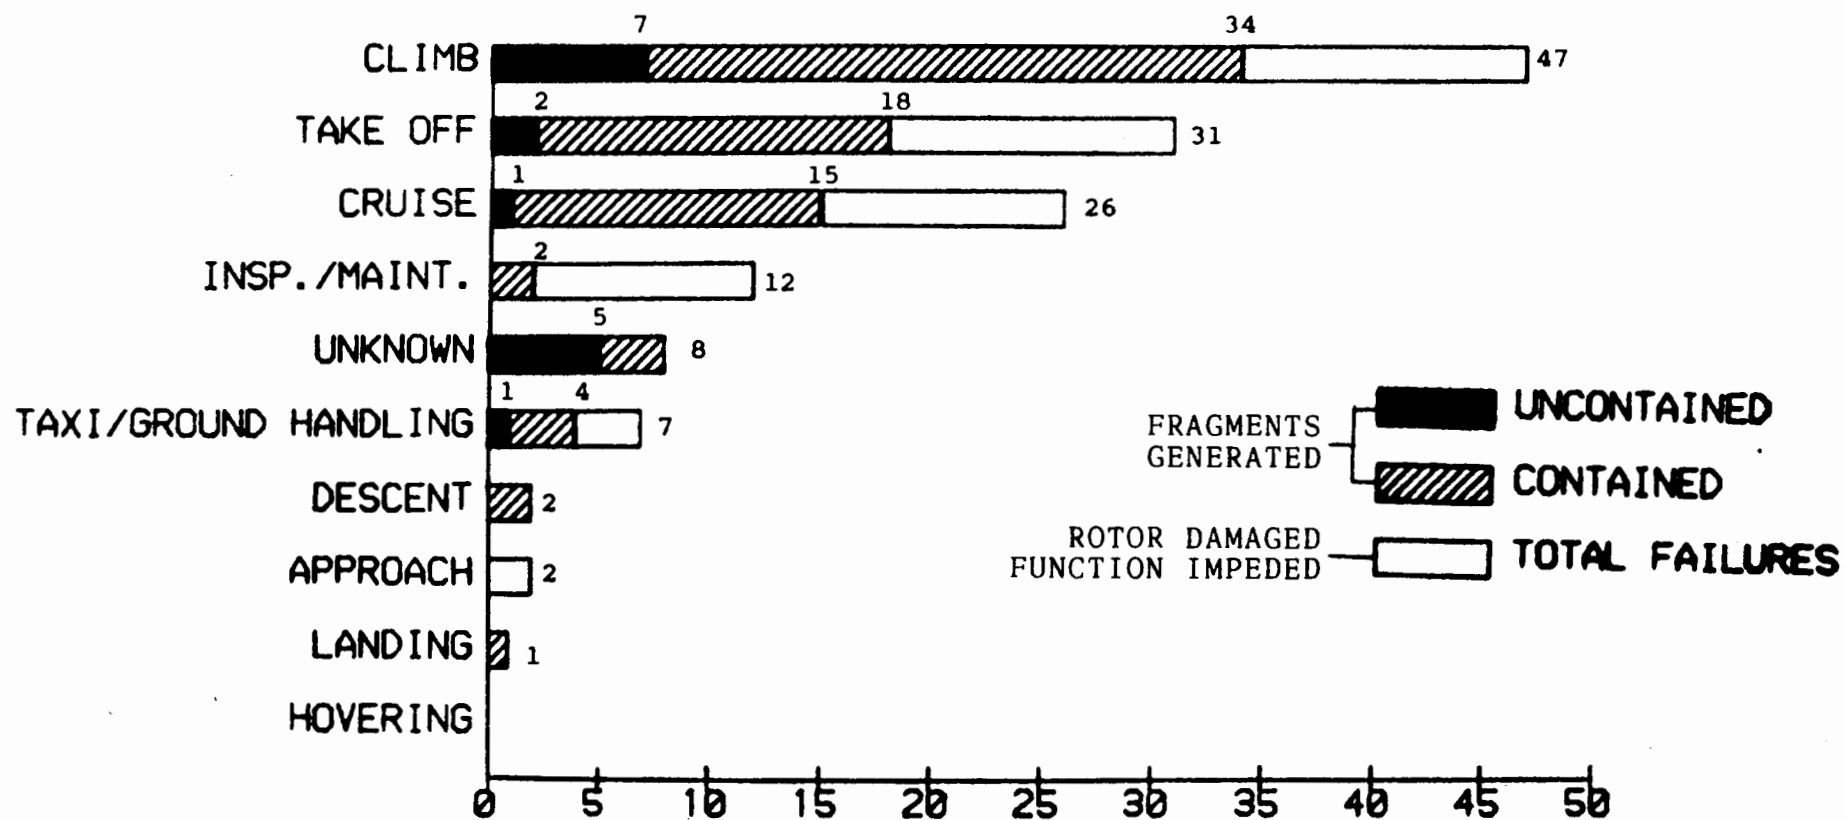
FIGURE 9: FLIGHT CONDITION AT ENGINE ROTOR FAILURE - 1981

f. Figure 9 indicates the flight conditions that existed when the various rotor failures occurred. Seventy-eight (57.4 percent) of the 136 rotor failures occurred during the takeoff and climb stages of flight. Fifty-two (61.9 percent) of the rotor fragment producing failures and 9 (56.3 percent) of the uncontained rotor failures occurred during these same stages of flight. The highest number of uncontained rotor failures, 7 (43.8 percent) was experienced during climb.

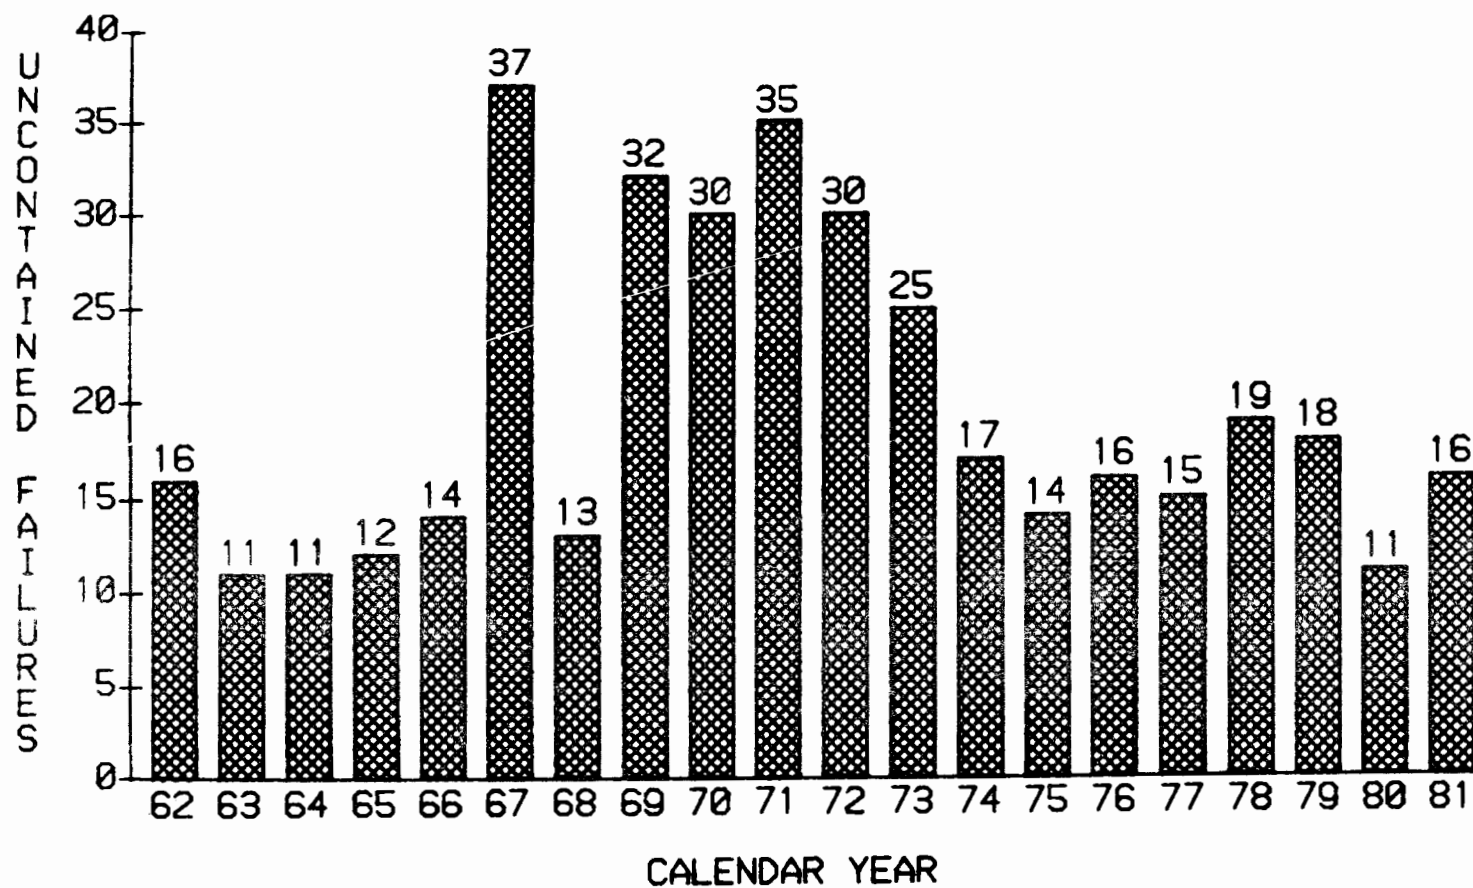
FIGURE 11: THE INCIDENCE OF UNCONTAINED ENGINE ROTOR FAILURE IN U.S. COMMERCIAL AVIATION 1962 - 1981

h. Figure 11 shows the annual incidence of uncontained rotor failures in commercial aviation for the years 1962 through 1981. During 1981, the incidence of uncontained rotor failure increased by five over the previous year, 1980. Over the past six years, 1976 through 1981, an average of 16 uncontained rotor failures per year have occurred. During the same time period, the rate of uncontained rotor failures has remained relatively constant at an average of approximately one per million engine operating hours.

The high incidences of uncontained rotor failures in calendar years 1967 through 1973 (except for 1968) were probably due to the introduction of newly developed engines entering the commercial aviation fleet such as the JT9D and CF6 engines.
