# **Preventing Transverse Bumps and Cracks in New Asphalt Overlays over Crack Sealants**

**Scott Shuler**

**Report No. CDOT-2017-02  
January 2017**

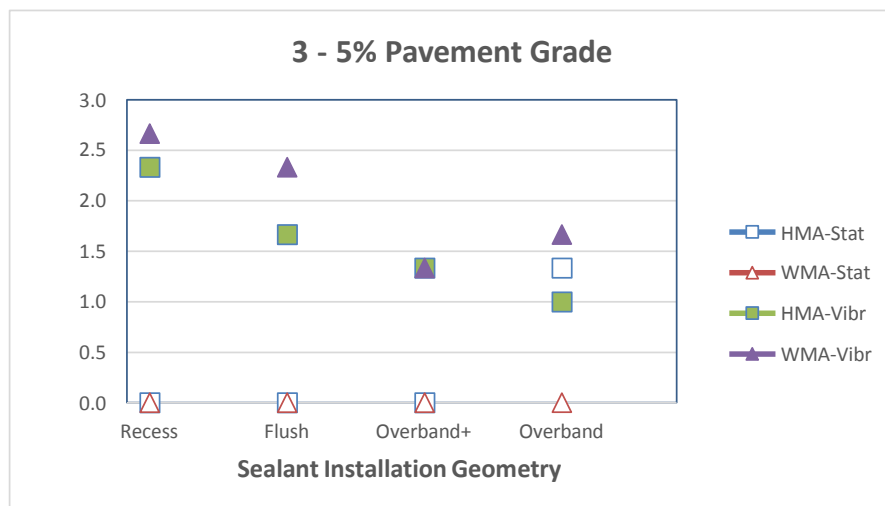
Vibratory breakdown rolling produced the most significant bumps and cracks over the overbanded and overbanded with release agent crack sealant for the hot mix overlay. However, bumps and cracks also appeared over the recessed and flush filled cracks after two or three passes of the roller. Bumps and cracks also occurred in the warm mix overlay over all four types of crack preparation, but generally required one additional pass of the breakdown roller to occur. The results of these observations are determined as an average for five cracks in each test section depicted in Figure 1 so decimal values instead of whole numbers often represent the number of passes required to generate bumps.

**FIGURE 1. Appearance of Bumps after Breakdown Rolling at 300 feet per minute**

Results shown in Figure 1 suggest that vibratory breakdown rolling has a larger effect on bump generation than mixture temperature since bumps occurred in both the warm mix and hot mix sections when vibrating during breakdown. However, only the hot mix section with the overbanded crack sealant displayed bumps when static rolling was done.
