# **Guardrail Height Safety Requirements Given Recent Crash History and Evolution of Vehicle Design**

FDOT Contract No: BED32-977-03

Final Report

Principal Investigator: Scott Parr, Ph.D., PE  
Graduate Student: Delaney Morgan, M.S.

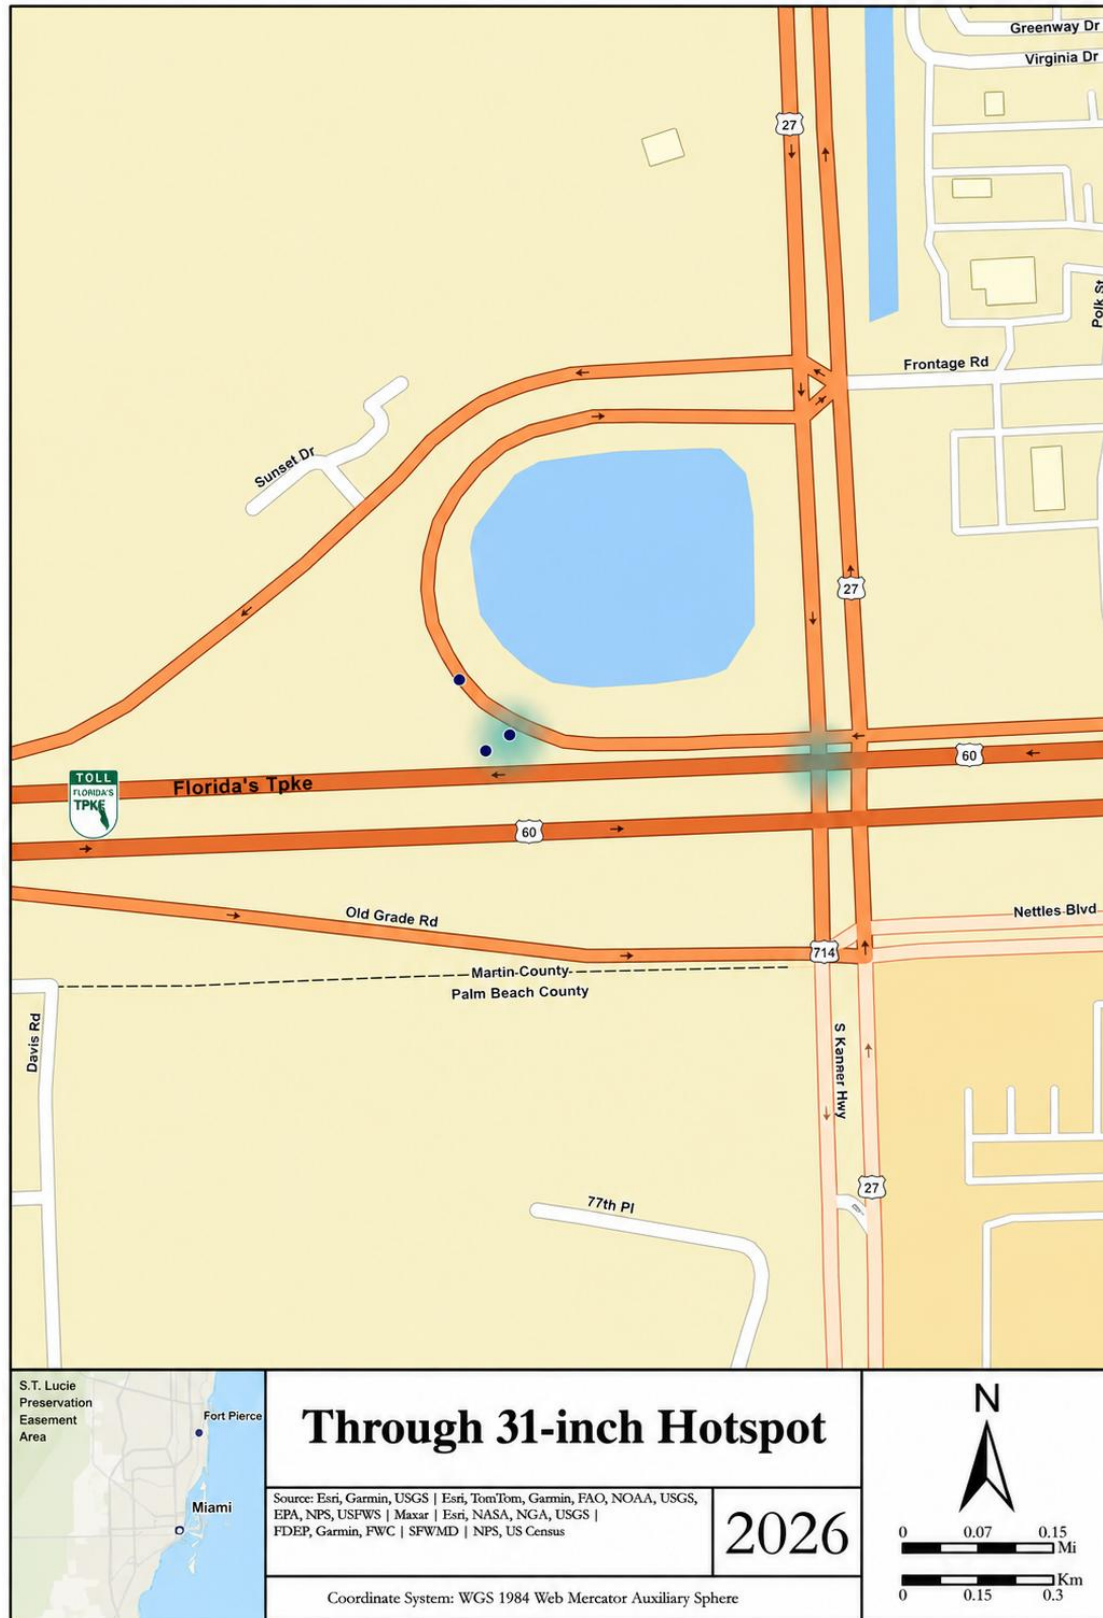
Figure 7-7: Hot-spot location 1 — Miramar, Florida

The first selected hot-spot location is in Miramar, Florida, at the westbound exit ramp from Florida's Turnpike to NW 27th Avenue. This location includes three confirmed guardrail failure events occurring in close spatial proximity. All three failures were classified as Through failures and were associated with the 31-inch guardrail height standard.

Figure 7-7 shows the mapped location of the three confirmed Through failures at the westbound exit ramp from Florida's Turnpike to NW 27th Avenue. The figure illustrates the close spatial proximity of the failure events and provides the basis for identifying this ramp as a selected hot-spot location for detailed review.

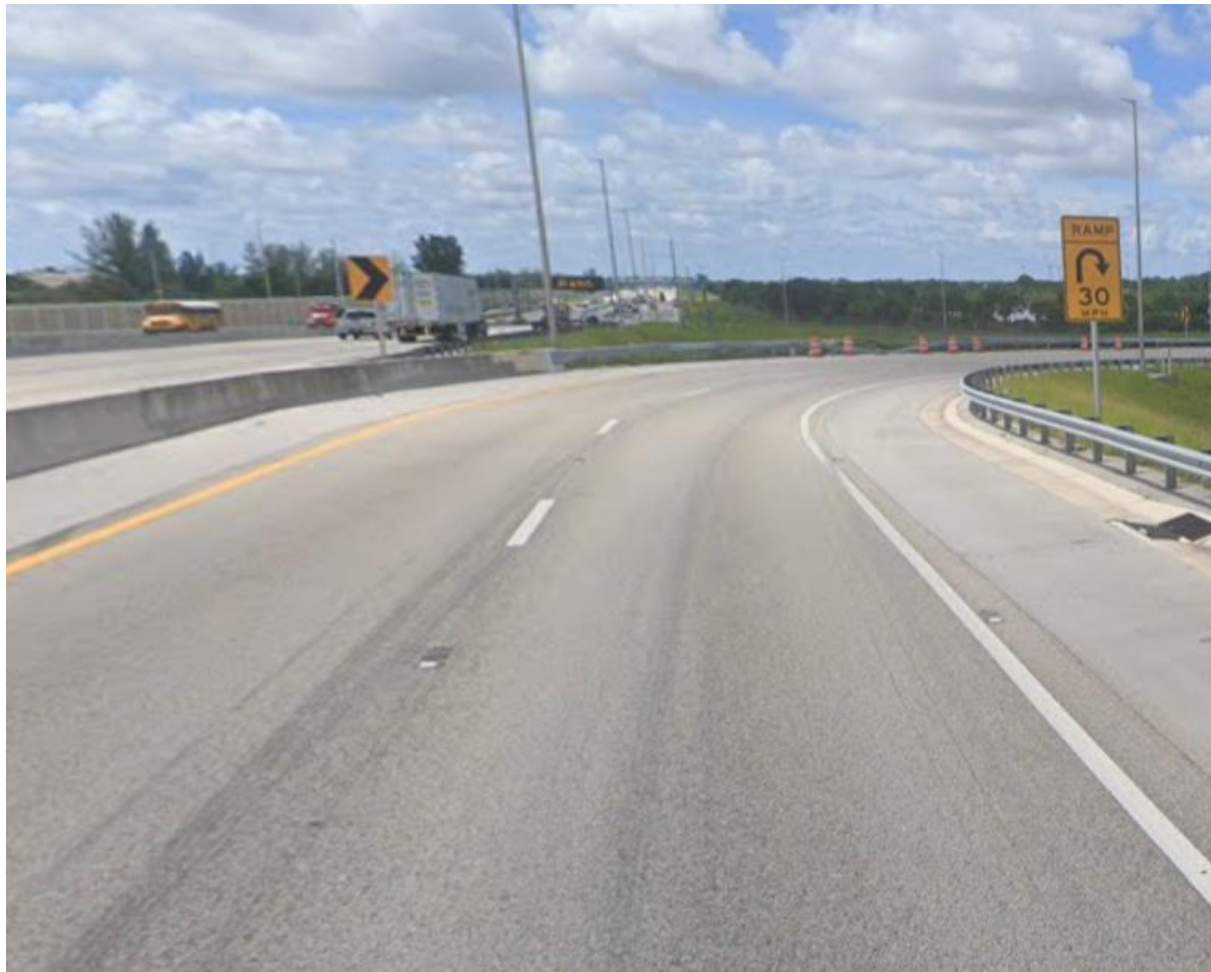
**Figure 7-8: Hot-spot location 1 site image**

The repeated occurrence of Through failures at this ramp location suggests that the site may represent an area of concern. Based on available imagery provided in Figure 7-8, the ramp includes a curved alignment, and the failure events appear to be concentrated within the ramp environment. This type of location may involve interactions between approach speed, ramp curvature, driver path, impact angle, and roadside barrier placement. Figure 7-8 provides a site-level image of the ramp area to support the preliminary review of roadway context.

Figure 7-8 shows the exit ramp from Florida's Turnpike to NW 27th Avenue. The image shows a ramp advisory speed of 30 mph and visible evidence of a recent guardrail Through failure at the time the image was captured. The apparent failure location is on the outside of the ramp curve, where vehicles departing the roadway would be expected to strike the guardrail face.

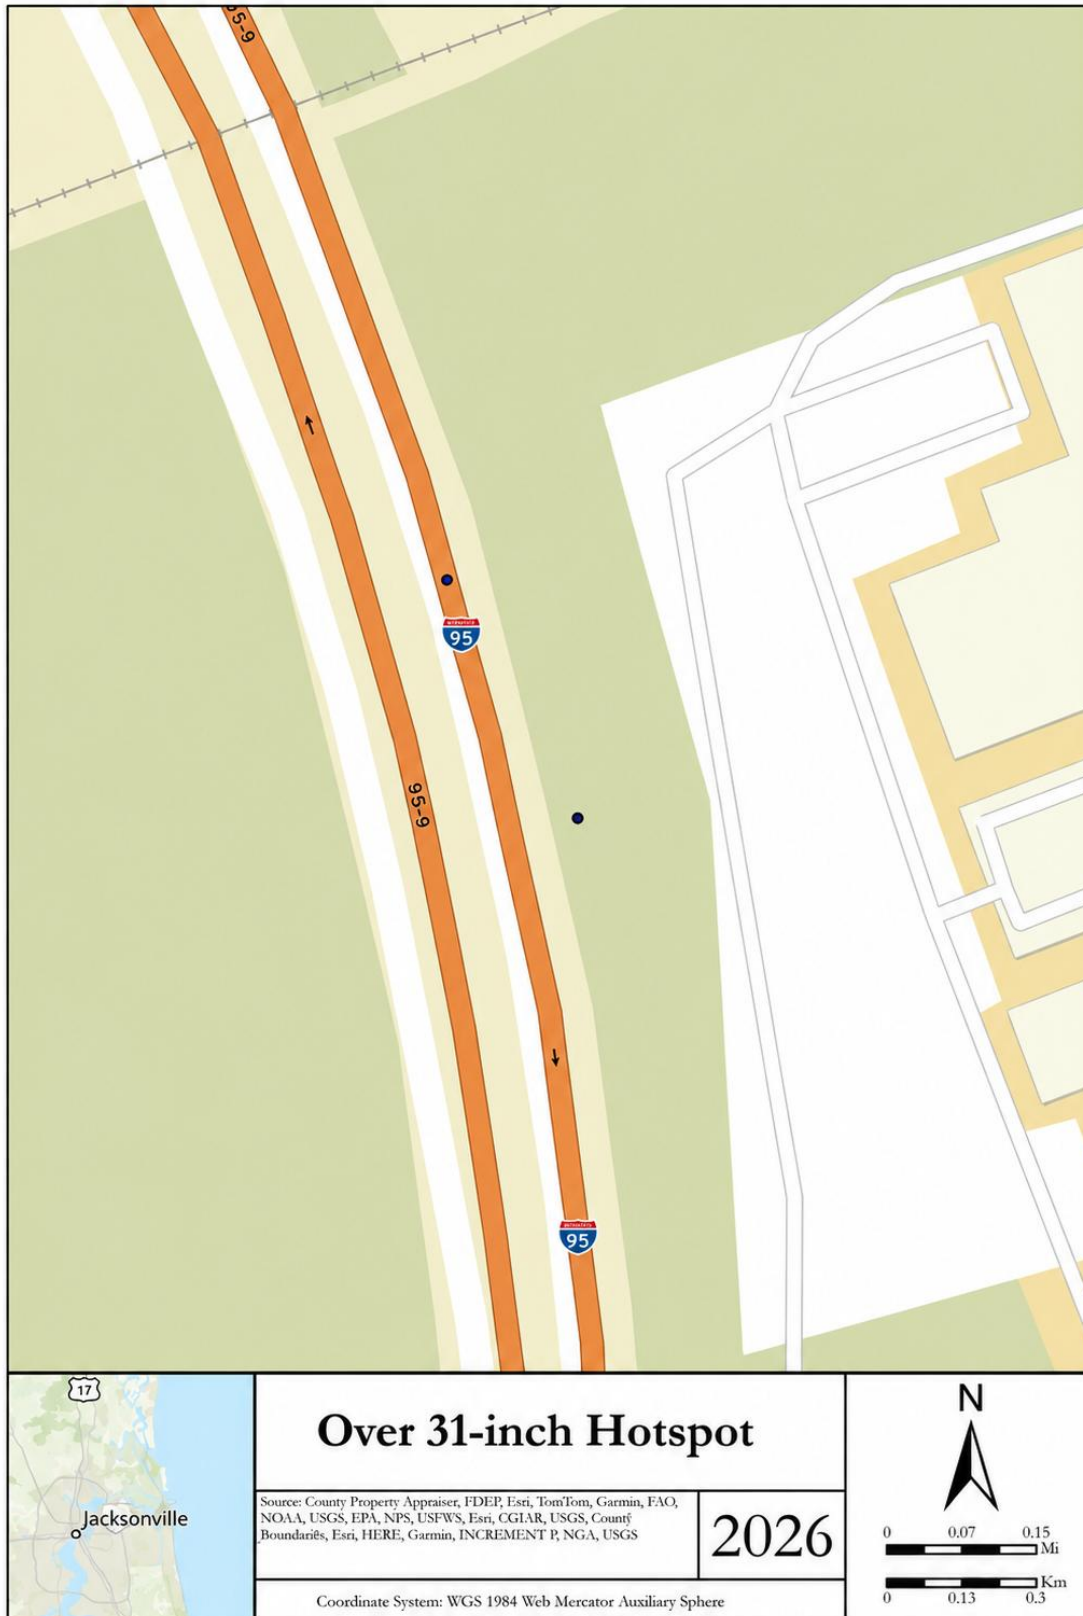
Figure 7-9: Hot-spot location 2 — Jacksonville, Florida

Both failures were classified as Over failures and were associated with the 31-inch guardrail height standard.

Figure 7-9 shows the mapped location of the two confirmed Over failures along northbound I-95 in Jacksonville. Both failures occurred in close proximity and were associated with the 31-inch guardrail height standard, supporting the selection of this site for detailed review.
