Report No. DOT/FAA/TC-26/13

**Assessment of Emerging Metallic Structures  
Technologies through Test and Analysis of Fuselage  
Structure: Test Panel 3**

July 2026

Final report

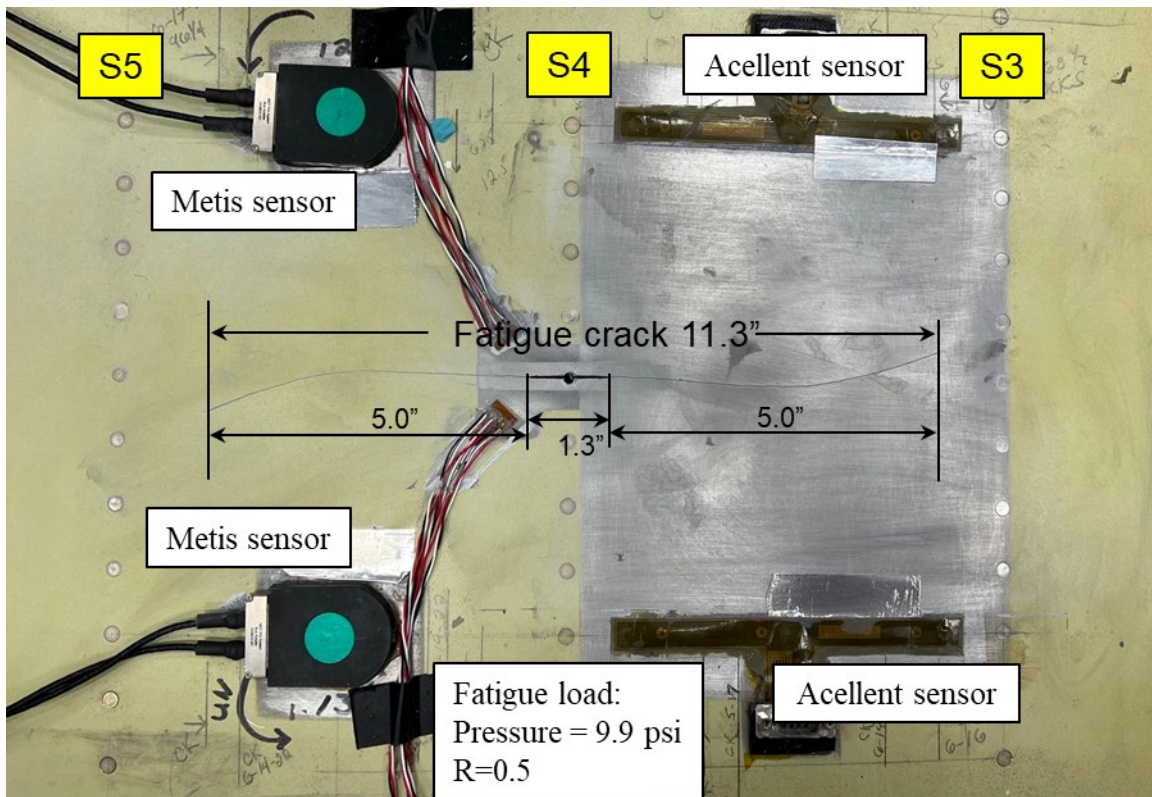
Figure 11. Picture of Phase 1 fatigue crack growth at 48,850 cycles

The panel was fatigue tested under simulated flight load conditions for 48,850 cycles, during which the skin crack extended across two stringer bays to a final length of approximately 11 in., as shown in Figure 11 and Figure 12. In general, slow and stable crack growth was observed during the fatigue test. The crack surface morphology had distinct transition points where, on both sides, the crack surfaces changed from flat to S (slant) fracture. Results indicate that crack-growth rates changed at these transition points similar to those observed in panel 1 and panel 2 testing (Tian, Stanley, & Bakuckas, 2021).

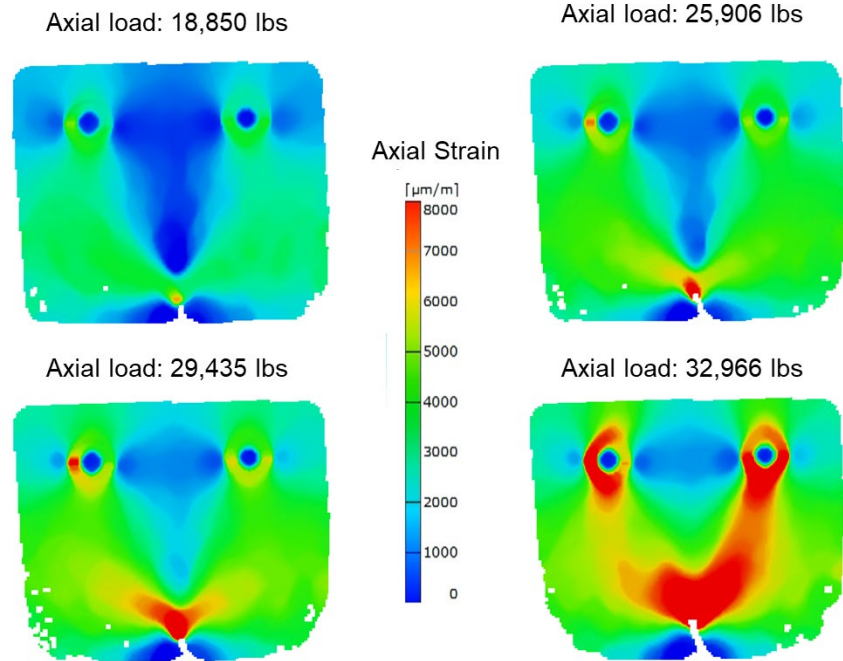
Figure 18. ARAMIS result during the circumferential direction limit load test

Strain gages located on the inner and outer flanges of the stringer ahead of the fatigue crack revealed that the stresses were below the yield strength of the stringer material (see Figure 17). The intact stringers ahead of the crack were effective in containing the damage. In addition, limited stable-tearing extension and crack tip plasticity were observed from each crack tip, as shown in Figure 18 using DIC measurements.

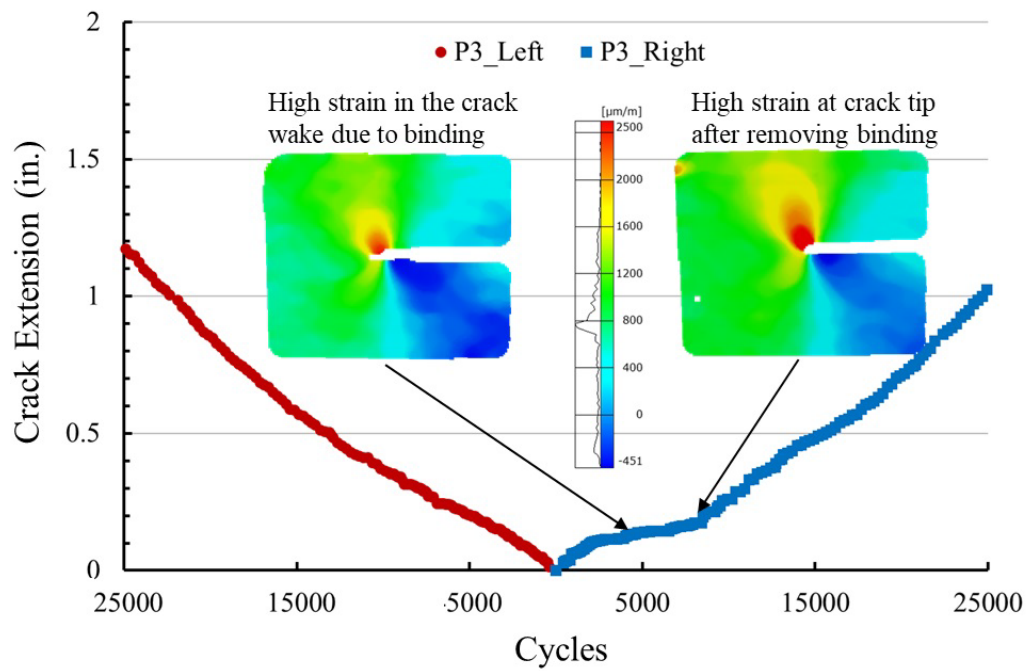
Figure 21. Slow fatigue crack growth on right side due to binding

However, the right-side crack growth is still slower than the other side. Post-residual strength test investigation revealed that the asymmetrical crack growth was due to the transition of crack surface morphology resulting in crack growth-rate changes as observed during Phase 1 fatigue test, as shown in Figure 12. The left-side crack had slanted crack surface throughout the whole fatigue testing. However, the right-side crack transition from slant to V or less slant crack surface during the fatigue from approximately 18,000 to 28,000 shifted cycles (27,000 to 37,000 total cycles), as shown in Figure 22, which led to the slower crack grow. However, panel 3 exhibited

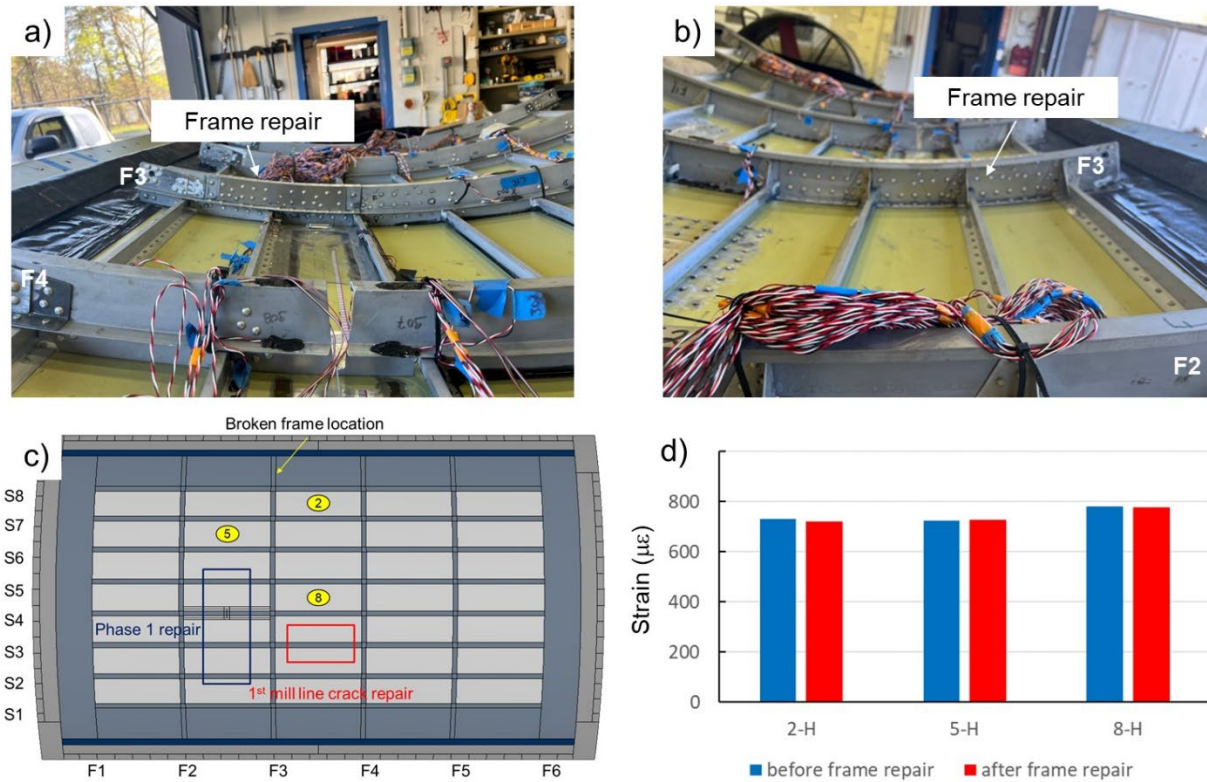
Figure 25. Frame repair and strain survey after frame repair

During Phase 2 fatigue testing, two additional test segments were added, introducing cracks along the mill line. These test segments were designed to evaluate SHM systems' capability and reliability in a mill line crack scenario (Appendix E). The details of these SHM tests will be reported in a separate report. Furthermore, the frame end of F3 was unexpectedly broken at 32,900 cycles. The test panel was removed from the FASTER fixture and repaired (Appendix F). The panel was installed back on the FASTER fixture after the repair, and strain survey was conducted to ensure the frame repair did not change the load distribution in Phase 2 test area, as shown in Figure 25.

During the Phase 2 fatigue testing, the frame end of F3 was unexpectedly broken at 32,900 cycles even though the panel 3 frame ends were reinforced similar to panel 2. However, it was found that the reinforcement pieces were installed without structural adhesive. The test panel was removed from the FASTER fixture due to the limitation of working space inside of the pressure box and the intensity of the repair work. The broken frame end was reinforced as shown in Figure F- 1. All other frame ends reinforcements were disassembled and reinstalled back with adhesive. The panel was then installed back on the fixture after the repair, and the strain survey was conducted to ensure the frame repair and reinforcements did not change load introduction.

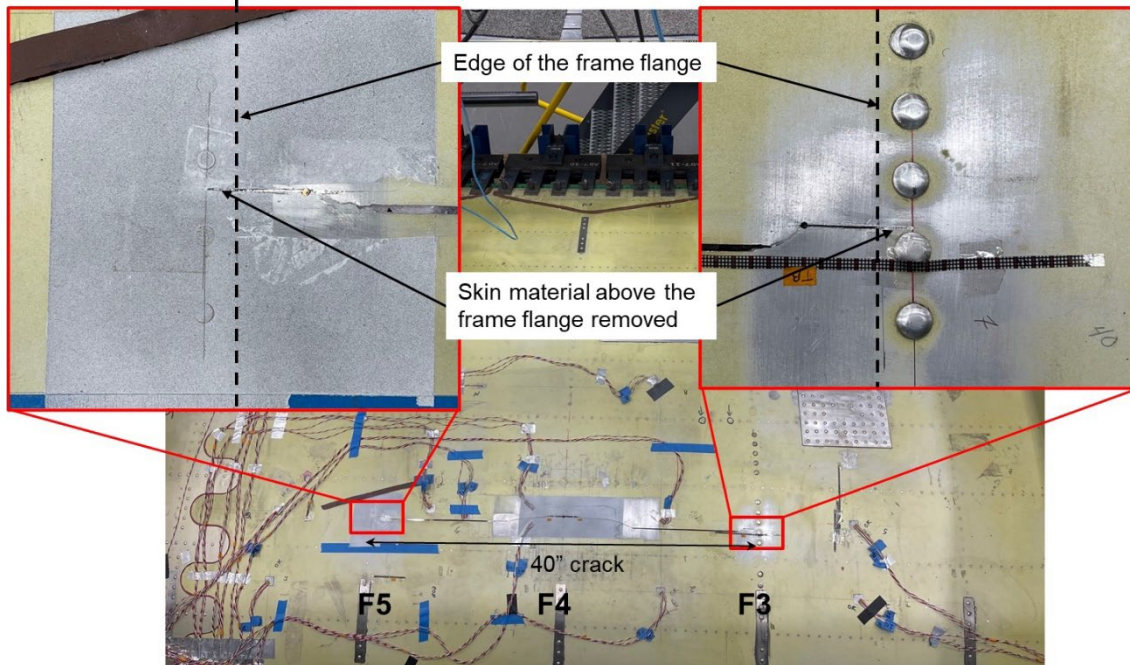
Figure 26. Final damage configuration before the residual strength test

After fatigue testing, the final stage of testing was a residual strength test to certain limit load conditions identified in 14 CFR §25.571 (b) (Damage-tolerance... , 2023). The residual strength test was conducted under pressure loading applied quasi-statically. For panel 3, the team decided to conduct the residual strength test for a two full bay 40 in. crack condition. The fatigue test stopped at a crack length of about 12.5 in., the crack was extended with a saw cut all the way to the edge of the frame flange. The skin on top of the frame was then scribed as deeply as possible without damaging the frame attachment flange beneath it. The final damage configuration before the residual strength test is shown in Figure 26. Post-test photo and video analysis showed unstable tearing occurred at a maximum applied pressure of 13.3 psi, resulting in failure of the panel. The pre-test residual strength analysis demonstrates a good prediction of the failure pressure (Appendix G), as shown in Figure 27. Extensive damage occurred to the panel where the skin crack extended to a total length of 60 in., as shown in Figure 28. The pressure at failure exceeded the residual strength damage-tolerance requirements in 14 CFR §25.571 (b) (Damage-tolerance... , 2023).
