DOT/FAA/CT-88/23

# Statistics on Aircraft Gas Turbine Engine Rotor Failures that Occurred in U. S. Commercial Aviation During 1982

July 1988

Final Report

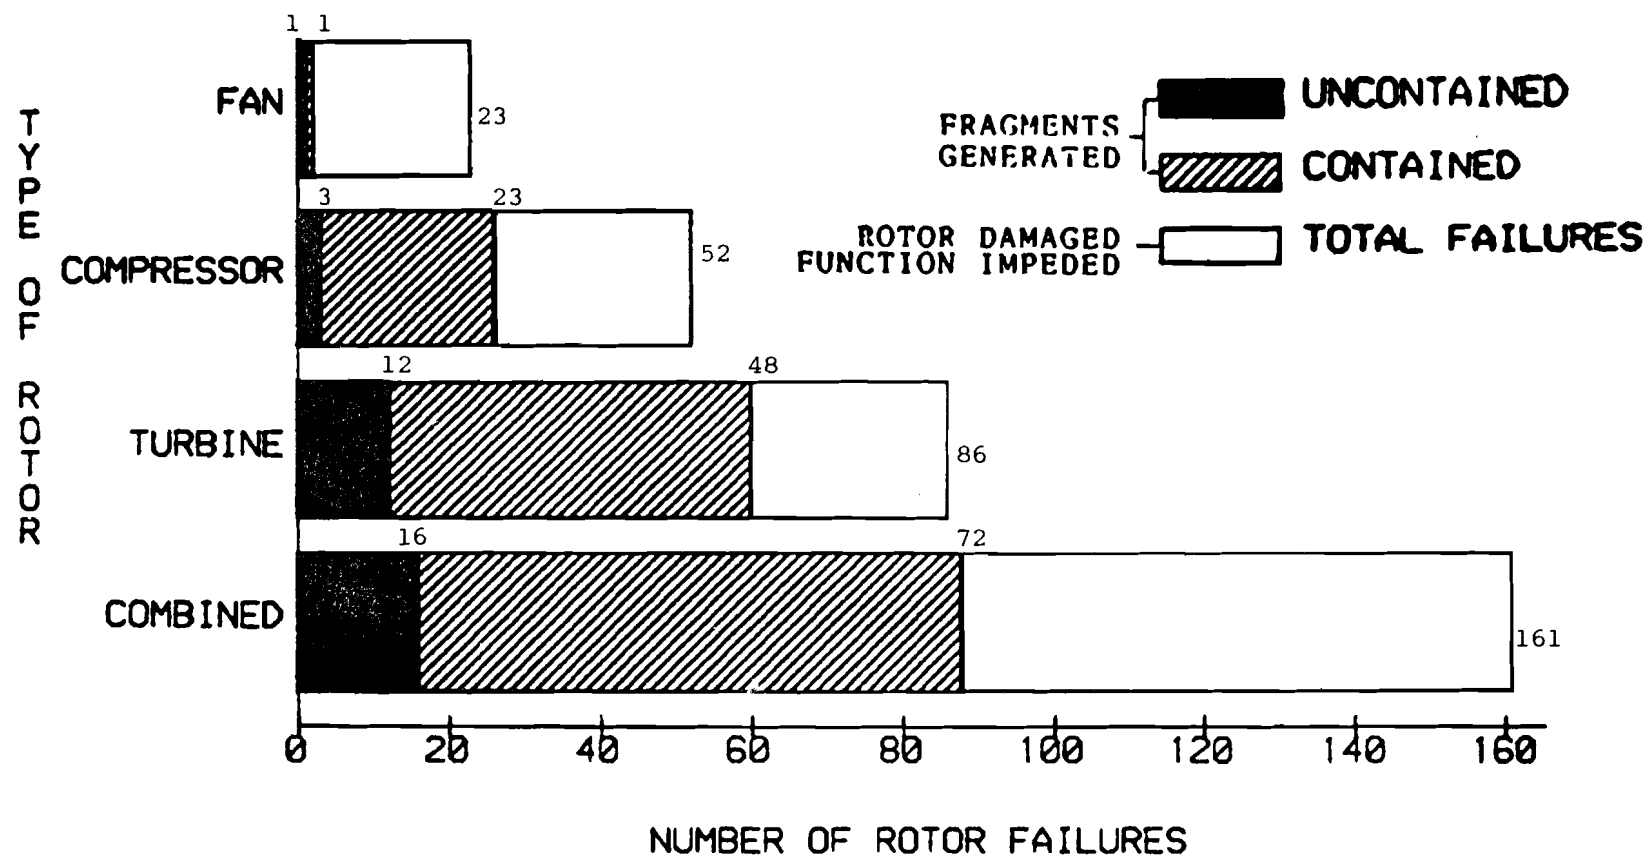
FIGURE 1. INCIDENCE OF ENGINE ROTOR FAILURES IN U.S. COMMERCIAL AVIATION - 1982

Figure 1 shows that 161 rotor failures occurred in 1982. These rotor failures accounted for approximately 9.3 percent of the 1722 shutdowns experienced by the U.S. commercial gas turbine powered aircraft fleet during 1982. Rotor fragments were generated in 88 of the failures experienced and, of these, 16 (18.2 percent of the fragment-producing failures) were uncontained. This represents an uncontained failure rate of 2.1 per million gas turbine engine powered aircraft flight hours, or 1.3 per million engine operating hours.

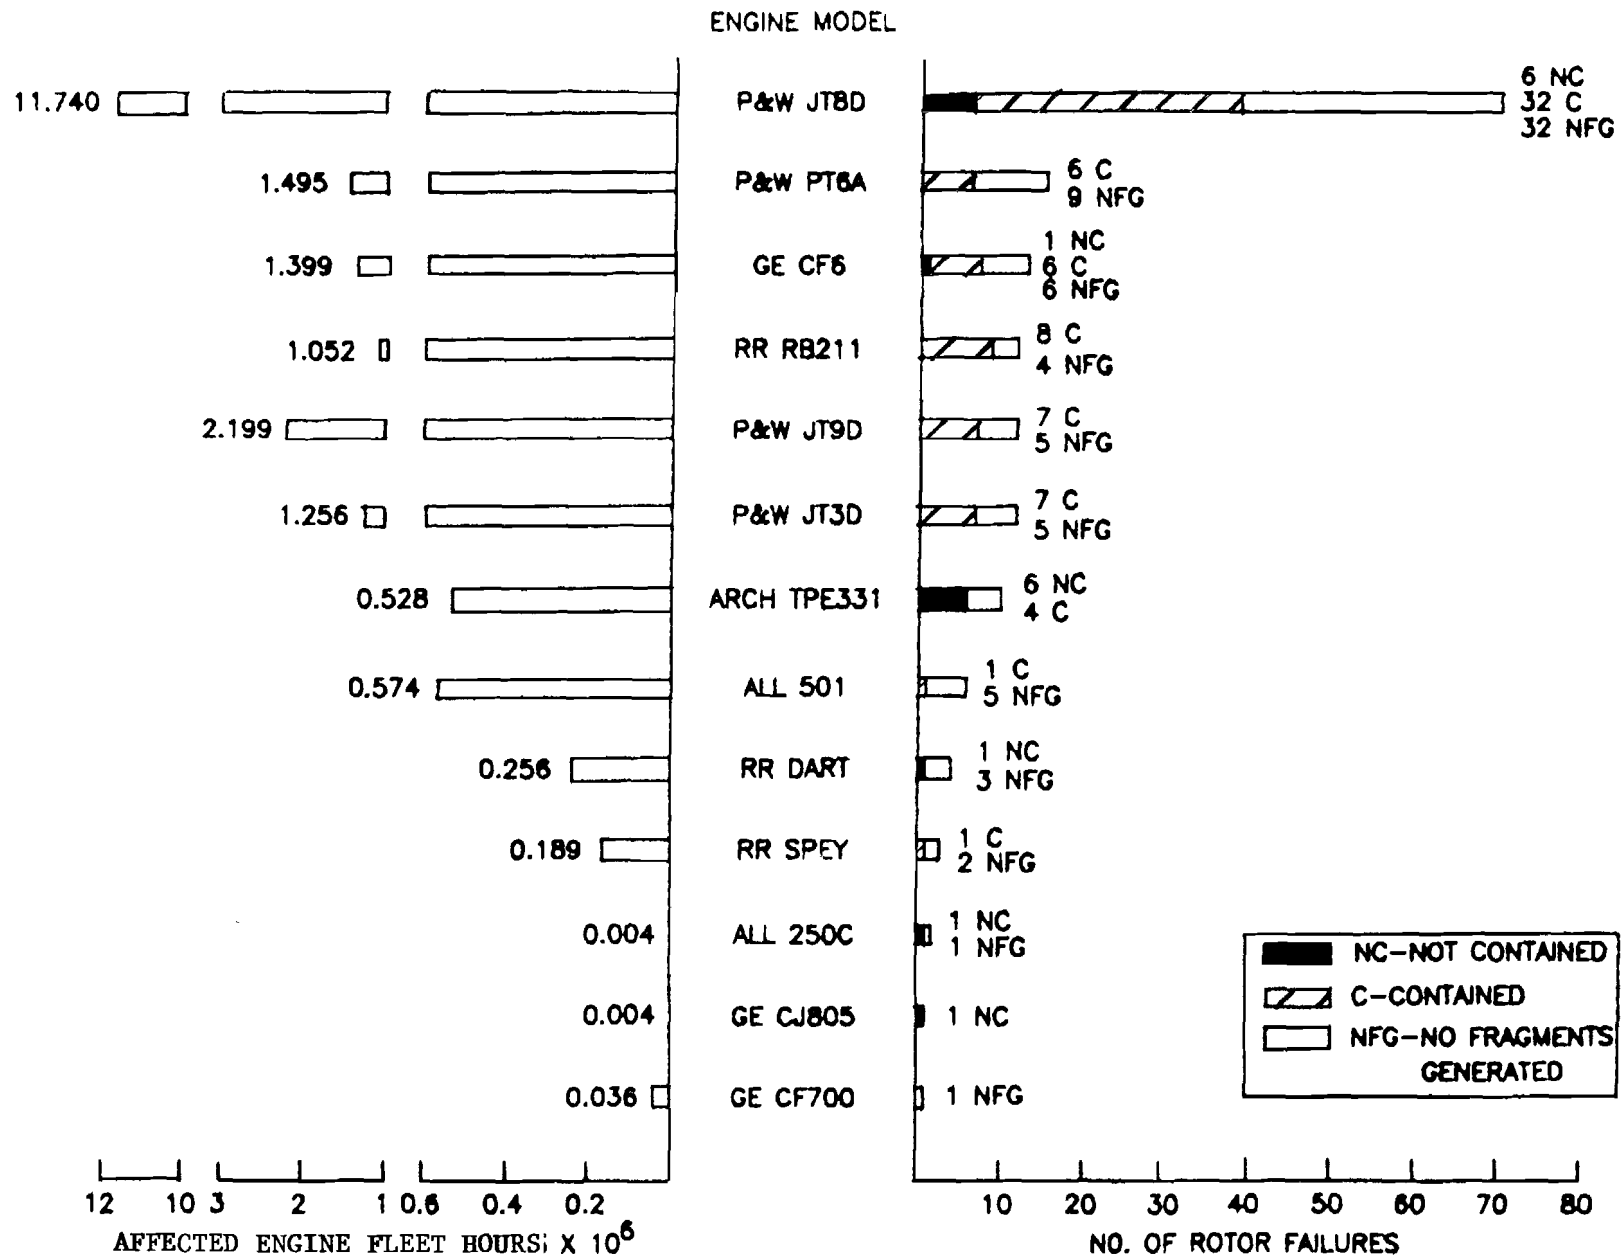
FIGURE 2. THE INCIDENCE OF ENGINE ROTOR FAILURES IN U.S. COMMERCIAL AVIATION ACCORDING TO AFFECTED ENGINE FLEET HOURS FOR EACH ENGINE MODEL - 1982

Approximately 7.6 million aircraft flight hours and 20.8 million engine operating hours were logged by the U.S. commercial aviation fleet in 1982. Gas turbine engine fleet operating hours relative to the number of rotor failures and type of engines in use are shown in figure 2.

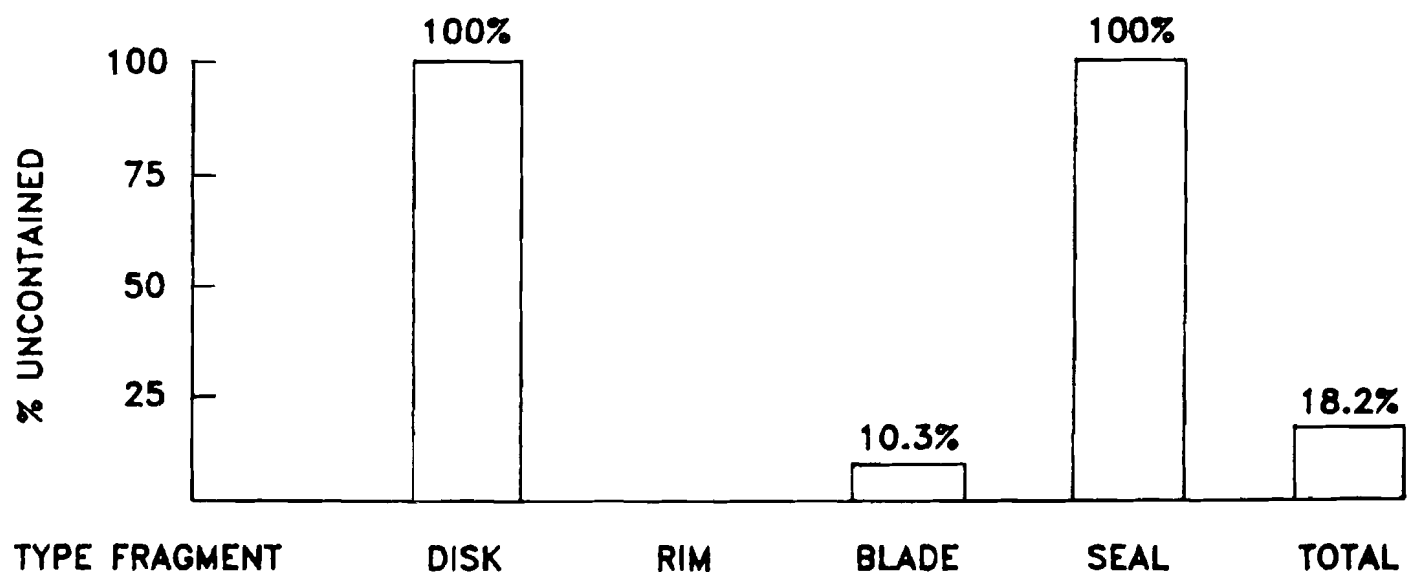
FIGURE 3. COMPONENT AND FRAGMENT TYPE DISTRIBUTIONS FOR CONTAINED AND UNCONTAINED ROTOR ENGINE FAILURES (FAILURES THAT PRODUCED FRAGMENTS) - 1982

Figure 3 shows the distribution of rotor failures that produced fragments according to the engine component involved (fan, compressor, turbine), the types of fragments that were generated, and the percentage of uncontained failures according to the type of fragment generated. These data indicate that:

1. The incidence of turbine rotor fragment-producing failures was approximately two times greater than that of the compressor rotor fragment-producing failures; these corresponded to 60 (68.2 percent) and 26 (29.5 percent), respectively, of the total number of rotor failures. Fan rotor failures accounted for two (2.3 percent) of the fragment-producing failures experienced.

2. Blade fragments were generated in 78 (88.6 percent) of the rotor failures; eight (10.3 percent) of these were uncontained. The remaining 10 (11.4 percent) rotor fragment failures were produced by disk, rim, and seal. While the disk and seal failures were a relatively small percentage of the total failures, all of the disk and seal failures were uncontained.

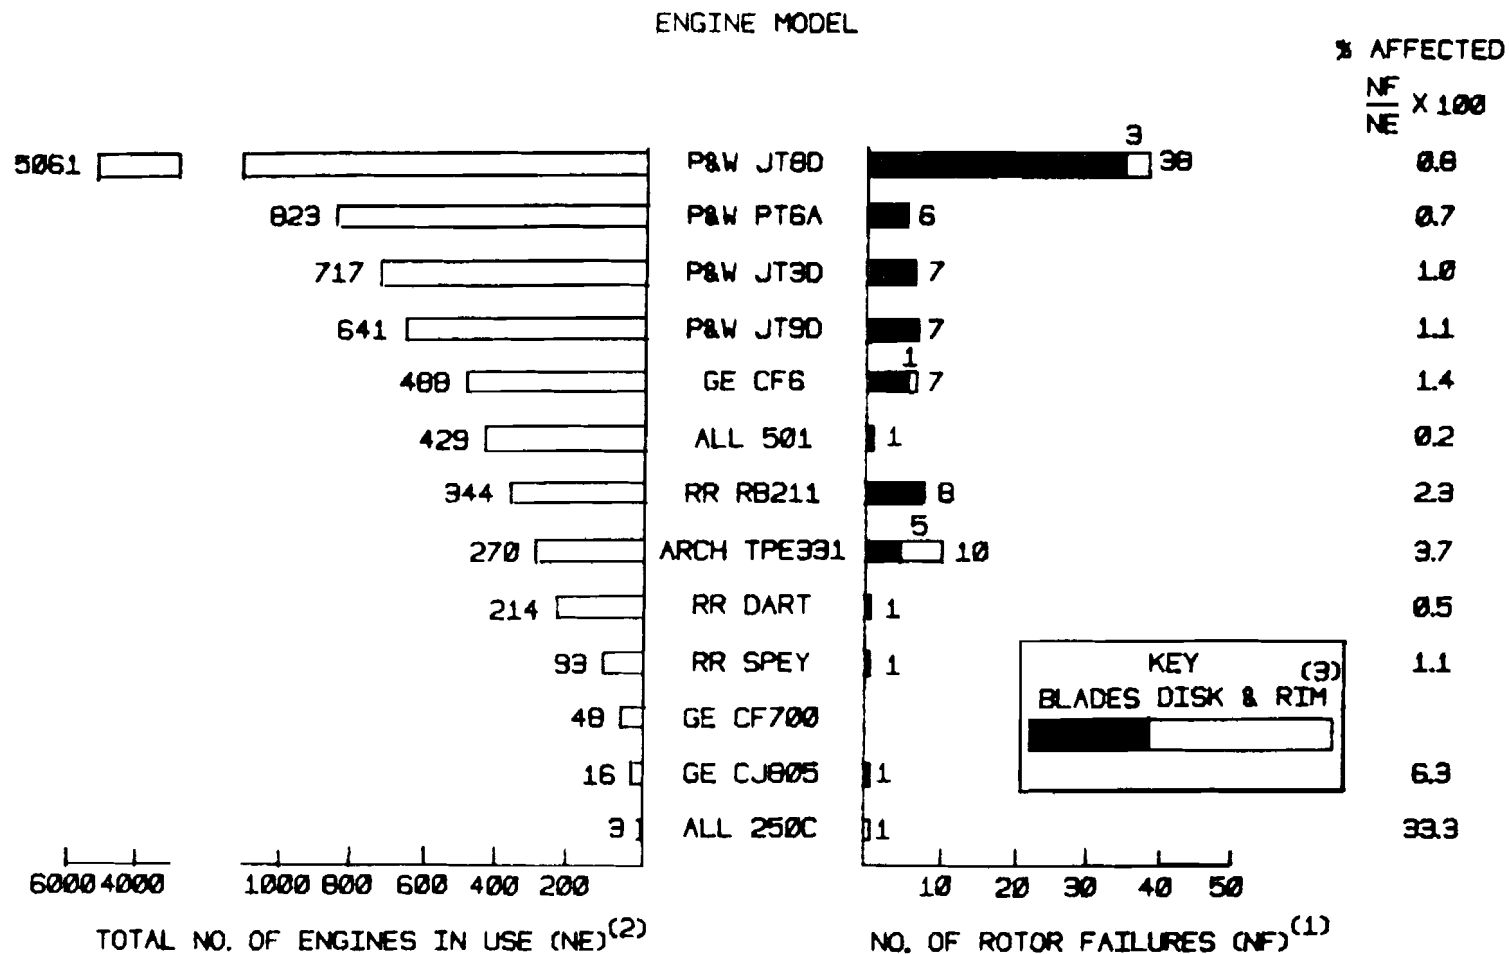
FIGURE 4. THE INCIDENCE OF ENGINE ROTOR FAILURES IN U.S. COMMERCIAL AVIATION ACCORDING TO ENGINE TYPE AFFECTED - 1982

Figure 4 shows the rotor failure distribution among the engine models that were affected and the total number of models in use.

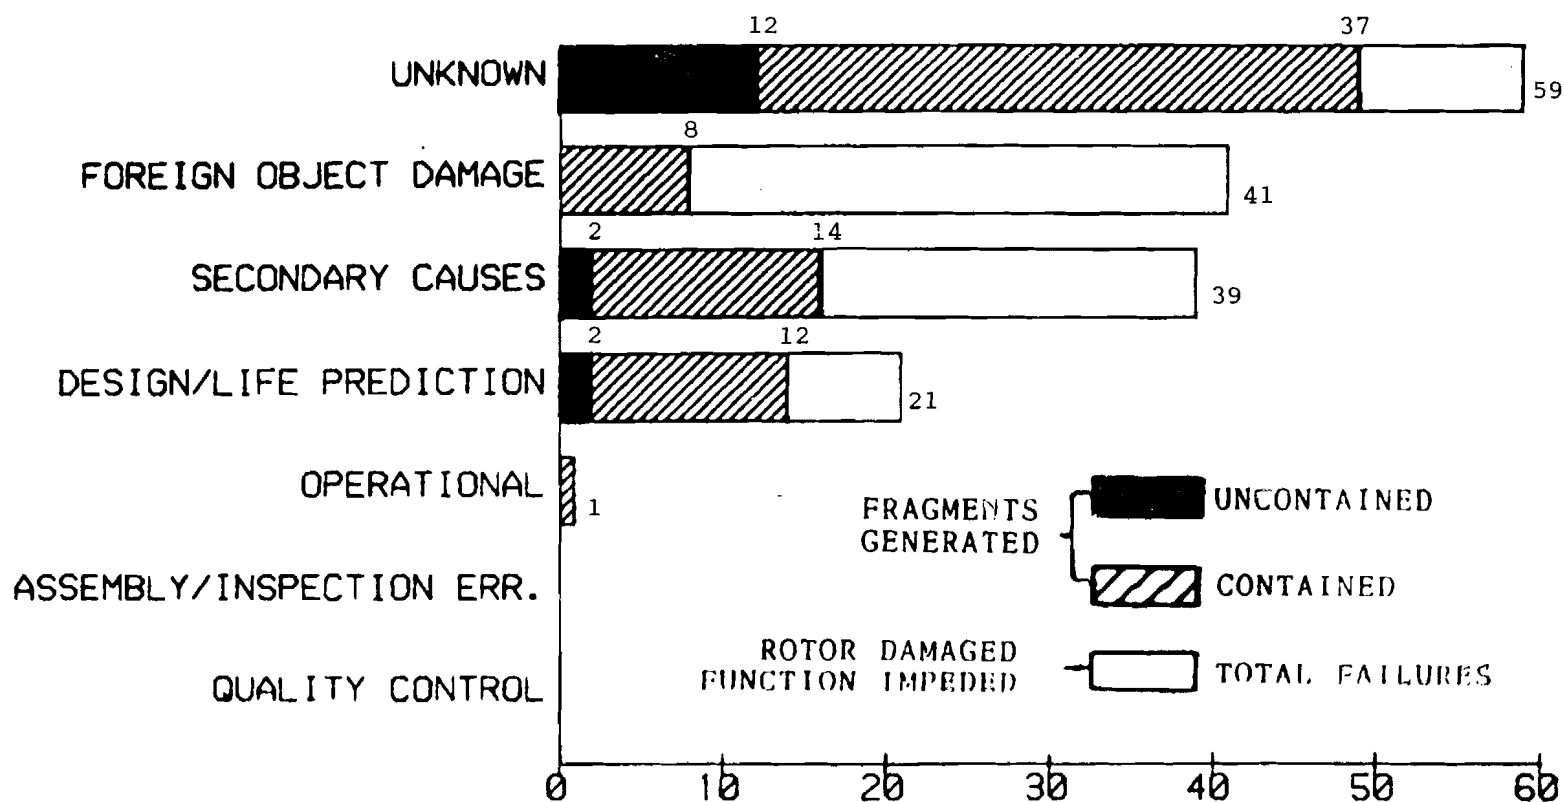
FIGURE 6. ENGINE ROTOR FAILURE CAUSE CATEGORIES - 1982

Figure 6 shows what caused the rotor failures to occur. Of the 102 known causes of failure (because of the high percentage of unknown causes of rotor failure, the percentages were based on the total number of known causes), the causal factors were (1) foreign object damage--41 (40.2 percent); (2) secondary causes--39 (38.2 percent); (3) design and life prediction problems--21 (20.6 percent); and operational--1 (1.0 percent).

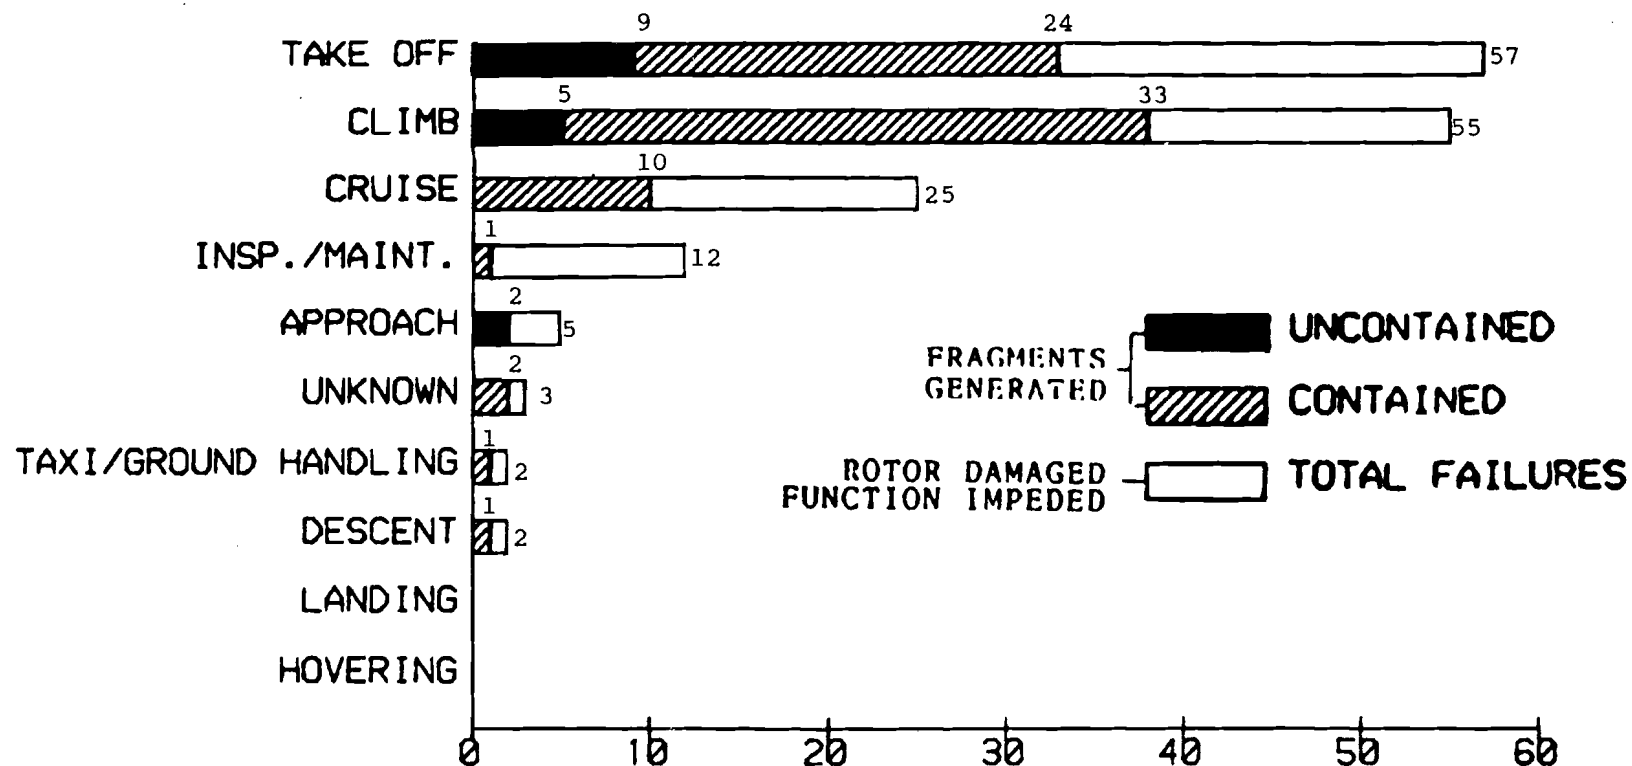
FIGURE 7. FLIGHT CONDITION AT ENGINE ROTOR FAILURE - 1982

Figure 7 indicates the flight conditions that existed when the various rotor failures occurred. One-hundred and twelve (69.6 percent) of the 161 rotor failures occurred during the takeoff and climb stages of flight. Seventy-one (80.7 percent) of the rotor fragment-producing failures and 14 (87.5 percent) of the uncontained rotor failures occurred during these same stages of flight. The highest number of uncontained rotor failures, nine (56.3 percent), happened during takeoff.

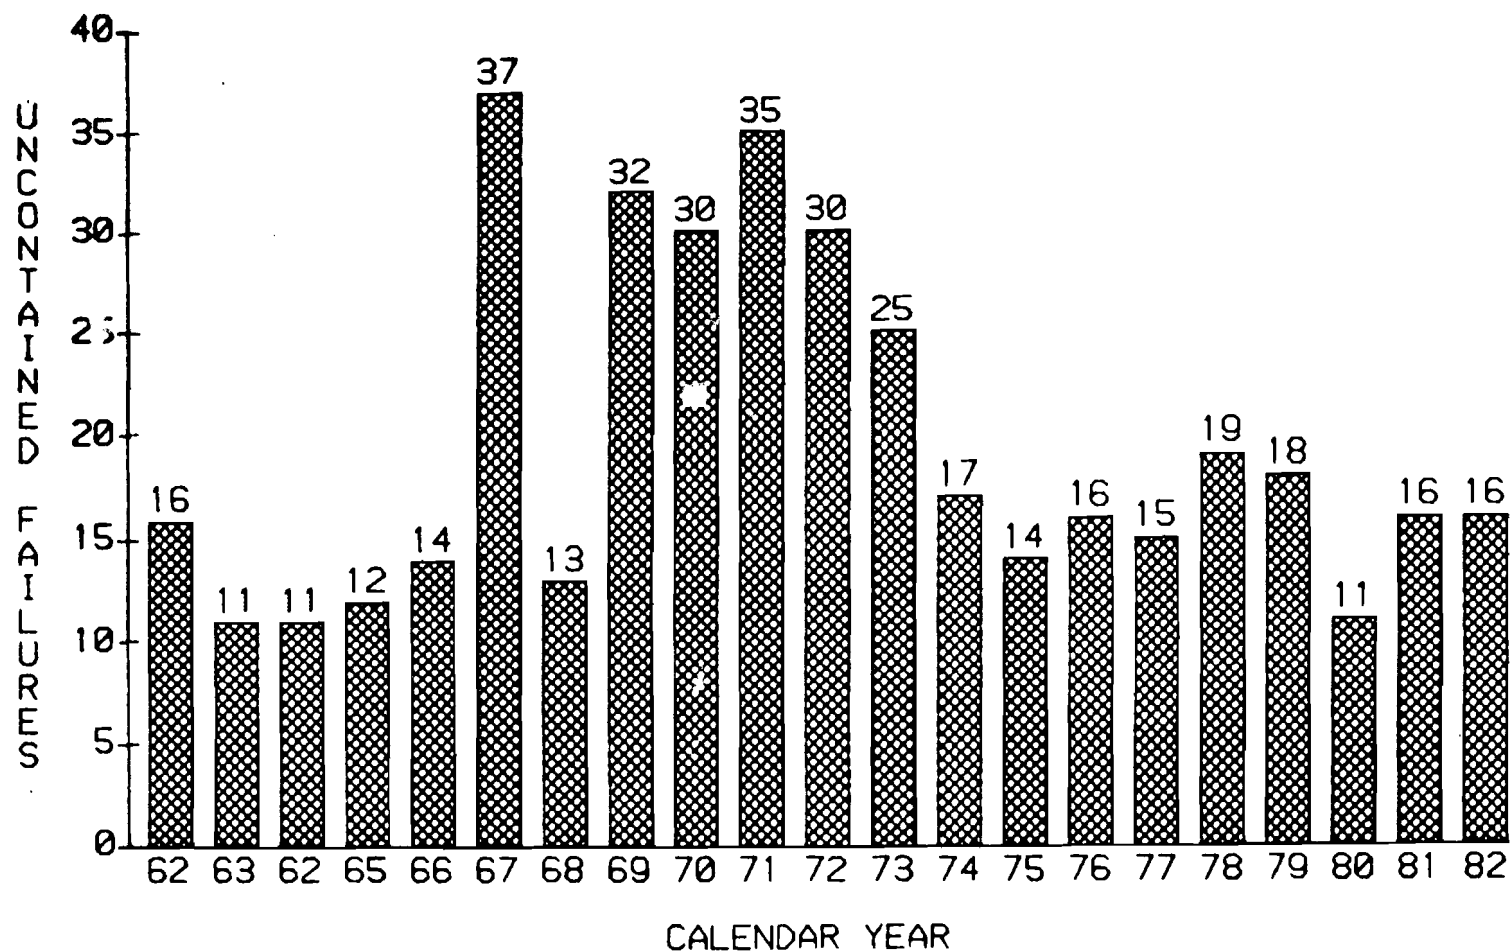
FIGURE 9. THE INCIDENCE OF UNCONTAINED ENGINE ROTOR FAILURES IN U.S. COMMERCIAL AVIATION - 1962 THROUGH 1982

Figure 9 shows the annual incidence of uncontained rotor failures in commercial aviation for the years 1962 through 1982. During 1982, the incidence of uncontained rotor failures (16) was identical to those reported the previous year, 1981. Over the past 7 years, 1976 through 1982, an average of 16 uncontained rotor failures per year have occurred. During the same time period, the rate of uncontained rotor failures has remained relatively constant at an average of approximately one per million engine operating hours.
