**Report No. CDOT-2007-7**  
**Final Report**

# **FORENSIC INVESTIGATION OF PAVEMENT FAILURE ON VASQUEZ BOULEVARD**

**May 2007**

**COLORADO DEPARTMENT OF TRANSPORTATION  
RESEARCH BRANCH**

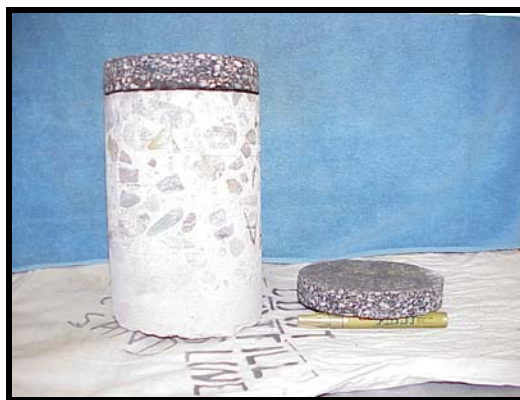
Figure 2: Core sample 4A SMA over PCCP

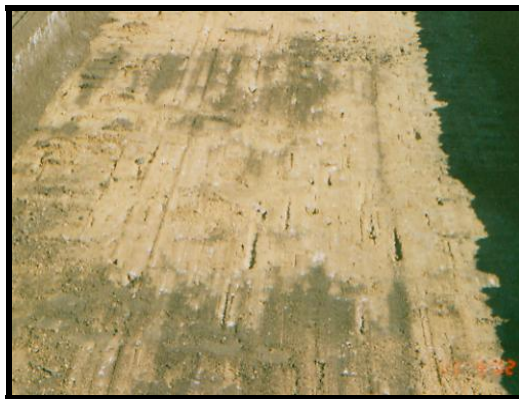
During the remediation of problem areas along Vasquez Boulevard, it was observed that newer SMA asphalt was very malleable to the touch and could be picked apart from old HMA quite easily. The SMA and the top few inches of HMA asphalt were saturated with moisture during removal. Frost had formed between the HMA and SMA layers, indicating that moisture could have seeped through and become trapped within interconnected voids. A cross section of the removed pavement showed that rutting in the top layers of the asphalt had not pushed into the roadbase but had stressed the top few inches of HMA. The roadbase appeared to be in very good condition at the time of the repair. Images of this repair are in Appendix A.

Figure 3: Roadbase exposed during asphalt remediation

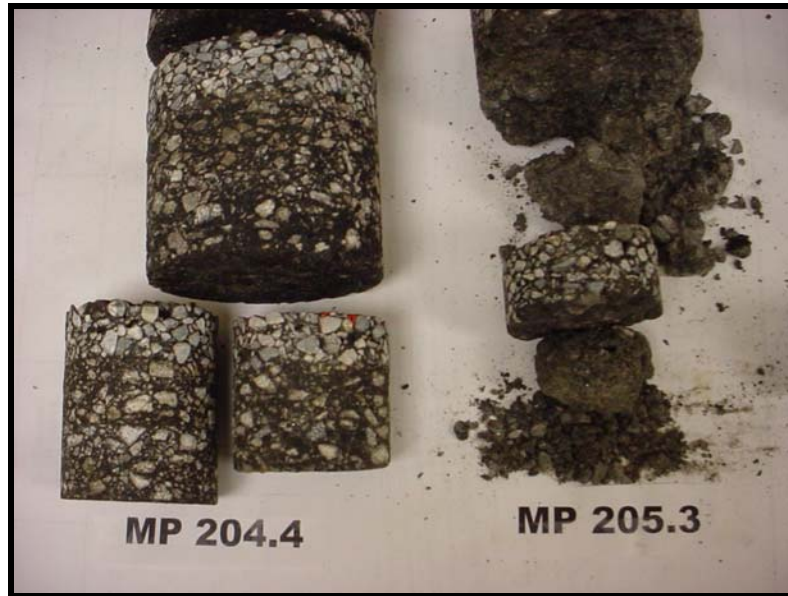
Figure 11: Core samples from I-75 south of Atlanta, Georgia

This picture shows the structural failure of the pre-lime Georgia HMA. The MP 205.3 core has nearly disintegrated.

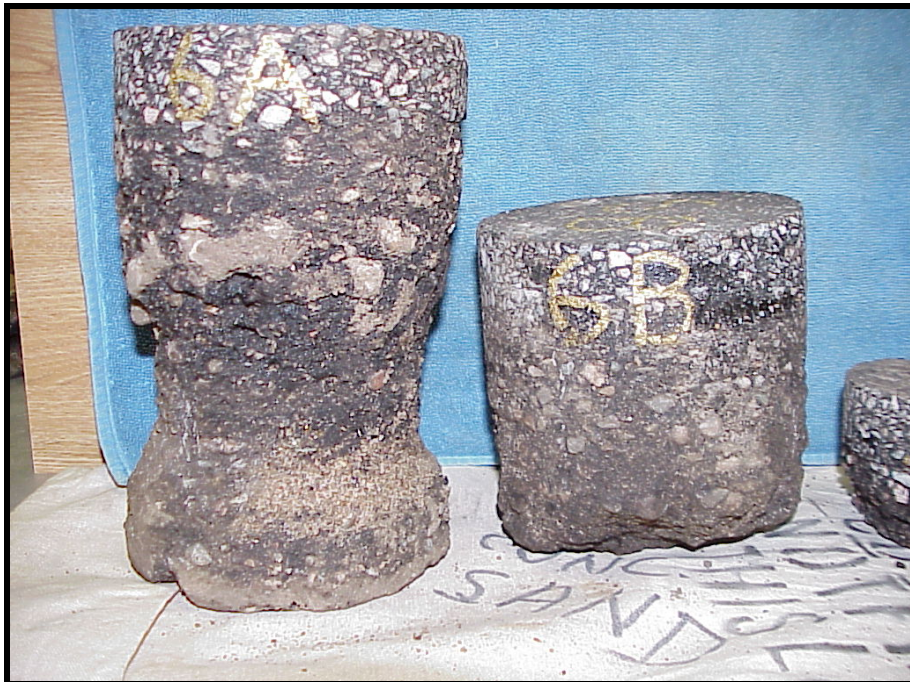
Figure 21: Core samples 6A and 6B from coring site 6

The hourglass failure is indicative of moisture damage in asphalt

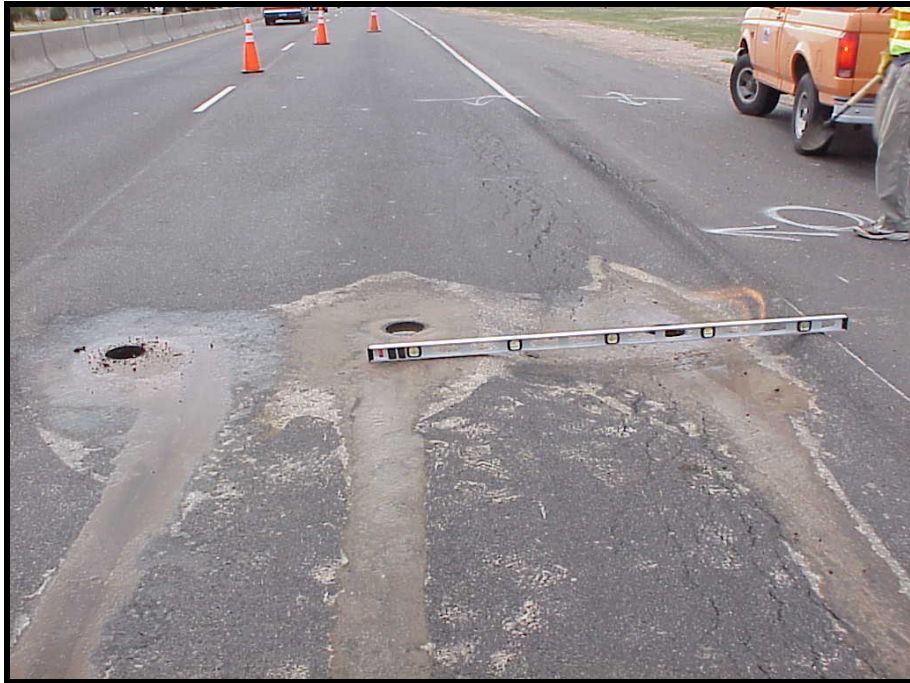
Figure 22: Coring location 6 showing one to two inch ruts in the number 2 lane

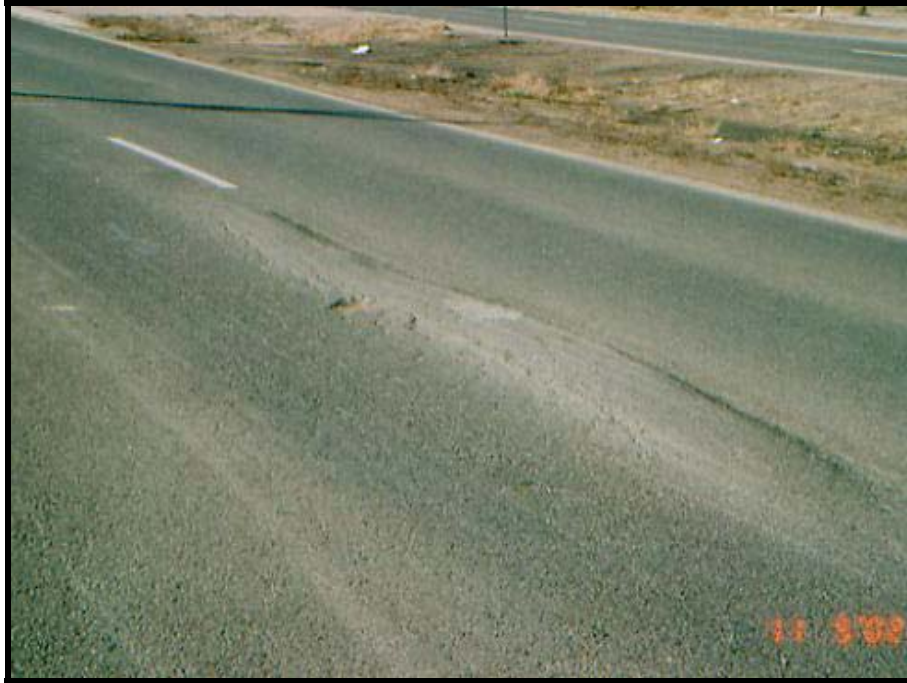
Figure 29: Failed SMA

Rutting and shoving evident during the remediation construction

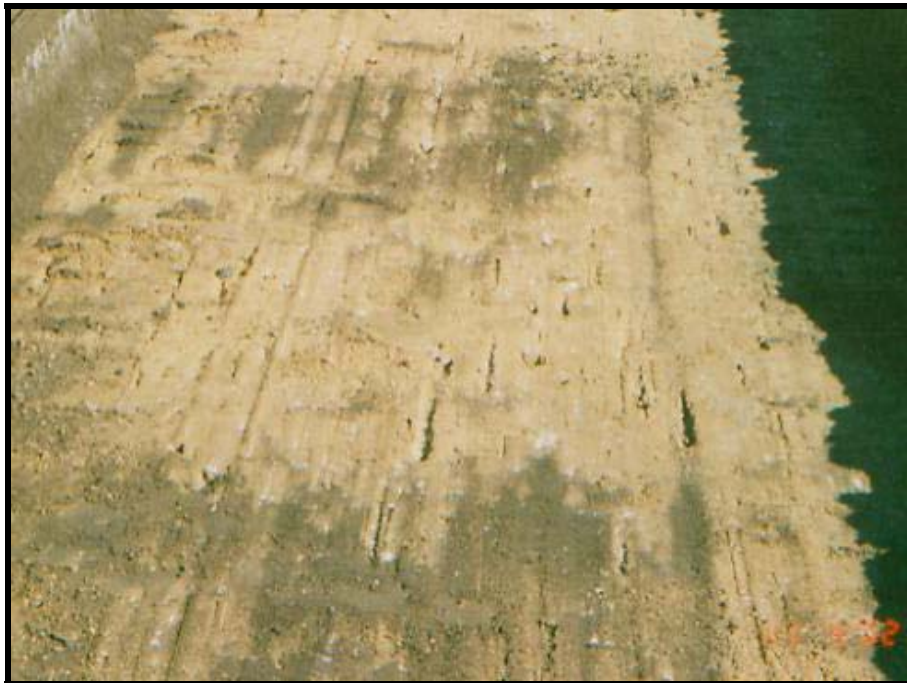
Figure 30: Roadbase exposed during remediation

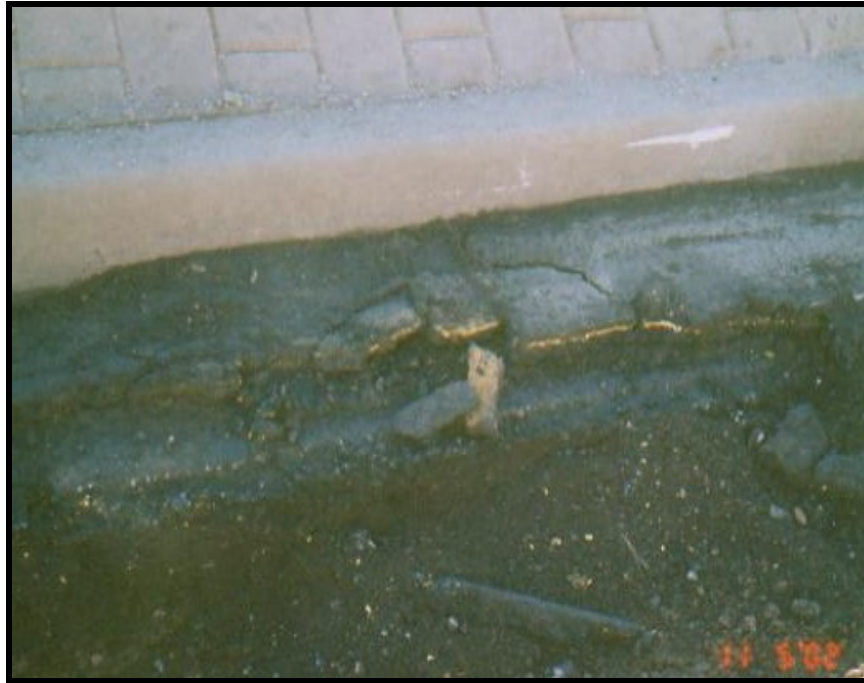
Figure 31: Asphalt removals during rehabilitation construction

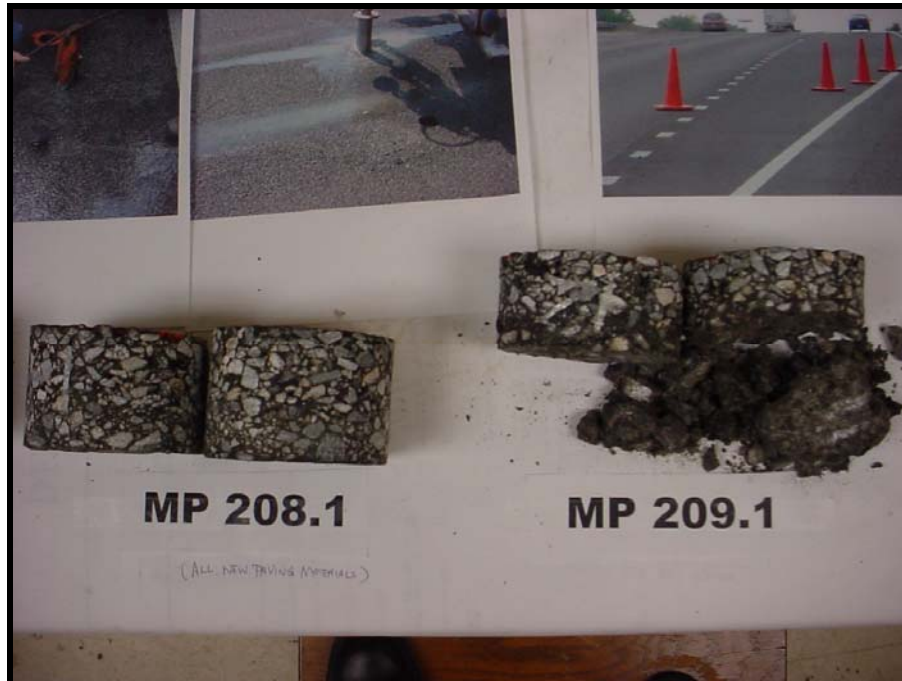
Figure 34: Core Samples MP 208.1 and 209.1

Core samples showing stripping from moisture damage

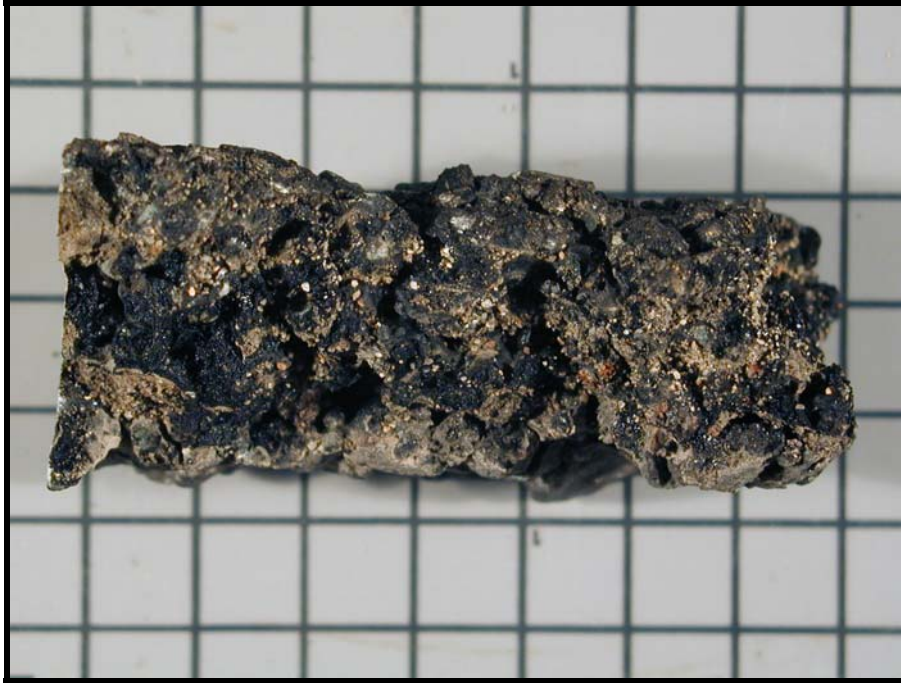
Figure 39: Core sample with evident striping and moisture damage

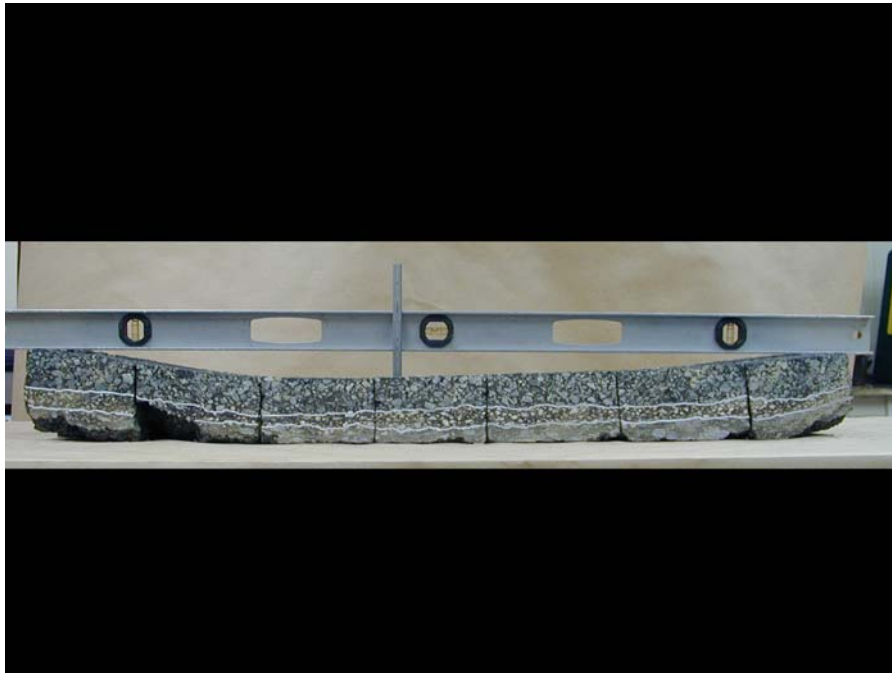
Figure 40: Cross section removed from I-495 showing 2"-3" ruts in SMA
