**Report No. CDOT-DTD-R-2006-8**  
**Final Report**

**PRECAST CONCRETE PAVING PANELS:  
THE COLORADO DEPARTMENT OF  
TRANSPORTATION REGION 4 EXPERIENCE,  
2000 TO 2006**

**Gary L. DeWitt, P.E.**

**August 2006**

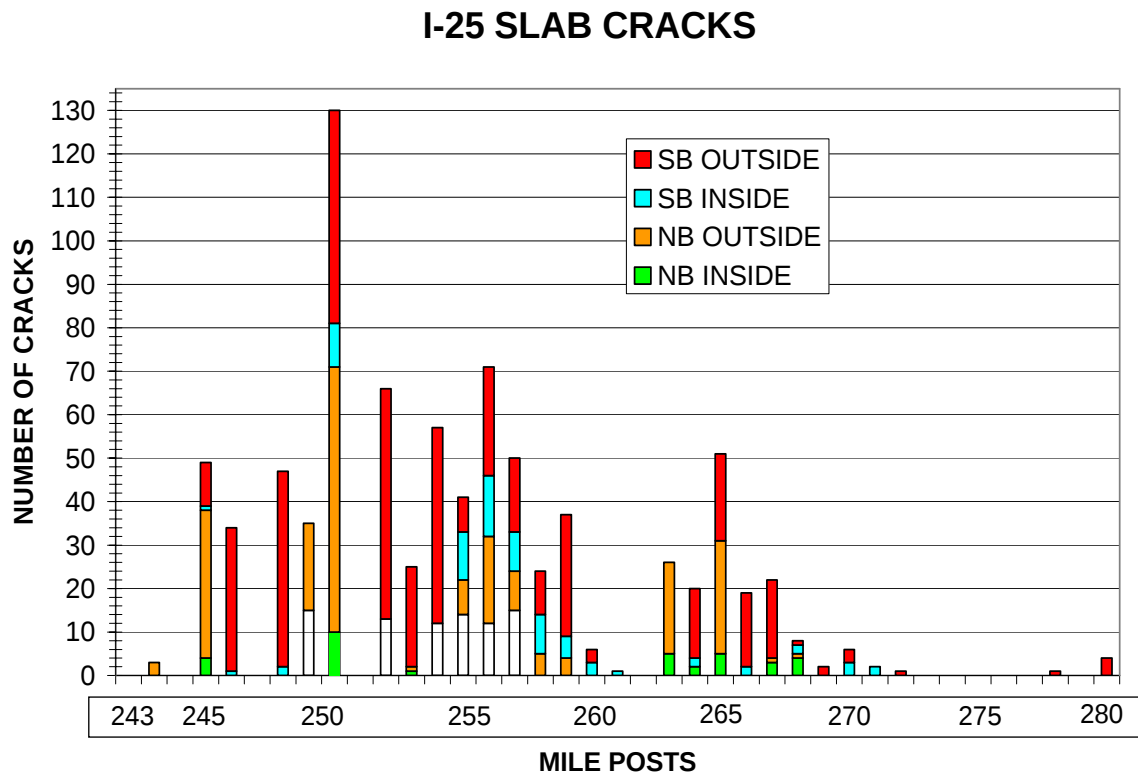
**FIGURE 1 PANELS WITH 3 PLUS FULL-DEPTH CRACKS I-25**

A field survey was conducted for the I-25 corridor to record the number of slabs that had 3 or more full-depth cracks.

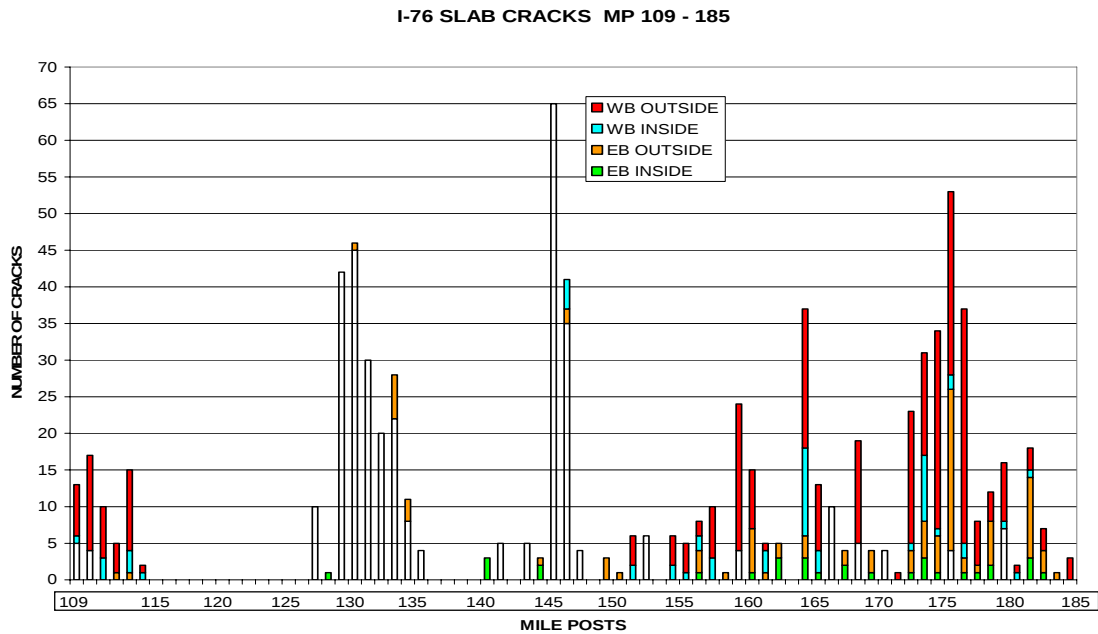
**FIGURE 3**  
**PANELS WITH 3 PLUS FULL-DEPTH CRACKS, MP 109 TO MP 185, I-76**

**TOTALS**  
**Inside slabs.....179**  
**Outside slabs.....659**

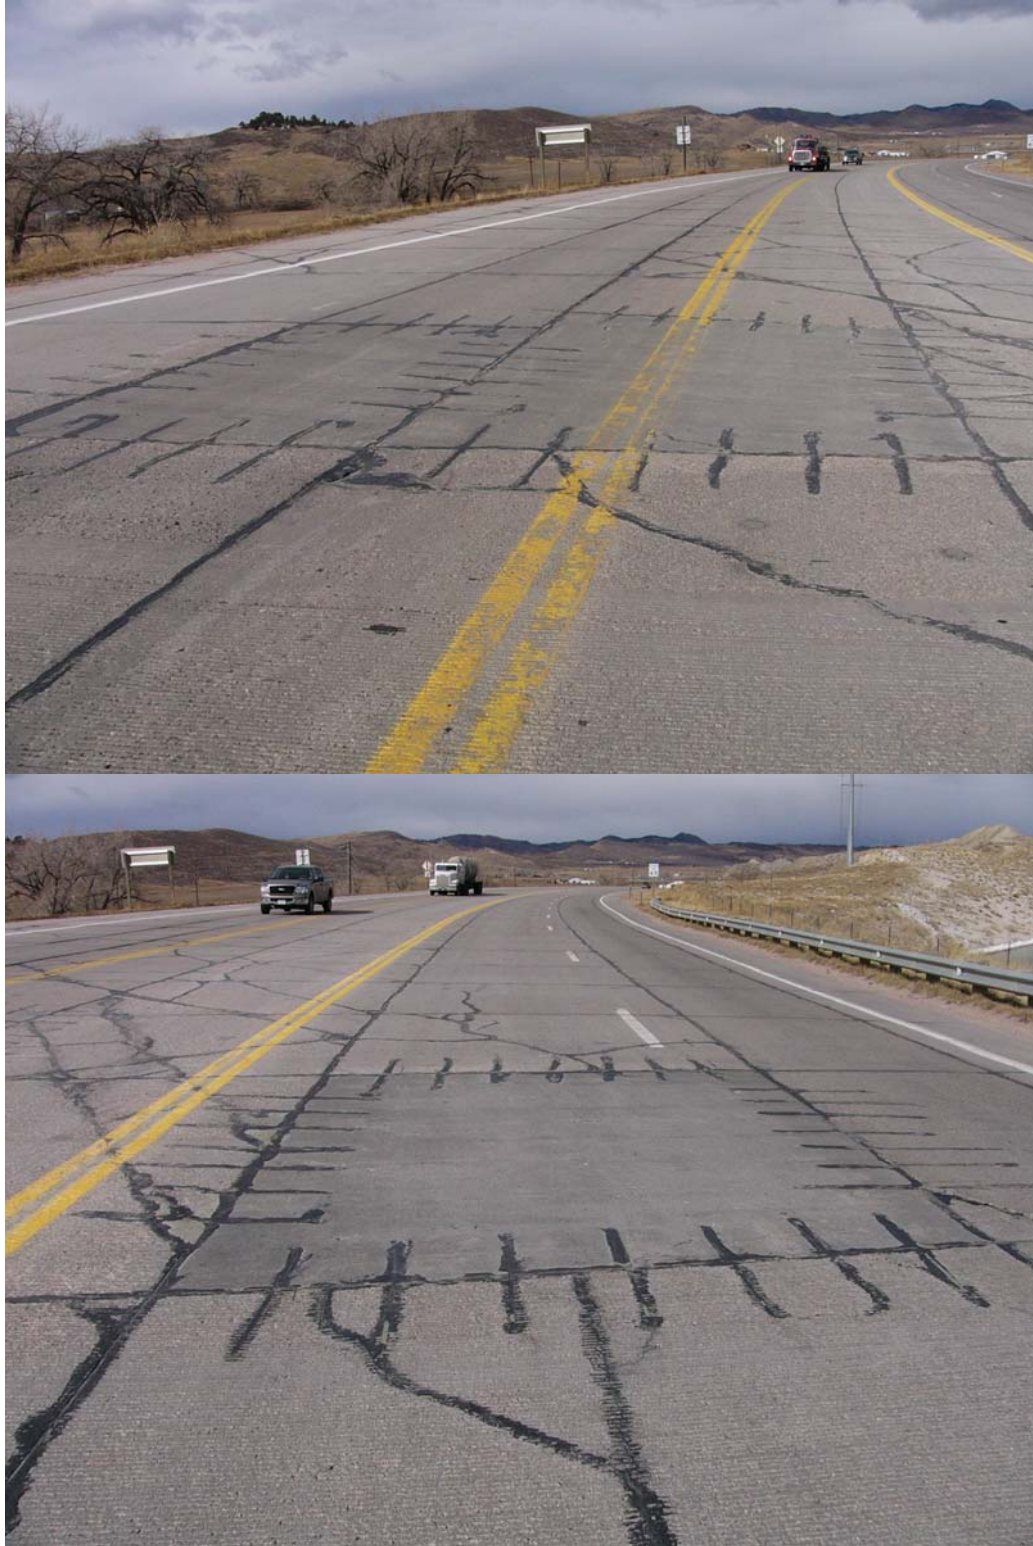
**PICTURES 1 & 2.**

No cracks are apparent from installation, slab remains in same position with no horizontal or vertical movement. Performance rating is excellent.

Precast panels installed November 30 –December 3, 2000 On Hwy 287 MP 350.9

**Performance:** excellent

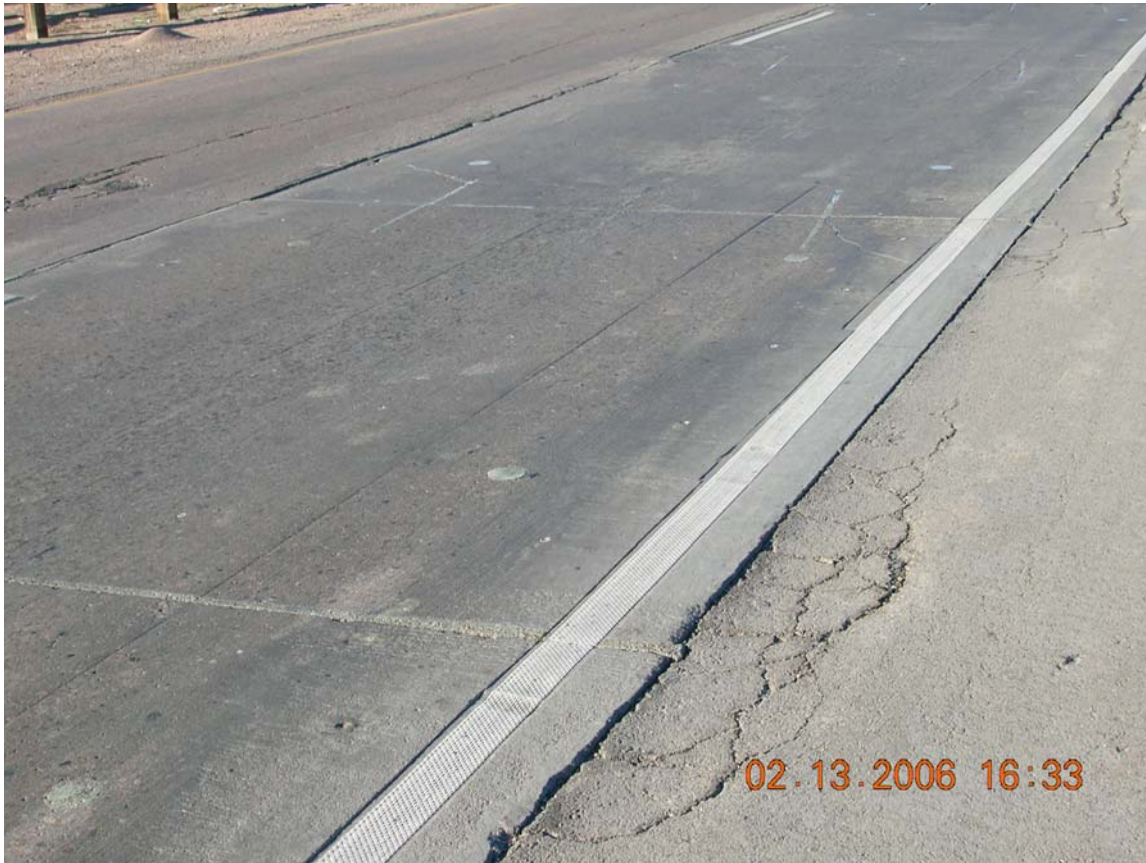
**PICTURE 5**

**MTCE 04-012** 10 inch precast concrete slabs with fiberglass ties skewed  
Hwy 85H in Greeley near MP 1.1

Series of 5 panels that fiberglass ties on transverse joint were not placed parallel with traffic flow. **Performance:** excellent

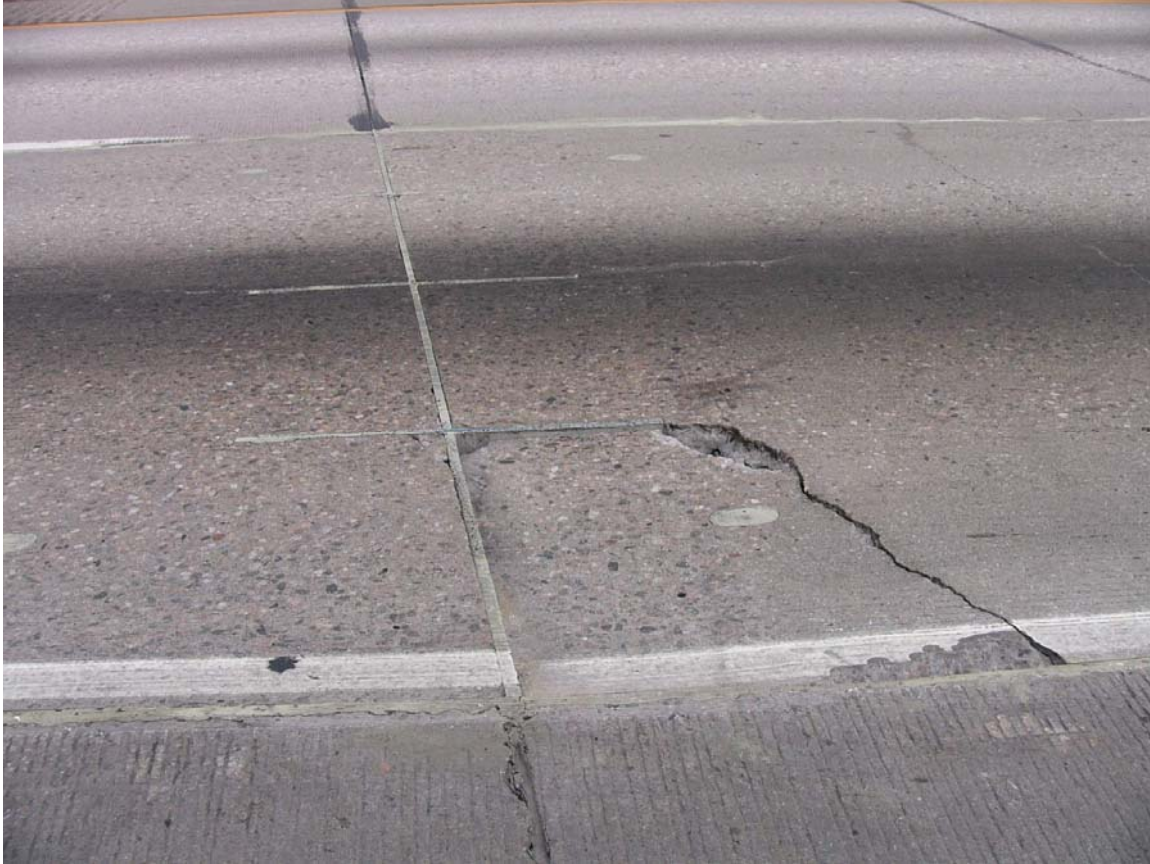
**PICTURE 6**

**MTCE 04-040** Typical crack failure on thin 5" to 7" precast slab  
On the away side (last traffic impact section)... I 25 MP

Traffic moves right to left on the picture. The crack leading to failure has been generally in this location for thin 5 "to 7" panels. **Performance:** poor

- Failure of polyurethane foam to reach density under light dead loads
- Lack of uniform distribution of foam under the panel
- Structurally deficient panels
