**Report No. CDOT-DTD-R-2006-2**  
**Final Report**

**FLOWFILL AND MSE BRIDGE APPROACHES:  
PERFORMANCE, COST, AND RECOMMENDATIONS  
FOR IMPROVEMENTS**

**February 2006**

**COLORADO DEPARTMENT OF TRANSPORTATION RESEARCH  
BRANCH**

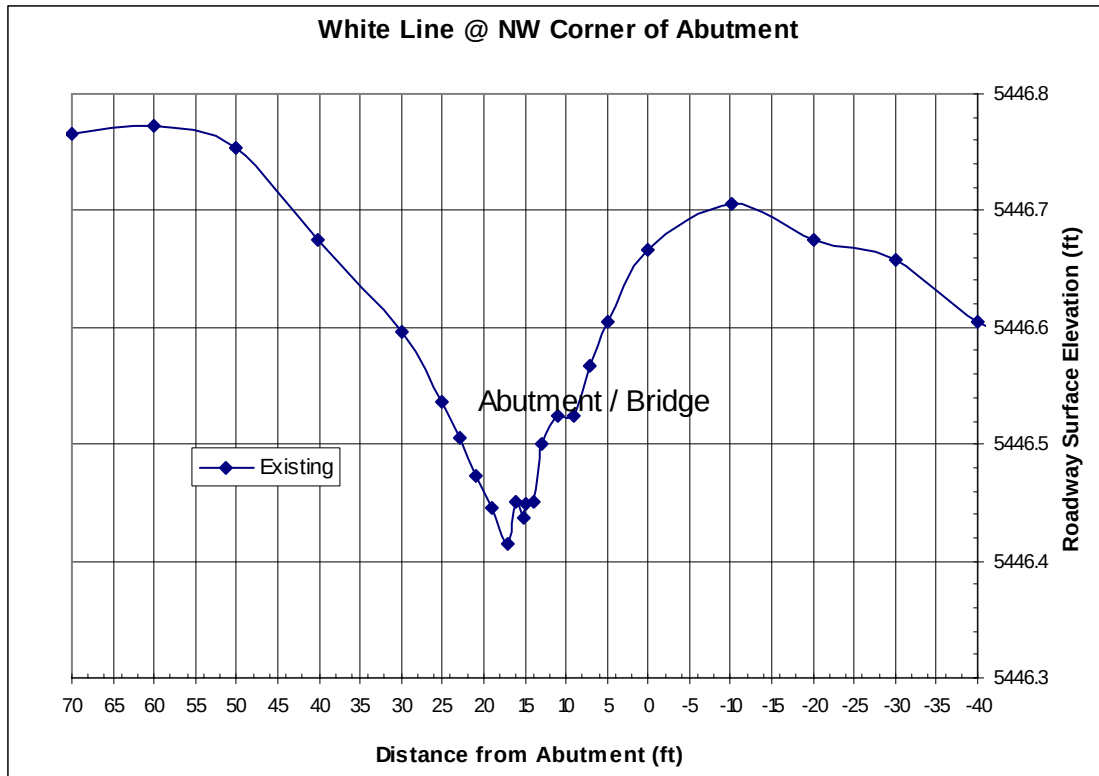
**Figure 5.17. Elevation Profile of the Approaches of Structure E-19-Z Before It Was Repaired.**

Based on the field test results, Alan Hotchkiss (2004) recommended the use of high pressure compaction grouting for this situation. Later in 2004, the bridge approaches were fixed with the compaction grouting. It is recommended that the long term performance of compaction grouting be monitored.

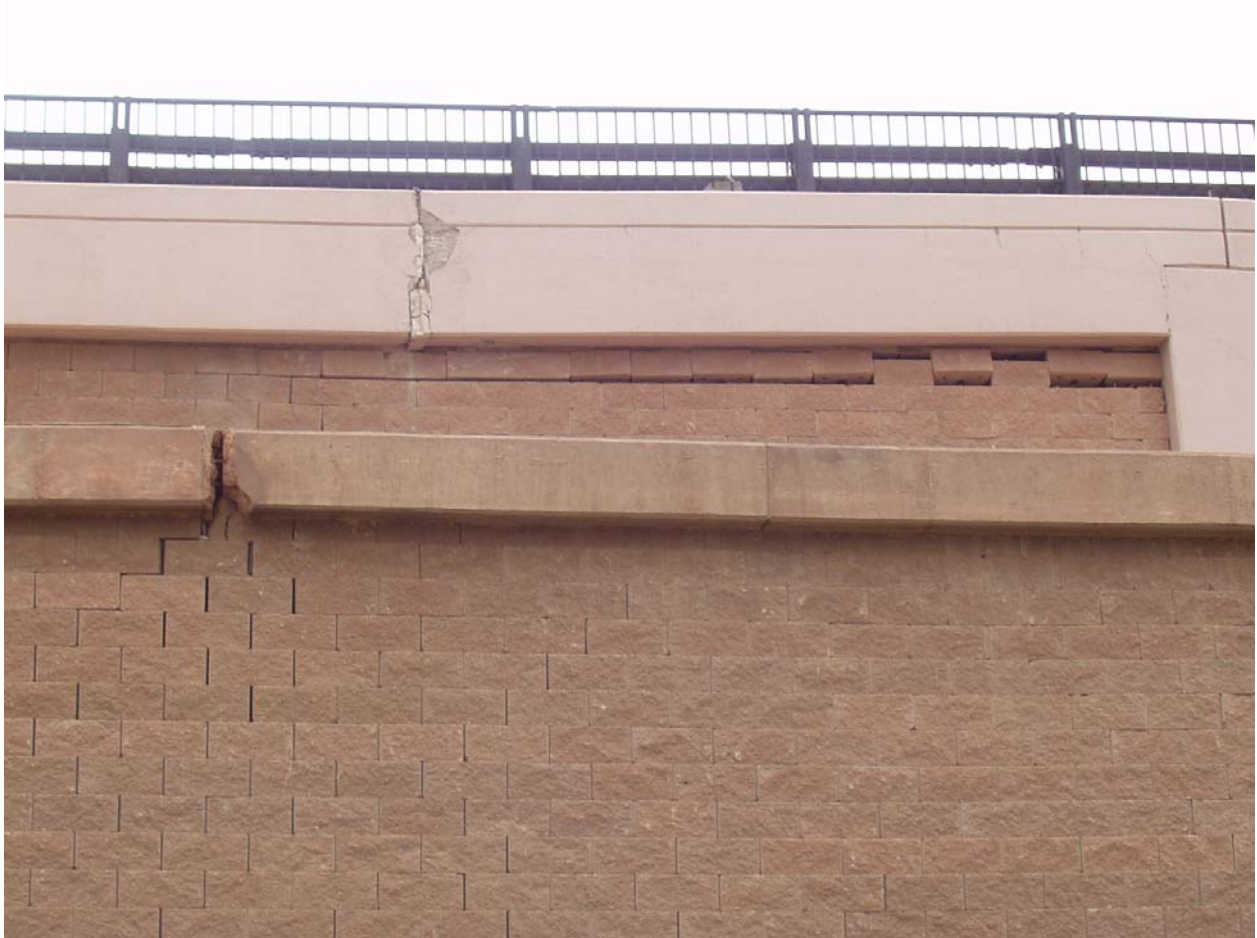
**Figure C.1. A View from the South West Corner of the Salt Creek Bridge (Structure L-21-DB, Region 2)**

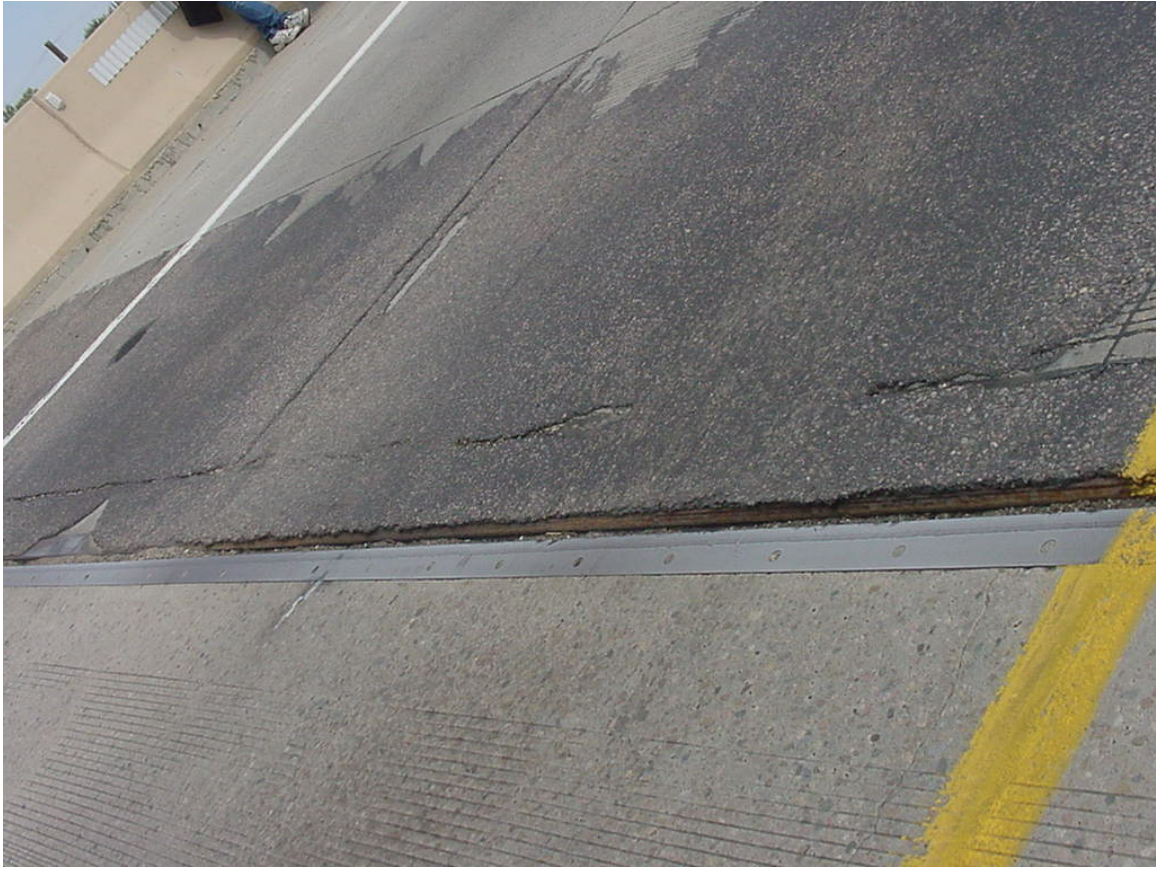
**Figure C.2. The Eastern Side of the Roadway Approaches of the I-70/I-225 Interchange (Structure E-17-SW in Region 6).**

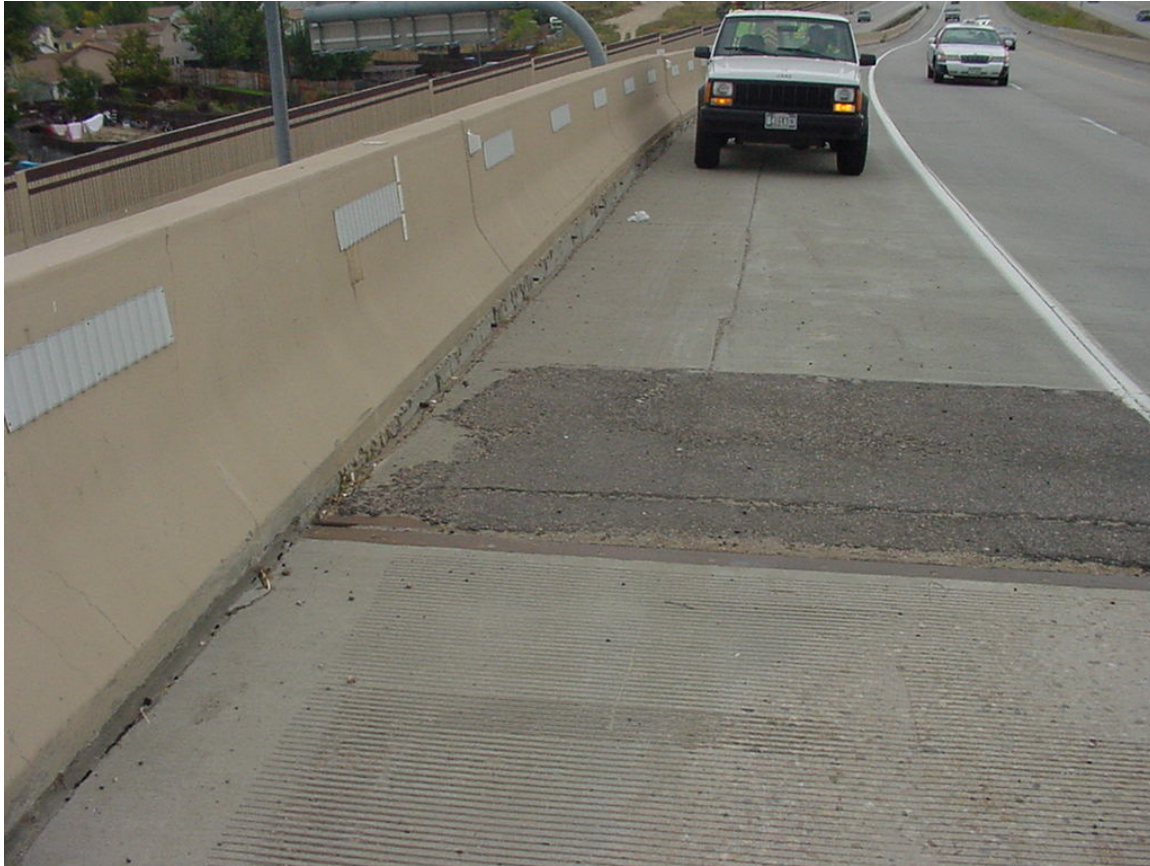
**Figure C.3. Northern-Eastern Side of the Roadway Approaches of the I-70/I-225 Interchange (Structure E-17-SW in Region 6).**

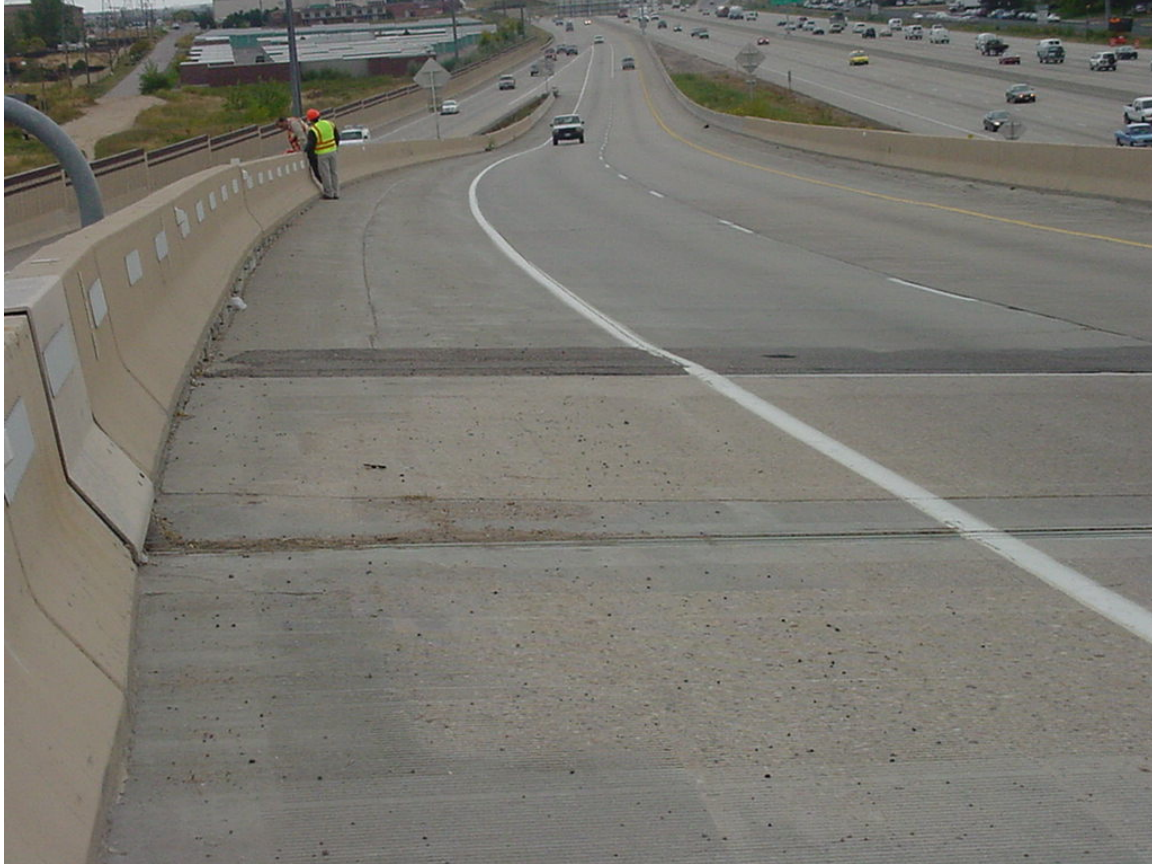
**Figure C.4. The Eastern Side of the Bridge and Roadway Approaches of the I70/I-225 Interchange (Structure E-17-SW in Region 6).**

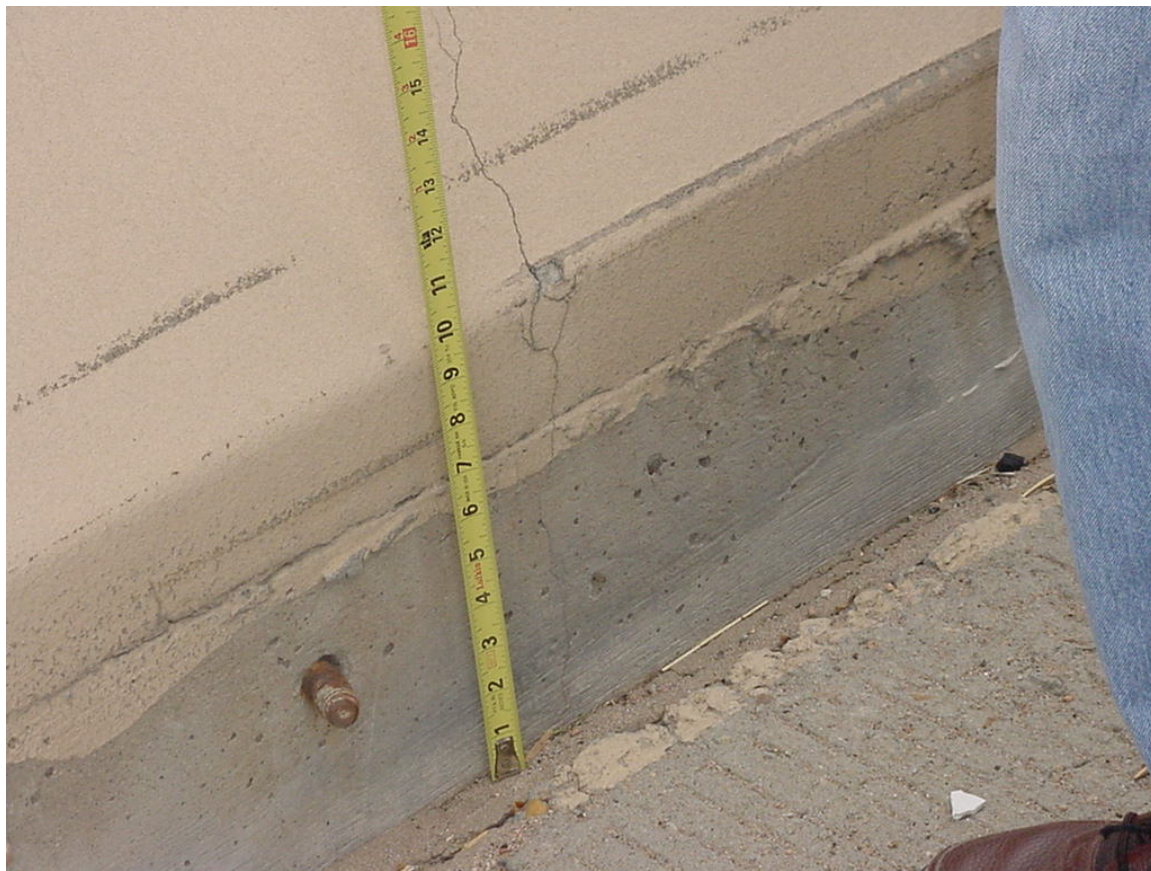
**Figure C.5. A Settlement of 6" Between the Roadway and the Bridge Concrete Rail:  
North-East Side of Structure E-17-SW in Region 6.**

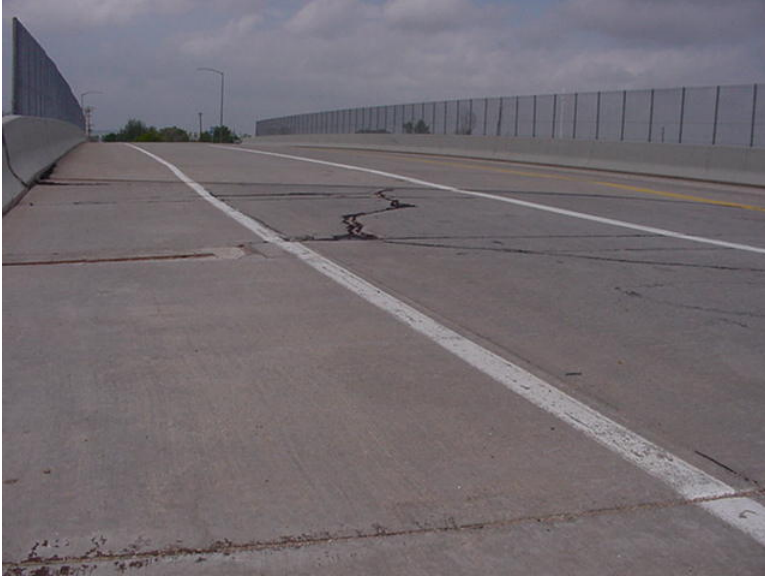
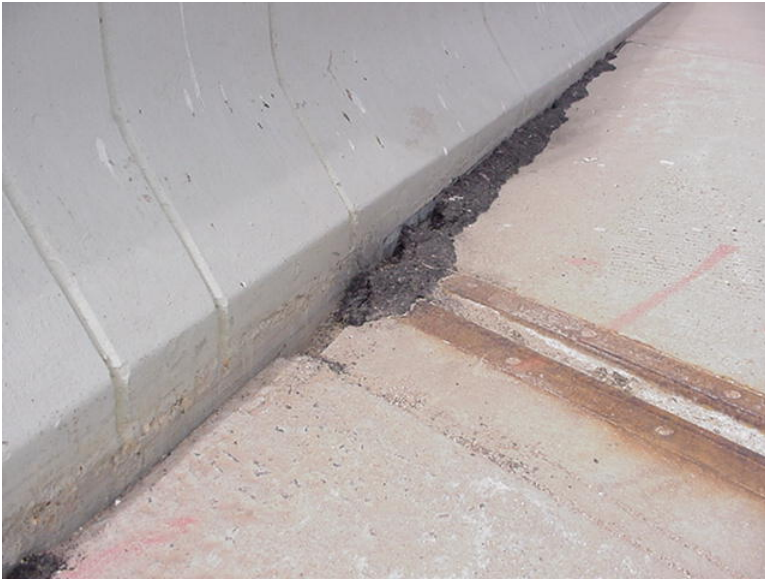
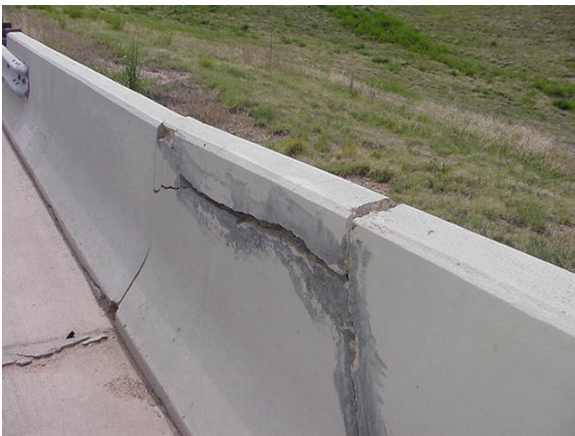
**Structures E-17-PR (Figure C.8) and E-17-SW (Figures C.2 to C.5):** for these two bridge structures with approaches ranked the worst, a detailed investigation to identify the causes of the problem was performed and the results are summarized in the next chapter. The approaches for structure E-17-PR were mud jacked for \$10,000. A field visit for the E-17-SW structure indicated that the wall's drainage pipes are clogged (not functioning) as the investigation suggests. The Uretex method was employed to fix the departure approaches of E-17-SW late 2004 and will be used to fix the arrival approaches in the Spring of 2005. For these two structures, the recommendations for repair (see next chapter) included drainage improvements and the use of compaction grouting or polyurethane deep injection.

**Figure C.8. Photos of Structure E-17-PR in Region 6.**
