## **DURAFLEX CURB**

**COLORADO DEPARTMENT OF TRANSPORTATION  
RESEARCH BRANCH**

Report No. CDOT-2007-3

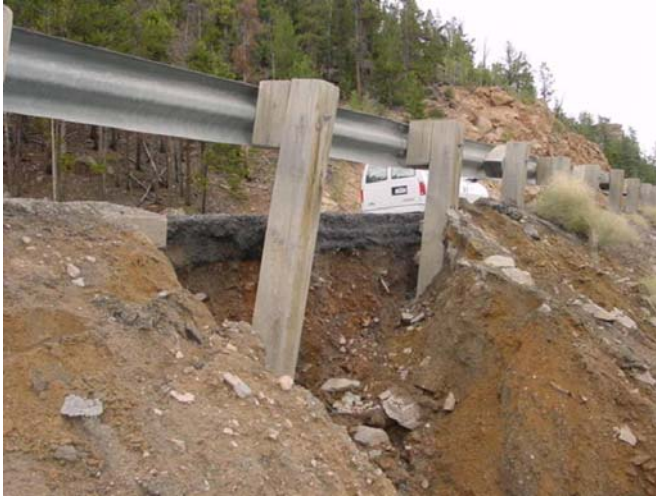
**Figure 1. Dangerous erosion on US-50.**

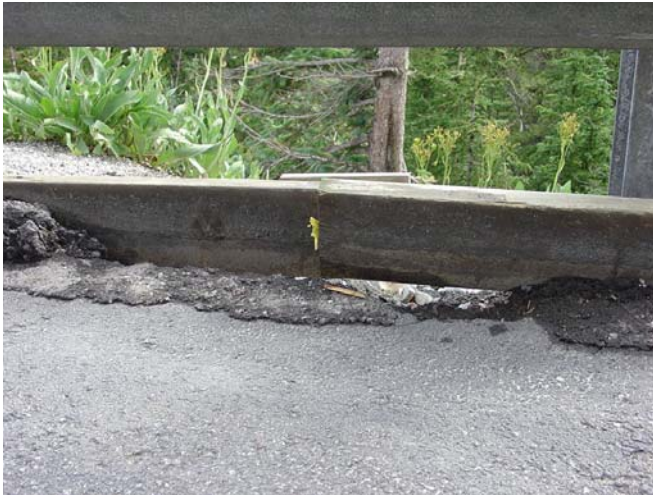
split, crack, twist and warp (**Figure 3**). That tendency is what led CDOT to try new curb materials.

**Figure 3. Wood curb can twist and warp.**

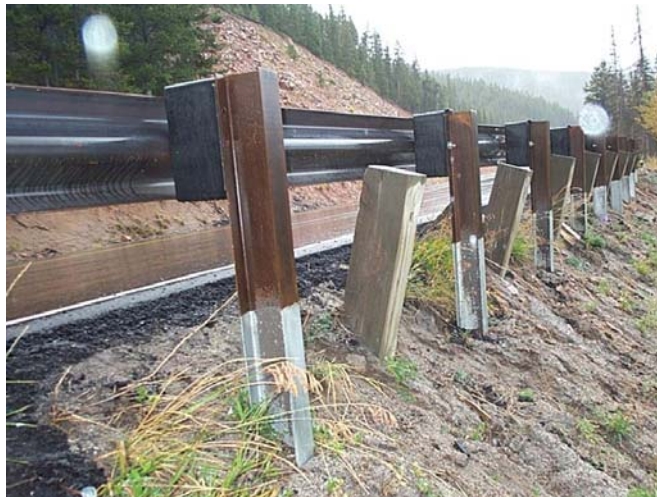
**Figure 4. US-50 has steep slopes to both sides.**

Much of the highway is cut into the side of the mountain with steep slopes above and below (**Figure 4**). About 2,000 feet of DFC and nearly 7,000 feet of composite curb was installed on the project. Annual average daily traffic is 2,300 with 20.1% trucks.

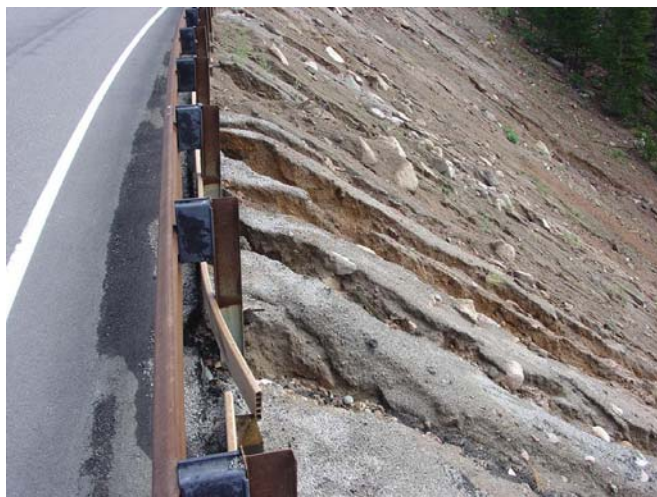
**Figure 5. Severe erosion can occur very rapidly.**

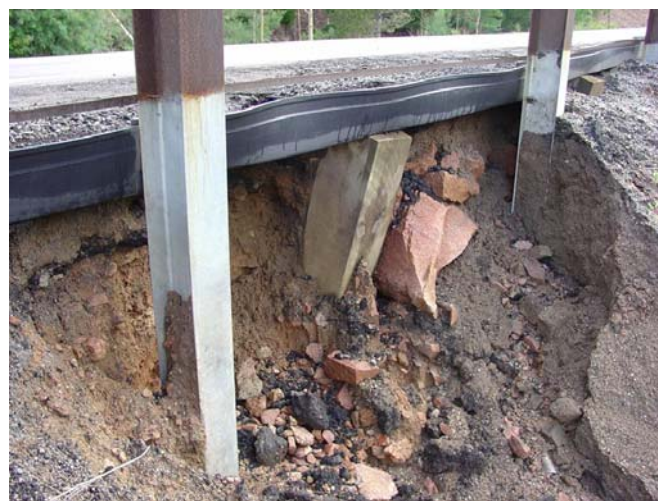
**Figure 9. Without the support of the DFC, the edge of the pavement would have collapsed.**

water between the HDPE and the pavement. DFC's strength shown in **Figure 9** is also a potential weakness: Where the curb is embedded in the pavement it may provide a weakened plane and an access path for moisture to get into the pavement. Its efficiency practically guarantees the presence of some moisture all along the curb. In cold mountain locations, freeze-thaw cycles will almost certainly lead to failure if any moisture penetrates the pavement.

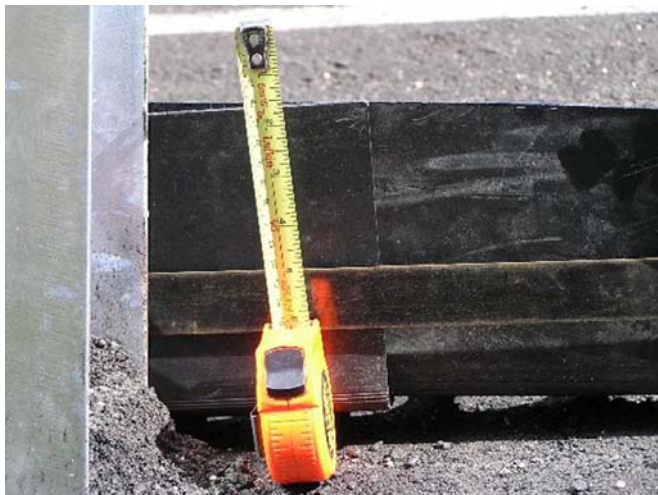
the curb continued to try to flatten out, it actually pulled many of the four-inch nails out of the asphalt. As **Figure 11** shows, the base of the curb was not tight against the pavement in many places. This was partly due to movement in the curb as described, and was partly due to the

**Figure 11. Air gaps between the curb material and the pavement surface.**

uneven surface below the curb. In any case, the gap causes a weak place in the pavement, and provides a path for water penetration.

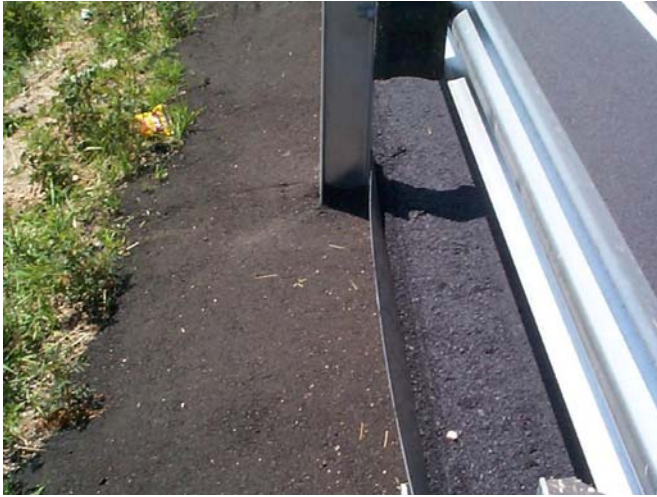
Another problem caused by the curb's memory resulted in bows in the vertical curb face between the guardrail posts. Heat and pressure from the final lift of asphalt on the face of the curb aggravated the effect. This condition, shown in **Figure 12**, was primarily a cosmetic problem. However, if it became too extreme, it would effectively lower the curb's height and reduce its water carrying capacity.

**Figure 12. Wavy curb face between guardrail posts is mainly a cosmetic problem.**

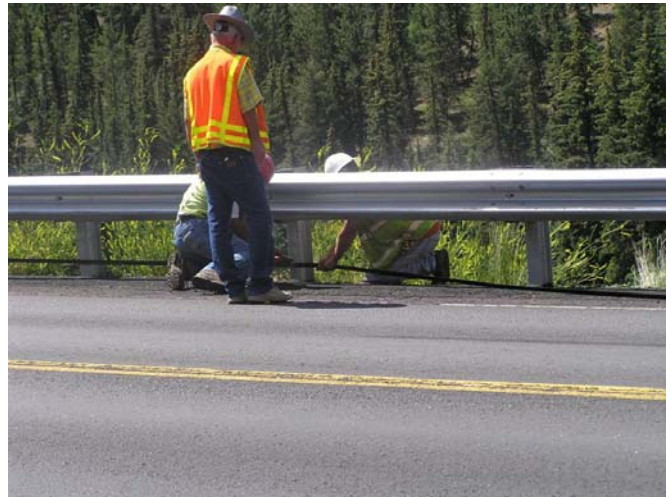
**Figure 13. Steel band was installed to provide support for the DFC between posts.**

as shown in **Figure 13**. While the band was not completely successful in eliminating the bows, it did provide some support for the vertical face of the curb.

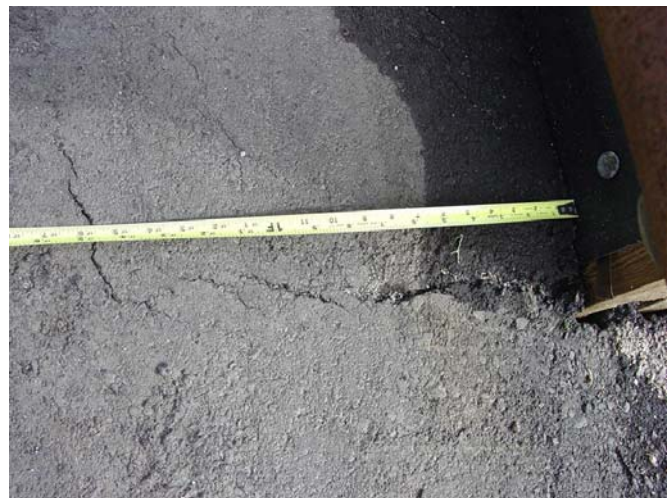
**Figure 15. Cracks are developing at the end and along the edge of the DFC on US-50.**

manufacturer thought the high temperature of the hot mix would soften the HDPE and allow the asphalt to bond to it, effectively making the curb a part of the pavement. However, a short time after construction, evidence of cracking along the edge of the embedded curb seemed to indicate that the bond between the curb and the asphalt did not develop. **Figure 14** shows a developing crack on US-24, **Figure 15** shows similar cracks at the end of a DFC section on US-50.

**Figures 14 and 15**, above, show cracks in the asphalt along the edge of the curb's horizontal leg. It appears that the HDPE promotes weakness in the asphalt which resulted in the pavement beginning to delaminate. Apparently, the asphalt did not bond to the curb, and there was not enough adhesion through the holes in the curb to prevent the top lift from separating. It is also likely that reduced density of the hand placed and compacted asphalt contributed to weakening the pavement in the area.

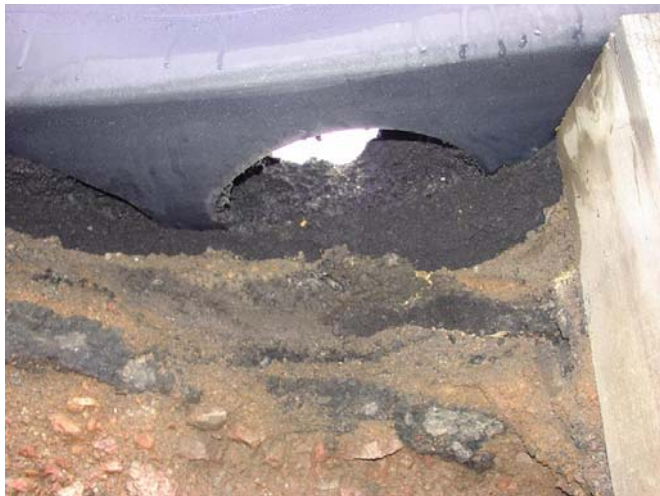
This picture, **Figure 18**, is a close-up of the damage shown in **Figure 9** above. It shows a section of DFC supporting the edge of the pavement after runoff washed a large hole under it.

The wood post in **Figure 9** is at the right edge of this picture. When the shoulder eroded away, the asphalt from below the DFC also washed out, and took the top lift from above the hole with it. If the asphalt in this area had been properly compacted it would probably have been able to carry its own weight and would not have been carried away by the water.

**Figure 18. Close-up of the washout in Figure 9.**

From a maintenance viewpoint, one of the main drawbacks of DFC is difficulty of repair if a curb section must be replaced. Removal of a damaged section, without causing significant damage to the pavement and to the adjacent sections of curb, is difficult. Repairs that require replacement of a curb section will often be the result of damage to the pavement or severe damage to the base. At the location in **Figure 18**, a significant amount of the base material will require replacement. Without removing at least one section of curb there is no way to place and properly compact material to fill the void below the pavement. The fill must be well compacted; it is also very important that the new base be carefully graded so it can properly support the new section of DFC and asphalt.

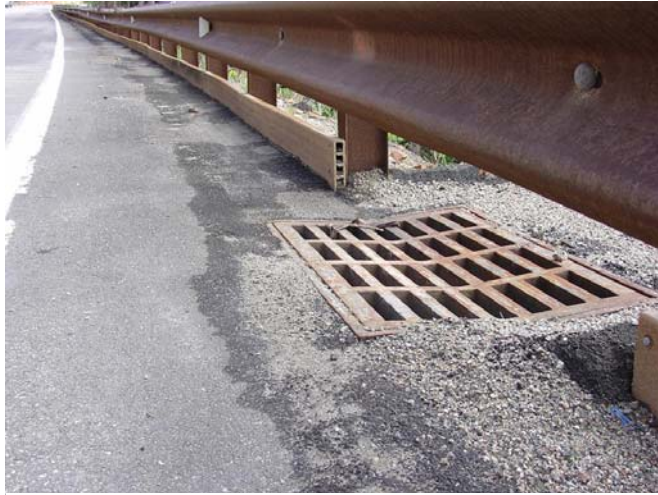
The composite curb used on Monarch Pass was a hollow 2 x 8 with four cross webs as shown in **Figure 19**. Probably as a result of its hollow nature, the material had deformation problems, a low resistance to buckling and was fairly easily broken. Solid material may have performed better.

The hollow cross-section composite lumber material used on US-50 was susceptible to cracking and breaking. Solid lumber may be more durable and better suited for use as highway curb.

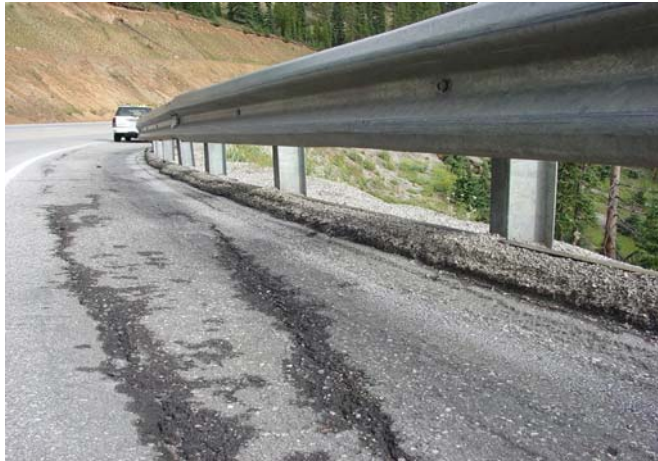
**Figure 21** shows an asphalt berm in front of a lumber curb. In locations where the guardrail is repeatedly subjected to small movements, this preventive maintenance treatment can be effective in reducing the repairs needed by the shoulder behind the curb.

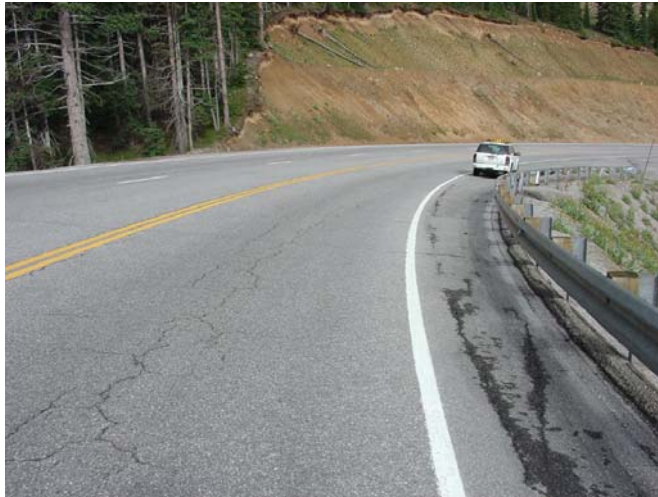
**Figure 22. Wide highway and steep shoulders.**

- US-50 on the west side of the pass is a two-lane highway with wide lanes and several passing zones. Its large surface area (**Figure 22**) collects a significant amount of water from rain and melting snow, and the grade and slope of the pavement give considerable velocity and force to the runoff. The water volume that the pavement gathers can overwhelm the curbs, which have an effective height of only four to six inches, with disastrous results – see **Figure 9**, above.

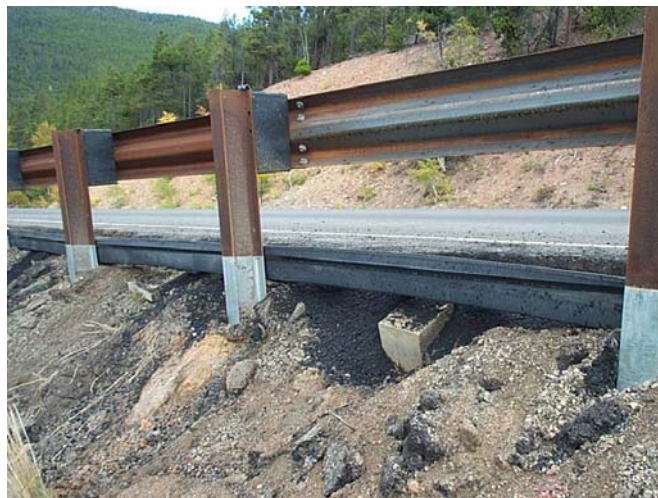
**Figure 23. Slopes start under the guardrail.**

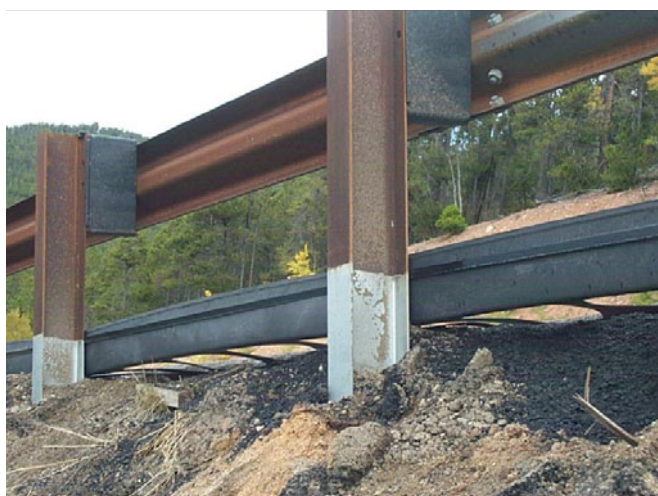
**Figure 24. Inadequate base for the DFC.**
