DOT/FAA/CT-90/10

# Fuselage Burnthrough from Large Exterior Fuel Fires

July 1994

Final Report

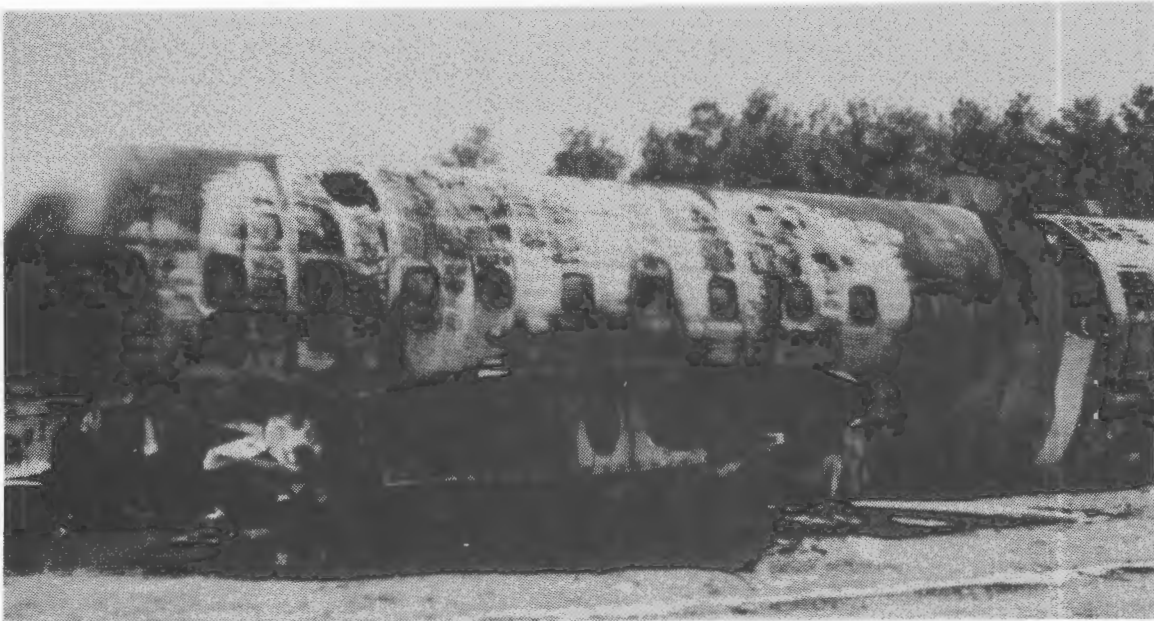
FIGURE 6. TEST 3 DC-8 CENTER SECTION FIRE DAMAGE

Skin Penetration. The skin aft of the wing (enclosing the wheel well) was completely melted away up to the top of the well (figures 6 and C-7). There was a small hole above the wheel well that went through the skin between the top of the wheel well and the cabin floor. Forward of the wing root the skin in the cheek area was melted through and the cargo liner was exposed. The liner was heavily charred but not penetrated. The window located directly above the trailing edge of the wing was completely consumed, allowing flame penetration into the cabin. The other windows exhibited varying degrees of damage but did not allow penetration. The skin both forward and aft of the wing above the melted sections was wrinkled and perforated. Both overwing exits were operable after the test. There was a 2- by 2-foot section above the trailing edge of the wing into the overhead section of the aircraft where the skin completely melted away.

Wing. The trailing edge of the starboard wing was completely melted away up to the rear spar. The leading edge of the wing was burned through above the water level in the tank. The underside of the wing was blackened but undamaged while the top surface was relatively clean and undamaged. The water level in the tank was reduced to a few inches. The leading edge of the wing dropped down approximately 18 inches from its original position.

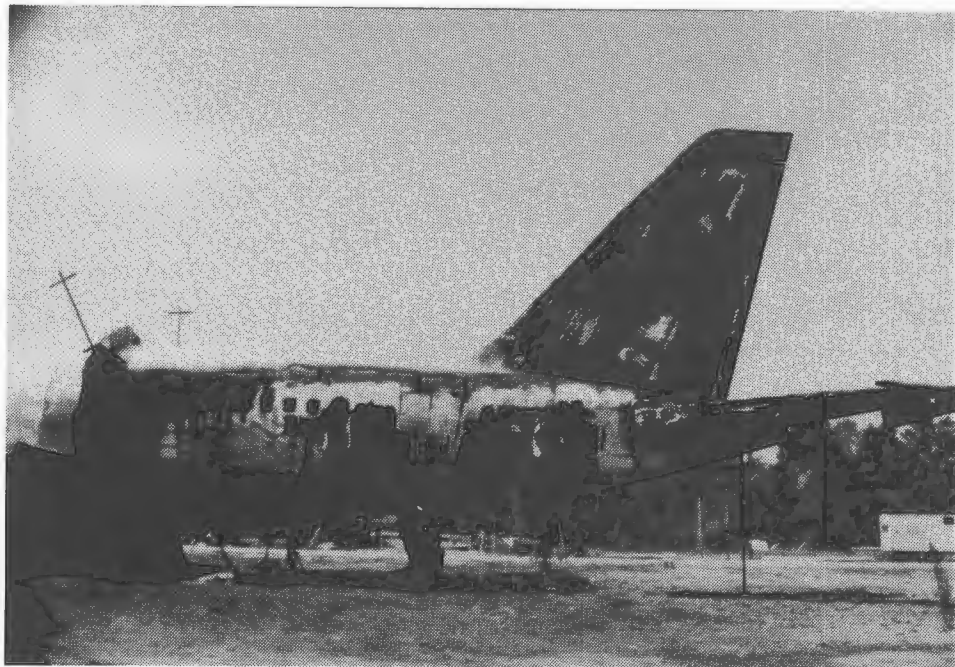
FIGURE 9. TEST 4 CV-880 PORT SIDE FIRE DAMAGE

Cargo Compartment. The cargo compartment was completely destroyed. The aft partition that separates the cargo compartment from the empennage crawlthrough area was completely gone. The ceiling of the compartment was

destroyed as well as 50 percent of the cabin floor above it. The forward bulkhead remained undamaged due to the protective steel partitions. The starboard cargo hatch was scorched on the inside but undamaged on the exterior. The hatch was inoperable after the test. The air temperature in the cargo compartment measured at station 1182 remained ambient for approximately 4 minutes at which time it rapidly rose to 1100 °F, dropped off to 700 °F and then peaked at 1600 °F at the conclusion of the test (figure D-18). The temperature in the cheek areas and between the floor and the top of the cargo compartment measured at station 1182 remained close to ambient for 4.5 minutes and then peaked at 1600 °F near the end of the test (figure D-19).

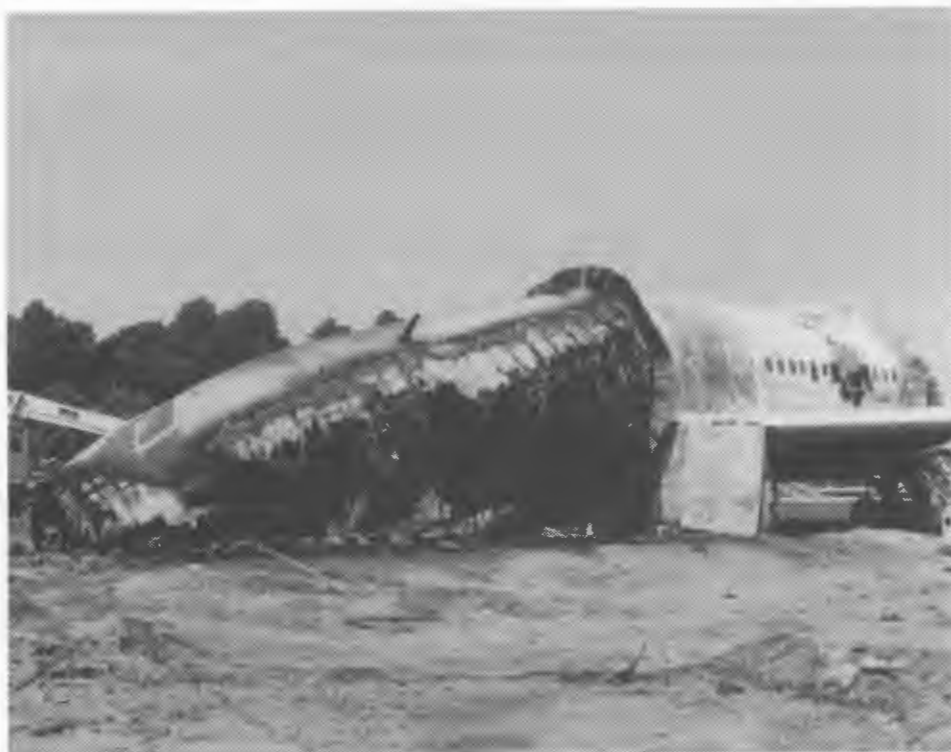
FIGURE 12. TEST 5 CV-880 PORT SIDE FIRE DAMAGE

Cabin Interior. The interior of the aircraft was consumed by the fire and there was little left that was recognizable. The cockpit was gutted leaving only the seat frames.

FIRE PATHS. Initial smoke penetration came from the cockpit area. The cockpit, however, did not receive the most extensive damage. The fire may have come into the cabin through the electronics bay and up through the crew access tunnel. The electronics bay was not insulated.

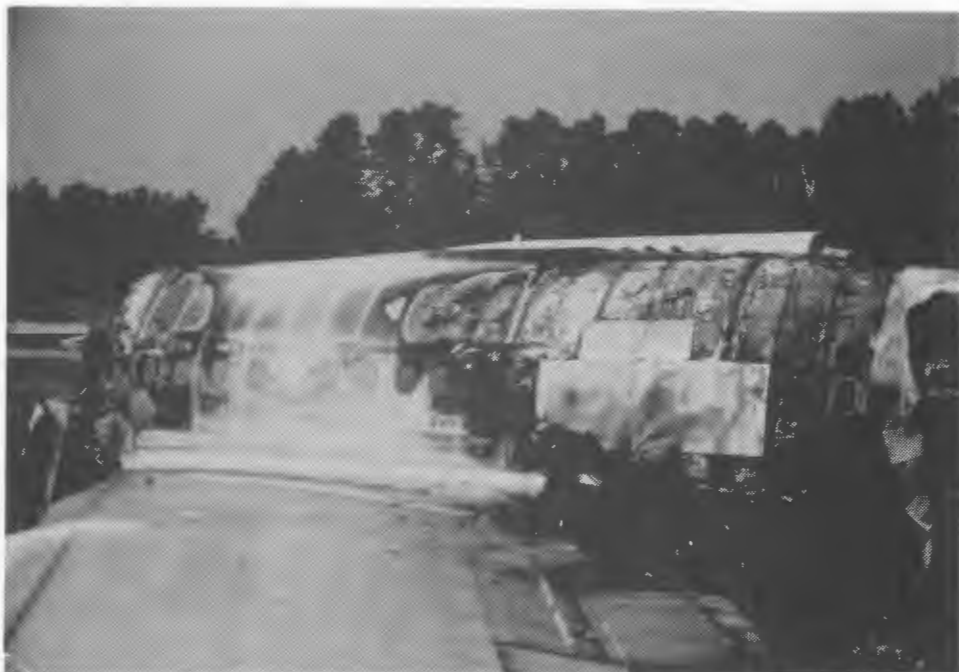
FIGURE 15. CV-880 PORT SIDE FIRE DAMAGE

Skin Penetration. The port side skin that was forward of the leading edge of the wing was completely burned away up to the top of the fuselage (figures 15 and F-7). The windows in this area (station 584) were completely burned through. The windows over the wing were charred but not penetrated. The skin aft of the wing was also burned away with damage extending forward to station 884. The exposed ribs at the aft end were buckled. The windows aft of the wing had their outer pressure panes completely burned away, but the inner fail-safe panes were

not penetrated. The insulation exposed by the melted skin on the fire side was charred but intact. The skin on the belly of the aircraft was heavily charred and buckled but not penetrated except forward and aft of the wing. The starboard side sustained damage similar to the port side (figures 16 and F-8). The skin aft of the wing was completely melted away exposing the insulation. The windows aft of the wing were burned through to the interior. The section forward of the wing also had the skin completely melted. The windows in this section had the pressure panes burned away with the fail-safe panes charred but not penetrated. The insulation throughout was heavily charred but intact.

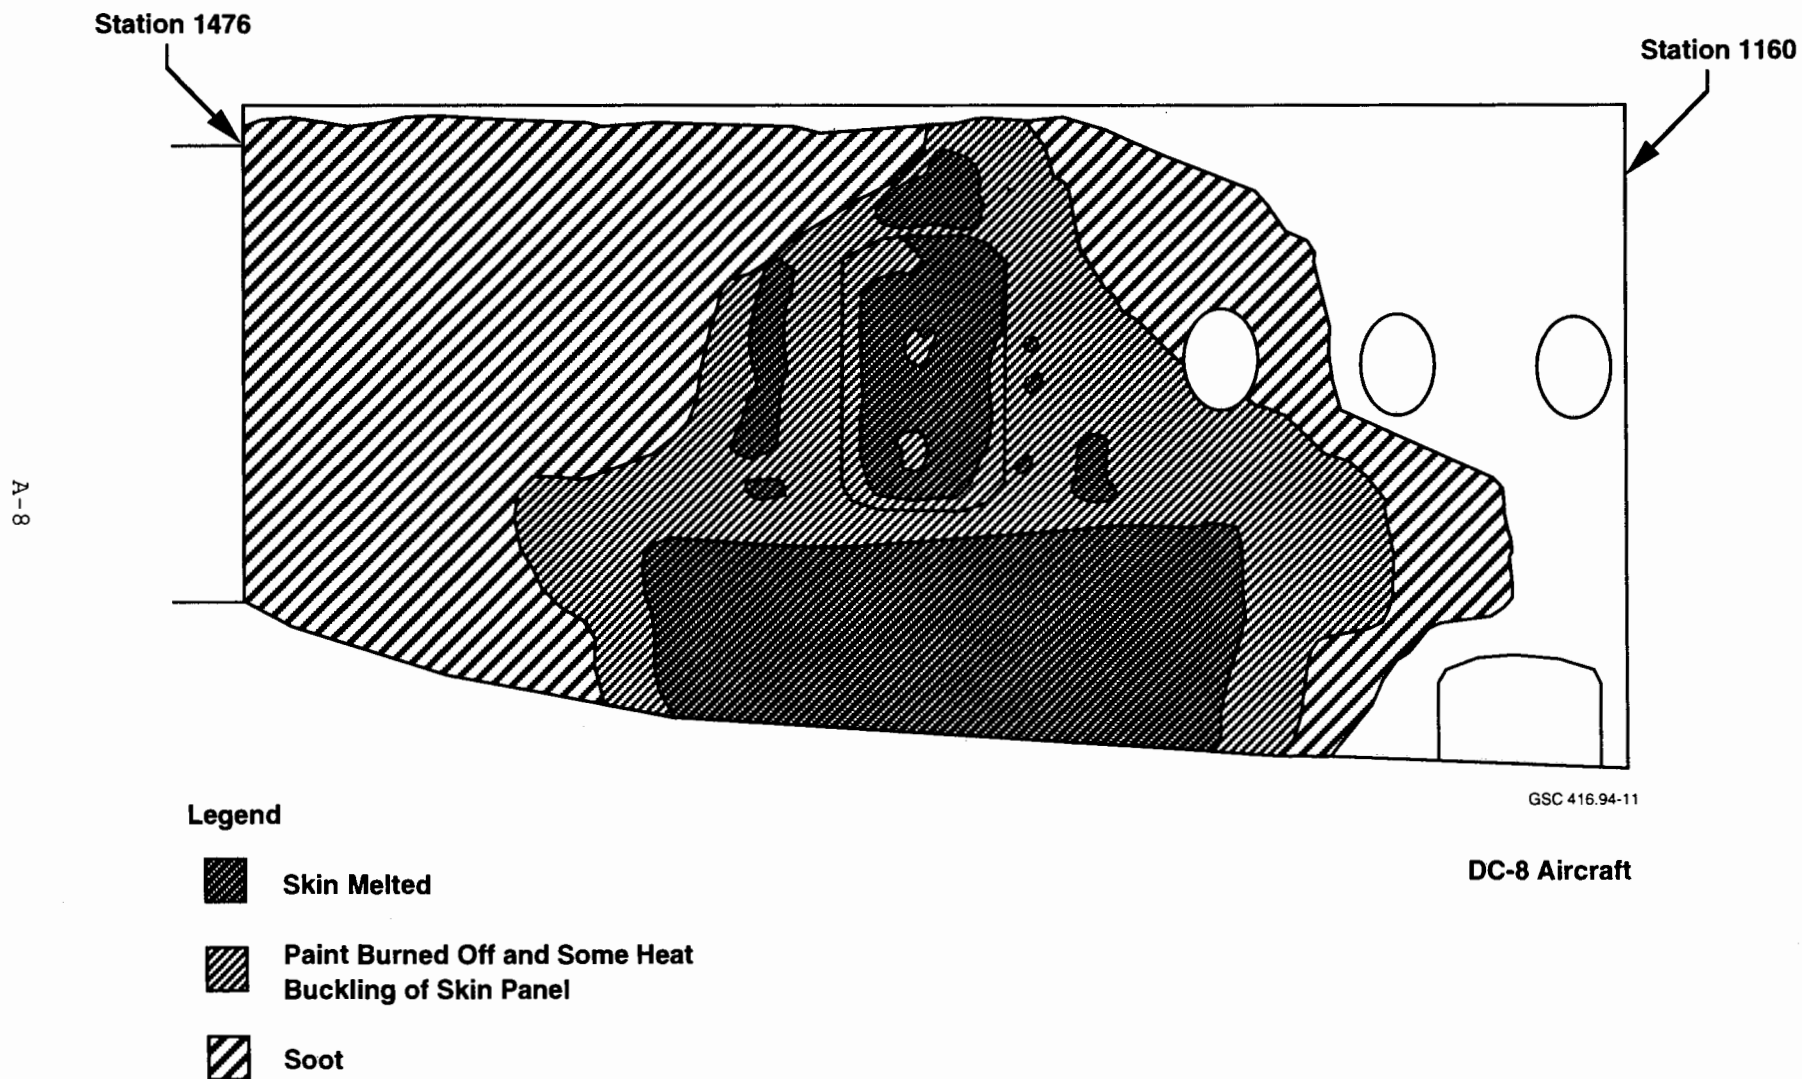
FIGURE A-8. TEST 1 EXTERIOR FIRE DAMAGE, AFT SECTION FUSELAGE STARBOARD SIDE

Skin Penetration. The aluminum skin melted away in an area below the floor and centered about the aft service door (figure A-8). The damage extended approximately 6 feet forward and 5 feet aft of the door. The skin was buckled approximately 30 inches on all sides of the melted area. The titanium doubler strips were undamaged. The skin above the door was melted in a triangular shape extending 12 inches on either side of the doorway and 30 inches above the door.

Fiber Glass Insulation. The insulation exposed by the melted skin was charred and extended downward 30 inches from the floor level but was mostly intact. The insulation had fallen away in the cheek area, approximately 3 feet forward of the aft service door, exposing the cargo compartment liner to the fire. The cargo liner was cracked and scorched in this area. Where the insulation remained in place there was no fire damage to the interior of the aircraft.

Aft Service Door. The exterior skin of the door was completely burned away exposing the door operating mechanism and interior panel to the fire. The door window's exterior pressure pane was opaque and bulged toward the fire but remained intact. The interior fail-safe pane was clear and undamaged.

FIRE PATHS. The smoke and fire that entered the cabin came through the air conditioning return grills located on the sidewall at the floor level. These grills are open into the cheek area on each side of the cargo compartment. This area forms a duct that channels the exhaust air to the outflow valves located in the empennage crawlthrough aft of the cargo compartment. The pool fire melted the skin in the cheek area, opening a path to the grills. The fire in the overhead did not travel up through the sidewalls or through the ventilation ducts. The skin above the door was penetrated directly by the pool fire plume (figure A-8). Here the insulation was dislodged, allowing access to the overhead.

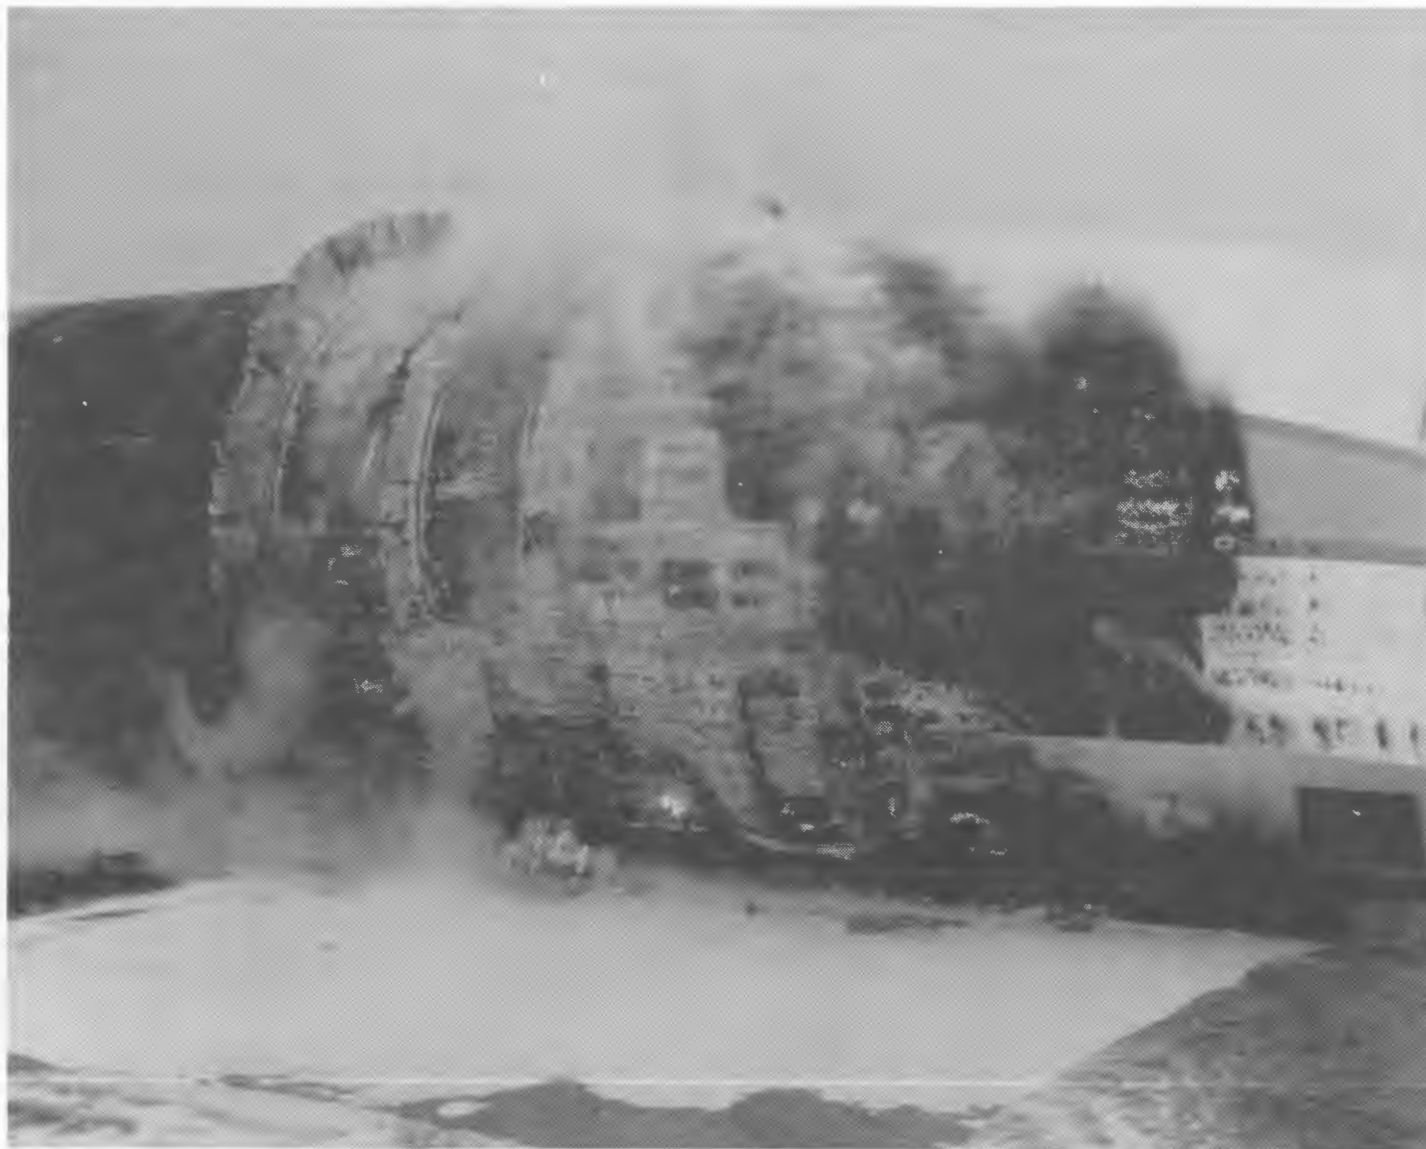
FIGURE B-7. TEST 2 EXTERNAL FIRE DAMAGE, DC-8 FORWARD SECTION

Skin Penetration. The aluminum skin was extensively destroyed from the fire barrier, located at the compartment partition, to approximately 16 feet forward as shown in figure B-7. The damage extended from ground level up to the center or the top of the aircraft (figure B-8). The skin on the service door was completely melted away. The cargo door skin was also melted away. Nearly all of the skin below the floor level was melted. The two windows on the starboard side were checkered but were still in their frames.

Forward Service Door. The skin on the door was completely melted away. Both the door window pressure pane and fail-safe pane were gone from their frame and much of the frame was melted. The interior door panel was 80 percent destroyed leaving a hole approximately 2 by 4 feet to the outside.
