## **Final Report**

Evaluation of Concrete Specimens Prepared with Corrosion Resistant  
Reinforcement after Long Term, Greater than 15 years, Outdoor and  
Laboratory Exposures

Contract Number – FDOT (BED27-977-04)  
FAU (AWD003253)

Submitted to  
Florida Department of Transportation  
Research Center  
605 Suwannee Street  
Tallahassee, Florida 32399

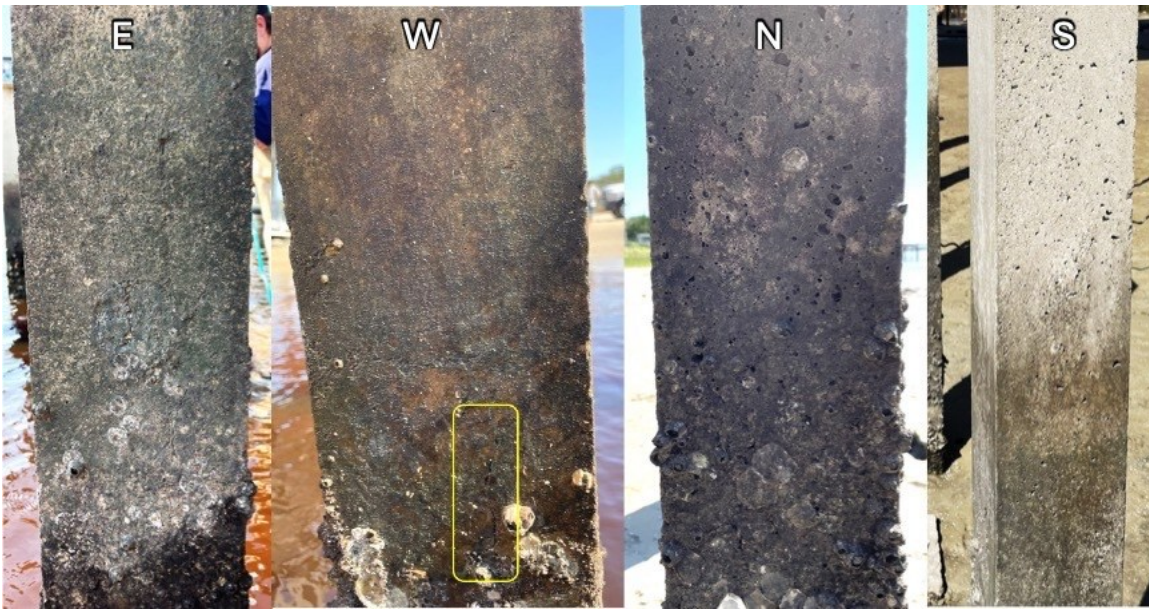
Most 3CR12 column surfaces showed cracks. All four surfaces in Column A had cracks (Figure 5-4). Cores were obtained by FDOT-SMO from Column A on a different date or after FAU had left the site. No rebars were included in the cores obtained.

Figure 5-4. Picture showing cracks on the surface of each face of column 3CR12-A.

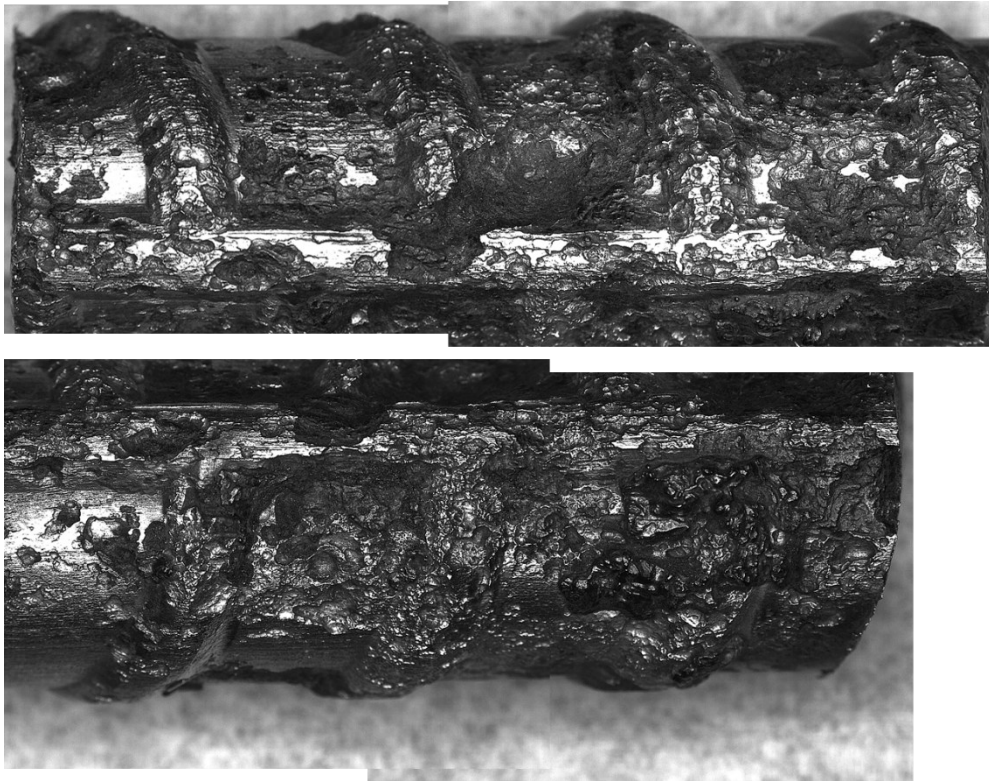
Figure 5-46. MMFX rebar section close-up of the region with most corrosion.

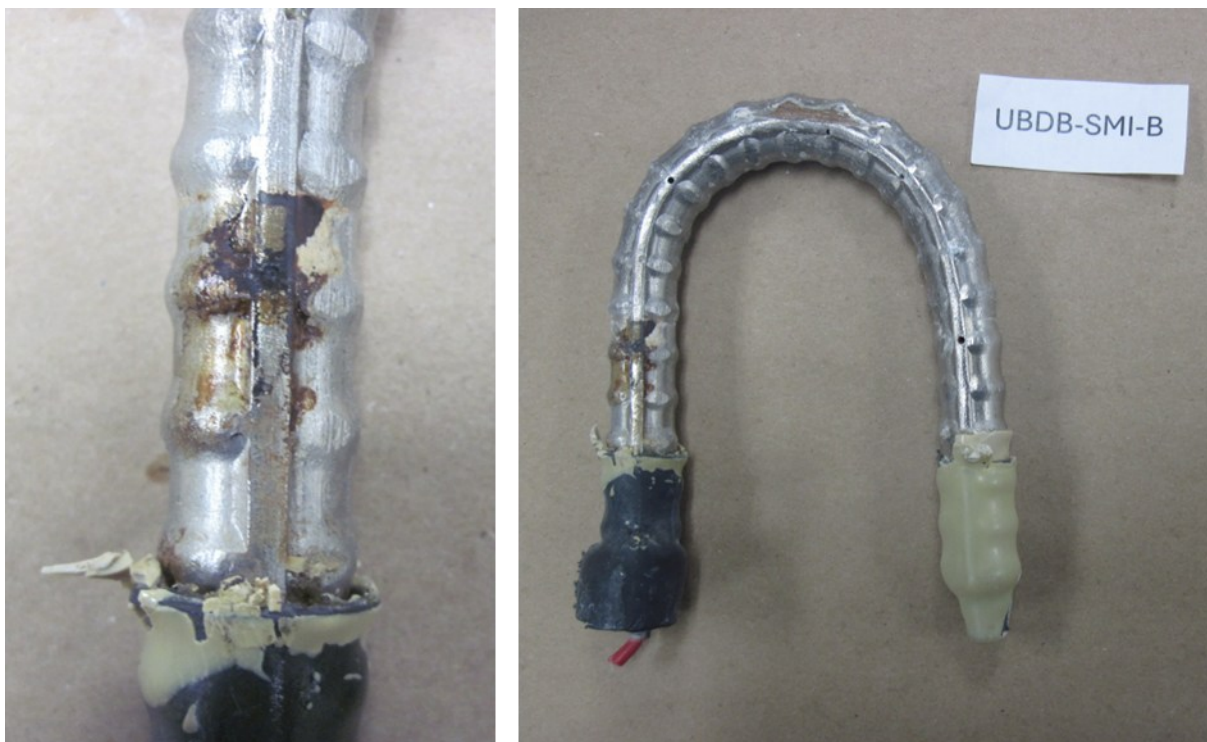
Figure 8-38. Corrosion spots on bottom side of sample UBDB-SMI-B (G109).

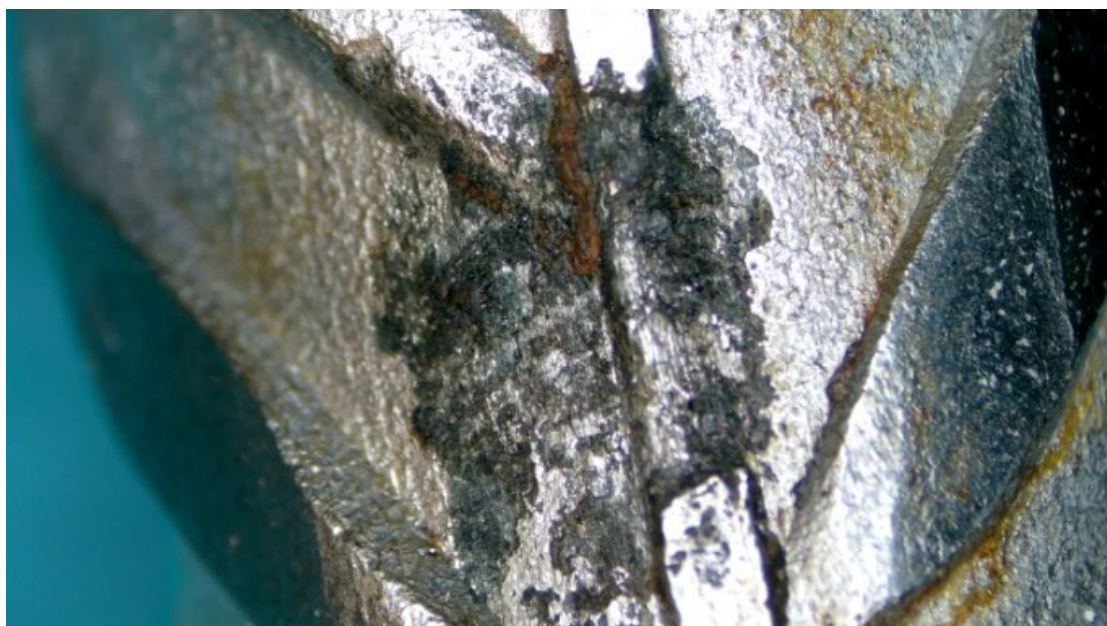
Figure 8-40. Corrosion spot observed on rebar 2 of STD3-2101-B.
