WL-TR-91-4032  
DOT/FAA/CT-91/23  
VOL II, Part 3

COMPOSITE FAILURE ANALYSIS HANDBOOK  
VOLUME II - TECHNICAL HANDBOOK  
PART 3 - CASE HISTORIES

R.J. Kar  
Northrop Corporation  
One Northrop Avenue  
Hawthorne, California 90250-3277

February 1992

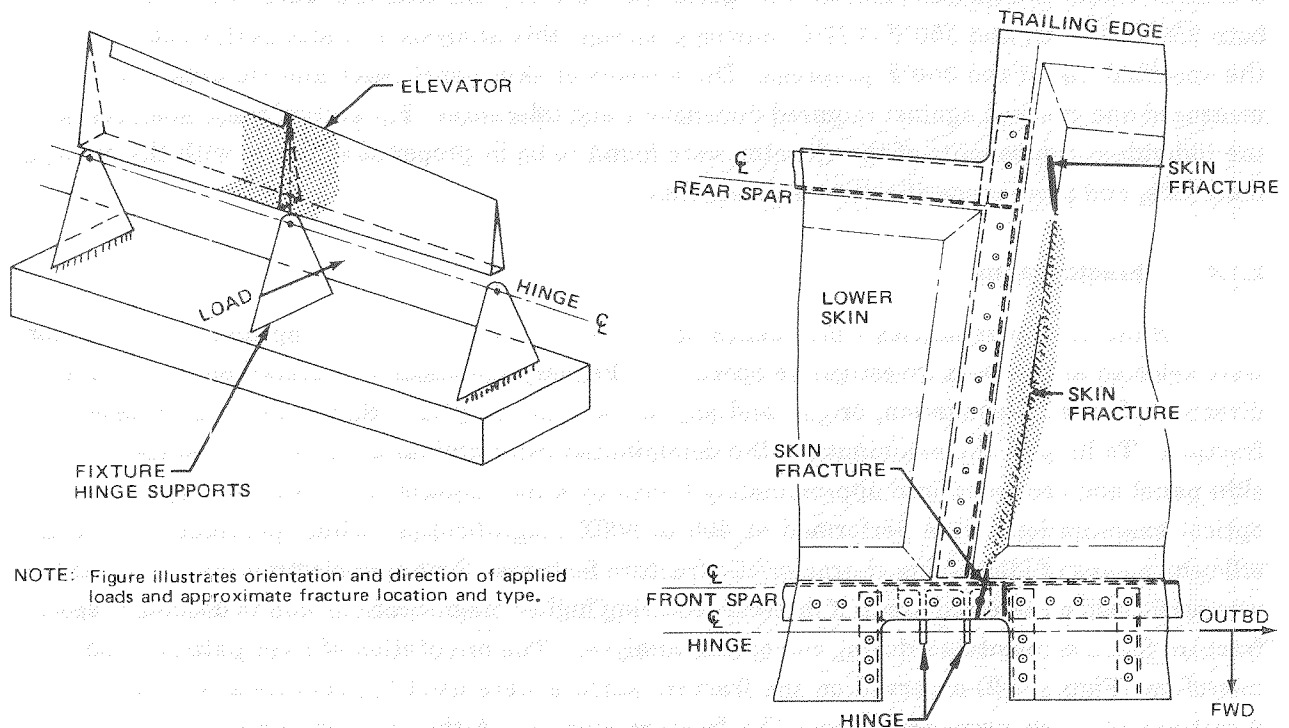
Figure 2-1. 737-300 Elevator Static Test Evaluation

Figure 2-1 illustrates a portion of a graphite/epoxy tapered box structure which fractured during test. This graphite/epoxy box consisted of two honeycomb skin panels fastened to a spanwise spar with intermediate chordwise ribs. A review of the test history revealed that premature fracture occurred during hingeline deflection of the front spar.

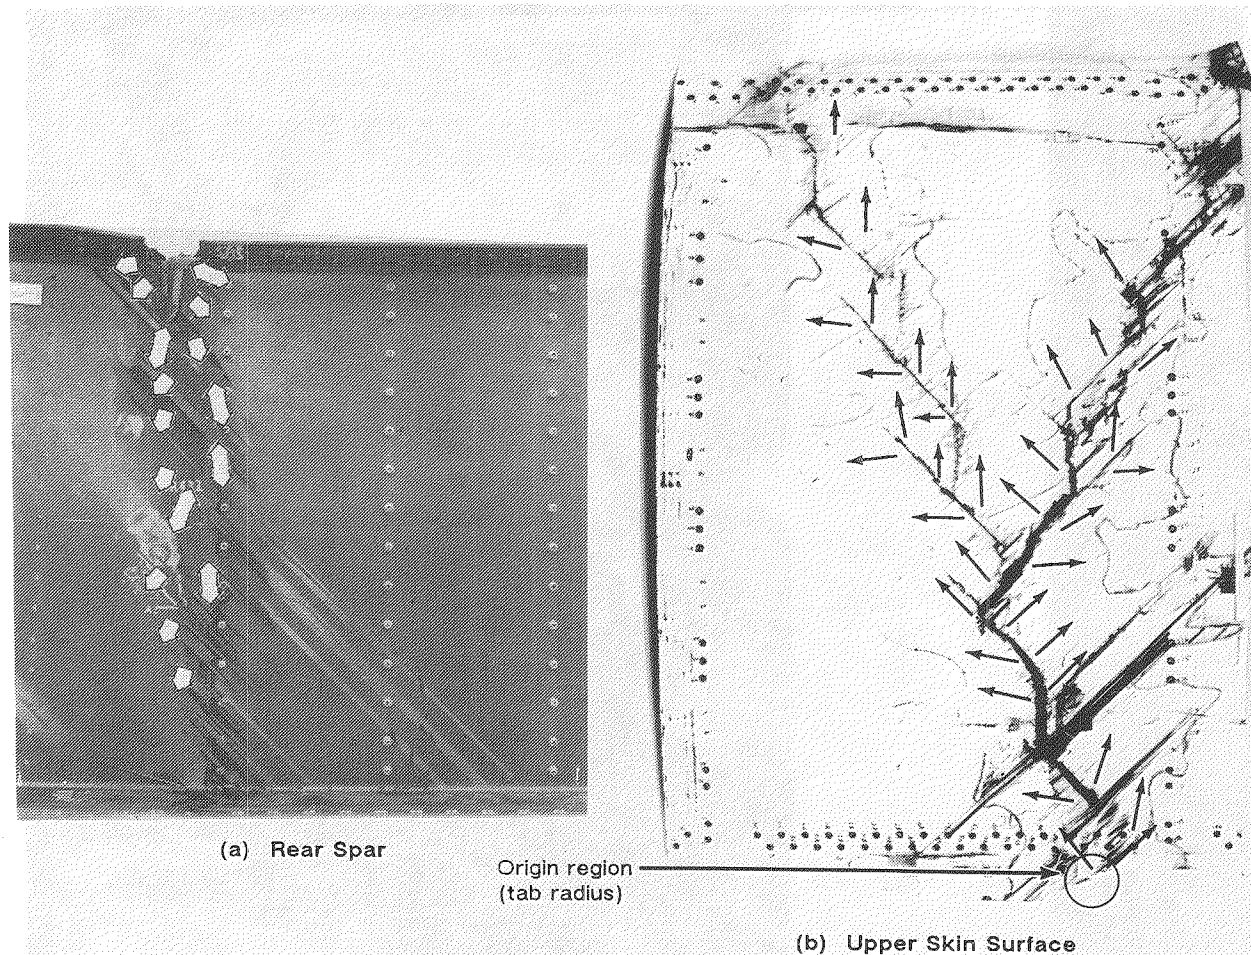
*Figure 2-8. JVX Wing Test Box Crack Mapping Results*

Using the outline of the delamination generated by NDE, the fractures were abrasively sectioned open to minimize artifacts. Detailed crack mapping of the delamination surfaces was performed by optical microscopy, with documentation of the fracture morphologies obtained by the SEM. Areas of delamination were found to be principally Mode I tension dominated, with localized Mode II shear regions. The overall crack growth directions, as well as the fracture origin regions for the upper skin surface and the rear spar are shown in Figure 2-8. These analyses revealed cracking of the upper skin initiated by compression buckling fracture mode at the trailing edge tab radius with resultant fracture propagating toward the leading edge. Similarly, the rear spar fracture originated in a region adjacent to the upper skin surface. Crack mapping in this region was very inconsistent, with a nearly random variation in the microscopic river marks and hackle orientation. No anomalous conditions such as porosity, resin starvation, or chemical contamination were identified in the origin regions.

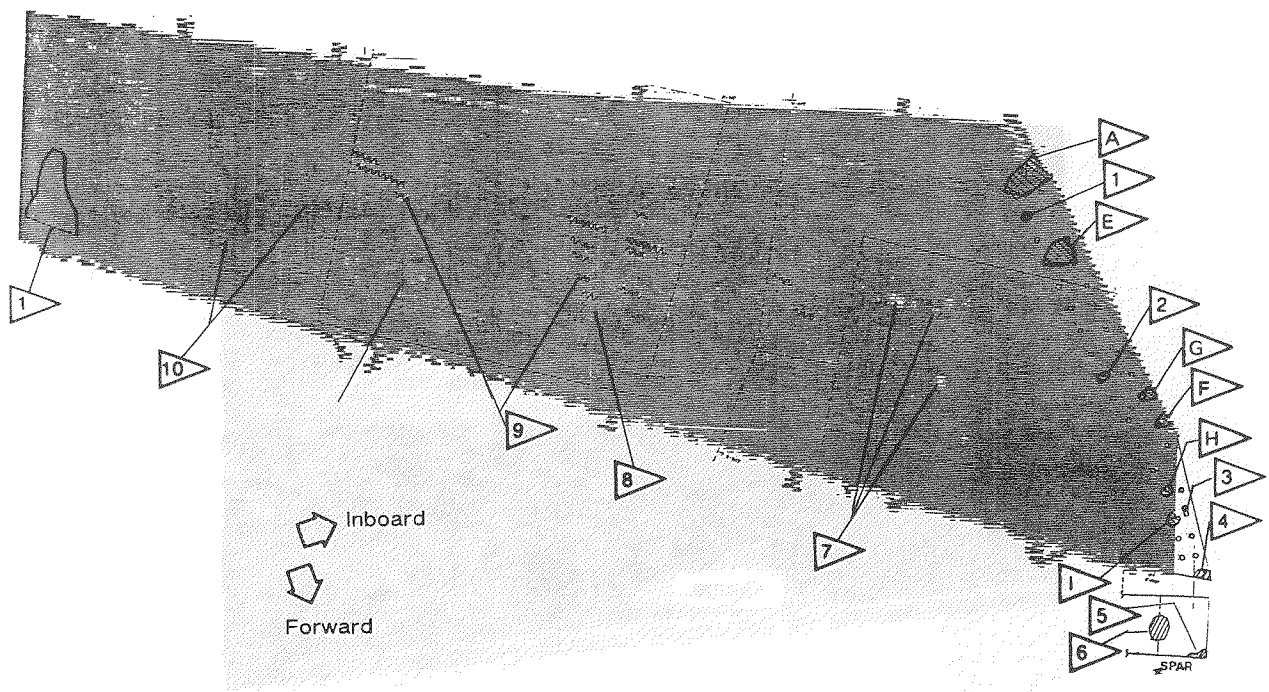
Figure 2-11. NDE Results of the Lower Surface

The hand-held pulse-echo inspections revealed the depth of each defect. The deepest delamination occurred 0.86 cm (0.34 inches) below the skin surface. These depth measurements became very useful when the handmilling cuts were made to remove the delamination regions. This allowed precise cutting, reducing the extent of damage to the remaining portion of the wing, and allowed a more successful repair.

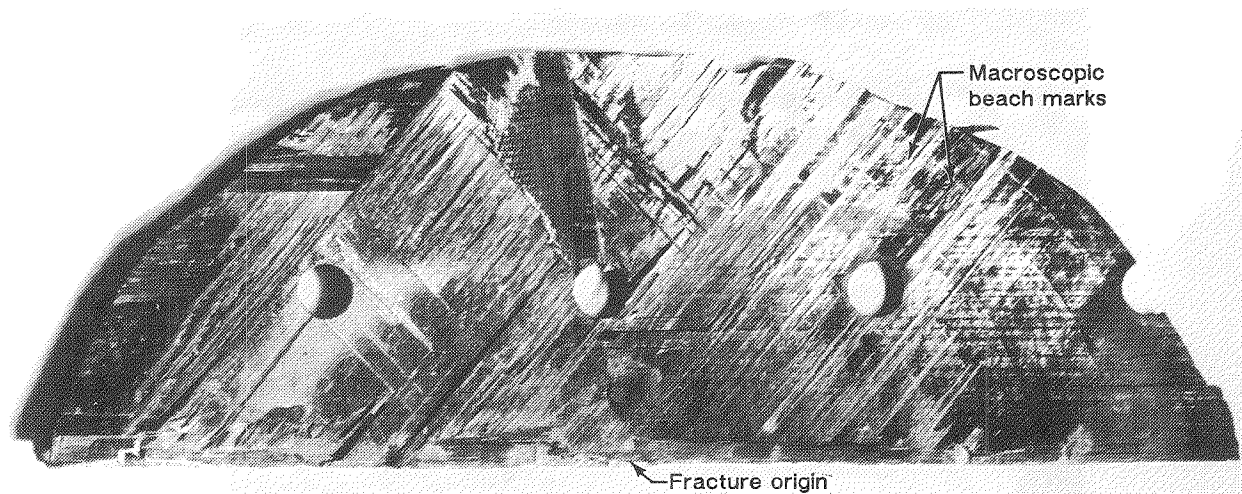
**Figure 2-16. Photomicrograph of Beach Marks Indicative of Cyclic Crack Growth and Crack Propagation Direction**

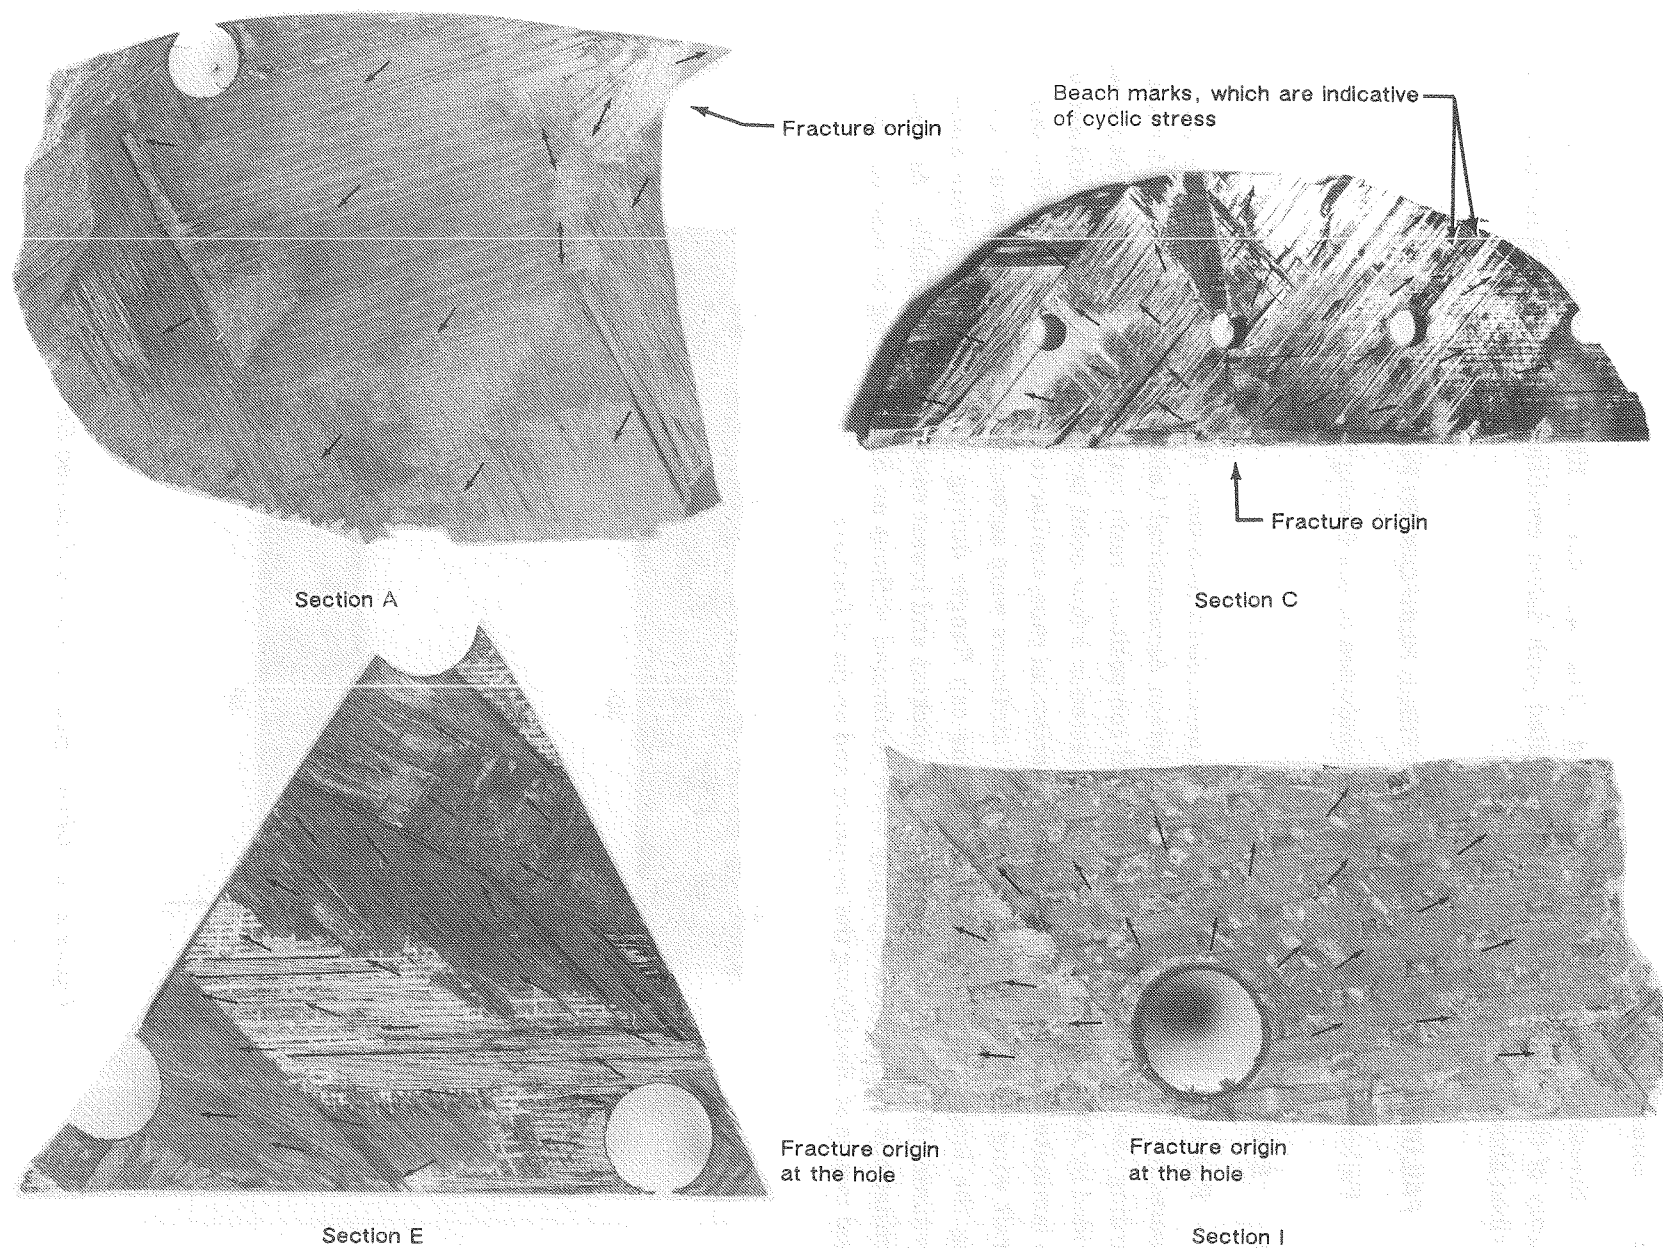
Figure 2-17. Crack Mapping Results From Selected Delamination Regions

| Delamination | Origin location | Fracture mode | Comments region |
|---|---|---|---|
| Section I | Fastener bore | Mode I tension | Porosity aided crack initiation of fabric graphite plies |

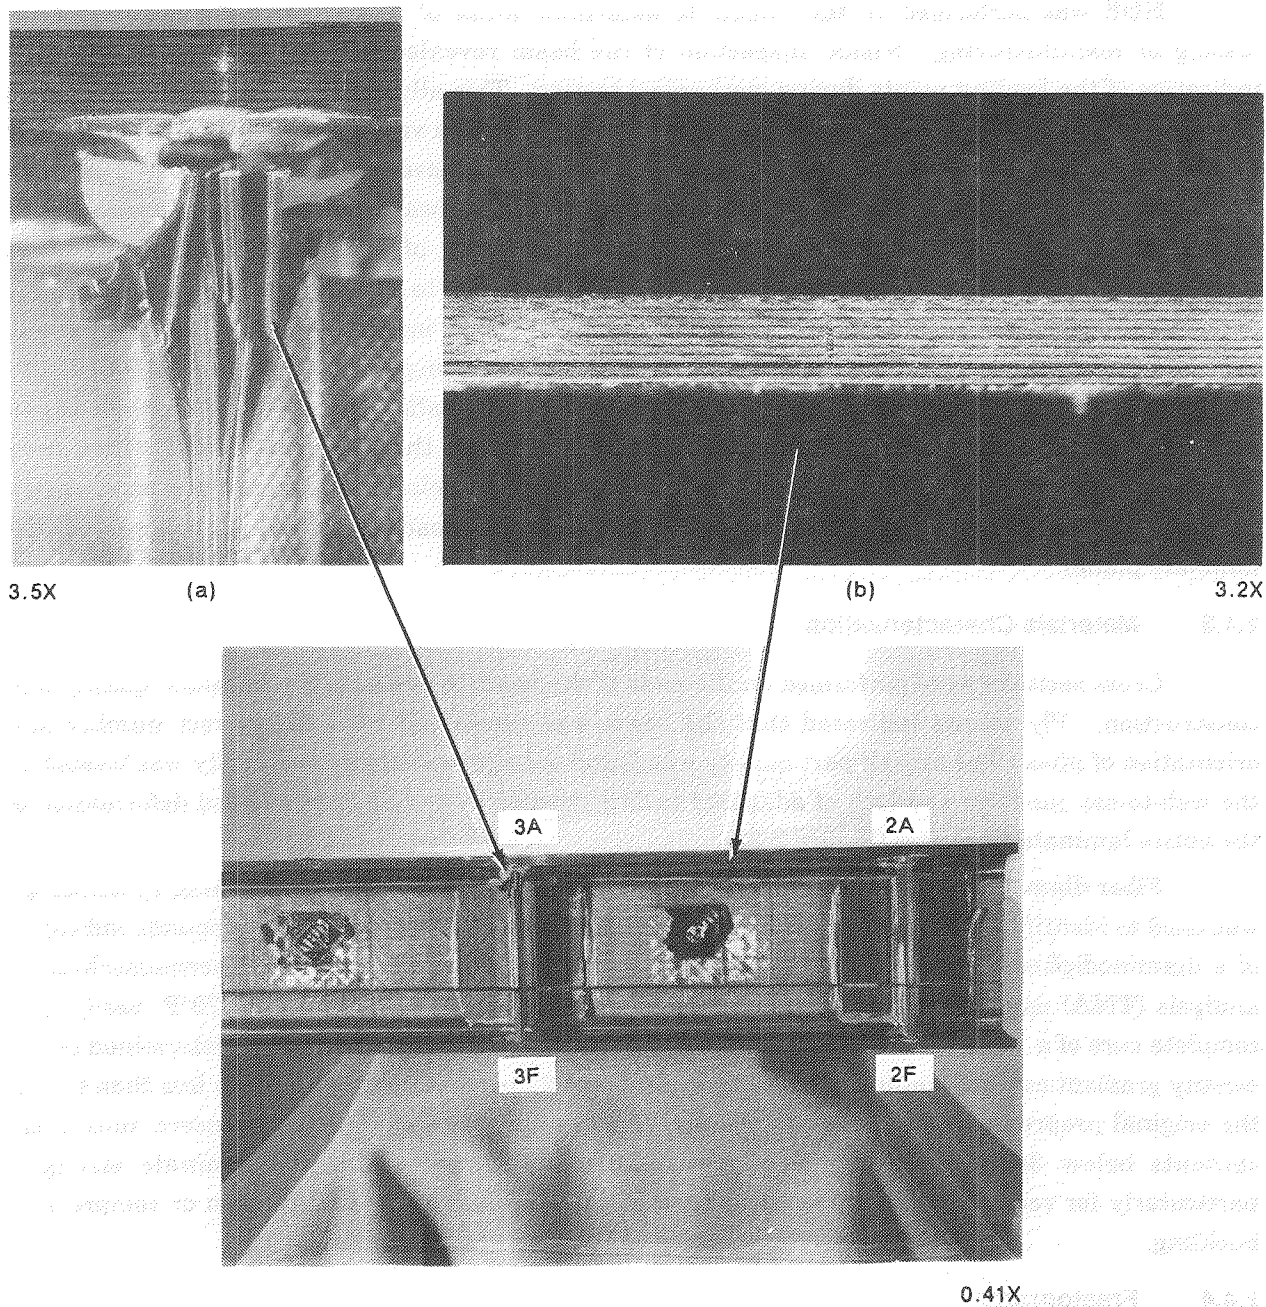
The delaminations in the upper cap were removed by cutting to prevent further delamination. Visual macroscopic inspection of the surfaces revealed the presence of both shiny and milky appearing regions, indicative of tension and shear dominated delaminations, respectively. The fracture occurred at the interface between the 0 and 45 degree plies, most likely due to the stress gradient between the axial 0 degree ply (which carries the primary axial flexural loads) and the off-axis 45 degree ply. Crack mapping was performed with the optical microscope, with the localized

Figure 2-19. Regions of (a) Compression Buckling and (b) Delamination in the Upper Cap Section of the I-Beam

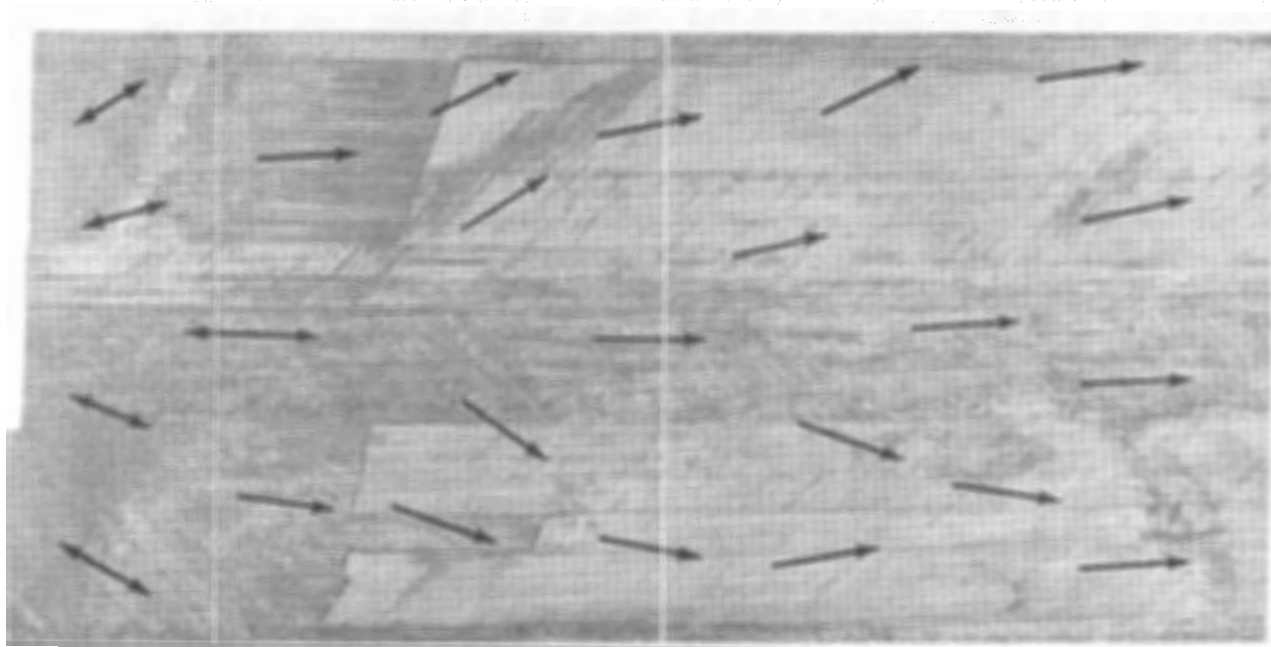
crack directions determined by examining the orientation of the hackles in the shear dominated regions and the river marks in the tension dominated regions. Cracking was found to initiate by shear at the web-to-cap junction, under the loading contact points. Cracking continued along the central region of the cap (where extensive porosity was evident) by mixed mode, although primarily tension toward the ends of the beam, as shown in Figure 2-23.

**Figure 2-23. Results of Fractographic Crack Mapping of an Upper Cap Delamination**

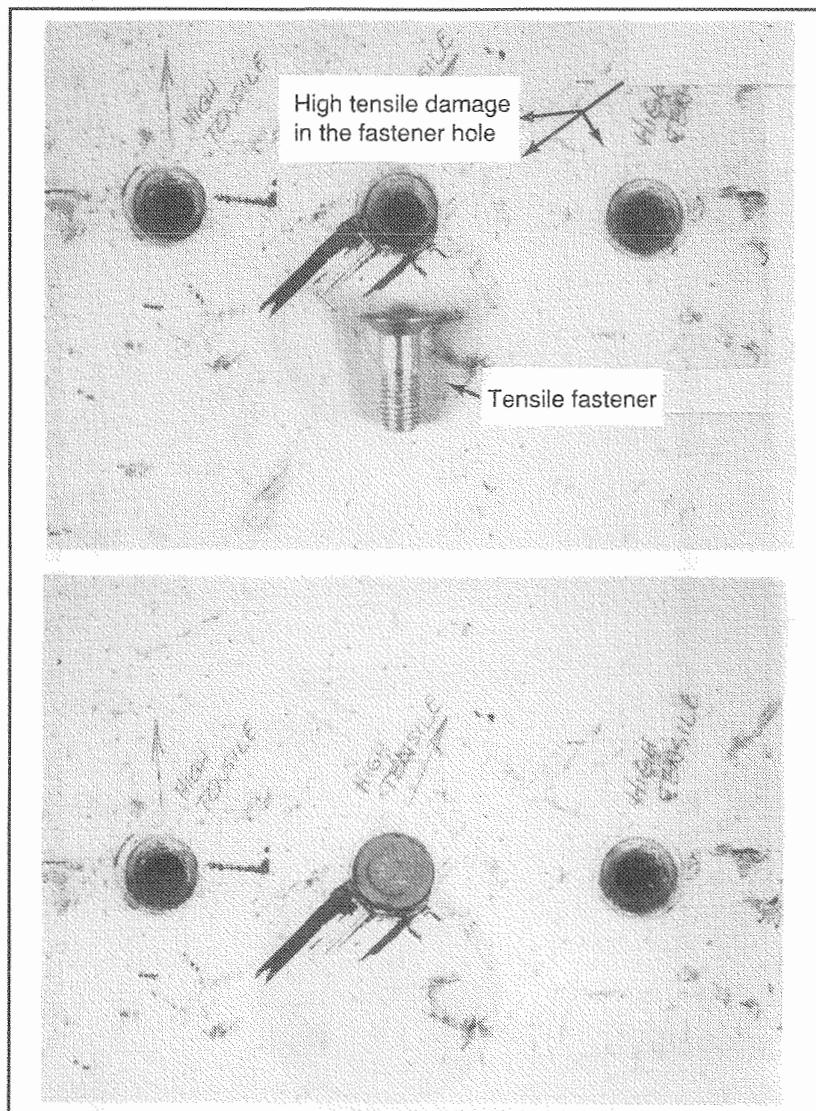
a. Tensile fastener (fits loosely in fastener hole)

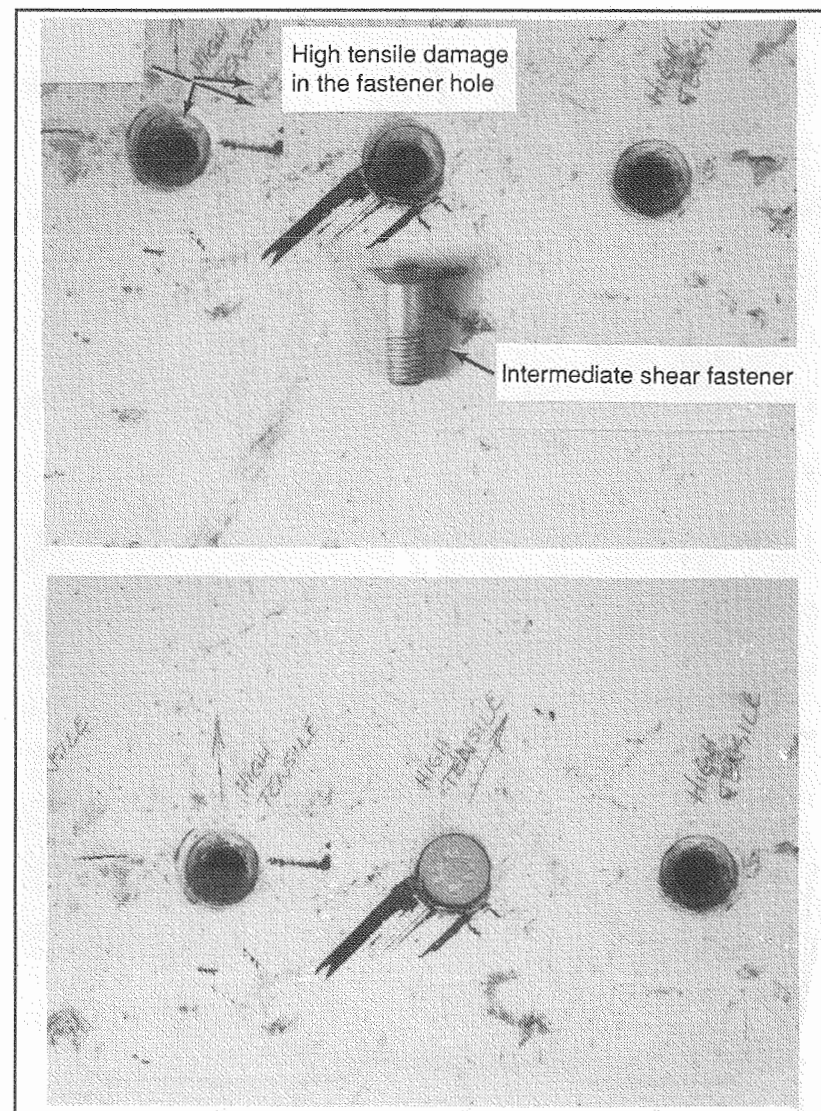
b. Shear (intermediate) fastener (fits snugly in fastener hole)

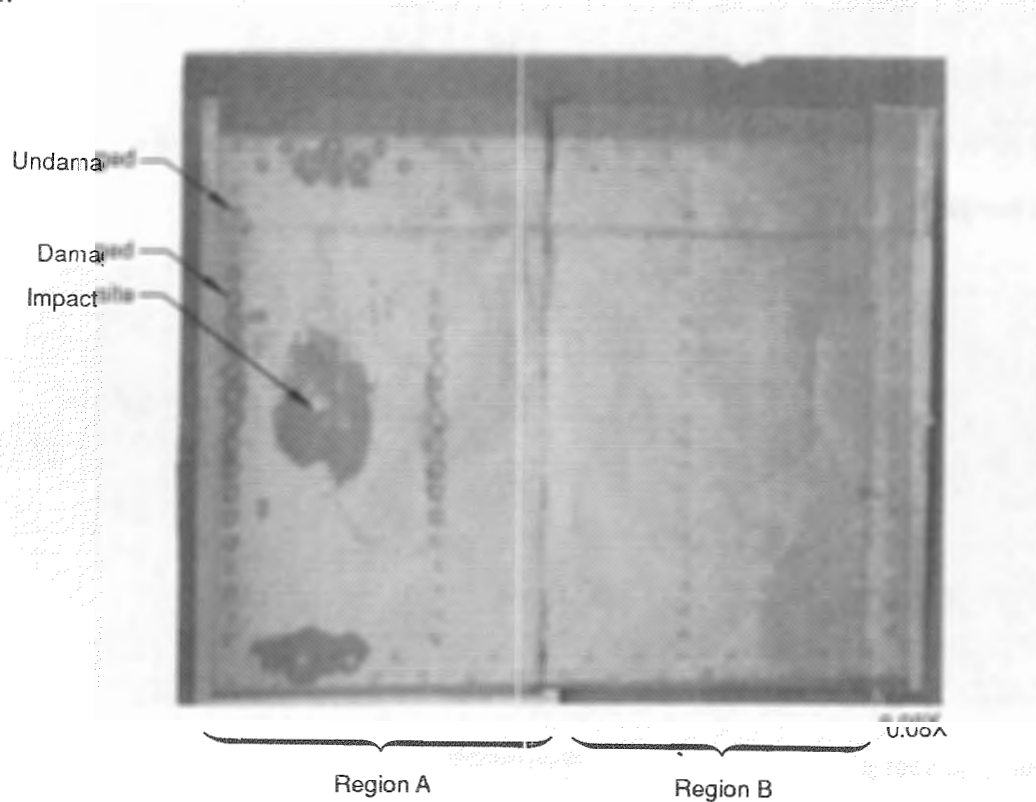
Figure 2-31. Through Transmission Ultrasonic (TTU) Scan of Component

To determine the extent of the damage, through-transmission ultrasonic inspection (C-scan) was performed. The dark-shaded regions in the vicinity of the fastener holes and at the apparent impact site indicate the damaged region. These regions are shaded due to higher attenuation from the anomalous regions. Most of the damage occurred on one half of the panel, Region A, as shown in Figure 2-31.

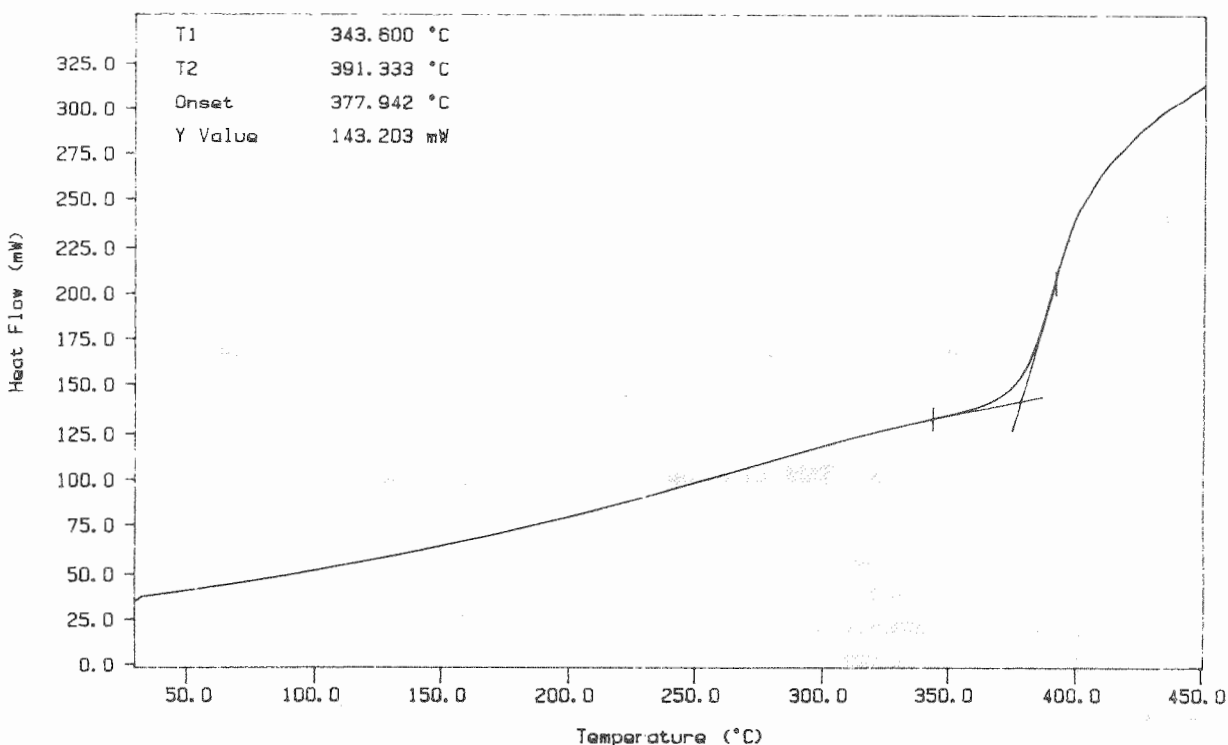
Figure 2-33. DSC Thermogram

Differential scanning calorimetry (DSC) showed no exothermic peaks, indicating that the material was fully cured (Figure 2-33). A decomposition at 378°C was also observed. Thermomechanical analysis (TMA) showed the average glass transition temperature ( $T_g$ ) to be 210°C (410°F, Figure 2-34). Thermogravimetric analysis (TGA) indicated the composite decomposed at approximately 357°C (675°F, Figure 2-35)

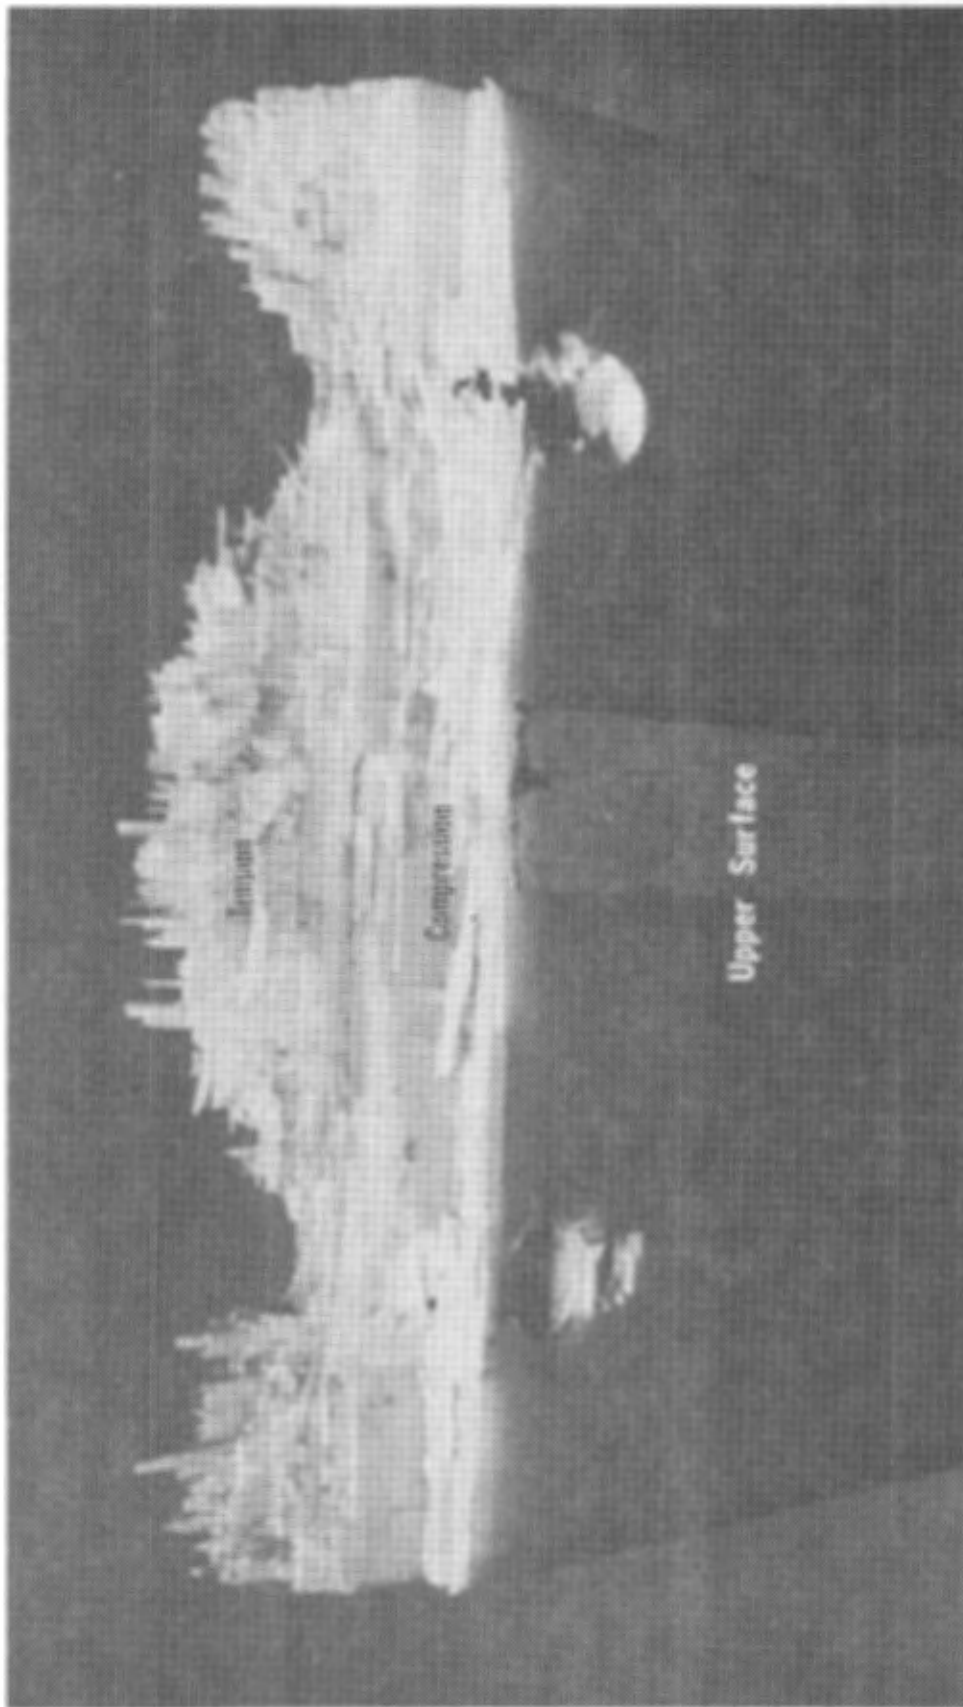
**Figure 2-39. Macrograph of the Translaminar Fracture Surface on the Small (Fixed Piece) of the Strut**  
 Note: Tension failure is multiphase and shows individual fibers or bundles; compression failure is planar.

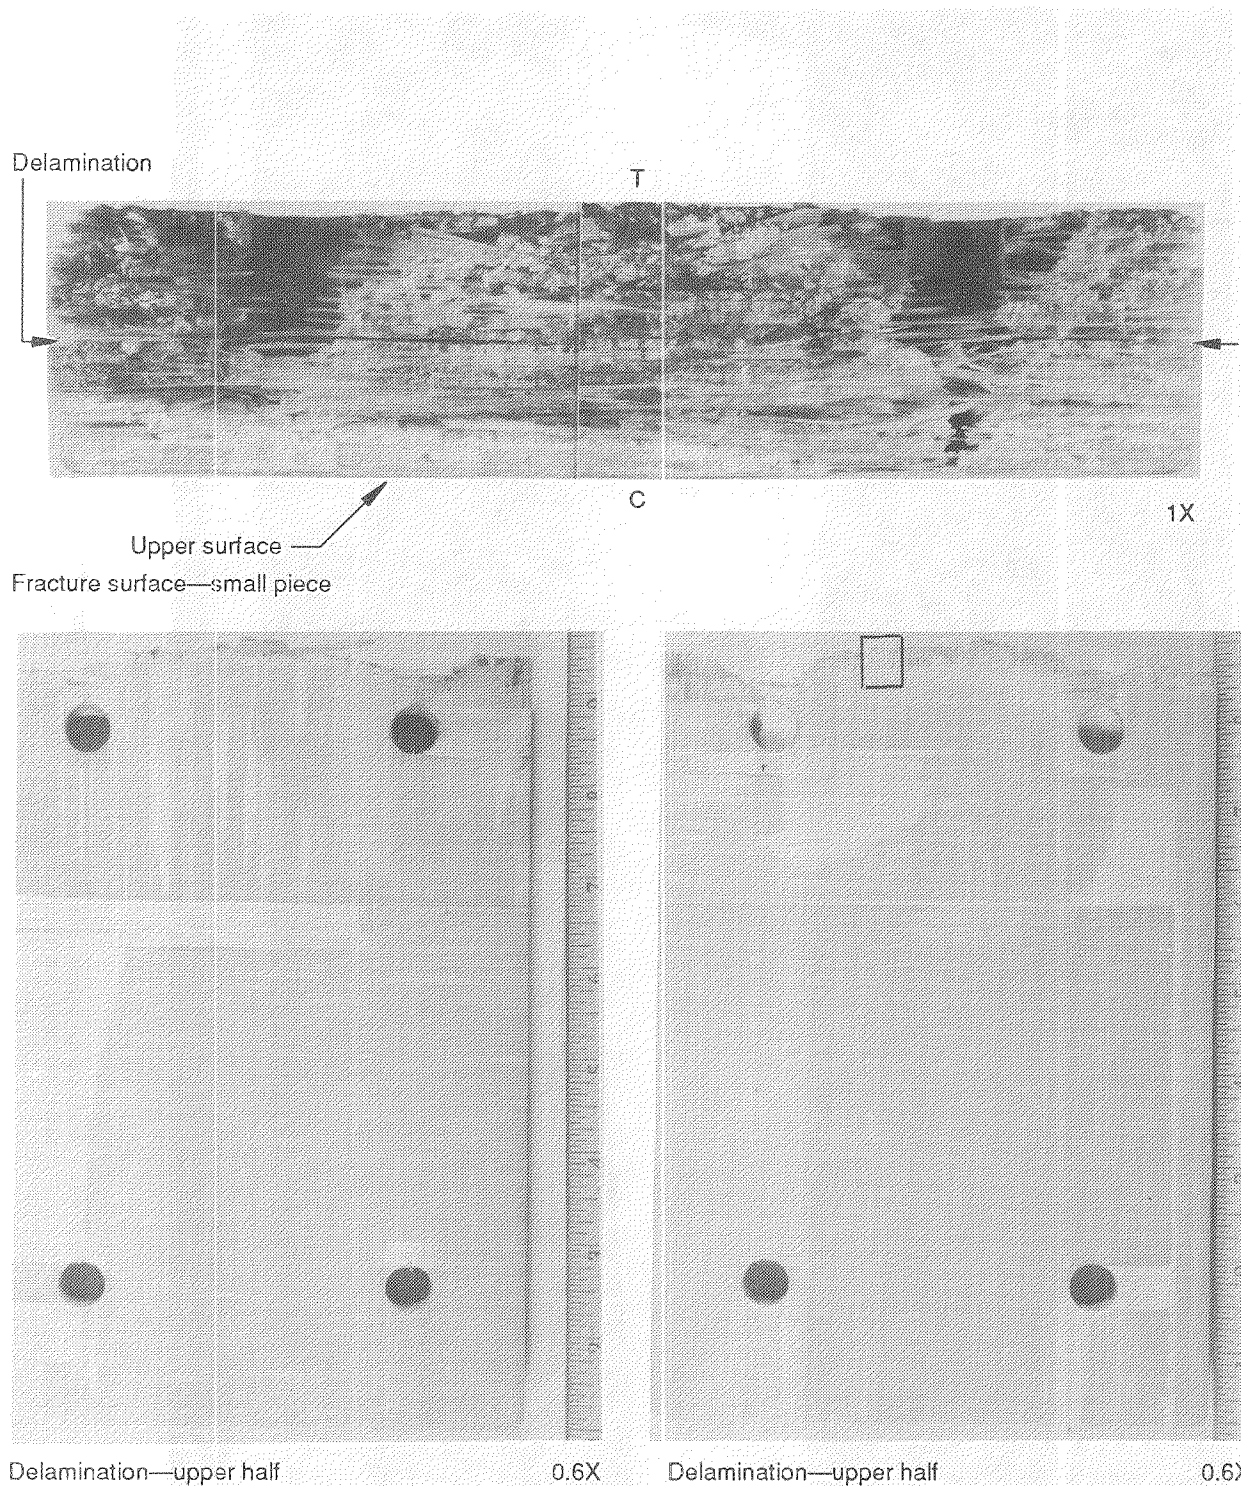
**Figure 2-40.** *Macrophotographs of the Top of the Small Piece Fracture Surface Showing Delamination, Upper Surface, Tension Fracture (T) and Compression Fracture (C)*  
 The lower macrophotographs show the mating delamination surfaces after laboratory separation of the delamination. The area shown by the small box is magnified in Figure 2-46.

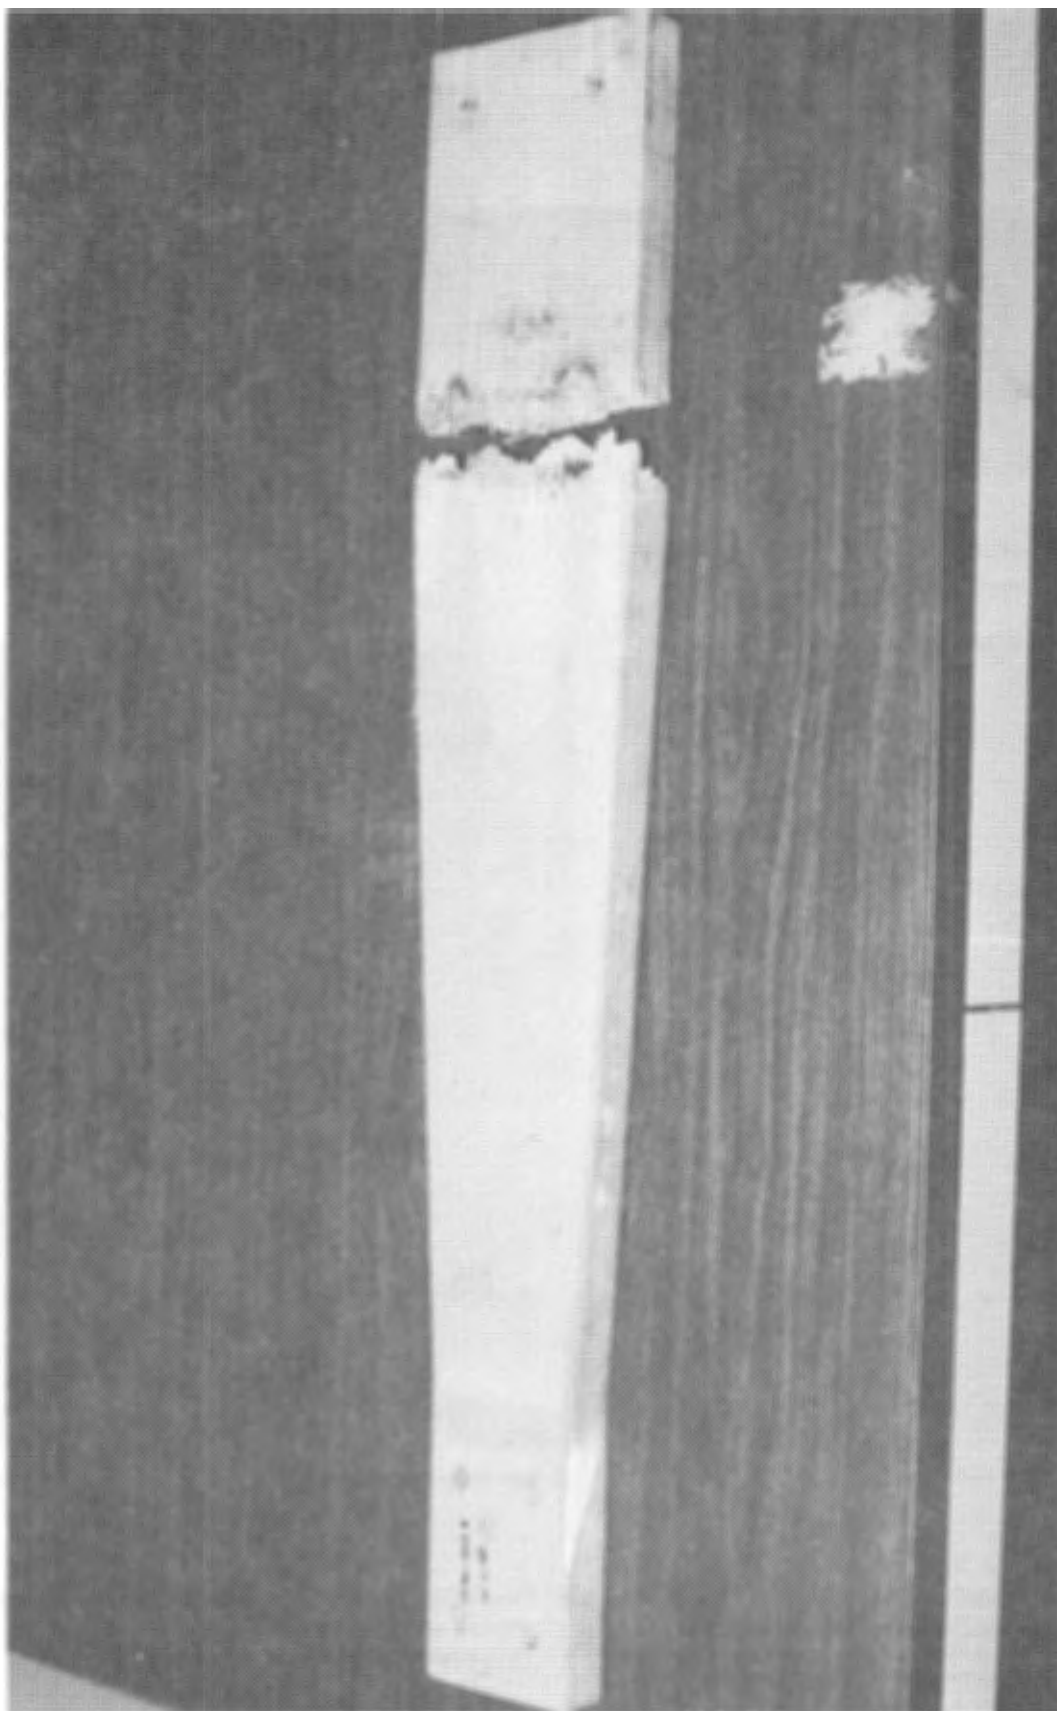
**Figure 2-41. Macro photograph of the Lower Surface of the Strut As-Received**

**Note:** The transverse fracture occurred at the bolt holes on the surface.

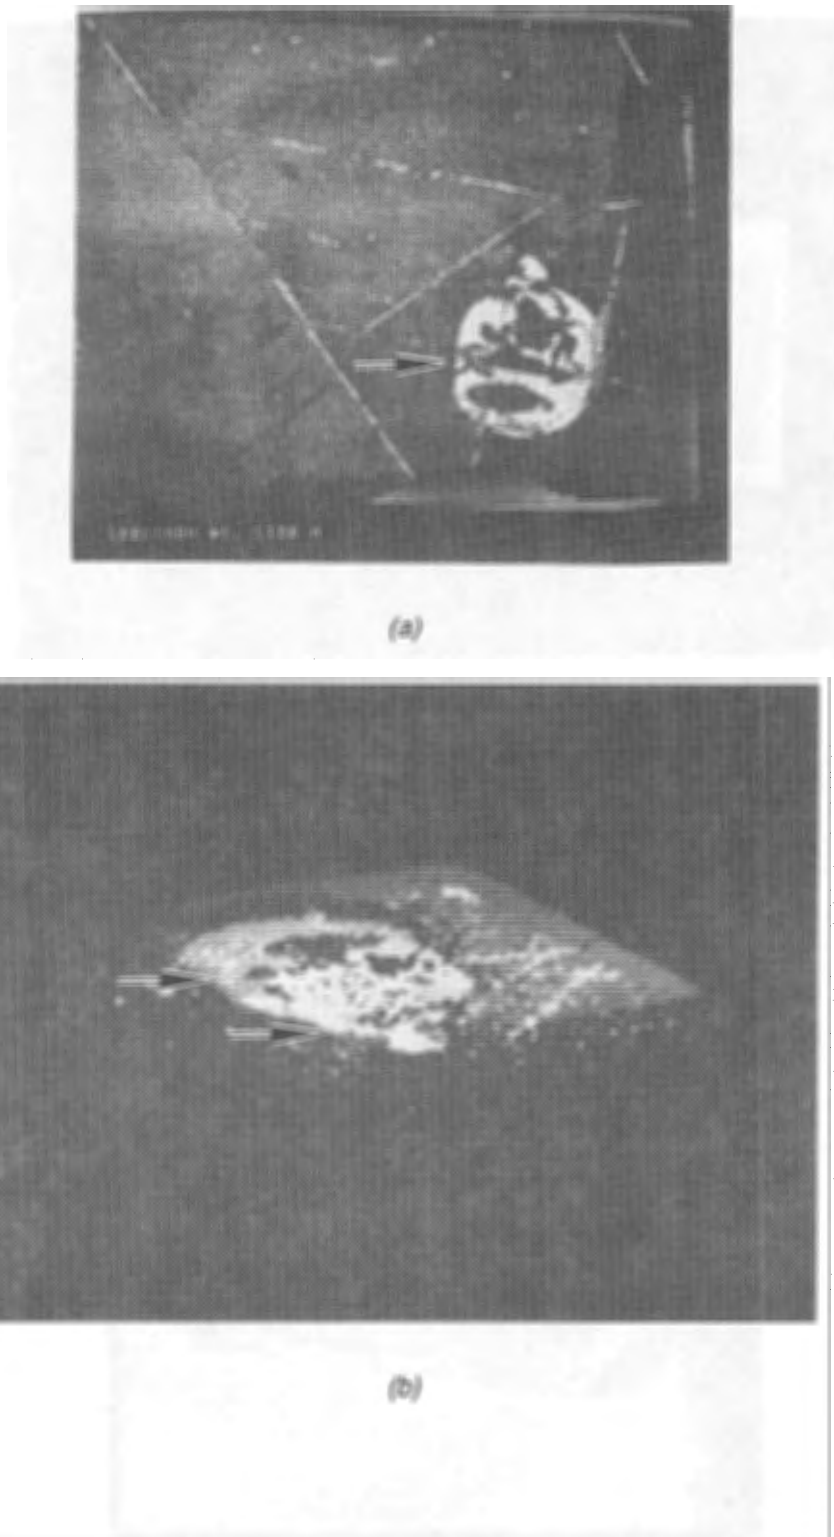
**Figure 2-54. Pulse Echo Images of Damaged Region**  
(a) 2-D B-Scan Shows Primary Delamination (Arrow)  
(b) 3-D B-Scan Shows Multiple Delaminations (Arrows) and Porosity

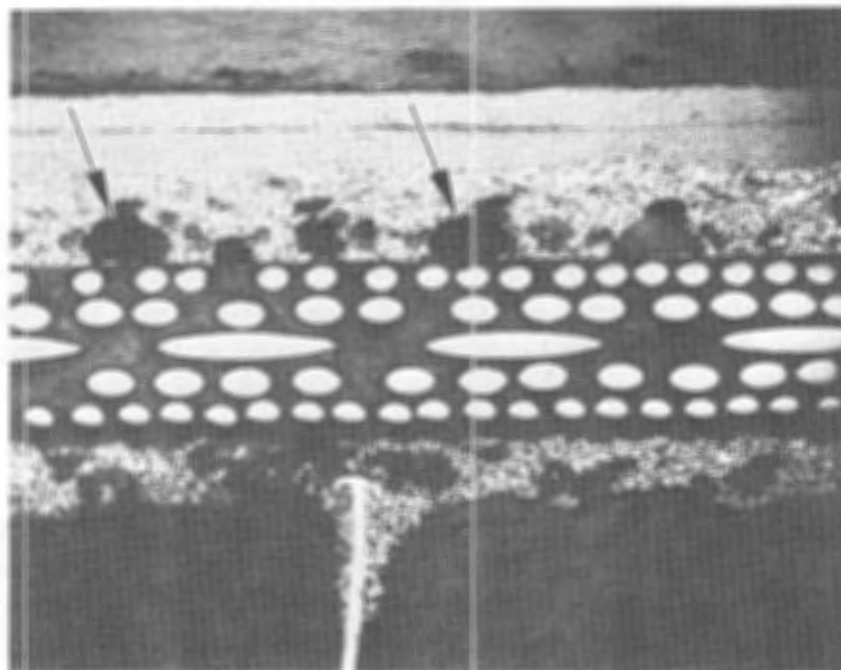
**Figure 2-59. Photograph of Cross-Section Taken Through Rudder Skin**  
 Note Porosity in Skin at Arrows

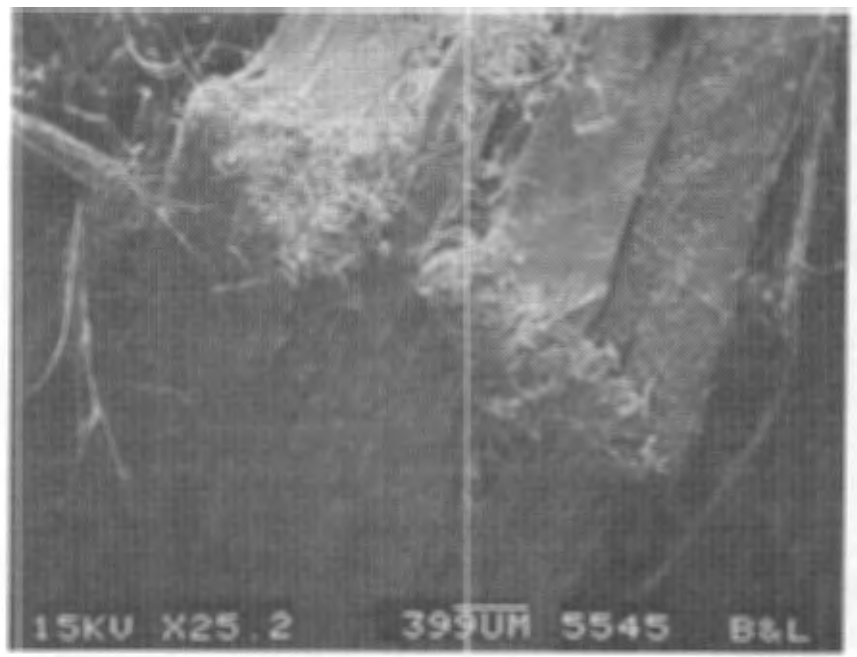
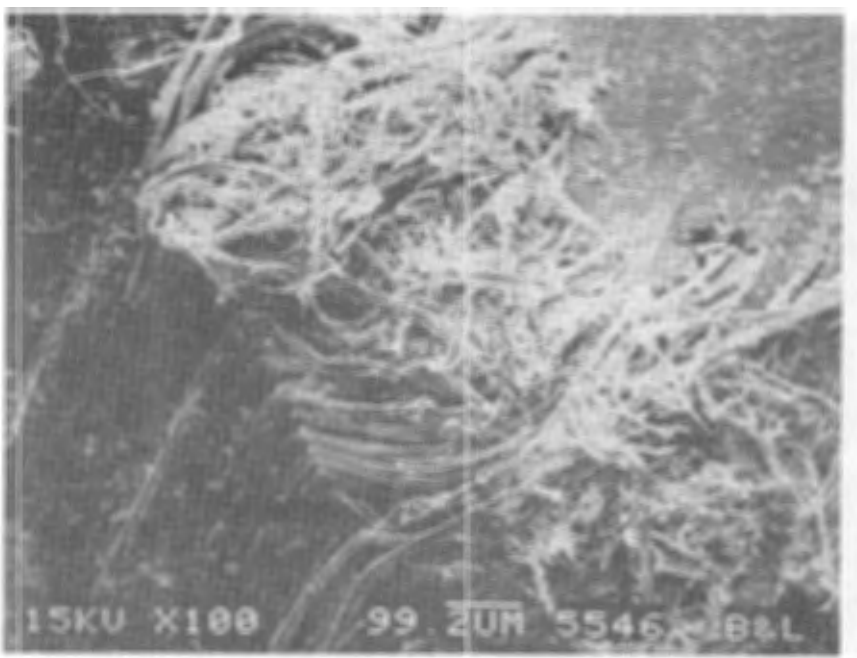
**Figure 2-73. SEM Photographs of Damage on Outer Surface of Cylinder**  
 (a) Low Magnification Showing Displacement of Fiber Bundles, Splits and Defibrillation of Fiber Ends  
 (b) High Magnification Photograph Showing Fibril Clusters

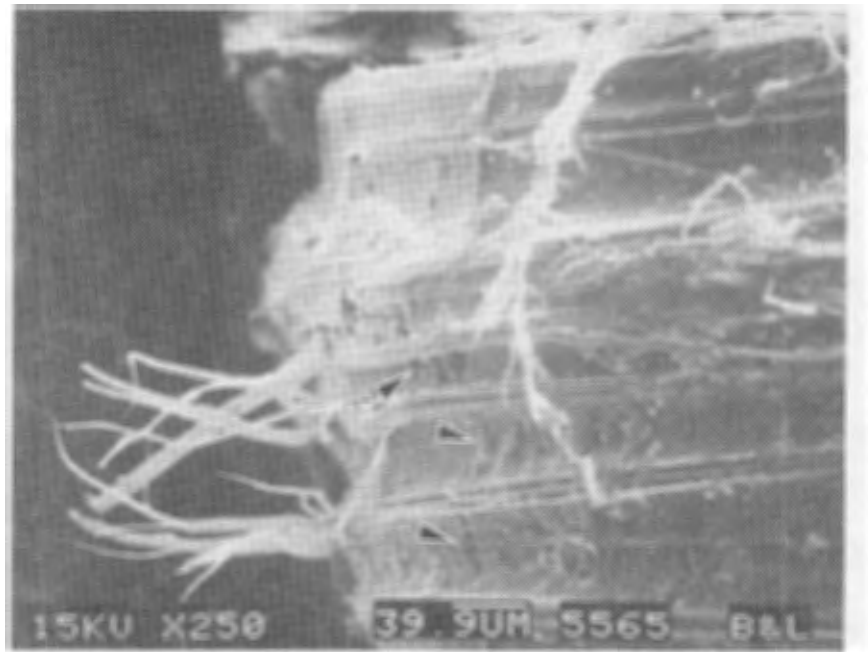
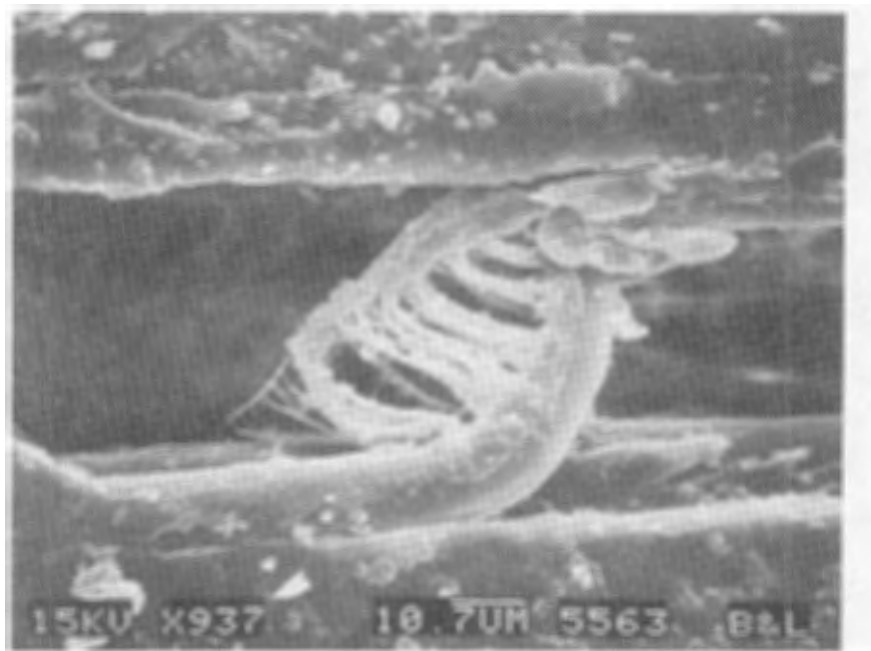
Figure 2-74. SEM Photographs of Outer Surface Damage With Clusters of Fibrils Removed  
 (a) Hackles (Arrows) in Resin  
 (b) Localized Bending of Fibers
