WL-TR-91-4032  
DOT/FAA/CT-91/23  
VOL II, Part 3

COMPOSITE FAILURE ANALYSIS HANDBOOK  
VOLUME II - TECHNICAL HANDBOOK  
PART 3 - CASE HISTORIES

R.J. Kar  
Northrop Corporation  
One Northrop Avenue  
Hawthorne, California 90250-3277

February 1992

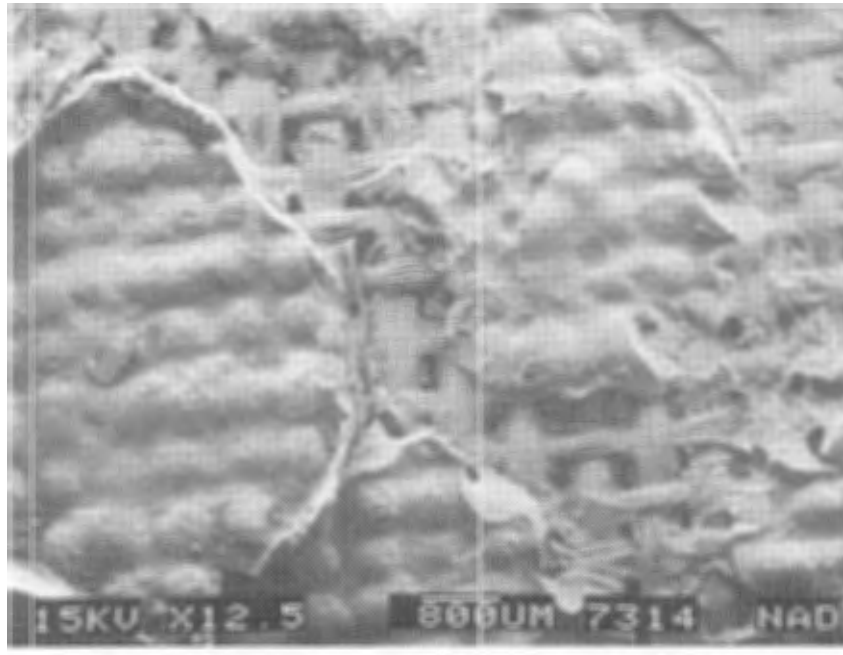
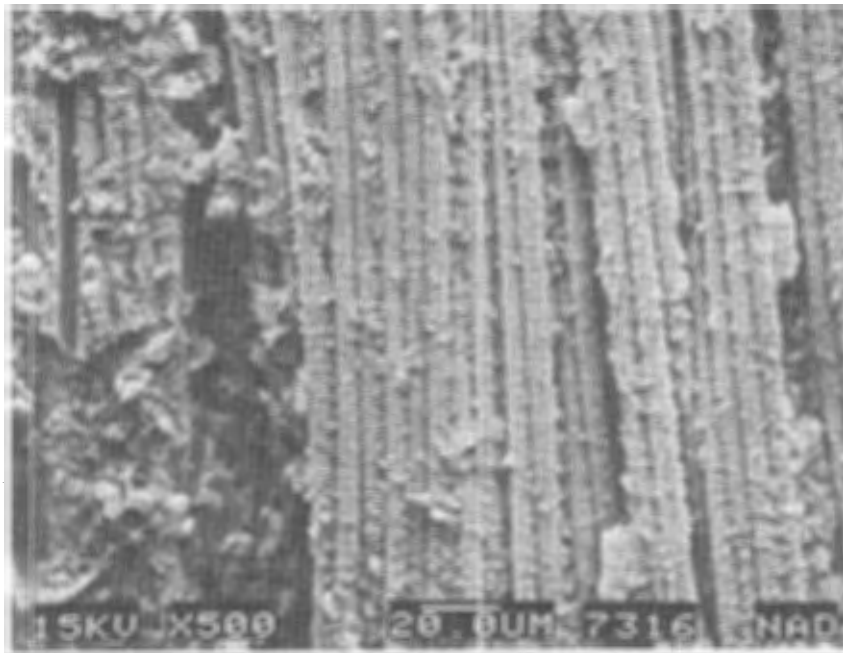
Figure 2-80. SEM Photographs in Region C (Honeycomb Region) of Delamination of Bottom Surface of Compound Plate  
 (a) Adhesive Failure of Honeycomb  
 (b) Heat Damage to Adherend

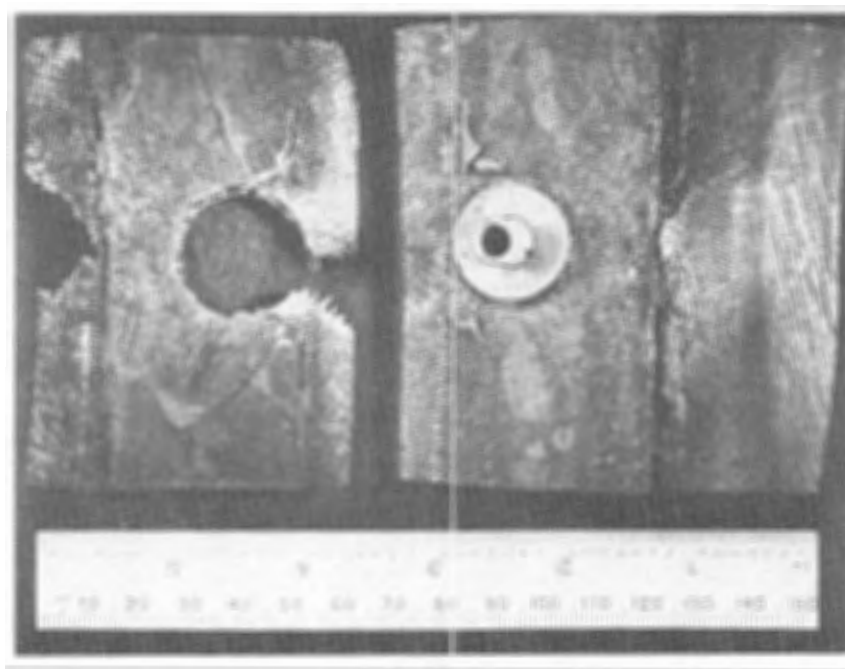
The top surface of the compound plate was also examined. The section was extremely brittle and delaminated upon gentle handling with a tweezer (Figure 2-82). Evaluation of the fragment, which appeared to be ceramic in nature, revealed evidence of overheating as suggested by the bent contour (Figure 2-83a) and voids observed during SEM examination (Figure 2-83b).

*Figure 2-82. Delamination in Top Surface of Compound Plate (Mating Halves)*
