**DOT/FAA/CT-92/04**

# **Commuter/Air Taxi Ditchings and Water-Related Impacts that Occurred from 1979 to 1989**

July 1994

Final Report

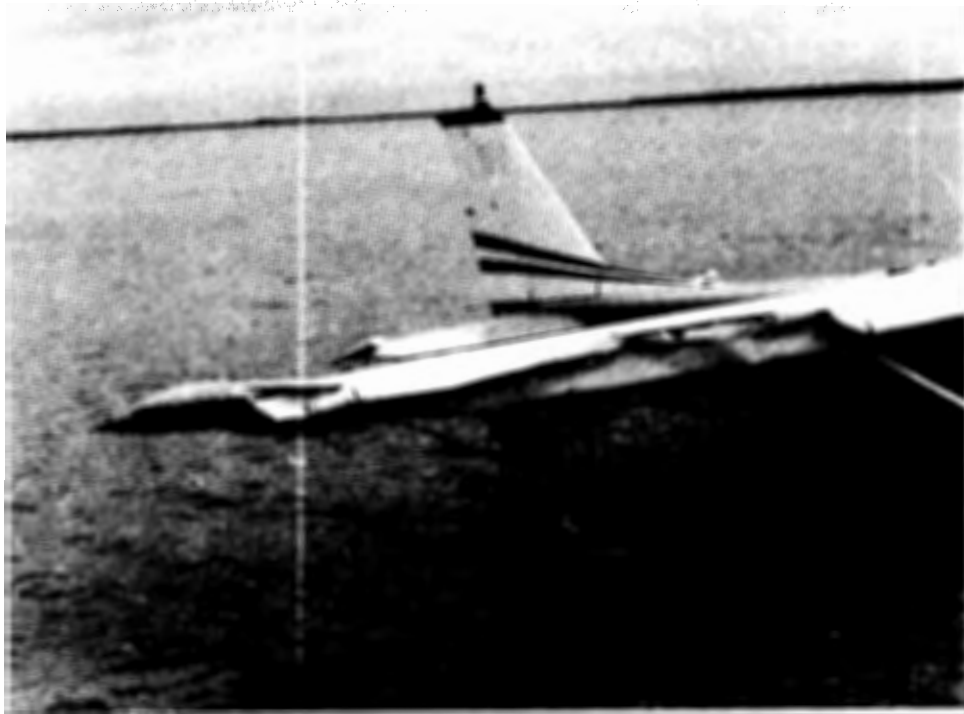
FIGURE 4.1. CASE STUDY 3, DAMAGED LEADING EDGE OF RIGHT WING

- a. Right wing substantially damaged (figures 4.1, 4.2).
- b. Right wing flap slightly displaced (figure 4.3).
- c. Propeller blade bent.

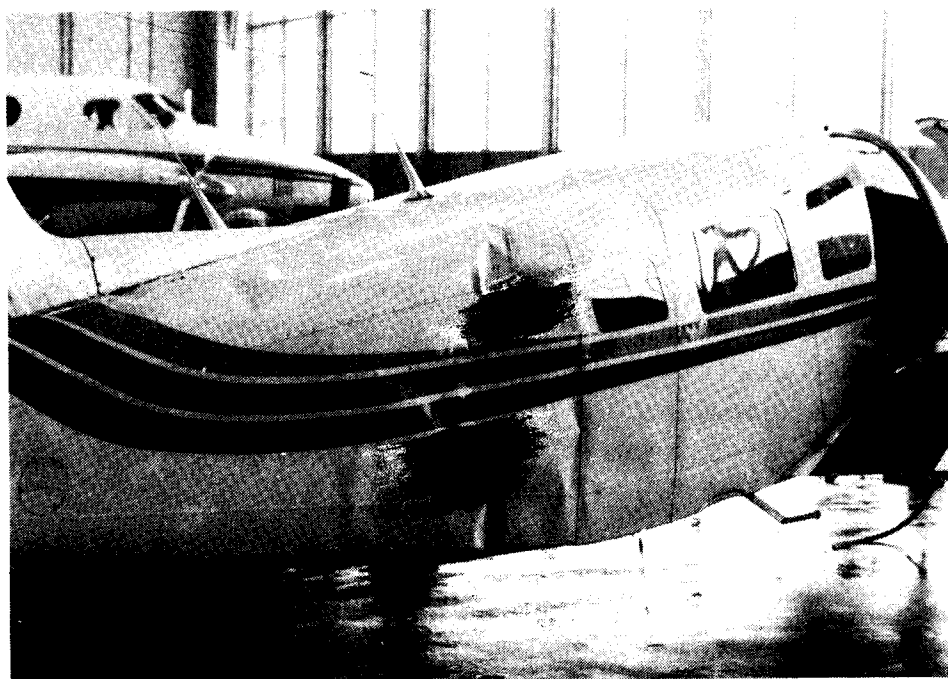
FIGURE 4.6. CASE STUDY 4, RIGHT VIEW OF REAR FUSELAGE DAMAGE

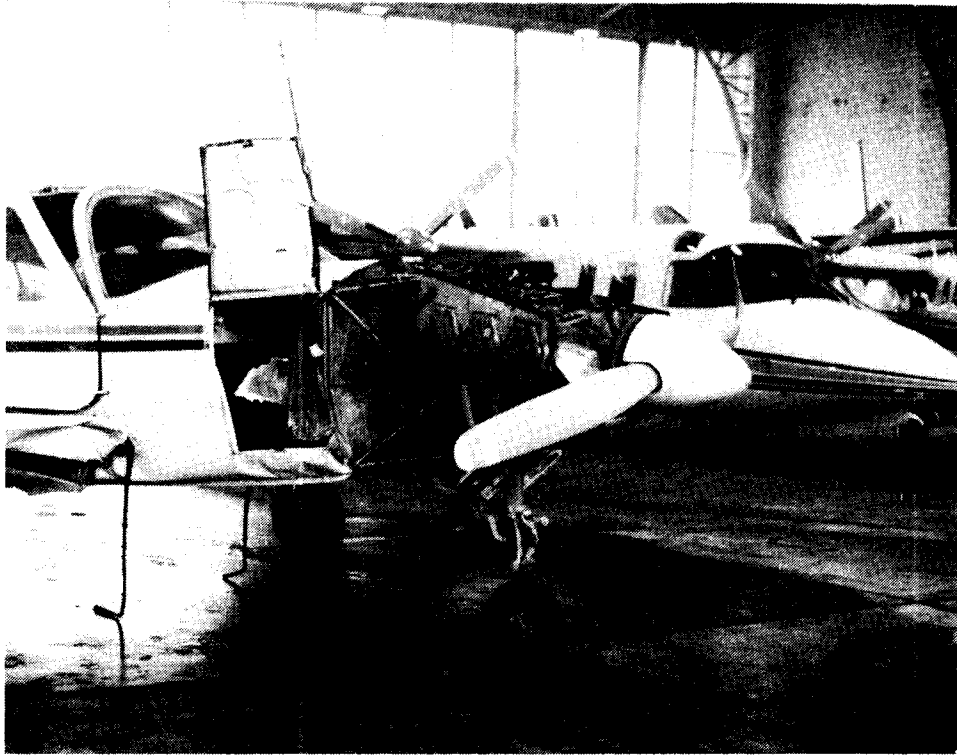
FIGURE 4.7. CASE STUDY 4, RIGHT VIEW OF NOSE DAMAGE

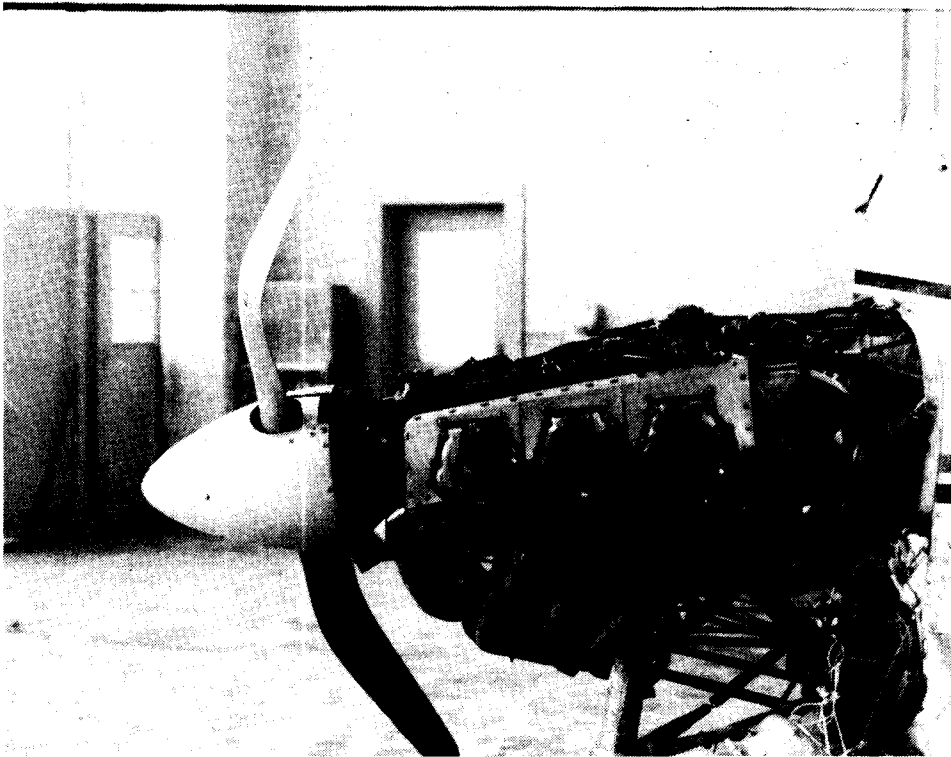
FIGURE 4.8. CASE STUDY 4, LEFT VIEW OF NOSE DAMAGE

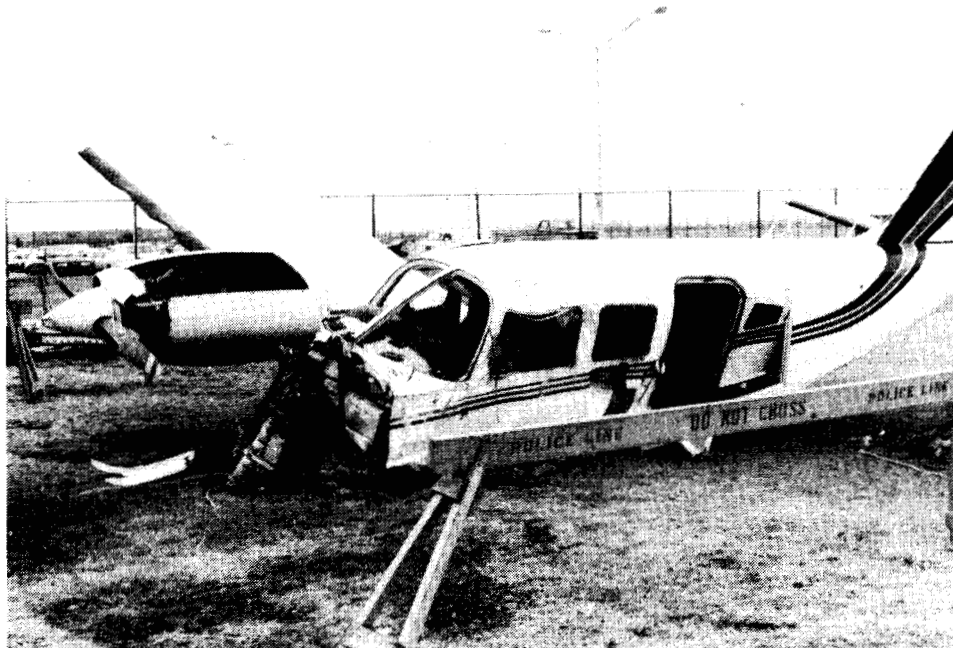
FIGURE 4.11. CASE STUDY 6, FULL VIEW OF LEFT FUSELAGE DAMAGE

- a. Left wing completely separated from fuselage and inverted (figure 4.11).
- b. Forward upper left fuselage side indentation resembling left wing tip (figure 4.11).
- c. Fuselage door under the wing (figure 4.11).
- d. Left, right, and nose gear in down position (figure 4.12).
- e. Nose wheel and lower part of nose strut missing (figure 4.11).
- f. Right wing tip missing (figure 4.12).
- g. Rudder slightly wrinkled.
- h. Nose crush damage (figure 4.11).

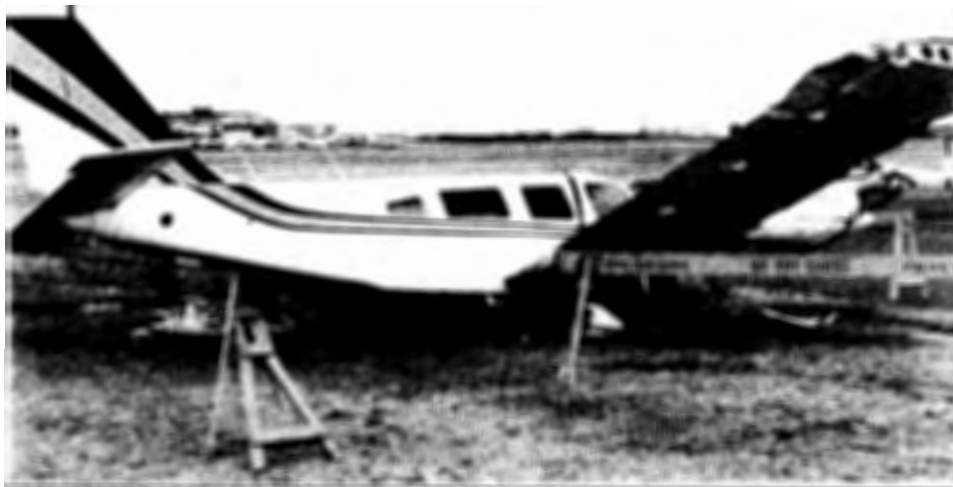
FIGURE 4.12. CASE STUDY 6, FULL VIEW OF RIGHT FUSELAGE DAMAGE
