**Report No. CDOT-DTD-R-2004-10**  
**Interim Report**

## **CABLE GUARDRAIL**

**COLORADO DEPARTMENT OF TRANSPORTATION**  
**RESEARCH BRANCH**

## **Interim Report**

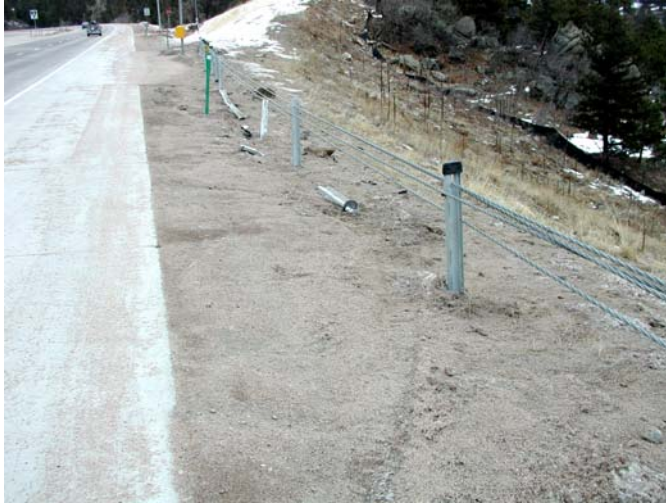
**Figure 1. The most severe hit on the Windy Point systems damaged only six posts.**

on US-285, Research was notified of four hits. Three of them were so minor that the impacting vehicles left without law enforcement being informed. One required replacement of 4 posts; the second, 2 posts; and the third, 3 posts. The fourth hit was more severe. It involved a CDOT engineer from Durango who credits the Brifen WRSF system with saving his life. This more severe accident required replacement of only 6 posts. None of the accidents required replacement or repair to anything other than posts and hardware such as cable locator pegs and post caps.

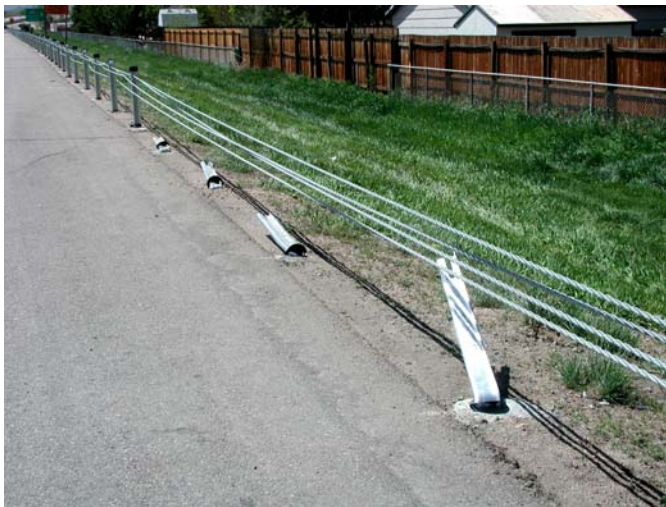
**Figure 2. Only four posts were bent in this drive-away accident on US-285 at Kipling.**

**US-285 at Kipling Parkway:** In early May of 2003, the system on southbound US-285 (**Figure 2**) was hit once requiring replacement of 4 posts. This appears to

have been another drive-away situation; there is no record of a report to law enforcement, and there have been no reports of any additional hits on the system.

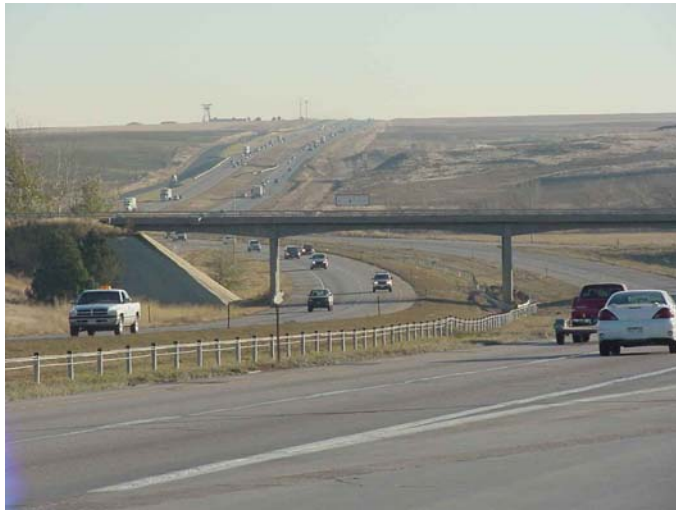
**Figure 3. The I-25 – SH-56 interchange, looking south.**

Three of the accidents occurred on the same day, November 22, 2003, in a period of about an hour, when the area was experiencing icy driving conditions. Two of the accidents were on the system north of SH-56 and one was to the south, beyond the overpass in **Figure 3**.

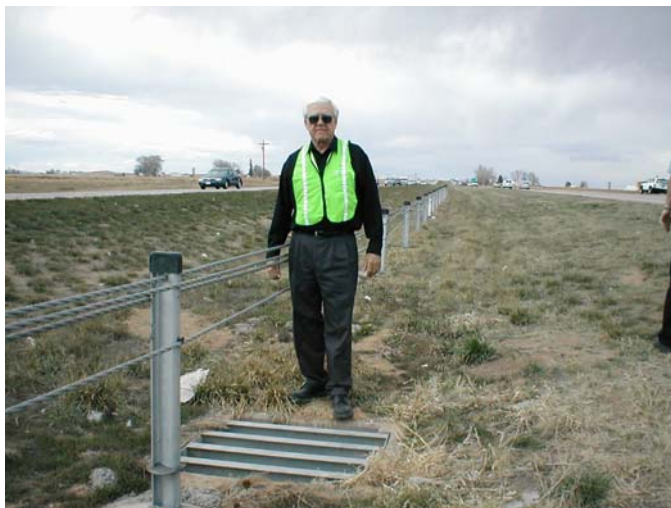
**Figure 4. The cables over this drain inlet are much farther off the ground than the design specification.**

According to the accident report, in addition to the side hit by the southbound vehicle, the Honda was damaged quite extensively on its top. It appears that the vehicle happened to penetrate the cable system at a drain inlet. The depression at the inlet appears to have allowed the vehicle to pass under the cables. The fact that, according to the accident report, there was considerable damage to the top of the vehicle, and that it did not roll, supports this theory. The accident report specifically mentions that there was no damage to the cables or support posts at the point of penetration.

**Figure 4** shows the height of the cables at the drain inlet where it is believed the Honda went under the cable guardrail. About eight inches above the bottom of the post in the foreground there is a flange that is designed to keep debris out of the post socket – that flange should be at ground level. The tension of the woven cables is actually holding the post up partially out of the socket. On the near side of the post the cable can be seen below the locator peg. Normally the lowest cable should be 20 inches above the ground. Because of the depression around the inlet drain in the picture it is considerably higher – enough higher that the Honda mentioned above was able to pass under the entire system. A solution for this problem is discussed in the Recommendations section of this report.

From a design and construction standpoint, correct cable height along outside shoulders is usually easy to establish due to the constant slope of the shoulders. Correct cable height can be more easily established in median installations by running the cable guardrail system a set distance from the shoulder line of one side of the highway, rather than down the center of the median. (Brifen USA recommends 18 feet offset from the shoulder stripe if the median is wide enough, which should accommodate mowing operations. ) By putting the cable in an area where the slope does not vary up and down in short distances, it is easier to maintain a uniform height for the cables above the surface thus preventing high or low areas where the barrier can be more easily under- or over-driven. A barrier that follows the smooth curves of the highway is also more aesthetically pleasing than one in the center of the median that has to wander from side to side to avoid passing directly over depressions at drain inlets.
