**Report No. CDOT-DTD-R-2003-7  
Final Report**

# **EXTENT OF TOP-DOWN CRACKING IN COLORADO**

**Donna Harmelink, P.E. CDOT Research Branch  
Tim Aschenbrener, P.E. CDOT Materials and Geotechnical Branch**

**July 2003**

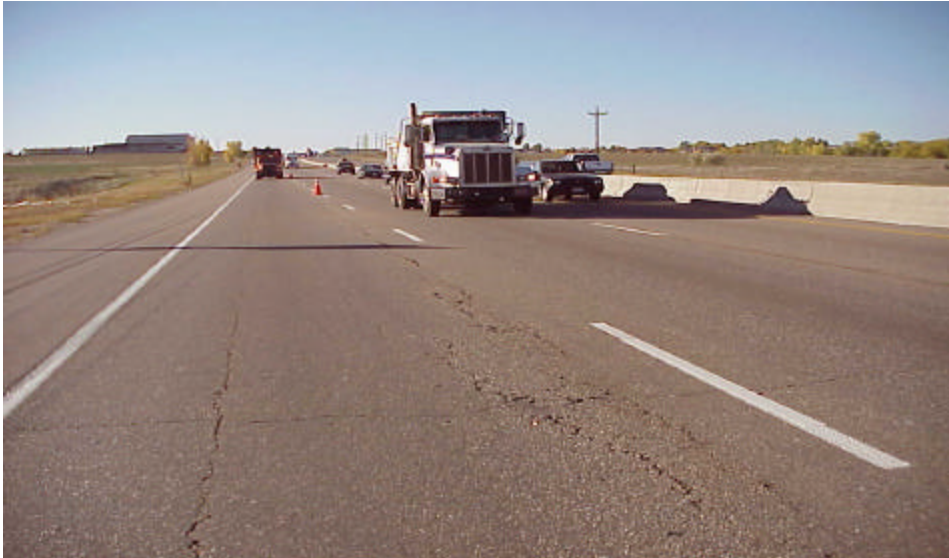
**Figure 1. Longitudinal cracking was found on this project as shown in this photograph. This cracking pattern was consistent throughout the entire length of the project.**

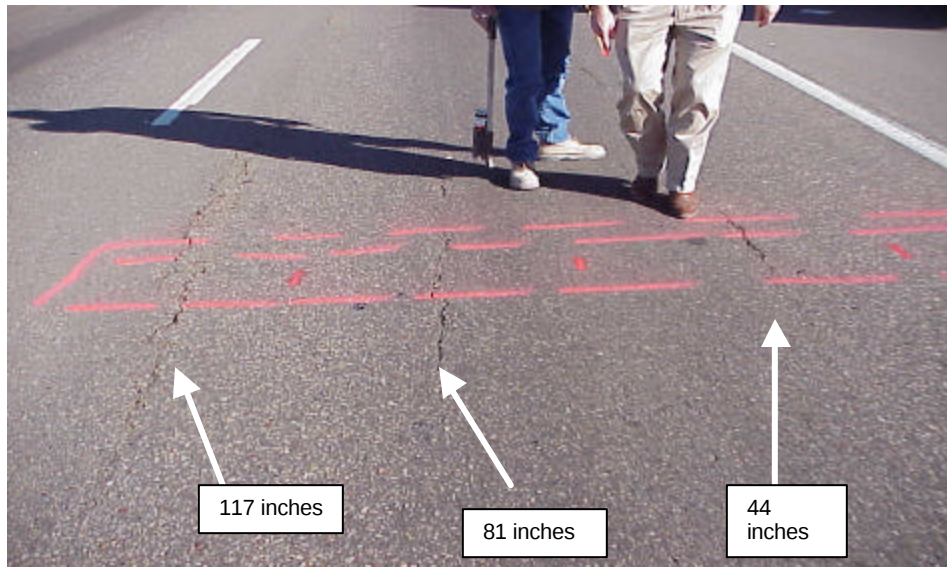
**Figure 2. This photograph shows the location of each crack with respect to the other cracks. The distance is measured from the outside shoulder stripe.**

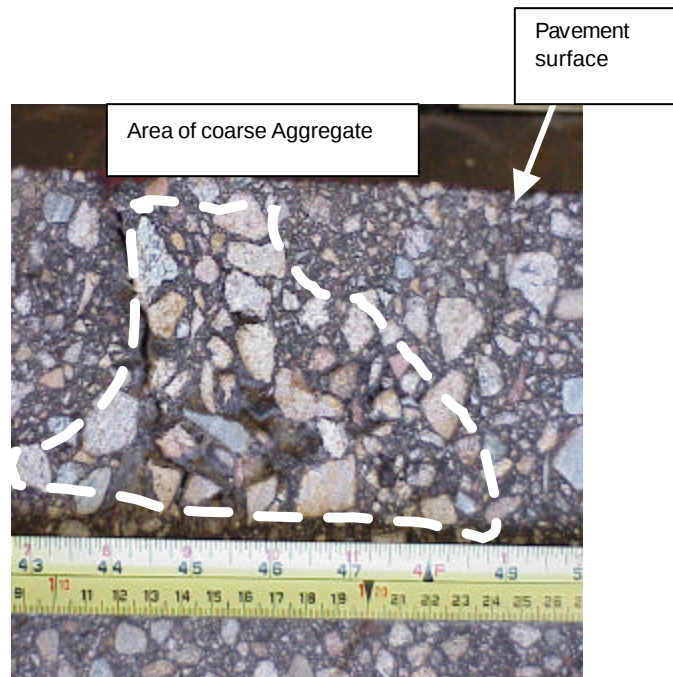
**Figure 3. There was segregation present within the mat at each of the cracks. The segregation was particularly severe at the 44-inch crack.**

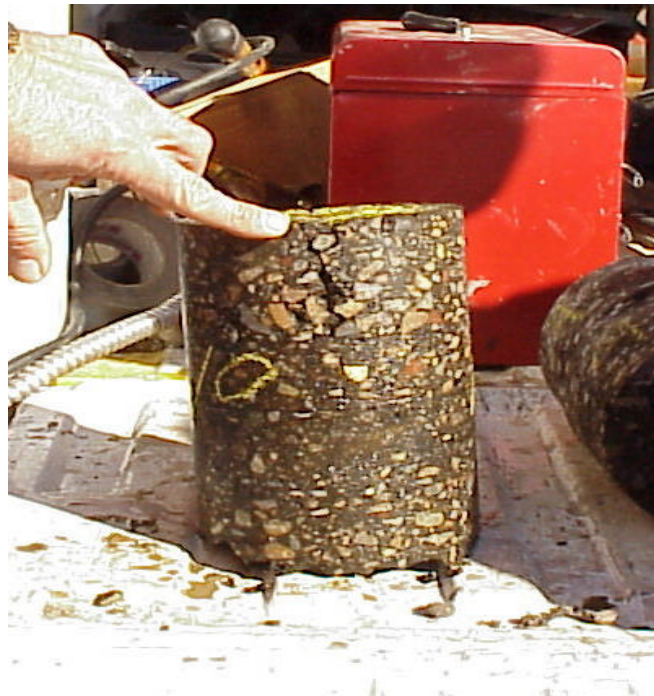
**Figure 7. This crack is top-down as you can see it is only visible in the top lift**

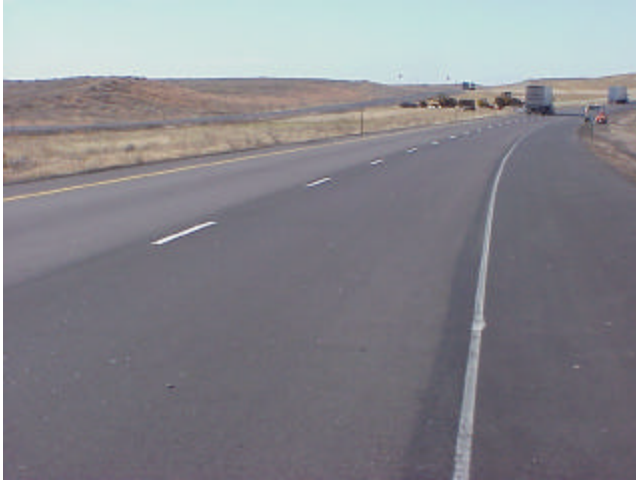
**Figure 10. This photograph shows the project shortly after construction. Segregation on the surface was not apparent.**

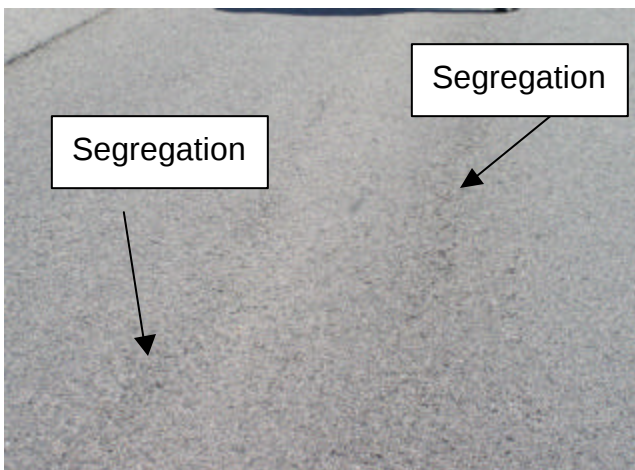
**Figure 11. This photograph was taken 4 years after construction. There are two areas where segregation has begun to appear.**

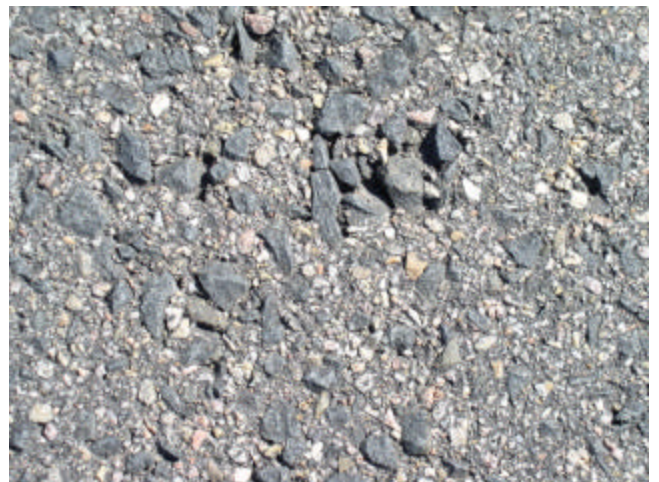
**Figure 12. This is a close-up of the segregated area in Figure 11.**

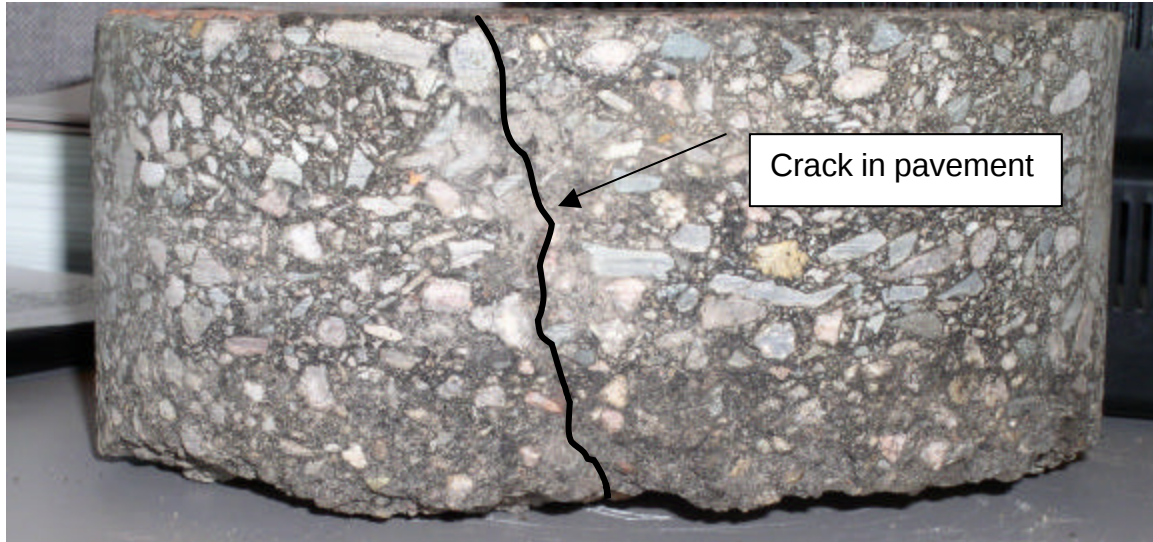
Figure 13 shows a photograph of a core taken from another project that has exhibited top-down cracking. This core was taken centered over the top-down crack. As you can see in the photograph, it is apparent that around the cracked area there are less fines than in the non-cracked area of the core.

**Figure 13. Photograph of core taken over a top-down crack. This crack was only found in the top mat; it was not apparent in the lower mat. Although it is not well defined it does appear that the material around the crack is coarser than the material on either side of the crack.**

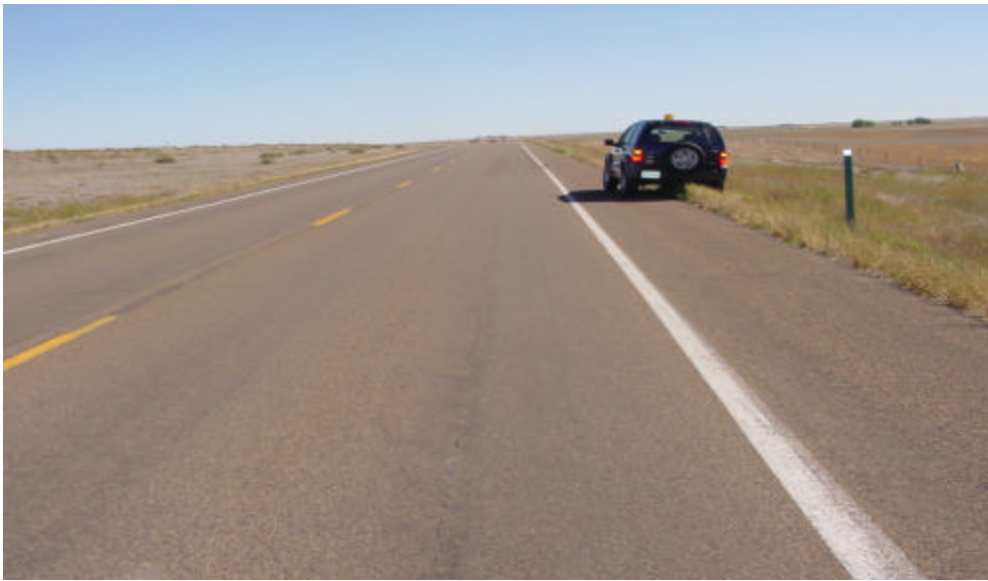
**Figure 14. This distress was a reflective crack. Note the linear straightness and low severity of the crack.**

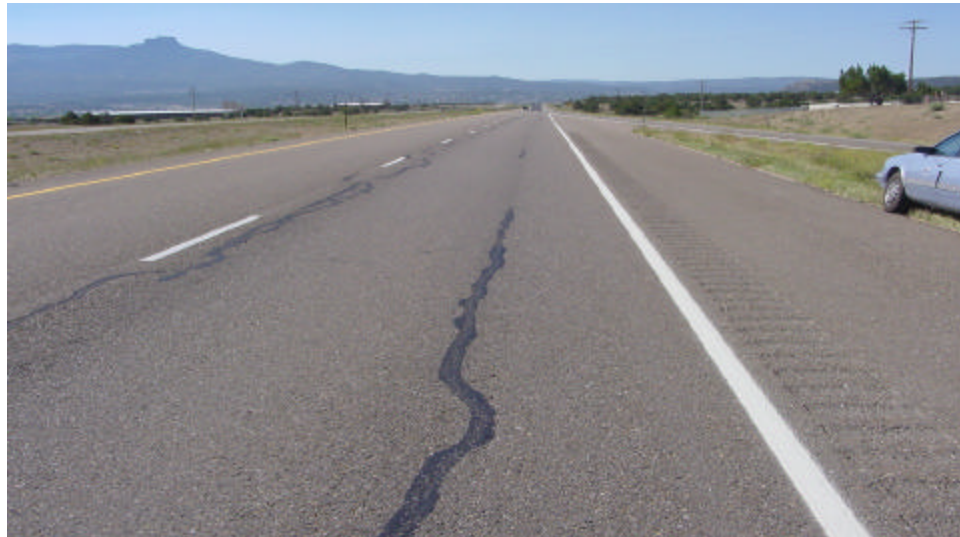
**Figure 15. This crack was top-down. Although the crack is straight, the severity was enough to warrant crack sealing.**

Since approximately 67% of the top-down cracking cores had visual signs of segregation, it is recommended that the cracks be sealed as soon as possible. If moisture is allowed into the pavement through the cracks the segregated areas

will be prone to rapid deterioration. Sealing the crack will prevent moisture from penetrating the pavement and deteriorating the pavement further.

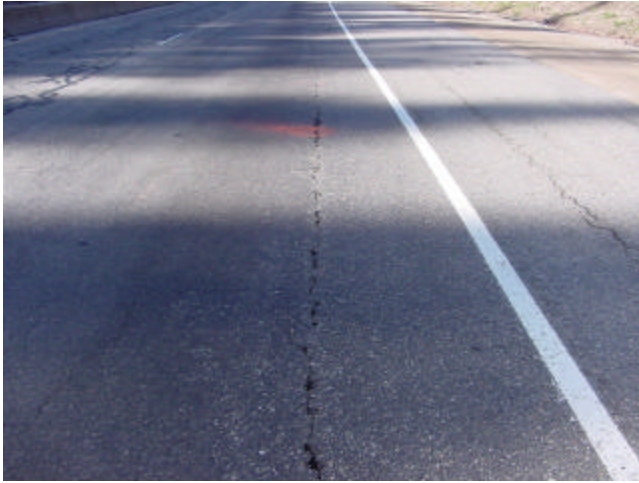
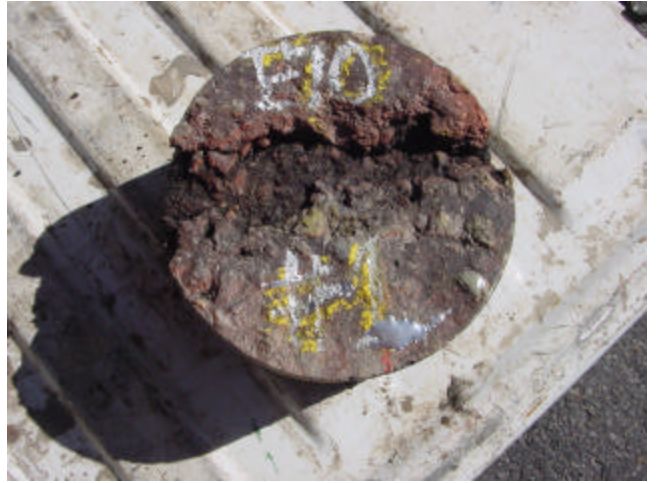
Site 1 (I-70, MP 185.7, Vail Pass)

| Site Number | Location | Visible Segregation | Core | Percent on No. 4 | Percent on No. 8 |
|---|---|---|---|---|---|
| 1 | I-70 EB Driving Lane, M.P. 185.7 (Region 1) | Yes | Cracked | 61 | 43 |

Top-Down Cracking

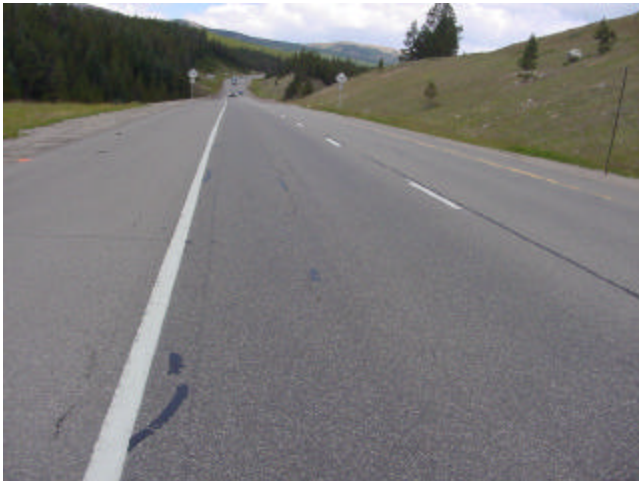
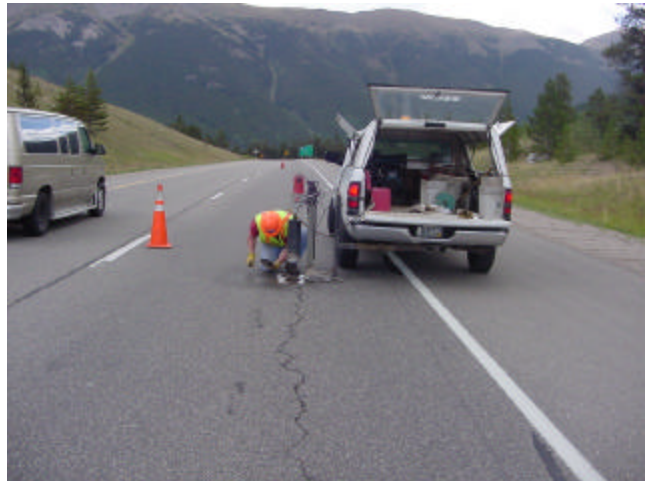
Site 2 (I-70, MP 193.8 – W. of Copper Mtn)

| Site Number | Location | Visible Segregation | Core | Percent on No. 4 | Percent on No. 8 |
|---|---|---|---|---|---|
| 2 | I-70 EB Driving Lane, M.P. 193.8 | Yes | Cracked | 45 | 34 |

Top-Down Cracking

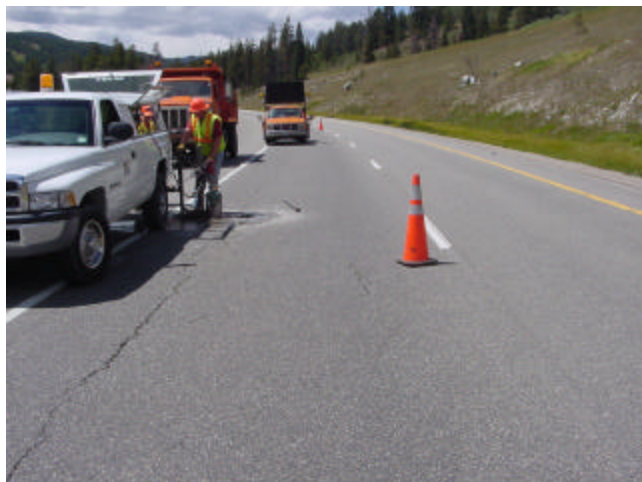
Site 3 (I-70, MP 194.3 W. of Copper Mtn)

| Site Number | Location | Visible Segregation | Core | Percent on No. 4 | Percent on No. 8 |
|---|---|---|---|---|---|
| 3 | I-70 EB Driving Lane, M.P. 194.3 | Yes | Cracked | 48 | 36 |

Top-Down Cracking

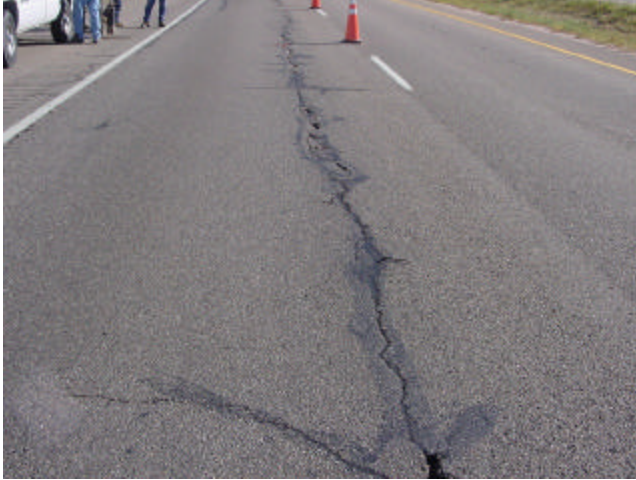
Site 5 (I-25, MP 75.3, Colorado City)

Reflective Cracking

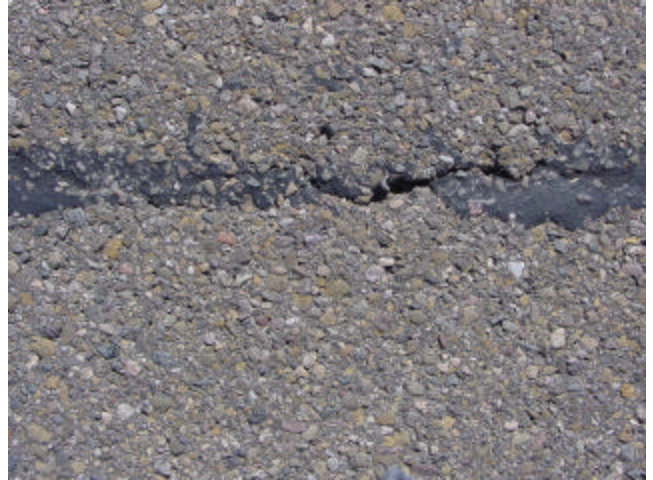
Site 6 (I-25, MP 17.6, N. of Trinidad)

| Site Number | Location | Visible Segregation | Core | Percent on No. 4 | Percent on No. 8 |
|---|---|---|---|---|---|
| 6 | I-25 Driving Lane, M.P. 17.6 | No | Cracked | 57 | 41 |

Top-Down Cracking

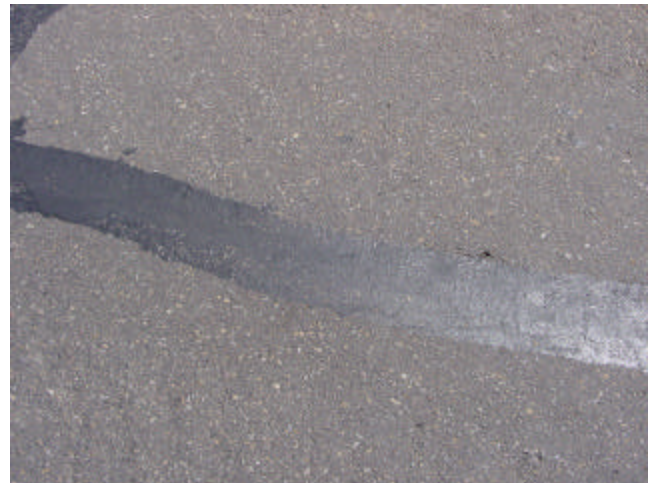
Site 7 (I-25, MP 11.7, S. of Trinidad)

Reflective Cracking

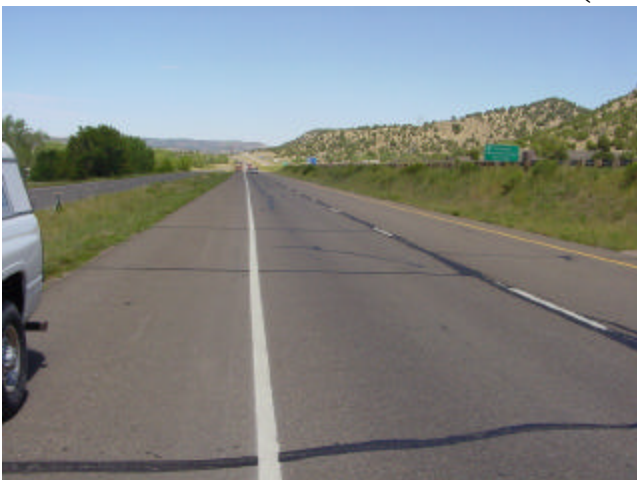
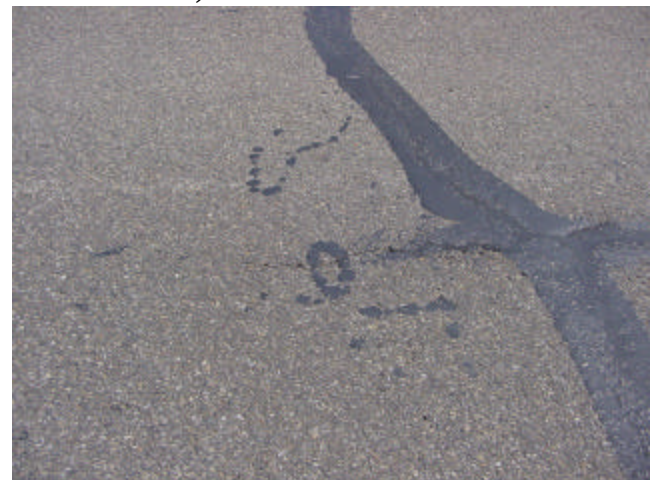
Site 8 (I-25, MP 9.2 Raton Pass)

Reflective Cracking

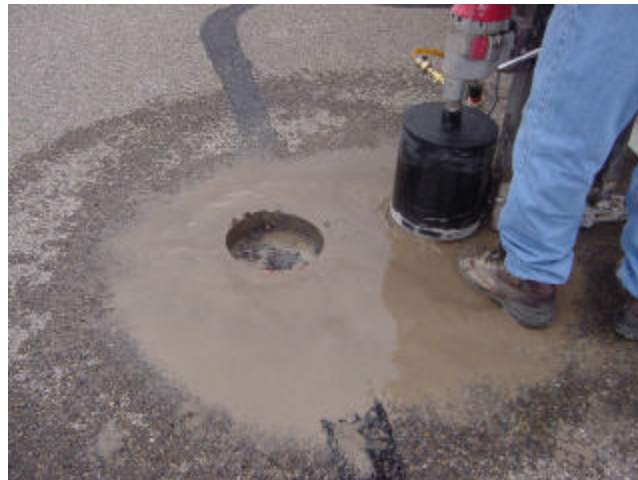
Site 12 (US 285, MP 96.5 – Saquache)

| Site Number | Location | Visible Segregation | Core | Percent on No. 4 | Percent on No. 8 |
|---|---|---|---|---|---|
| 12 | US 285, SB, M.P. 96.5 (Saquache) | No | Cracked | 52 | 36 |

Top-Down Cracking

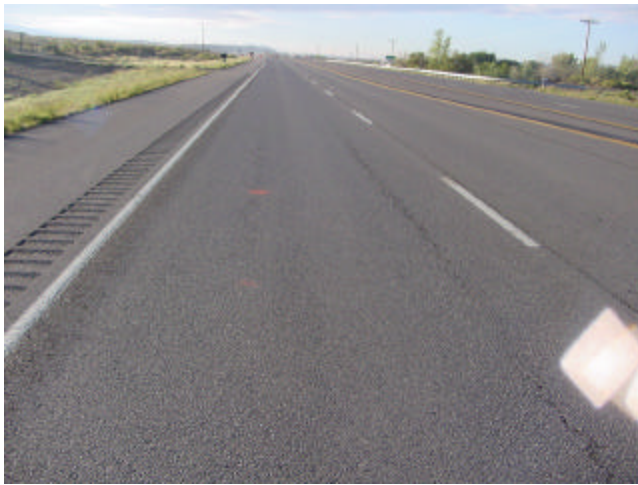
Site 13 (US 50, MP 41.2 – Red Mountain)

| Site Number | Location | Visible Segregation | Core | Percent on No. 4 | Percent on No. 8 |
|---|---|---|---|---|---|
| 13 | US 50, NB Driving Lane, MP 41.2 (Red Mountain) | No | Cracked | 42 | 29 |

Top-Down Cracking

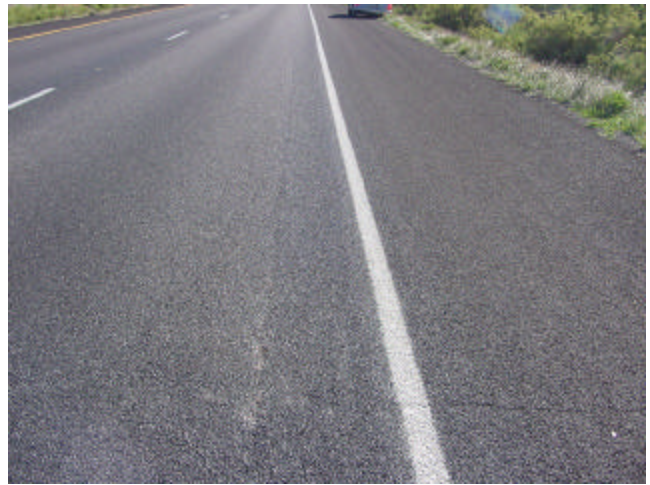
Site 14 (I-70, MP 38.2- Clifton)

| Site Number | Location | Visible Segregation | Core | Percent on No. 4 | Percent on No. 8 |
|---|---|---|---|---|---|
| 14 | I-70, EB M.P. 38.2 (Clifton) | Yes | Cracked | 56 | 42 |

Top-Down Cracking

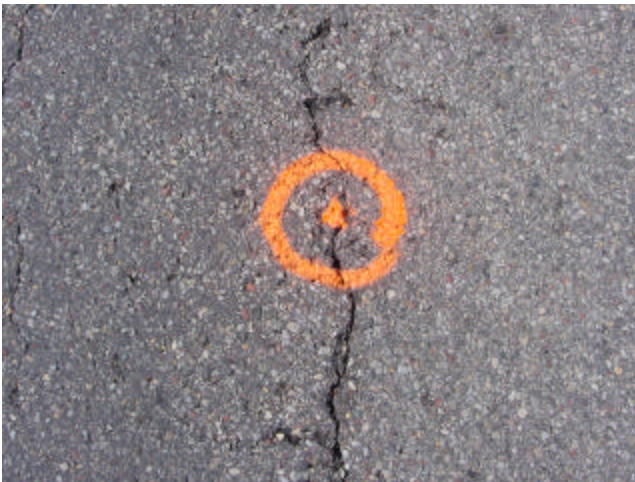
Site 15 (I-70, MP 64.0 – DeBeque)

| Site Number | Location | Visible Segregation | Core | Percent on No. 4 | Percent on No. 8 |
|---|---|---|---|---|---|
| 15 | I-70, EB M.P. 64.0, Driving lane (DeBeque) | Yes | Cracked | 58 | 45 |

Top-Down Cracking

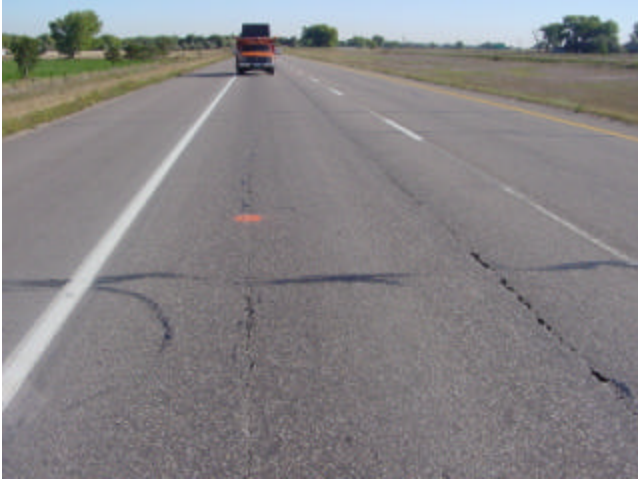
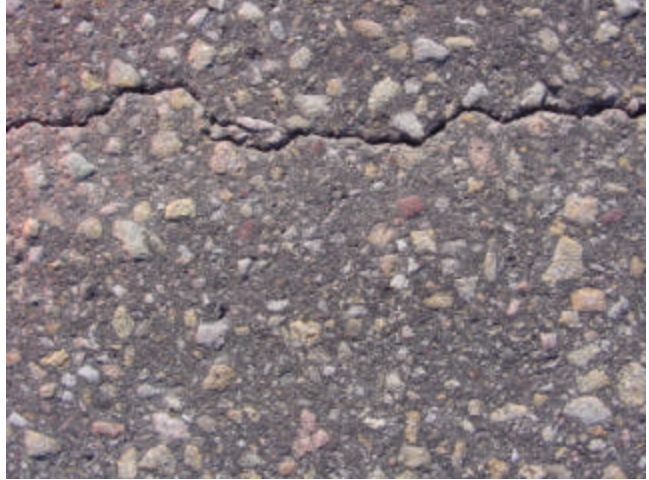
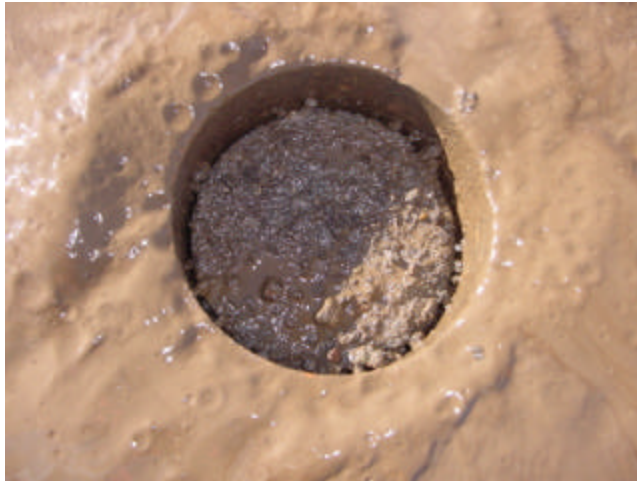
Site 17 (SH 119, MP51.7 – Longmont)

| Site Number | Location | Visible Segregation | Core | Percent on No. 4 | Percent on No. 8 |
|---|---|---|---|---|---|
| 17 | SH 119, SB Driving Lane; M.P. 51.7 (Longmont) | Yes | Cracked | 53 | 41 |

Top-Down Cracking

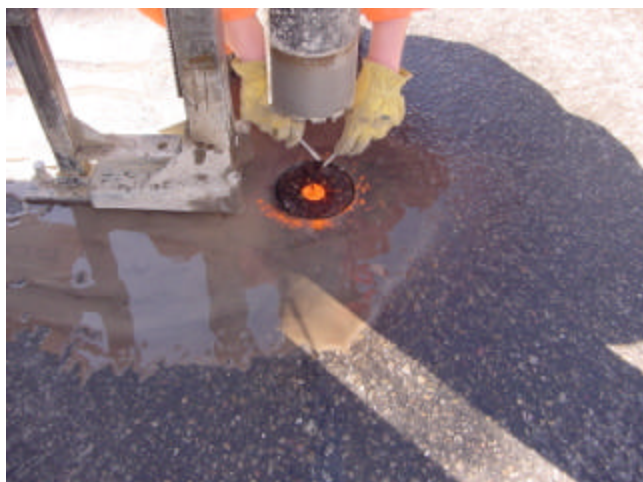
Site 18 (US287, N. of 9<sup>th</sup> Street, Longmont)

| Site Number | Location | Visible Segregation | Core | Percent on No. 4 | Percent on No. 8 |
|---|---|---|---|---|---|
| 18 | US 287, NB Driving Lane, (north of 9 <sup>th</sup> Street) | No | Cracked | 58 | 47 |

Top-Down Cracking

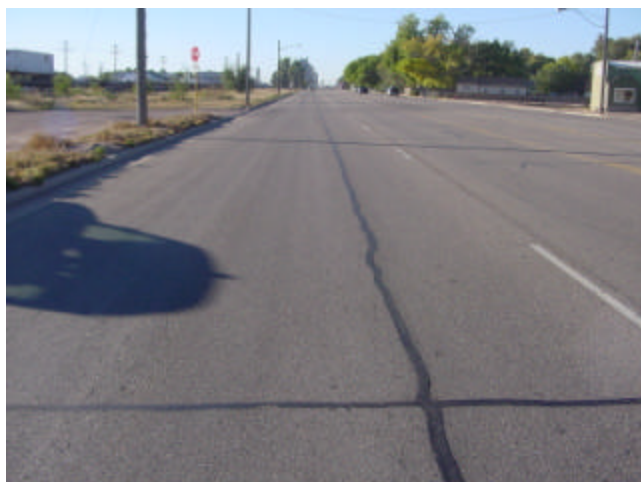
Site 19 (US 85, MP 280.2 – Ault)

| Site Number | Location | Visible Segregation | Core | Percent on No. 4 | Percent on No. 8 |
|---|---|---|---|---|---|
| 19 | US 85, MP 280.2, NB, Driving Lane (North of Ault) | Yes | Cracked | 53 | 38 |

Top-Down Cracking

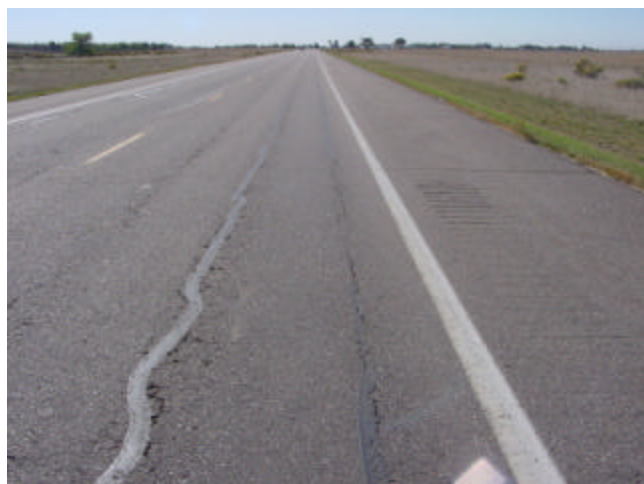
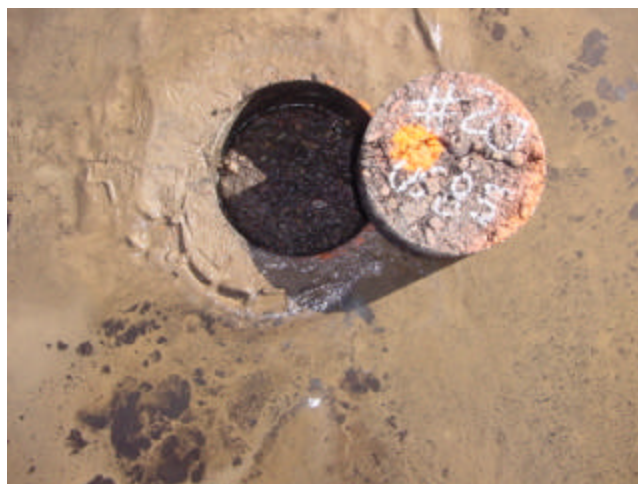
Site 20 (US 85, MP 290.2 – Nunn)

| Site Number | Location | Visible Segregation | Core | Percent on No. 4 | Percent on No. 8 |
|---|---|---|---|---|---|
| 20 | US 85, M.P. 292.2, SB (Nunn) | Yes | Cracked | 57 | 40 |

Top-Down Cracking

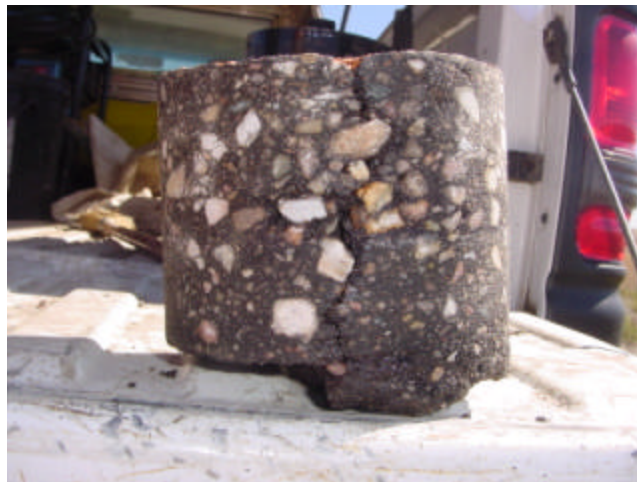
Site 21 (SH114, MP 198.8 – E. of Buckingham)

Reflective Cracking

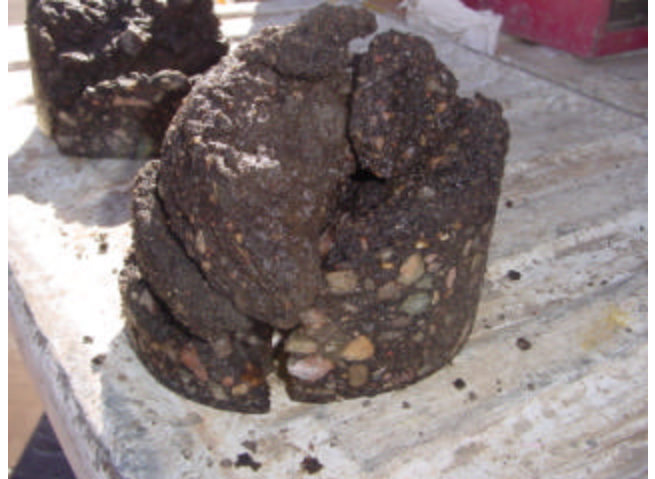
Site 22 (US 385, MP 253.3 – N of Wray)

Reflective Cracking

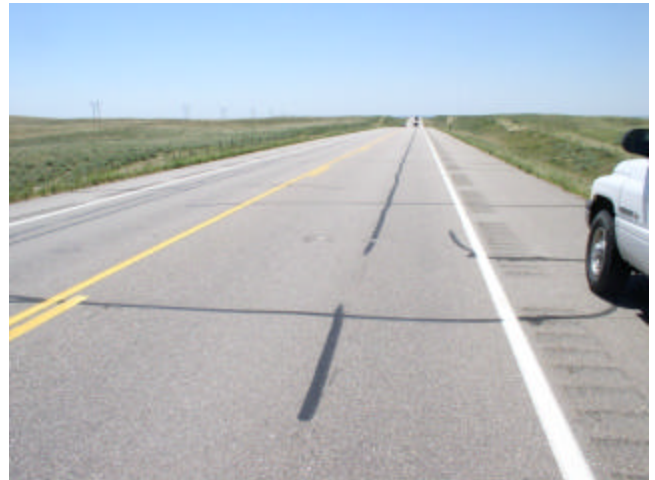
Site 24 (US6, WB, MP 409.2, (Sterling))

Reflective Cracking

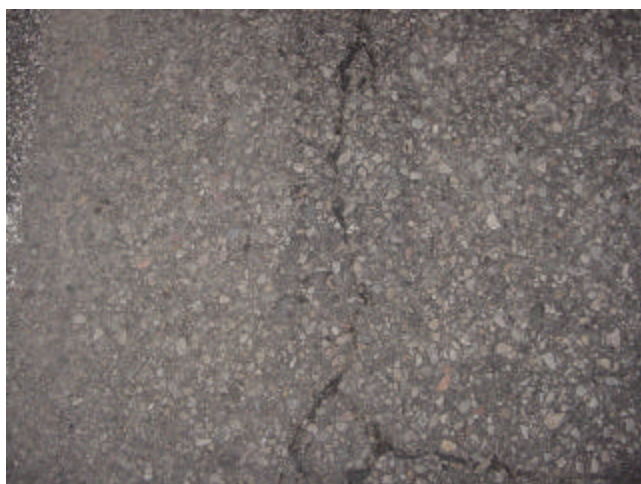
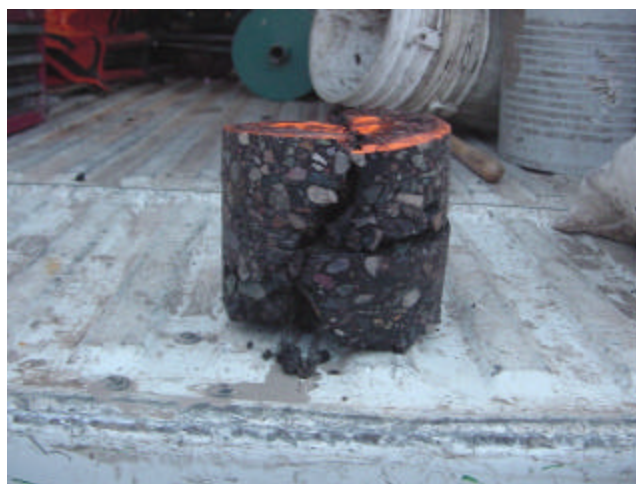
Site 10 (US160, MP87.7, Jct US550 in Durango)

Reflective Cracking

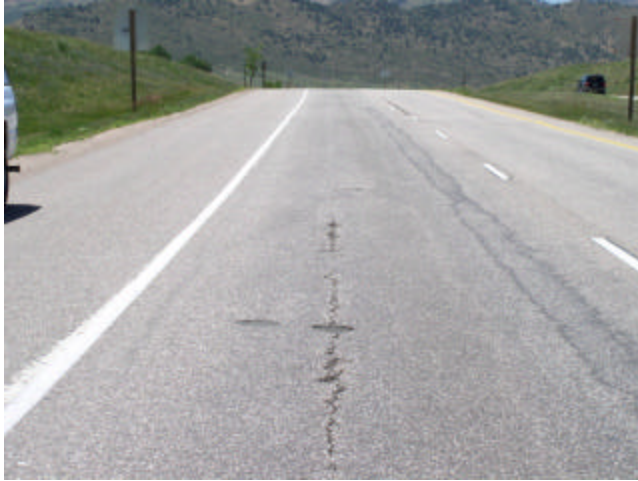
Site 25 (US 285, NB MP 251.3)

Top-Down Cracking

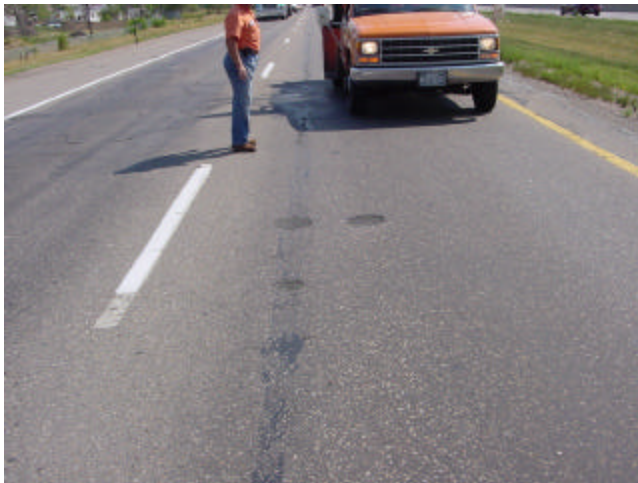
Site 27 ( I-76, WB Passing Lane; MP 1.3)

| Site Number | Location | Visible Segregation | Core | Percent on No. 4 | Percent on No. 8 |
|---|---|---|---|---|---|
| 27 | I-76, M.P. 1.2 – 1.3 | No | Cracked | 65 | 52 |

Top-Down Cracking
