DOT/FAA/CT-92/13

# Rotorcraft Ditchings and Water-Related Impacts that Occurred from 1982 to 1989 - Phase I

October 1993

Final Report

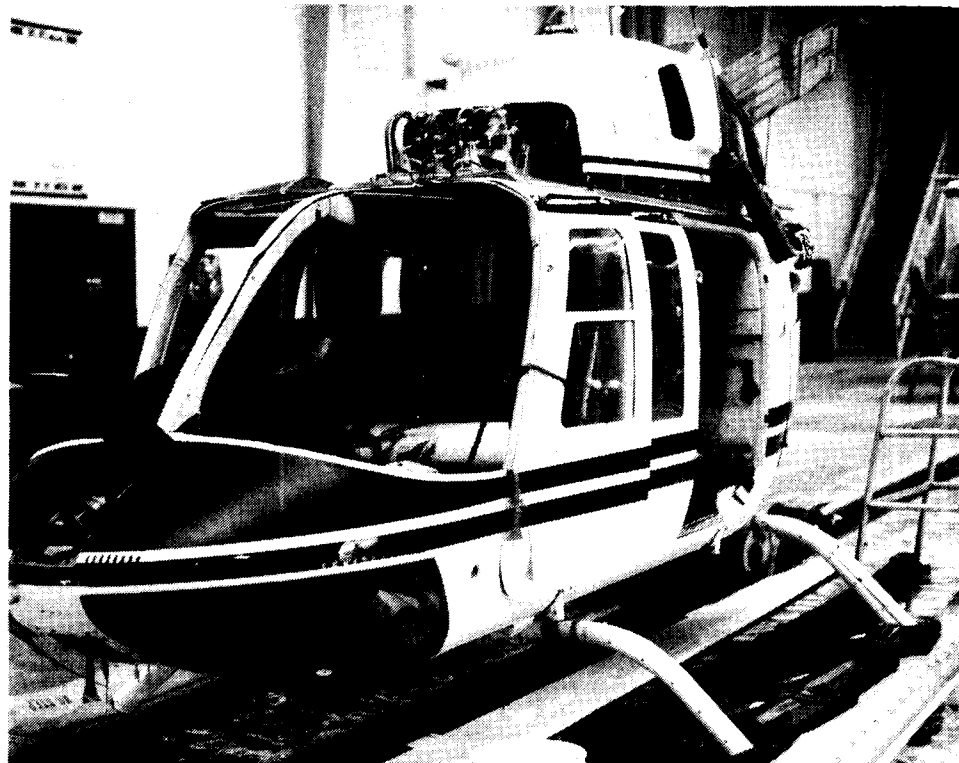
**Figure 8.2 Case Study 1, Left Front View of Aircraft**

- Airframe cracked three ft. forward of aft cross-tube (figure 8.3).
- Aft crosstube fairings crushed (figure 8.3).
- Cabin roof displaced three in. toward floor (figure 8.2).

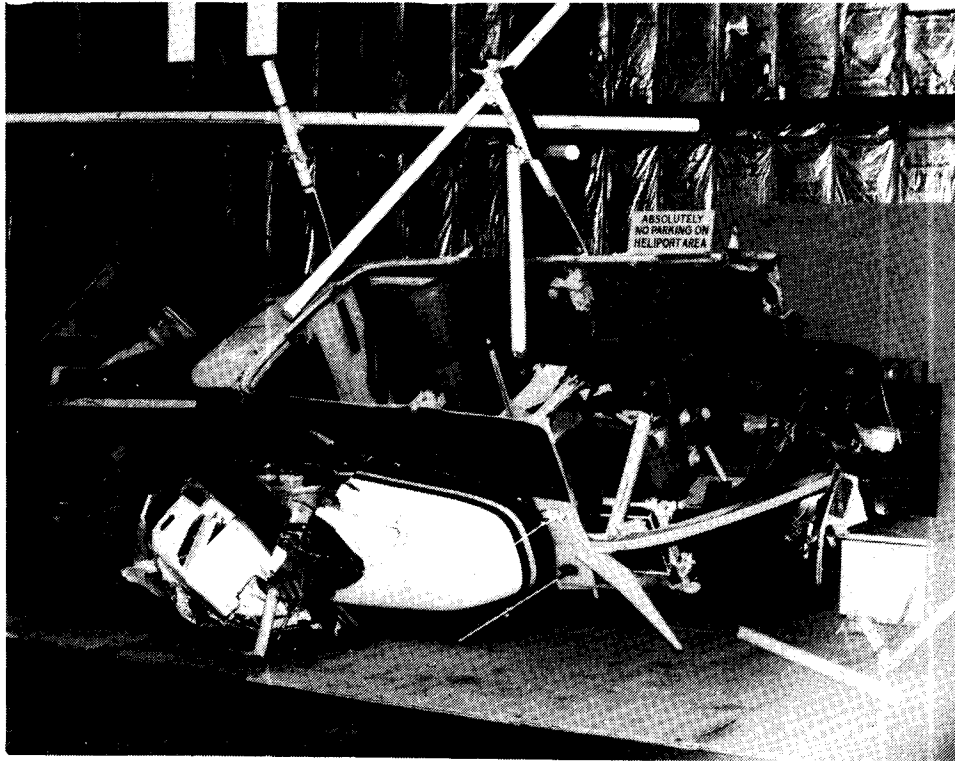
***Figure 8.4 Case Study 3, Top View of Aircraft***

- Both front chin bubbles and windshields destroyed (figure 8.4).
- Both front doors and posts torn away (figure 8.5).
- Left front seat and pedestal ripped out (figure 8.5).
- Tail boom broken off (figure 8.6).
- Main rotor blades and head assemblage broken off (figure 8.4).
- Transmission displaced forward and partially separated (split top of fuselage) (figure 8.4).
- Extensive damage to left side of cockpit and cabin and relatively minor damage to right side (figures 8.4, 8.7).

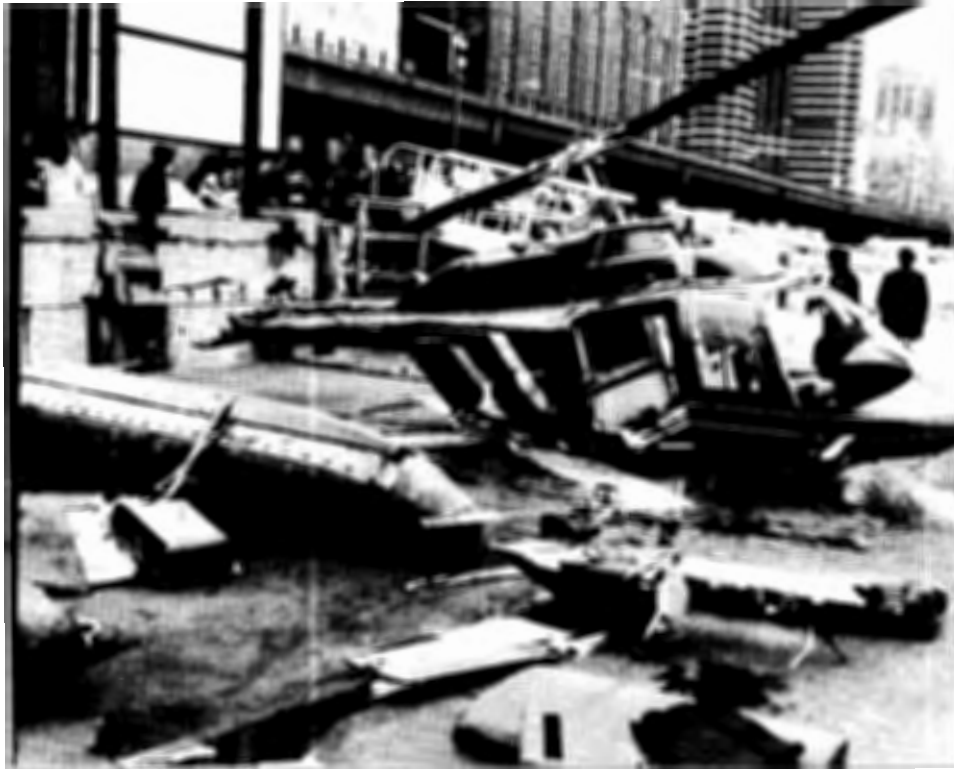
**Figure 8.8 Case Study 5, Right View of Salvaged Aircraft**

The floats were inflated at impact and then separated from the aircraft (figure 8.8).
