**Report No. CDOT-DTD-R-2003-5**

**CRACK REDUCTION STRATEGIES ON A  
PAVEMENT WARRANTY PROJECT  
(INTERSTATE 25 AT FOUNTAIN,  
COLORADO)**

**March 2003  
Final Report**

**COLORADO DEPARTMENT OF TRANSPORTATION  
RESEARCH BRANCH**

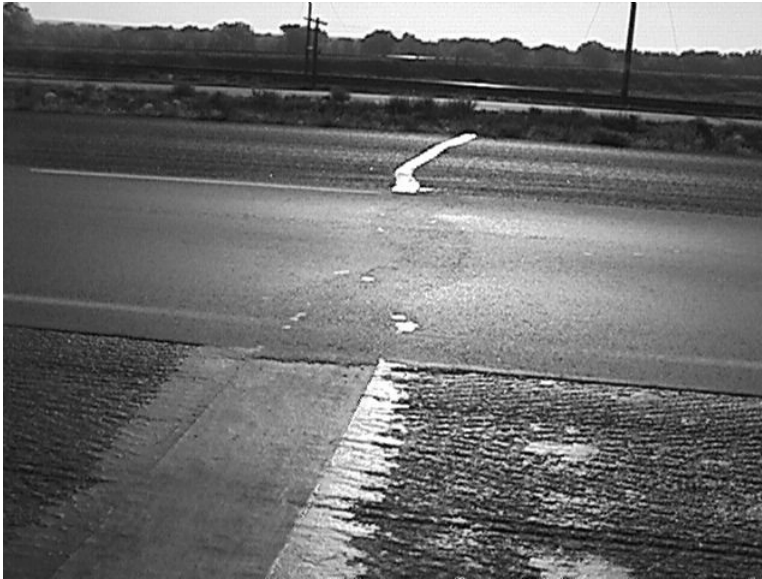
Shown in Figure 13 is a typical Petrotac treatment after the trenched section had been overlaid. The picture shows some of the excess tack material bleeding through the 1-1/2 inch overlay. The excessive tack was not apparent once the final lift was placed. Subsequent tack coat applications were reduced to ensure that the tack did not bleed through the mat and also to eliminate the shoving of the Petrotac fabric.

Figure 13 –Typical Petrotac treatment after the trenched section has been overlaid.

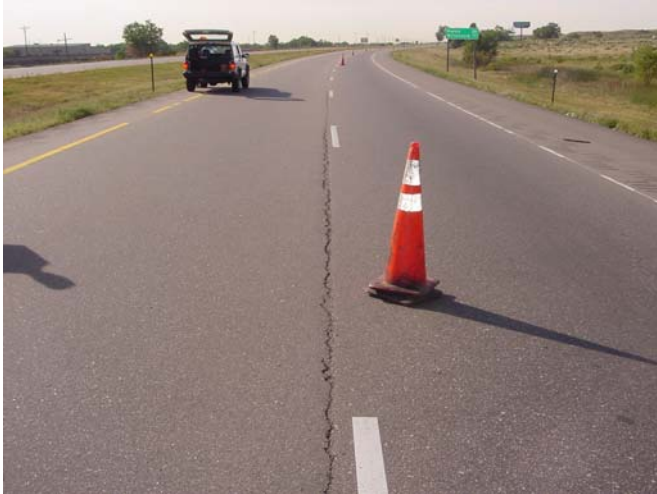
There was, however, an inordinate amount of longitudinal construction joint failure throughout the project, as validated by the Pavement Evaluation Panel (PET) after the end of the warranty period (3 years). The Principal Investigator of this report was present at the evaluation, and the series of photographs (Figures 14, 15, 16, 17, 18, 19, 20, 21, 22, and 23) will demonstrate this failure mode.

Figure 14 – Longitudinal construction joint failure at end of warranty period. Longitudinal crack is evident throughout most of the project.

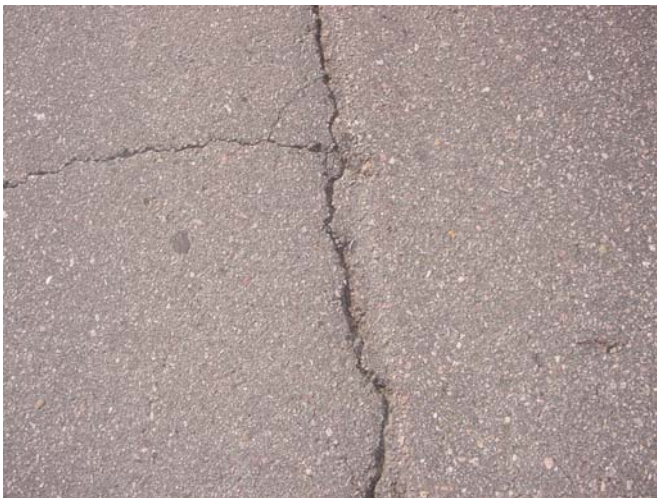
Figure 15 - Close-up view of a fairly open construction joint crack.

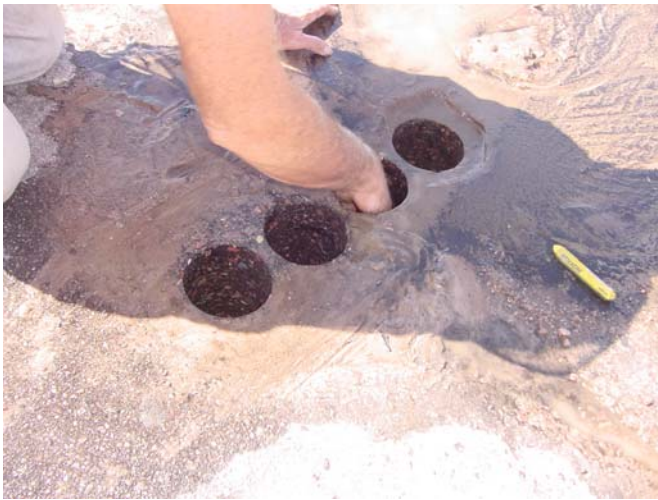
Figure 20 - In order to determine the lateral extent of stripping, additional cores were obtained at six-inch intervals transversely to the construction joint.

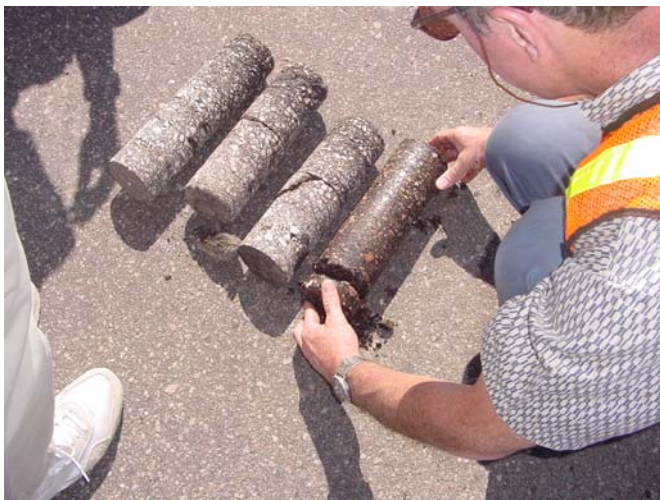
Figure 21 - It is apparent from this picture that the stripping occurs only immediately at the joint. Only the core sample right over the construction joint (right core) has evidence of stripping.

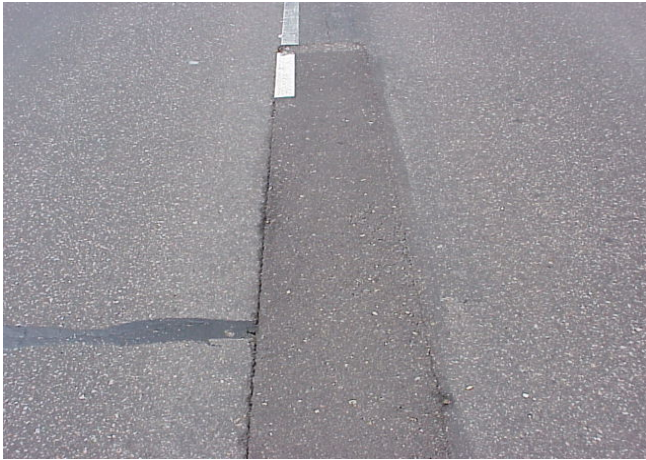
Figure 24 – This photo shows the initial longitudinal joint crack on the left. Then the contractor milled and filled one foot to the right of the crack. Eventually this pavement cracked on the edge of the 1-foot mill and fill, creating 2 cracks.

The recommendation of the PET led to a corrective project, consisting of milling approximately a one-foot-wide section along the construction joint and patching the milled area. Although such remedial action will prolong the life of this project for some time, the remedial action resulted in the replacement of one open joint with two well-sealed joints, which could ultimately exacerbate the problem (Figure 24).
