DOT/FAA/CT-93/1

# Vertical Drop Test of a Metro III Aircraft

June 1993

Final Report

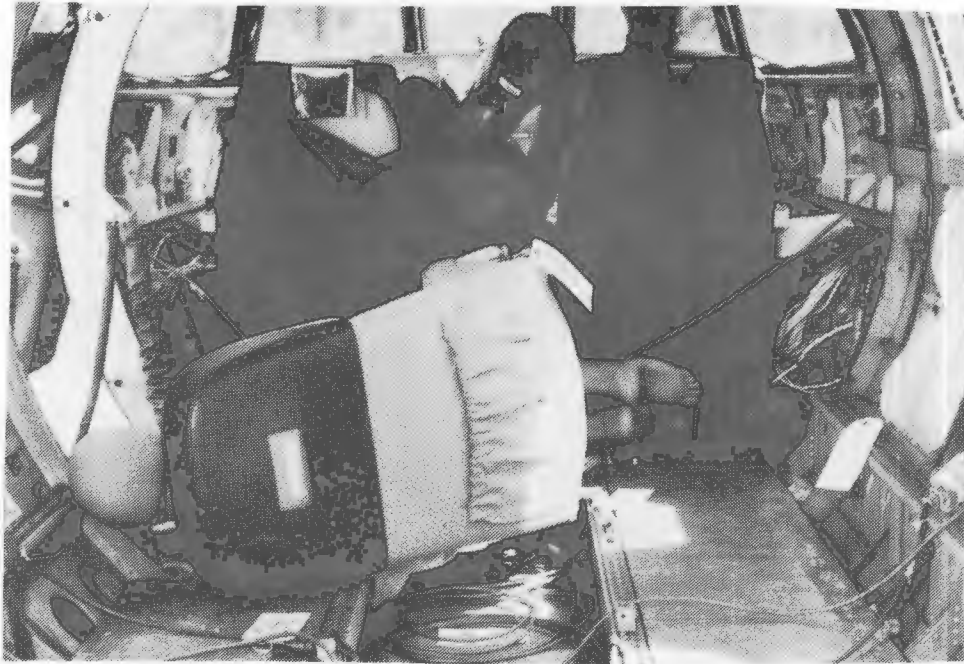
FIGURE 20. POST TEST SEAT 3

Figure 20 is a post-test view of seat 3. Figure 21 shows the damage to the inboard aft leg of seat 3, while figure 22 is a view of the seat track under seat 3.

**DAMAGE:** The seat frame broke on the inboard side under the seat cushion. A support tube on the inboard side was also broken.

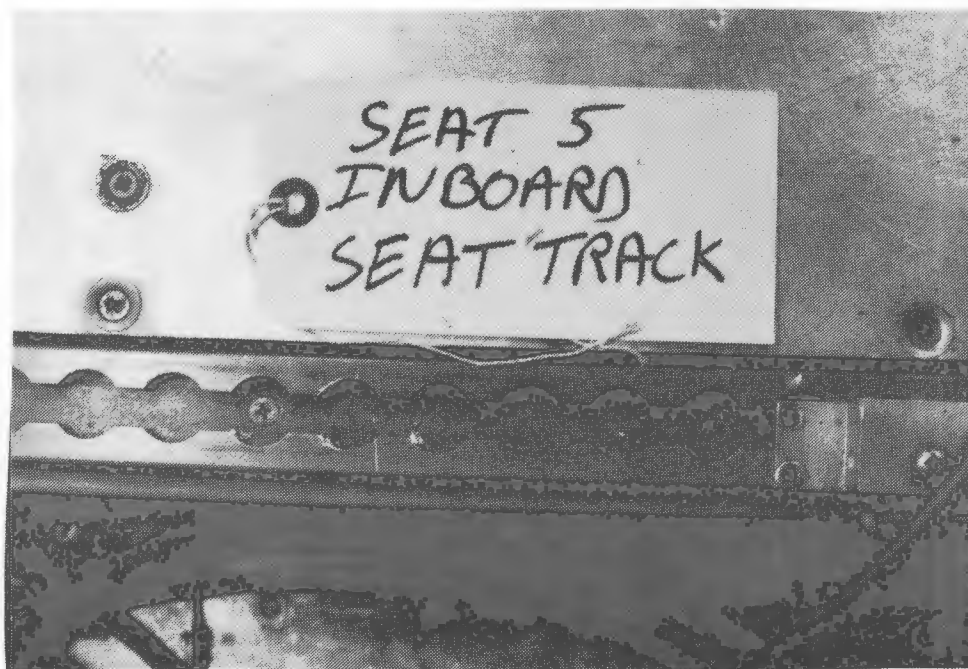
FIGURE 29. POST TEST SEAT TRACK, SEAT 5

Figure 26 is a post-test view of seat 5. Figures 27 and 28 show the inboard and outboard aft legs respectively, and figure 29 shows the damage to the seat track.

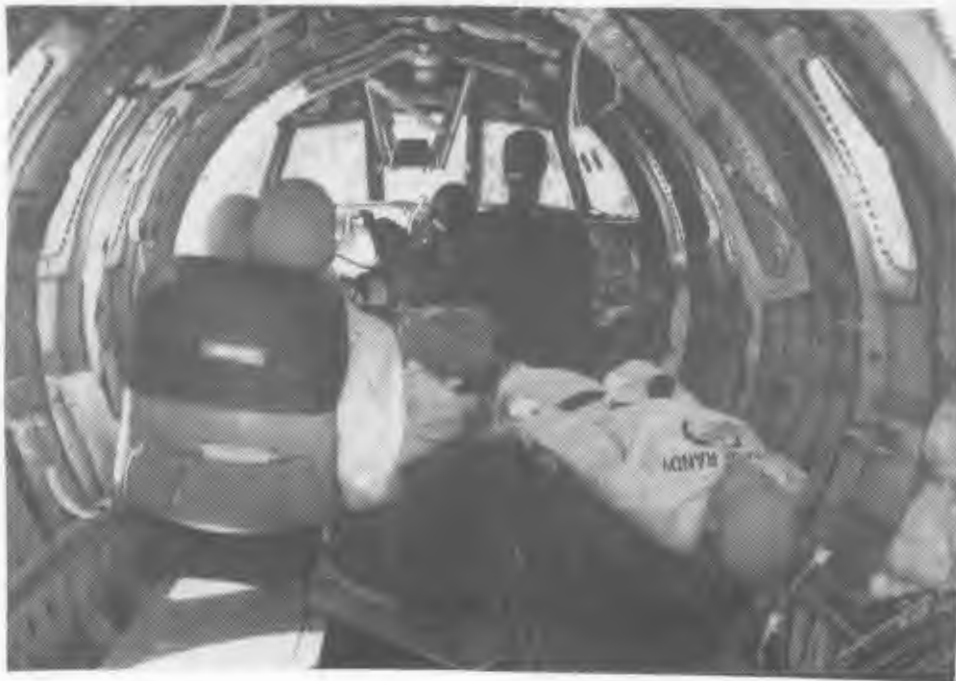
FIGURE 33. POST TEST SEAT 6 AND SEAT 7

Figure 33 shows seat 6 (on the left) and seat 7. Figure 34 shows the damage to the inboard aft leg of seat 7, and figure 35 shows the damage to the seat track under seat 7.

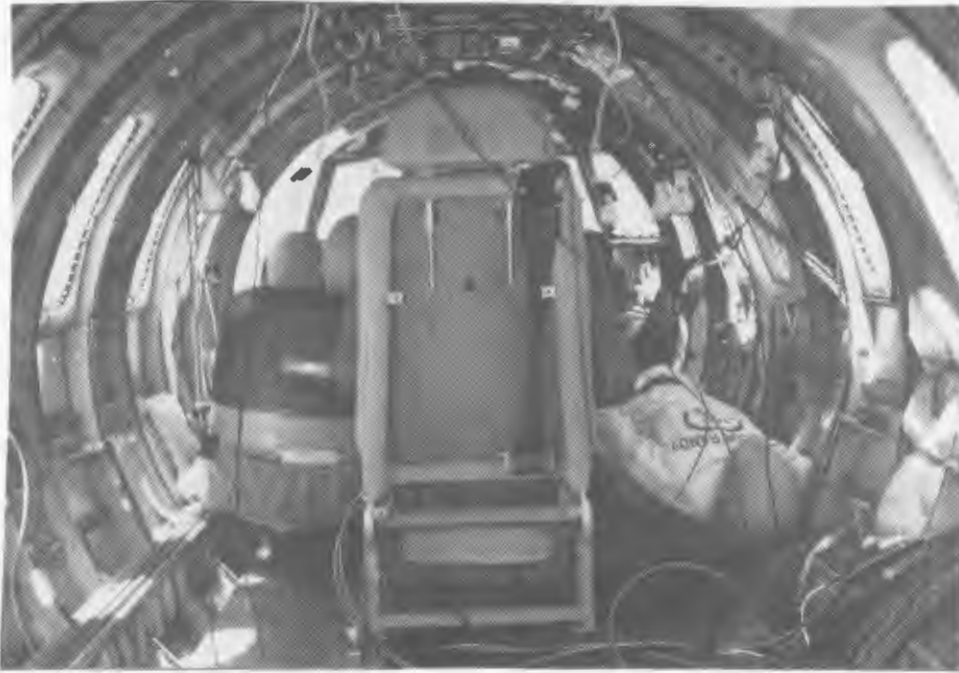
FIGURE 36. POST TEST SEAT 8, CAMI SEAT

Figure 36 is the rear view of the CAMI seat (seat 8) after the test. Figure 37 shows a closeup of the seat pan after the test; notice the deflection of the energy absorbing mechanism caused by the impact.

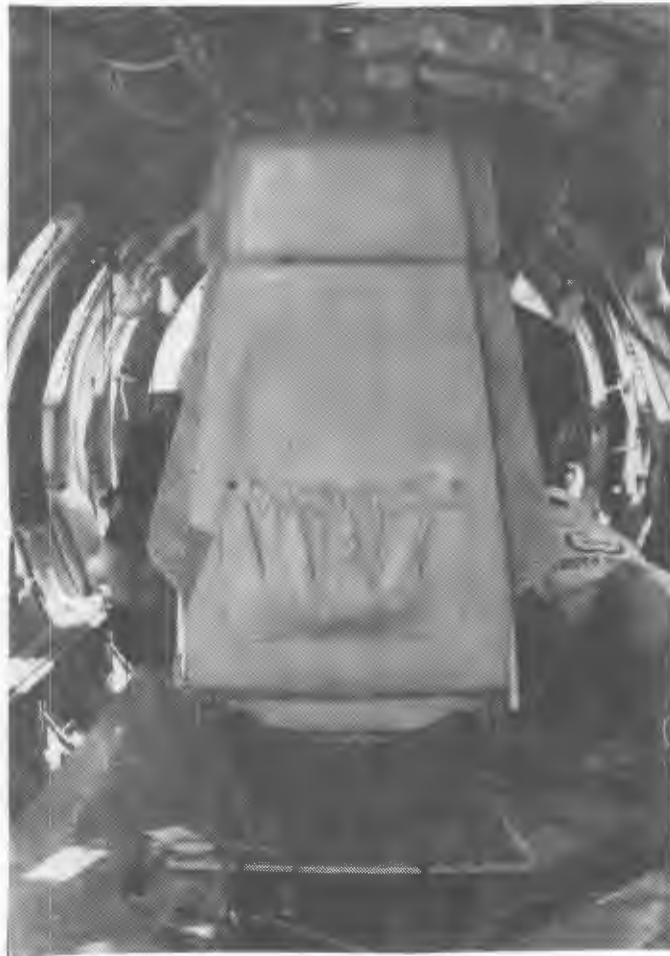
FIGURE 38. POST TEST SEAT 9, BEECHCRAFT SEAT

Figure 38 is a post-test view of the Beechcraft seat (seat 9), which had no visible damage.

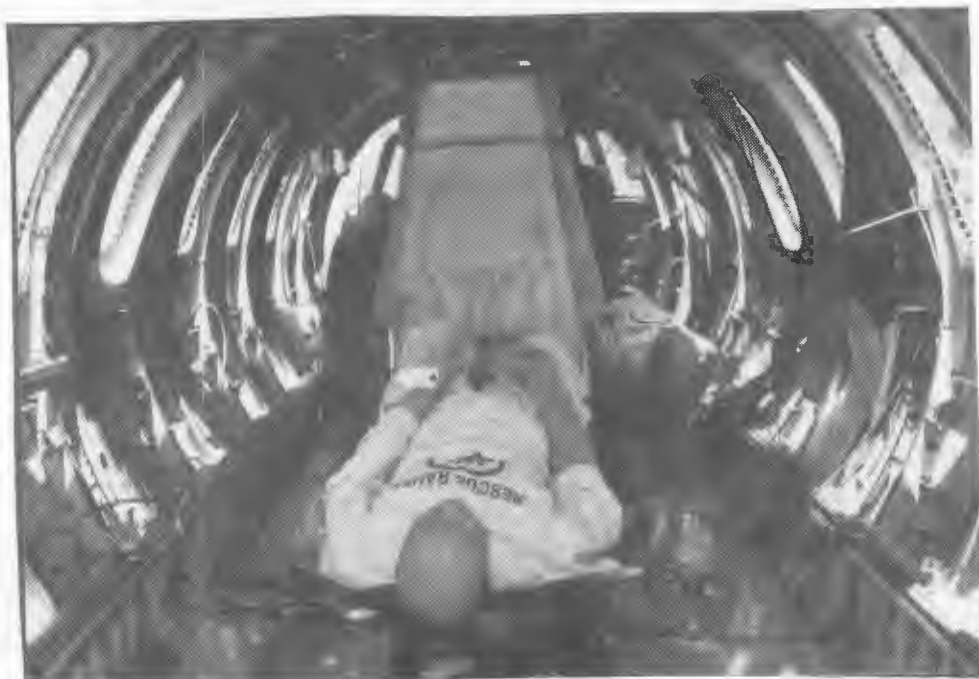
FIGURE 39. POST TEST SEAT 10, CENTER AISLE METRO SEAT

Figure 39 shows the center aisle Metro seat (seat 10) after the test. Figure 40 is a post-test view of seat 11, the stroking Metro seat; and figure 41 is a view of the broken seat back attachment on seat 11. Figure 42 shows the seat track under seat 11.

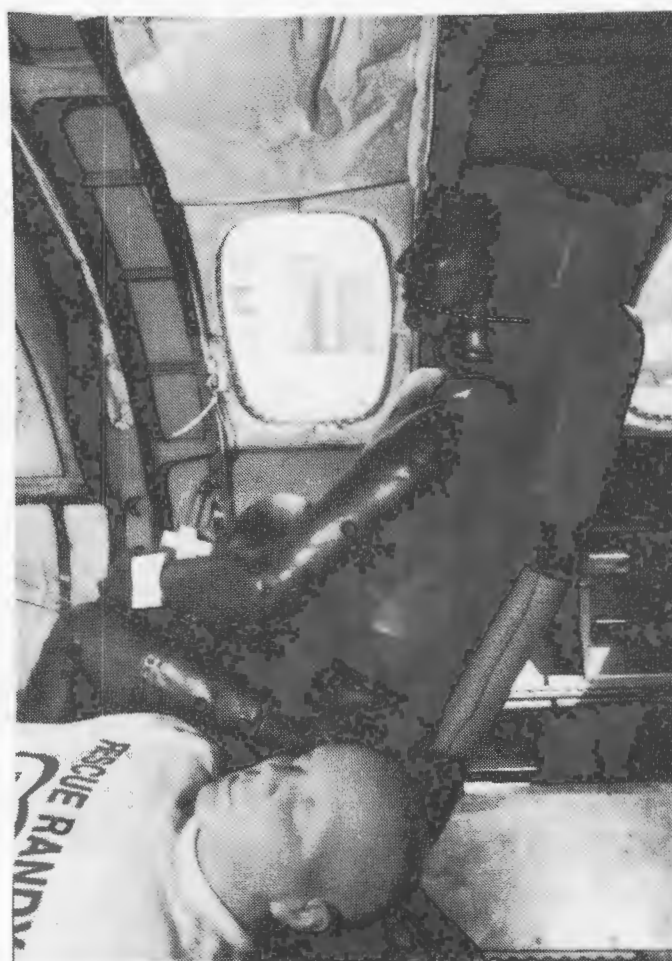
FIGURE 43. POST TEST SEAT 12

Figure 43 shows seat 12 after the test. Figure 44 shows the resulting damage on the inboard aft leg of seat 12.

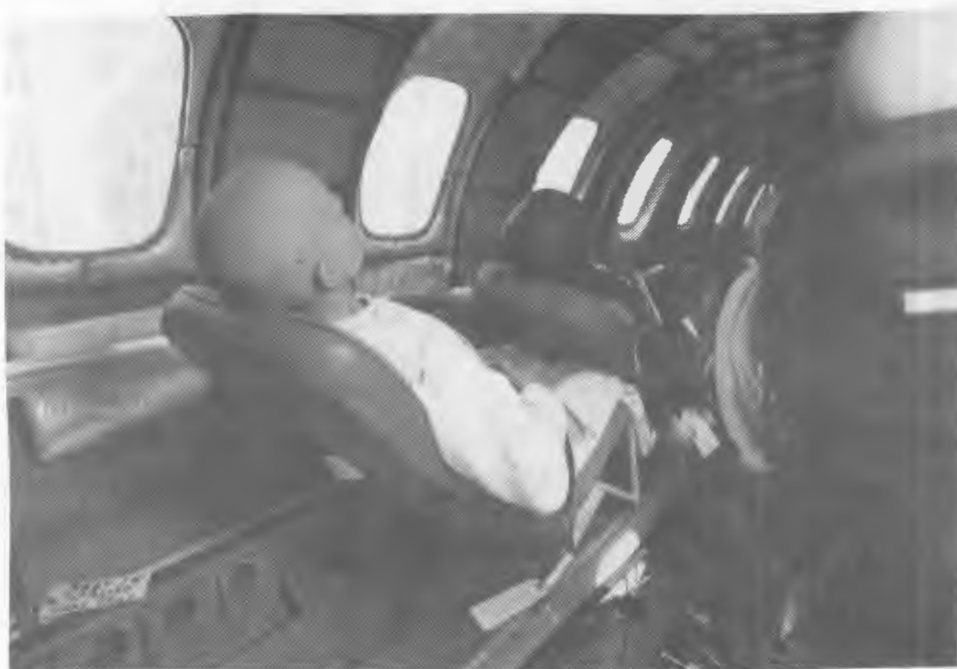
FIGURE 45. POST TEST SEAT 13

Figure 45 illustrates the damage incurred on seat 13 during the test. Figure 46 is a close-up of the inboard aft leg showing damage resulting from the impact.

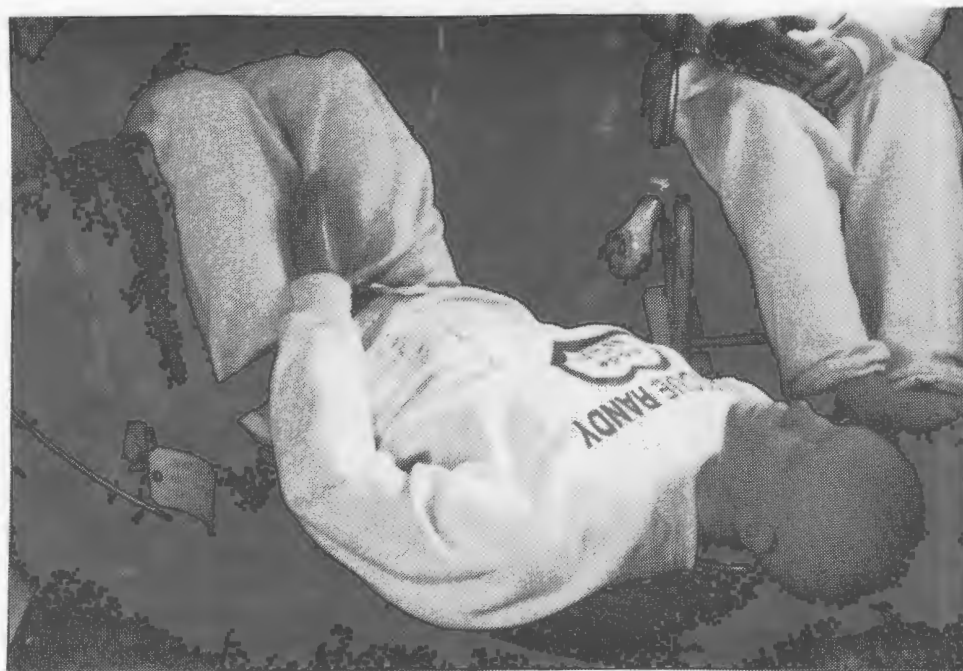
FIGURE 49. POST TEST SEAT 15 - 1

The damage to seat 15 can be seen from a variety of angles in figures 49, 50 and 51

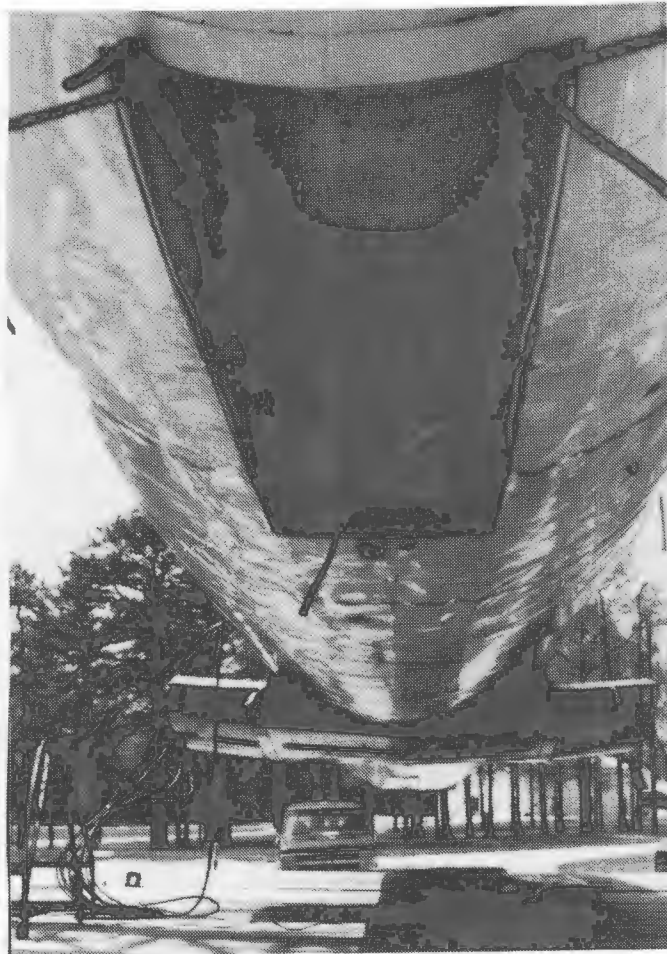
FIGURE 56. POST TEST UNDERSIDE FUSELAGE DAMAGE - 1

Figures 56, 57 and 58 show the damage to the underside of the aircraft caused by the drop test.

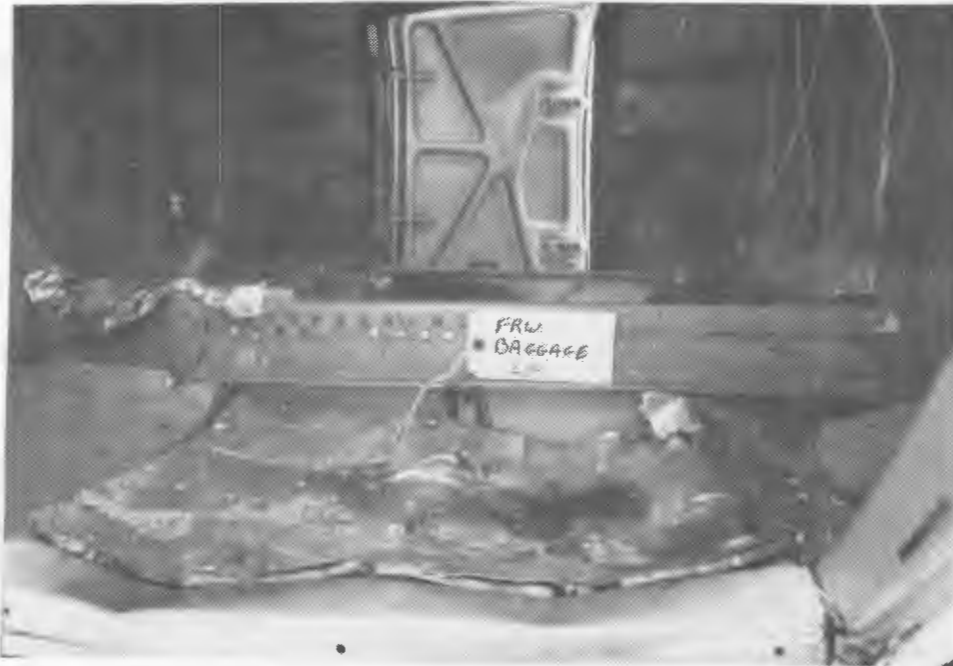
FIGURE 59. POST FORWARD BAGGAGE COMPARTMENT - 1

Figures 59, 60 and 61 view the inside of the forward baggage compartment after the test.

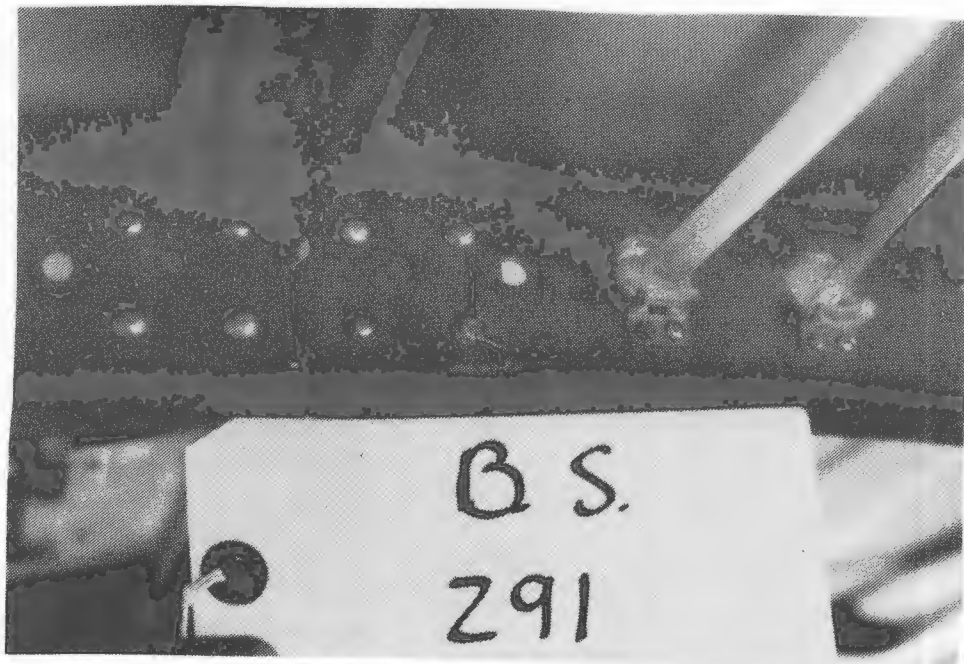
FIGURE 64. POST TEST INTERIOR FUSELAGE, CEILING

The interior of the fuselage also experienced some damage during the test. Figure 62 shows an example of such damage, occurring at body station 159. Figure 63 shows more structural damage at body station 189. Ceiling damage can be seen in figure 64, while sidewall damage is observed in figure 65.
