**Report No. CDOT-DTD-R-2003-1**  
**Final Report**

# **EVALUATION OF PREMATURE PCCP LONGITUDINAL CRACKING IN COLORADO**

**January 2003**

**COLORADO DEPARTMENT OF TRANSPORTATION  
RESEARCH BRANCH**

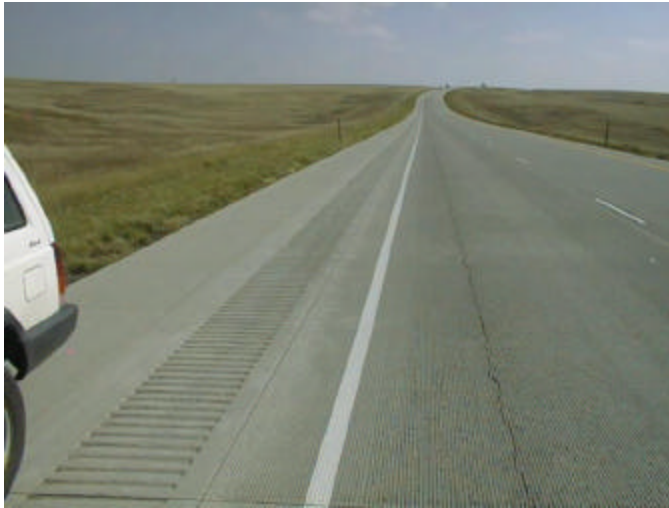
**Figure 1. Premature longitudinal crack on I-70 westbound near Agate.**

month of August 2001, distresses, mainly in the form of longitudinal cracks, were encountered at several locations in the westbound lanes (no distresses were reported in the eastbound lanes). The majority of the cracks were scattered between mileposts 340 and 346. Four cracks, each measuring approximately 200 feet in length, and located about four to five feet to the left of the shoulder paint stripe, appeared to be related to improper vibration practices. These cracks are very straight (**Figure 1**) and at a consistent distance from the edge of the pavement.

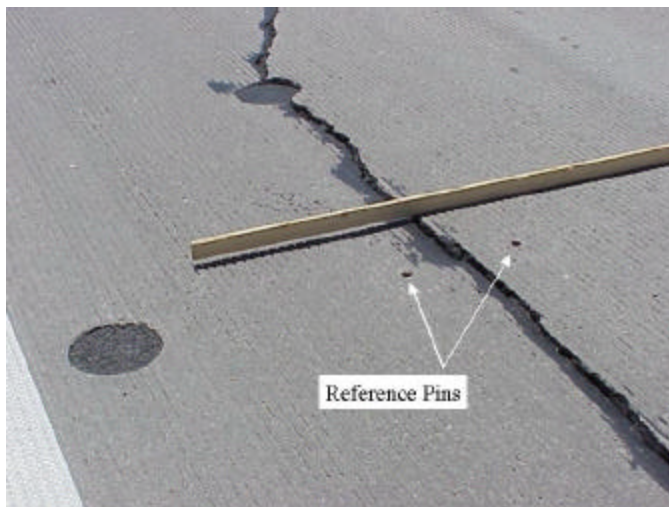
**Figure 2. Differential settlement on I-70 westbound near Agate.**

At some locations near Agate, cracks have developed with substantial differential settlement across the cracks. They tend to wander back and forth between the center of the lane and the right wheel path (**Figure 2**).

These cracks are probably due to under-compaction of the subgrade fill materials or to the high expansive potential of the of highly plastic clayey natural soils in the area (or to the combined effects of

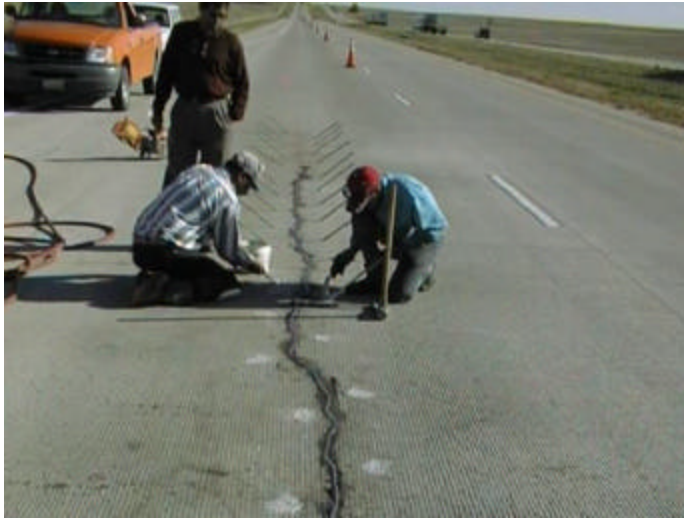
**Figure 4. Installation of stitches on I-70 at Agate.**

drilled through the concrete at about a 45° angle to the surface of the pavement so they crossed the crack near the middle of the concrete depth (**Figure 4**). Twenty-inch-long pieces of 5/8-inch steel rebar were coated with epoxy cement and driven through the concrete into the base. The ends of the bar were driven below the surface of the pavement and the holes sealed with epoxy cement. The performance of the cross stitches is being monitored.

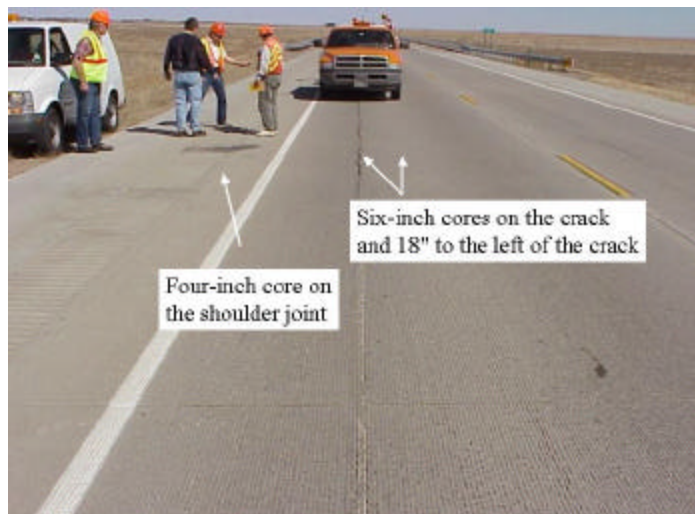
**Figure 5. Core locations on the vibrator trail - US-287 southbound.**

Split tensile strength tests were performed on 6-inch-diameter cores extracted from the vibrator trail where the tining tracks were deeper, but no longitudinal crack was evident – see the foreground of Figure 5. Split tensile strength tests were also conducted on cores taken next to the vibrator trails

The southbound cracks occurred primarily in the vibrator trail and are a consistent distance from the edge of the pavement (**Figure 5**). In contrast, while most of the longitudinal cracks in the northbound lanes are in the right wheel path, they wander from side to side (**Figure 7**).

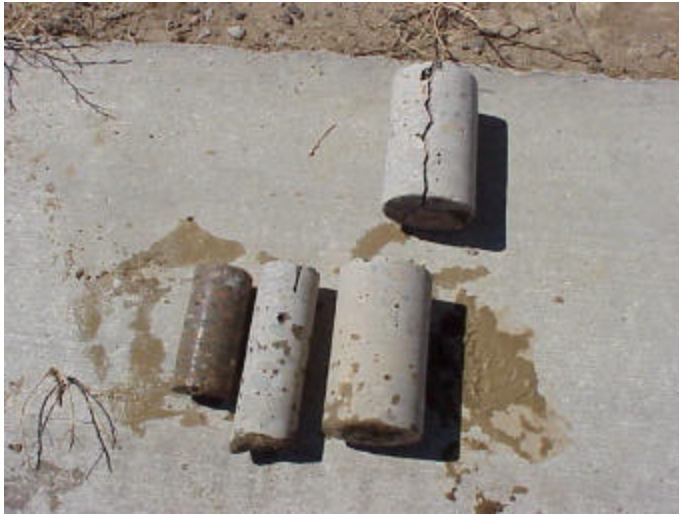
A set of three core samples was taken at each of three different locations southbound through the project. A set consisted of a six-inch core on the longitudinal crack, a six-inch core about 18 inches to the left of the first core, and a four-inch core on the shoulder joint (**Figure 5**). The six-inch cores were sent to Construction Technology Laboratories (CTL) for petrographic analysis; the four-inch cores were used to determine if the shoulder joint had cracked through, as it should (**Figure 6**).

**Figure 6. Cores from US-287 southbound.**

Examination of the four-inch cores taken on the shoulder joint revealed that the saw-cuts were not deep enough (less than  $0.4 D$  for 14-foot slabs) to instigate a weakened plane. As a result, longitudinal cracks developed in the travel lanes to release the strength gain of the concrete.

An overactive vibrator apparently created a vibrator trail which caused a weakened plane in the concrete. In some areas, longitudinal cracks developed along the vibrator trail even where the shoulder joint was working, i.e., the saw-cut was at a proper depth and the joint had cracked through.

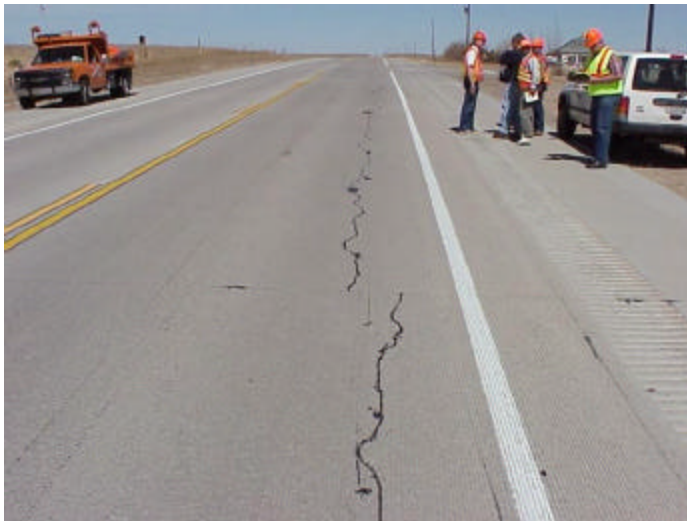
**Figure 7. Wandering cracks in the northbound lane of US-287.**

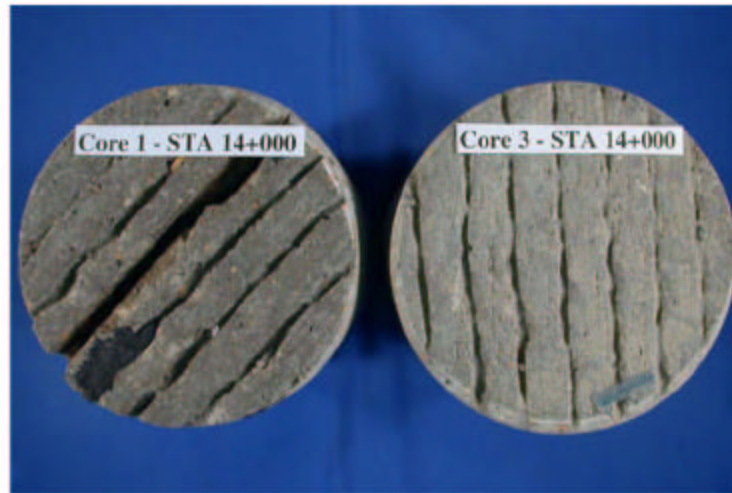
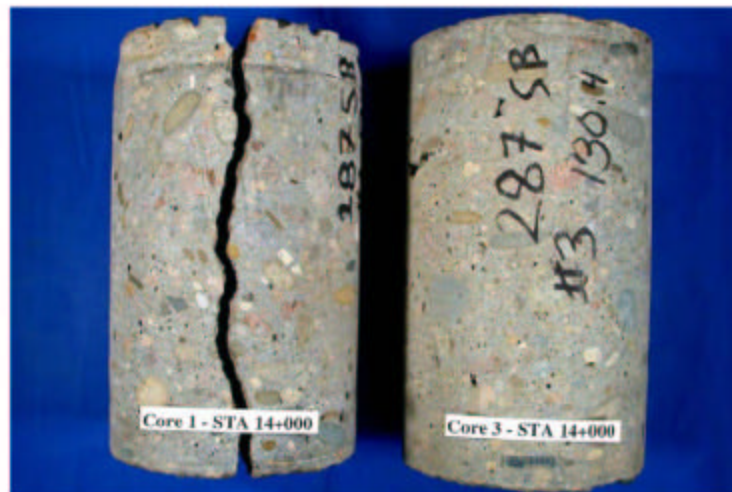
Fig. 1 (a & b) Concrete Cores 1 and 3, as received for analysis. Core 1 is from the cracked portion of the pavement and Core 3 is from the center of the lane.

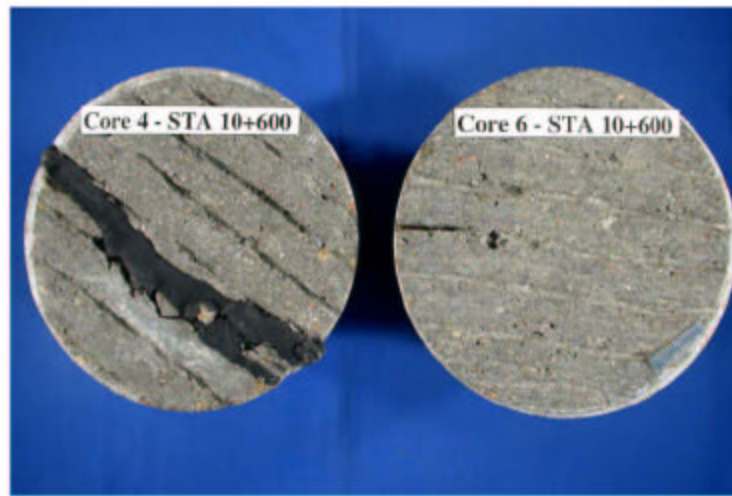
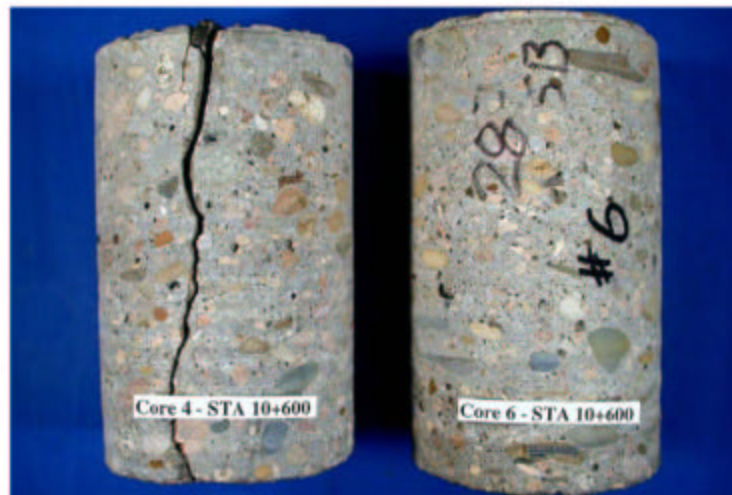
Fig. 2 (a & b) Concrete Cores 4 and 6, as received for analysis. Core 4 is from the cracked portion of the pavement and Core 6 is from the center of the lane.

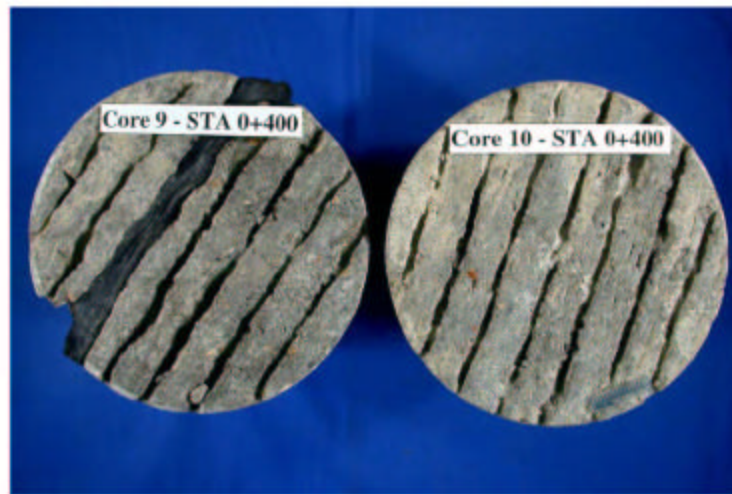
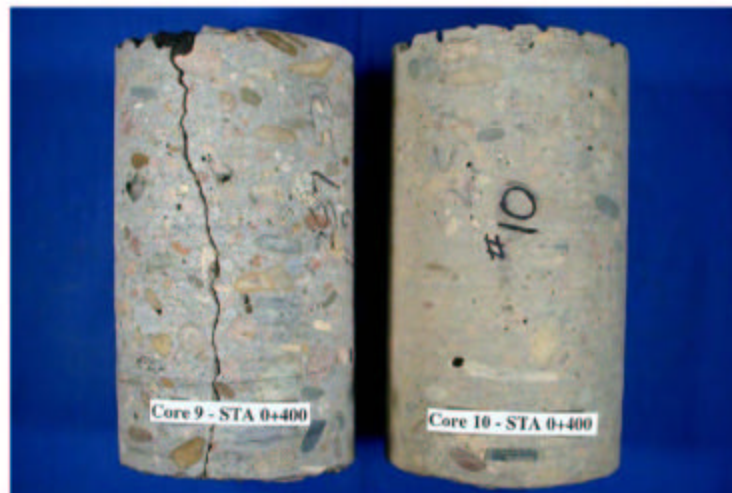
Fig. 3 (a & b) Concrete Cores 9 and 10, as received for analysis. Core 9 is from the cracked portion of the pavement and Core 10 is from the center of the lane.

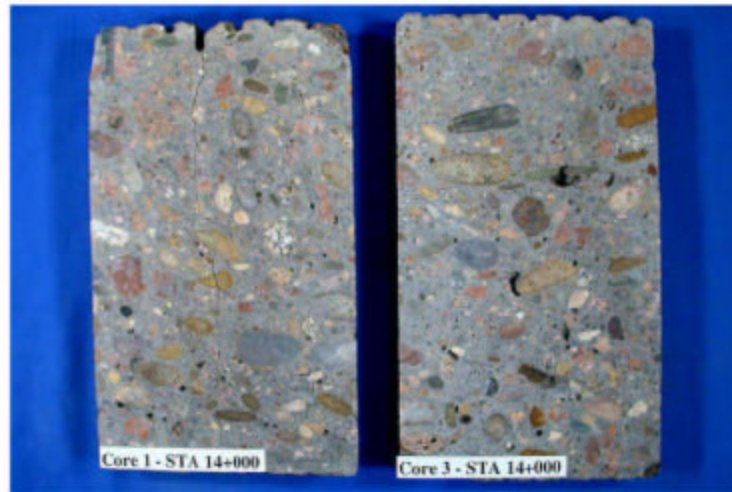
**Fig. 10** Cut cross section of Cores 1 and 3 showing the longitudinal crack in Core 1.

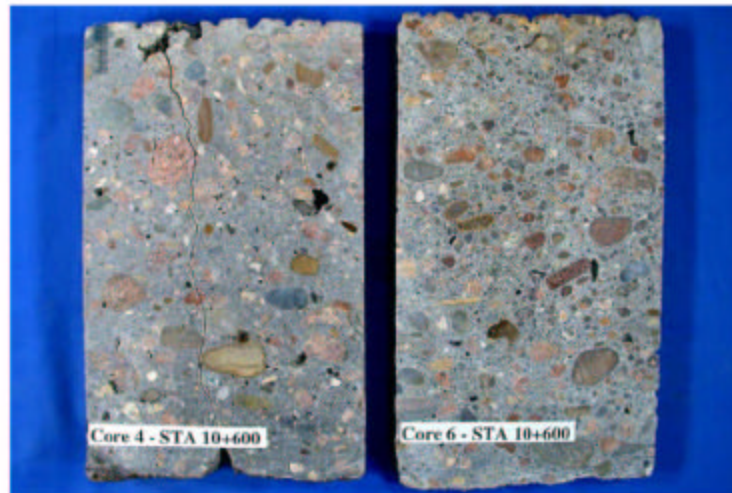
**Fig. 11** Cut cross section of Cores 4 and 6 showing the longitudinal crack in Core 4.

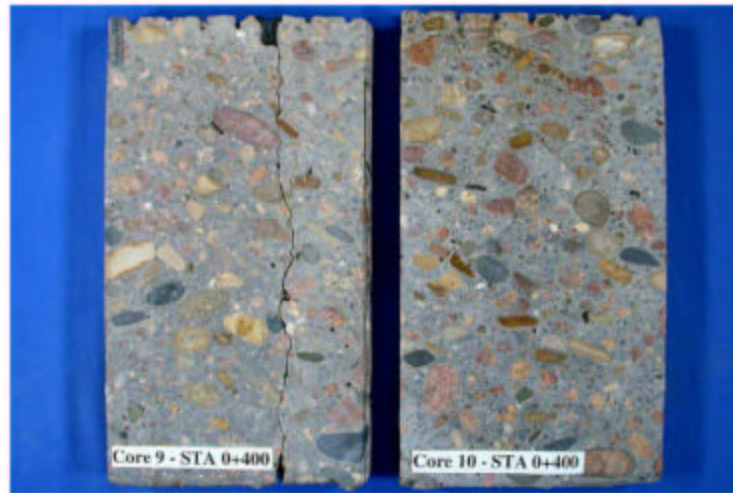
**Fig. 12** Cut cross section of Cores 9 and 10 showing the longitudinal crack in Core 9.
