**Report No. CDOT-DTD-R-2001-20**

## **SHRP CHIP SEAL**

**William (Skip) Outcalt**

**December 2001**

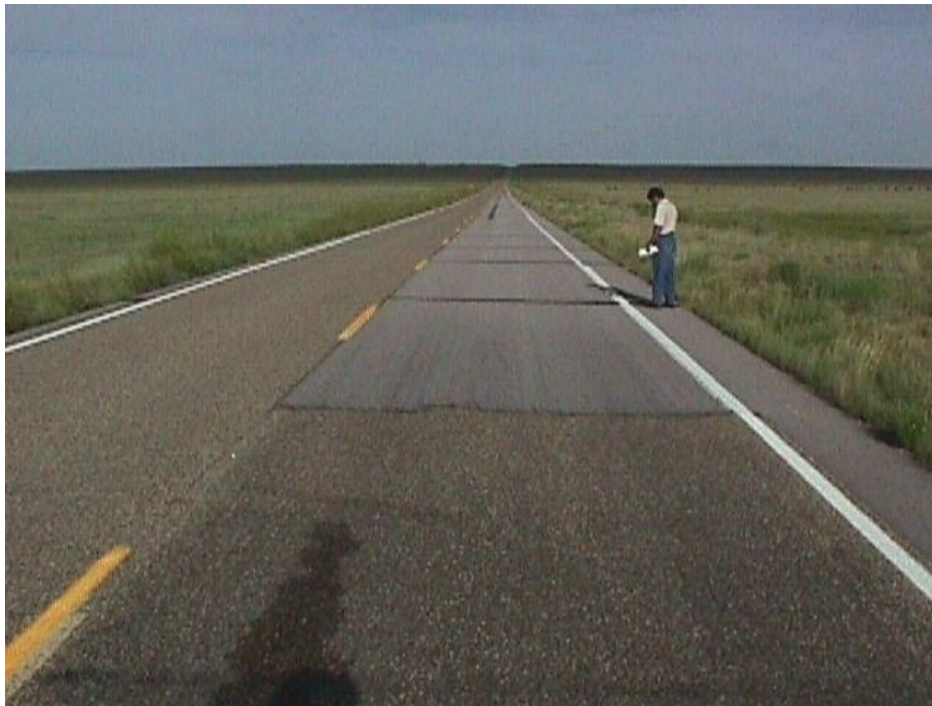
**Figure 1. Looking west from the fog sealed section into the control. The dark stripe next to the figure is a sealed crack. The dark patches in the left wheel path are water where the skid tester had just finished testing.**

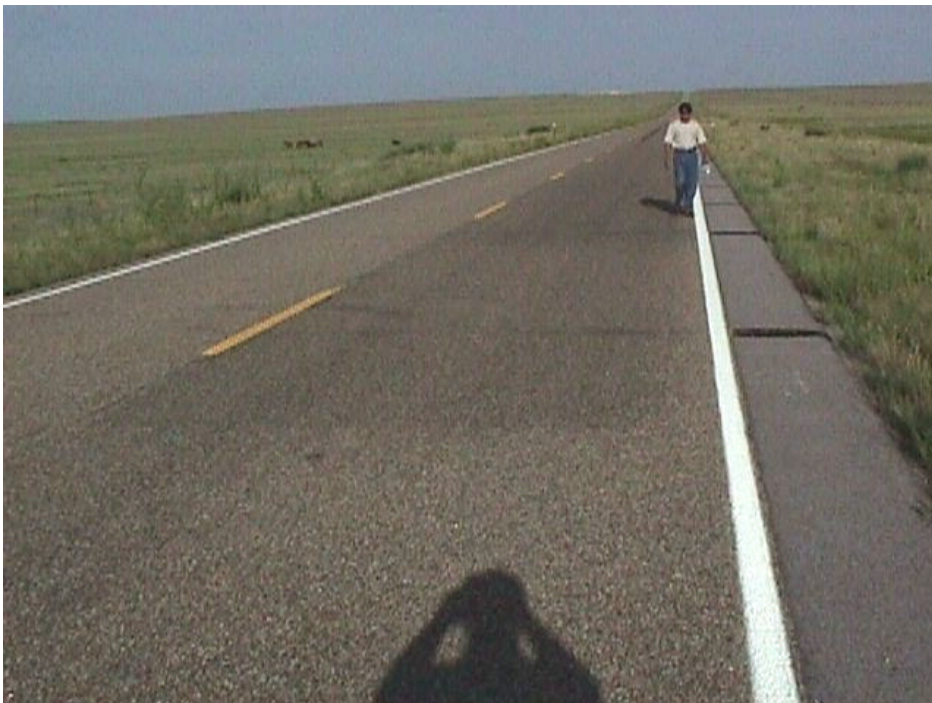
**Figure 2. The fog seal section starts where the pavement is darker. The dark stripes on the shoulder are seals applied to transverse cracks before the chip seals were placed.**

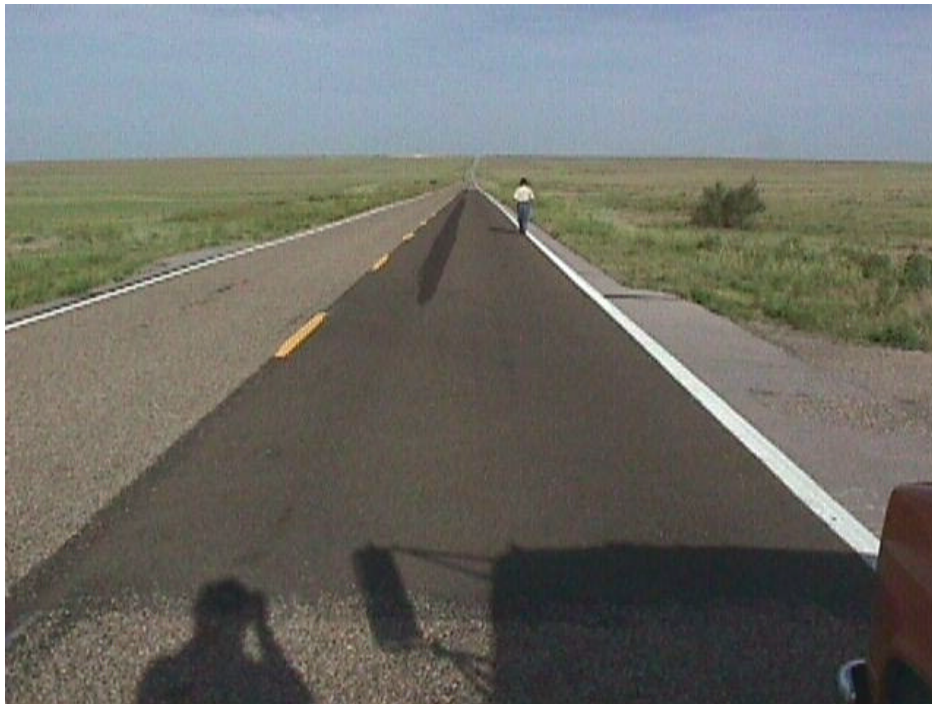
**Figure 3. The light weight chip section at the east end of the site.**  
**The right lane is the light weight chip seal. The dark patch in the left wheel path is water left by the skid testing equipment.**

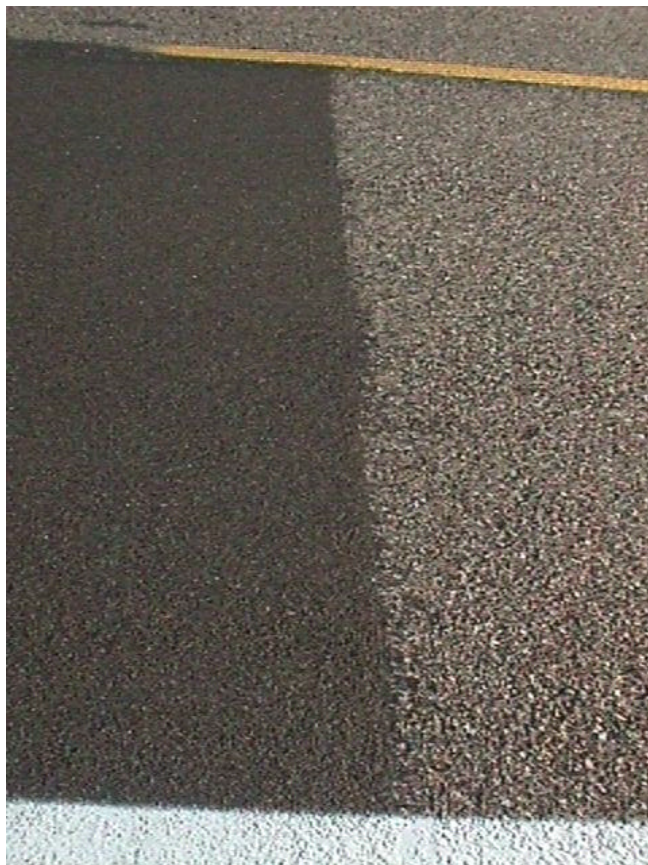
**Figure 4. The transition from light weight to standard weight chips.**  
**Light weight chips are the dark area on the left of the picture. To the right side and in the far lane are standard chips.**

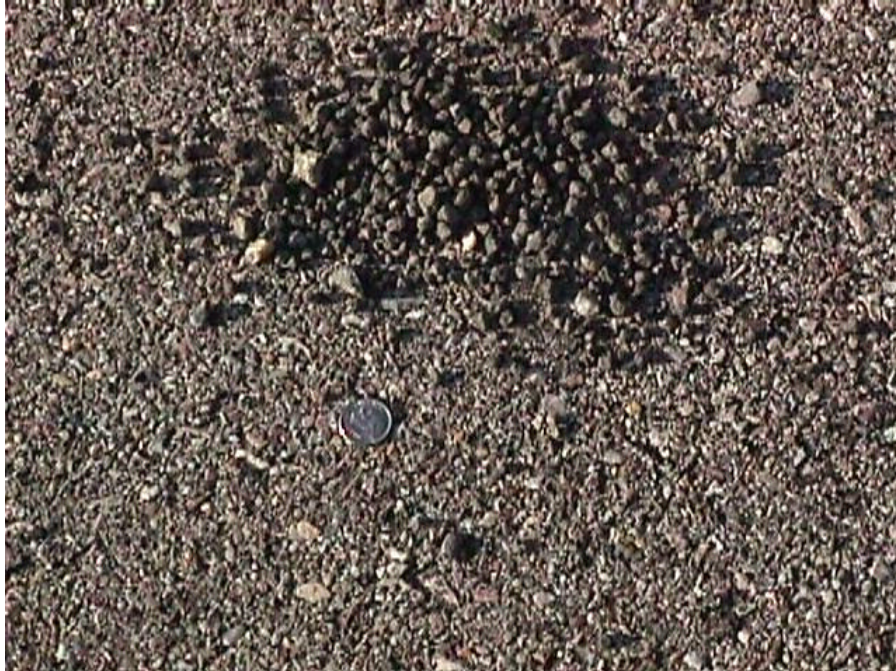
**Figure 5. A handful of the light weight chips.**  
**These are loose chips piled on the old pavement surface with a dime to show their size.**

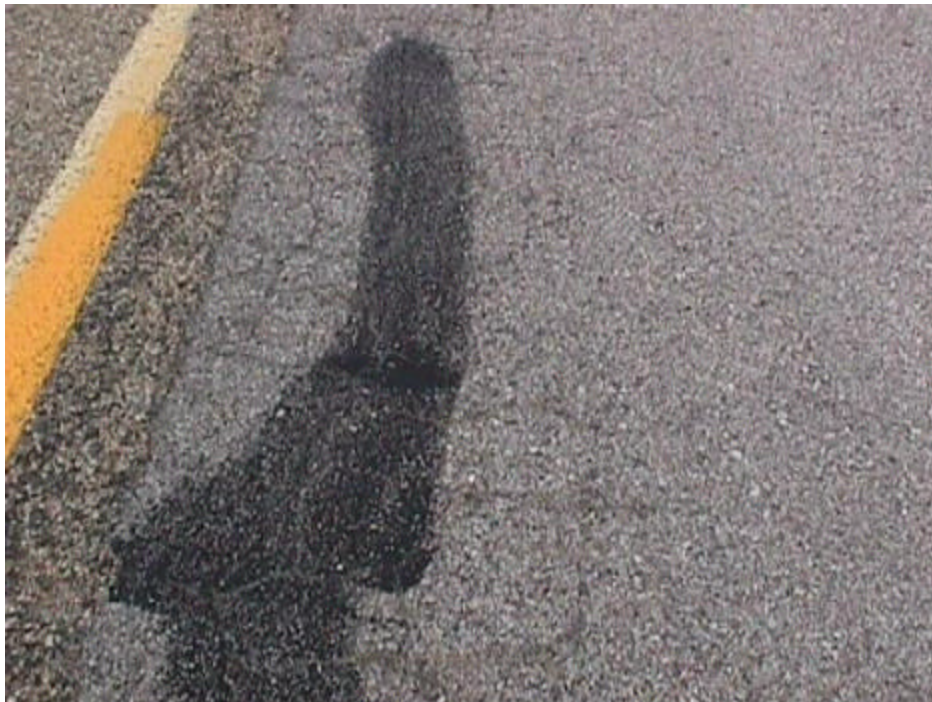
Before construction, the condition of the pavement at the site was visually evaluated and crack maps were made for each section showing the length and location of all visible cracks. The cracks were sealed with a rubberized sealer using an over-band method before the chip seals were applied. Since the chip seal was applied only in the lane, on the shoulder it was easy to see where the cracks had been sealed before the chip seal was applied. During post-construction evaluations those cracks that had not opened through the chip seal were not listed on the crack maps. However, if a crack had opened through the chip seal it was listed on the map at the date of the evaluation. At the time of the June '98 visit, portions of cracks that were seen and recorded during the March '98 visit had closed, probably due to the action of traffic during hot weather (the closed areas were mostly in the wheel paths). Table 1 shows the total amount of cracks measured during each visit. By the final evaluation in August of 2001, the control section had

developed some block cracking along the longitudinal cracks near the centerline. No additional crack sealing had been done in the control section since the chip seal was applied.

**Figure 6. Block cracking is developing in the control section near the skip stripe.**  
**The longitudinal crack just to the right of the yellow stripe appears to be the**  
**construction joint. The dark patch is old crack seal material.**
