**DOT/FAA/CT-94/89**

# **Corrosion of Fire-Damaged Aircraft**

**April 1995**

**Final Report**

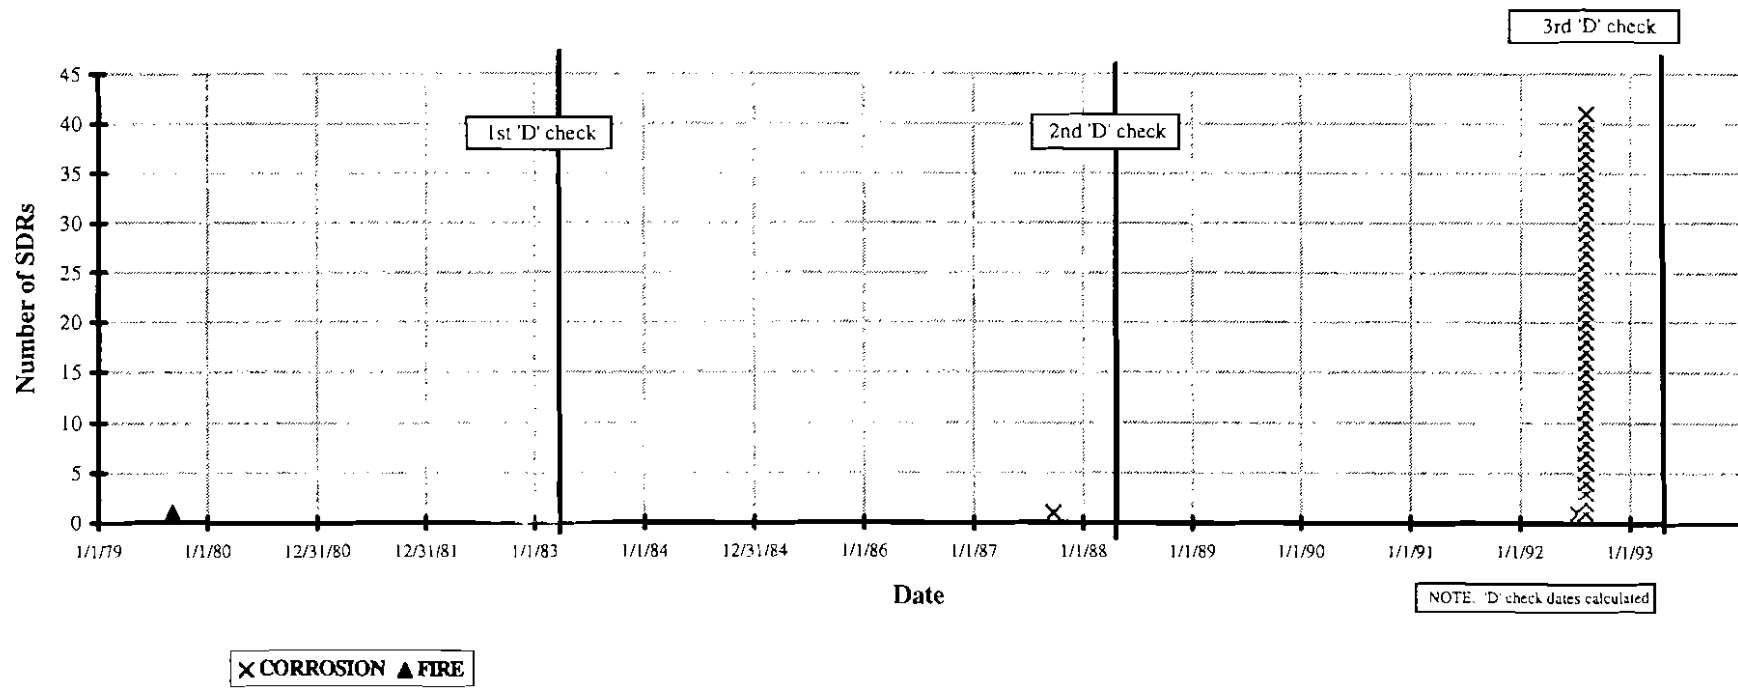
The 727 showing the most likely fire/corrosion relationship is S/N 21483. Data shown in figure 1 shows a possible fire/corrosion relationship, a fire in 1979 followed by high corrosion events reported 13 years later in 1992. Also, the first major incidence of corrosion reporting in 1992 occurred when the aircraft was less than 15 years old.

FIGURE 1. B727, S/N 21483: FREQUENCY OF CORROSION SDRs BEFORE AND AFTER A FIRE EVENT

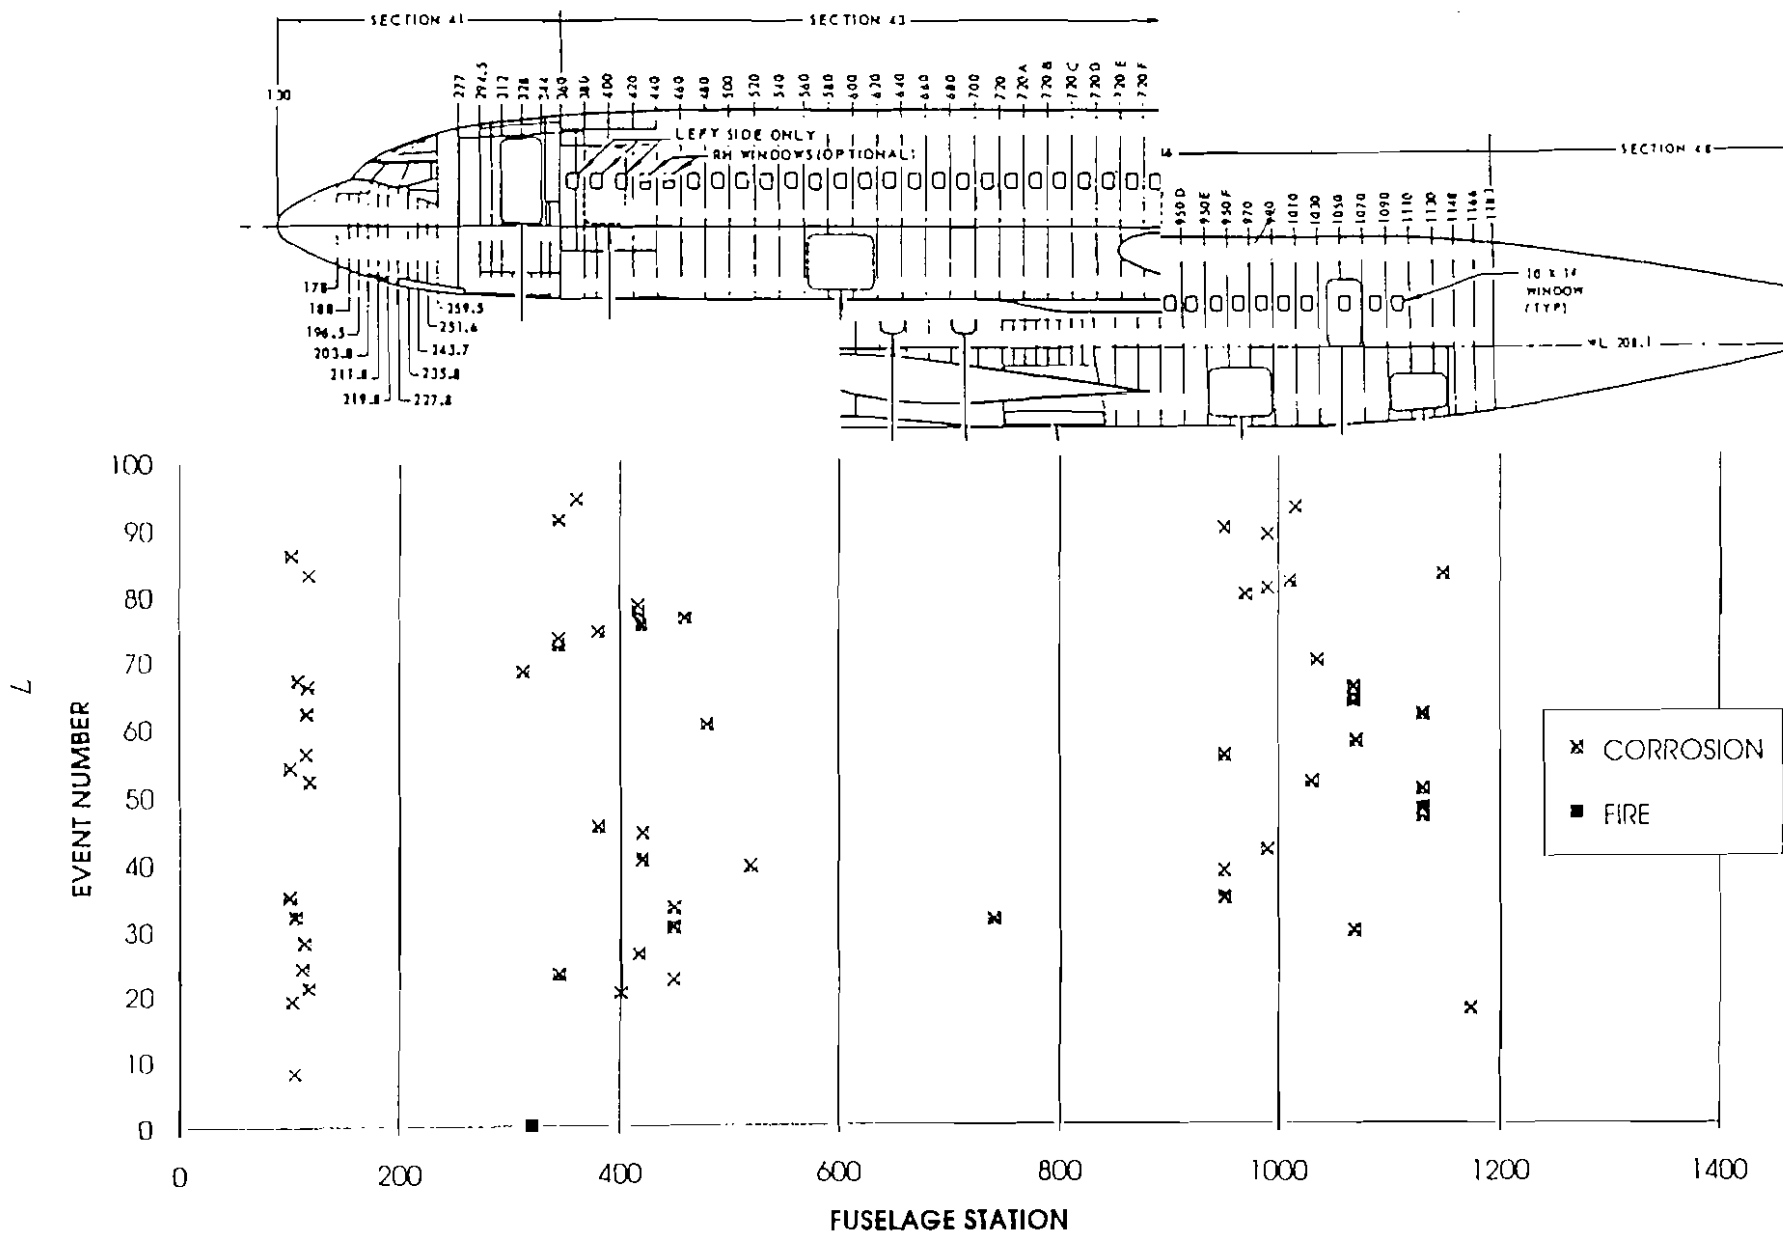
Mapping of interior fuselage corrosion locations and the fire location are shown in figure 2 for this aircraft. Nineteen corrosion events are shown within 200 inches of the fire. Data contained in the nineteen corrosion reports does not establish a definite relationship between the fire and corrosion. Mapping of corrosion location versus fire location for the other aircraft indicated no concentration of corrosion at or near the fire site.

FIGURE 2. B727, S/N 21483: CORROSION AND FIRE SDRs AS A FUNCTION OF FUSELAGE STATION

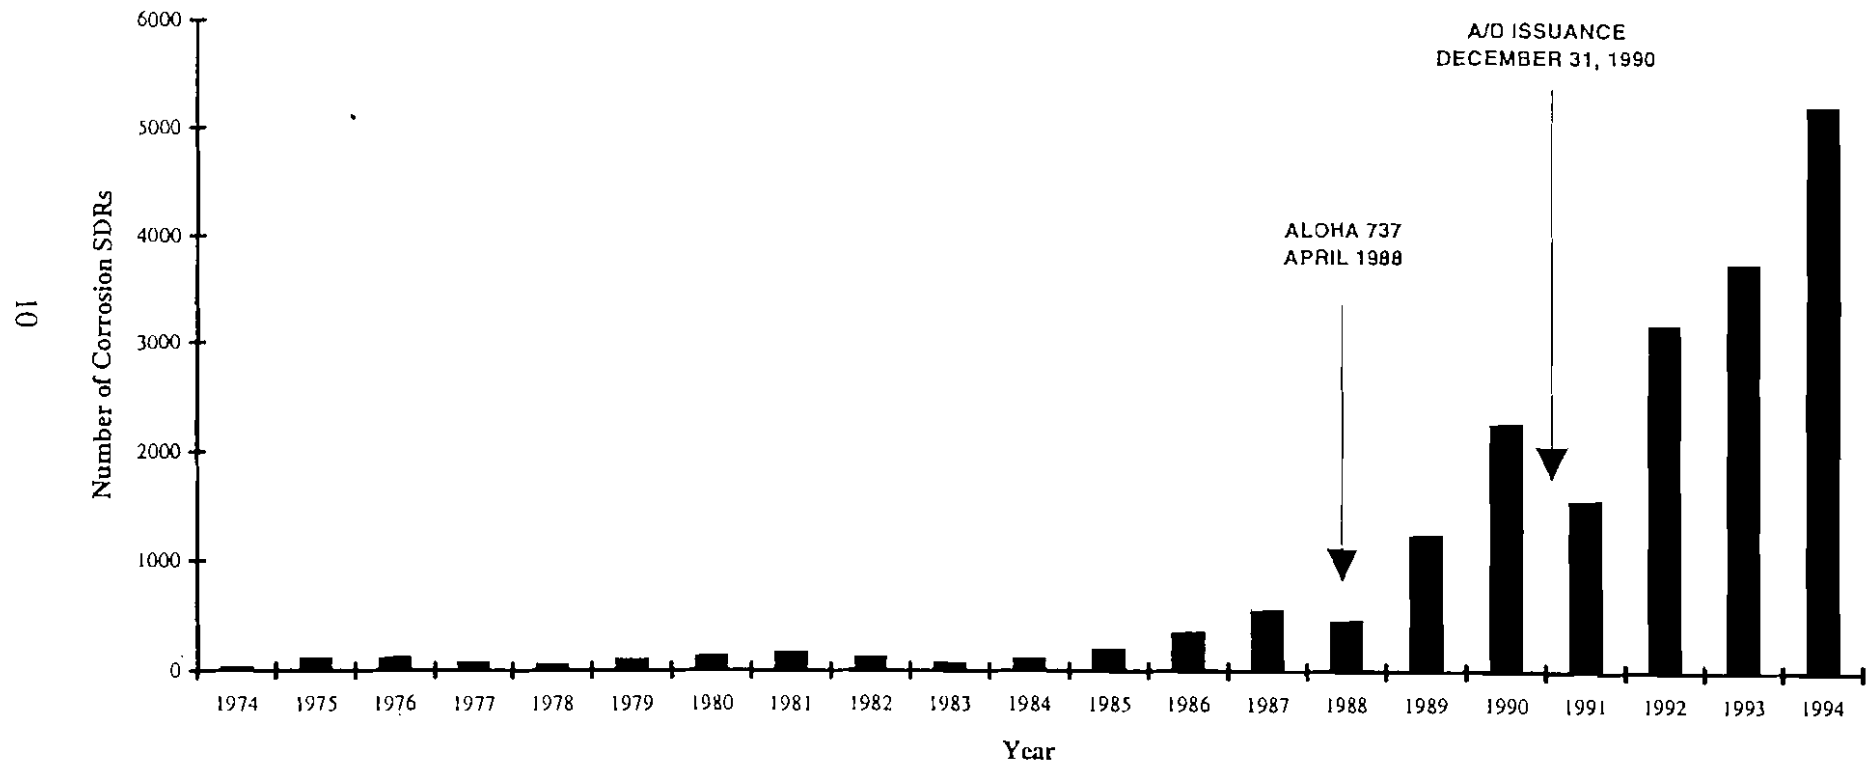
Fleetwide trends in aircraft corrosion were studied to see if aircraft with fires stand apart from overall fleet trends. It was found that on average the corrosion reporting for the 727 fleet has been low but has been increasing since 1984 when the first 727 became twenty years old. Figure 3 and table 5 illustrate this trend versus calendar time. Figure 4 highlights 1988 through 1994 and includes total fleet size and total aircraft over twenty years of age during that period. The aircraft aging trend is relatively flat and doesn't fully explain the increase in corrosion SDRs. A possible explanation as indicated on figure 4 might be increased corrosion awareness due to the Aloha incident (Boeing 737 fuselage failure) and the issuance of the Aging Aircraft Corrosion inspection ADs (table 2).

FIGURE 3. FLEETWIDE CORROSION REPORTING HISTORY FOR THE BOEING 727 AIRCRAFT

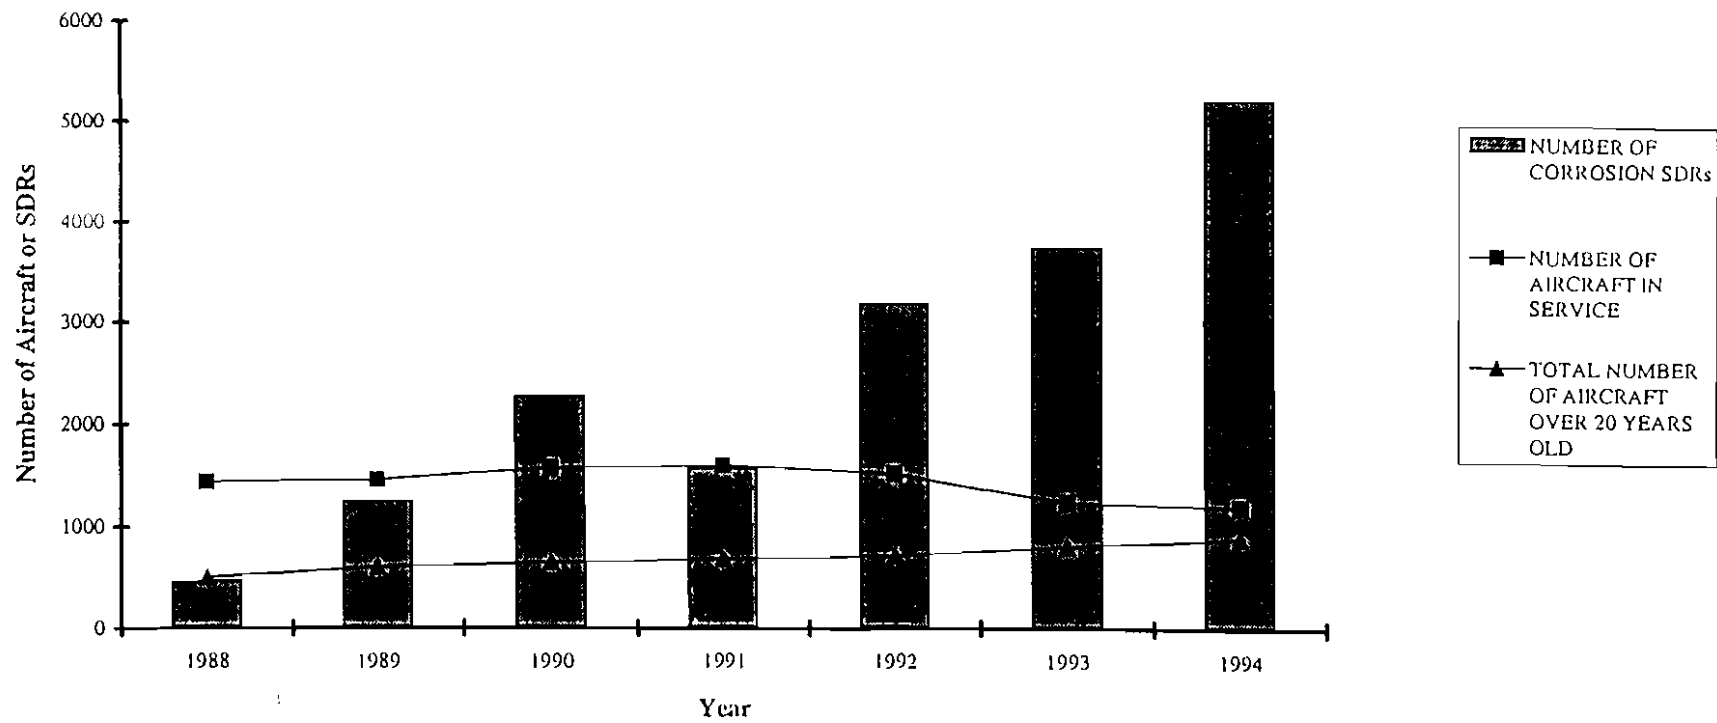
FIGURE 4. CORROSION REPORTING 1988 TO 1994 RELATED TO AIRCRAFT AGE AND FLEET SIZE, B727 AIRCRAFT
