Testing of State Roadside Safety Systems Volume XI: Appendix J— Crash Testing and Evaluation of Existing Guardrail Systems

PUBLICATION NO. FHWA-RD-98-046

1. Report No. FHWA-RD-98-046		2. Government Accession No.	
4. Title and Subtitle TESTING OF STATE ROADSIDE SAFETY SYSTEMS VOLUME XI: APPENDIX J - CRASH TESTING AND EVALUATION OF EXISTING GUARDRAIL SYSTEMS		5. Report Date April 1999

7. Author(s) King K. Mak, Roger P. Bligh, and Wanda L. Menges		6. Performing Organization Code	
9. Performing Organization Name and Address Texas Transportation Institute The Texas A&M University System College Station, Texas 77843-3135		8. Performing Organization Report No. Research Foundation 7147-Vol. XI

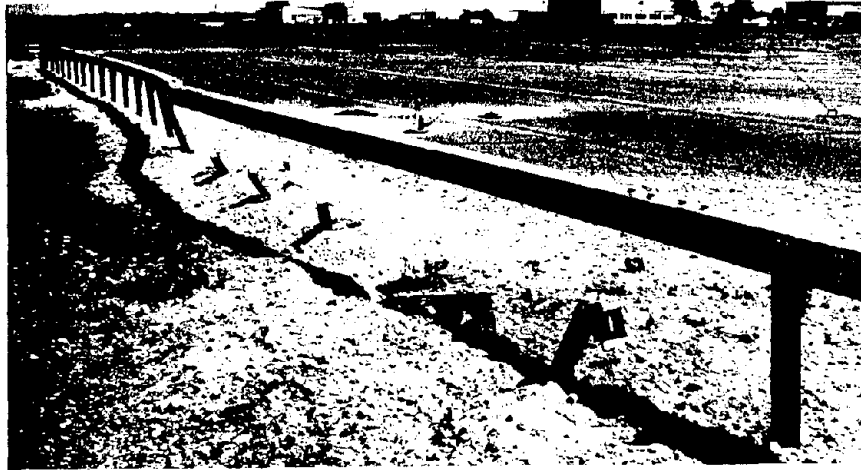
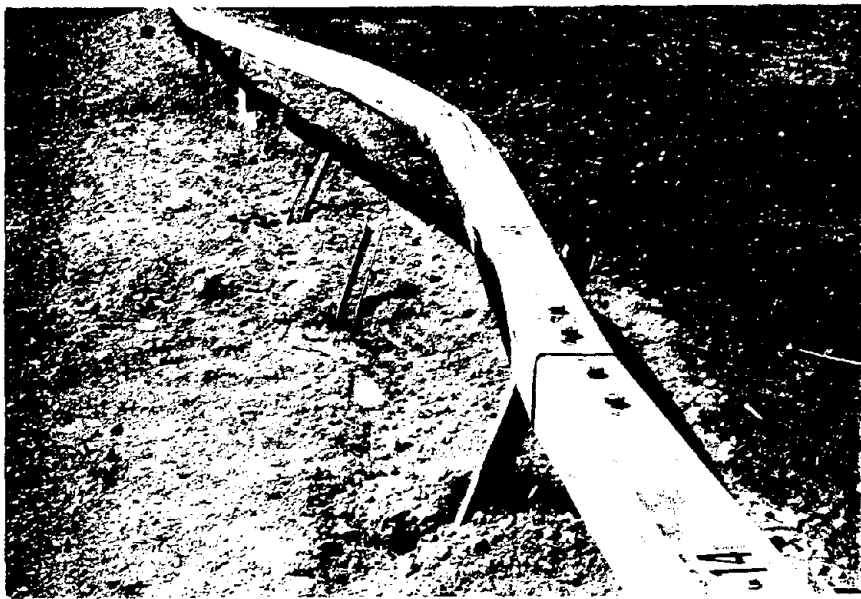
Figure 59. Box-beam (G3) guardrail after test 471470-33.

As seen in figures 59 through 61, the guardrail installation received moderate damage. There were tire marks on the face of the box-beam rail element from posts 15 through 21, and on posts 15 through 20. The box-beam rail element was separated from posts 16 through 20, and these posts were bent at ground level. The lateral deflections recorded at posts 12 through 22 are noted in table 3.

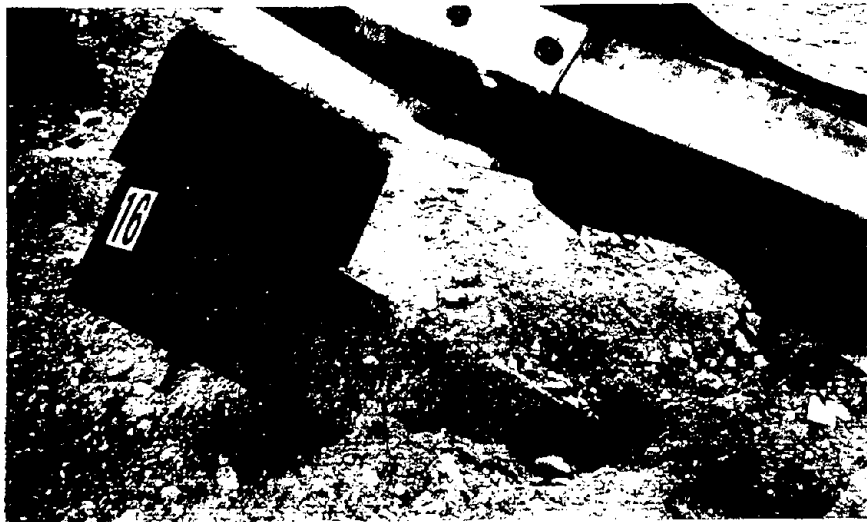
Figure 75. W-beam, wood-post (G4(2W)) guardrail installation after test 471470-26.

As can be seen in figures 75 and 76, the installation received moderate damage. The bolts were pulled out of the W-beam rail element at posts 15 and 16, and the blockout on post 16 was split. None of the posts broke off, but some posts were pushed back. The displacements of the posts are shown in table 4.

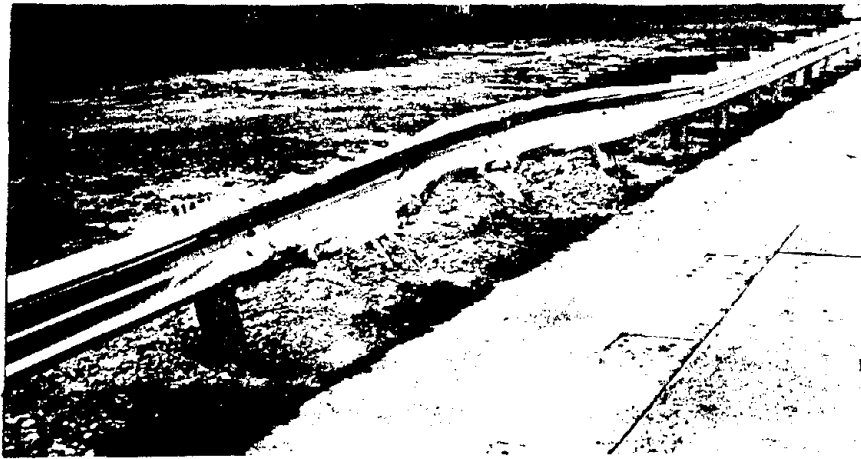
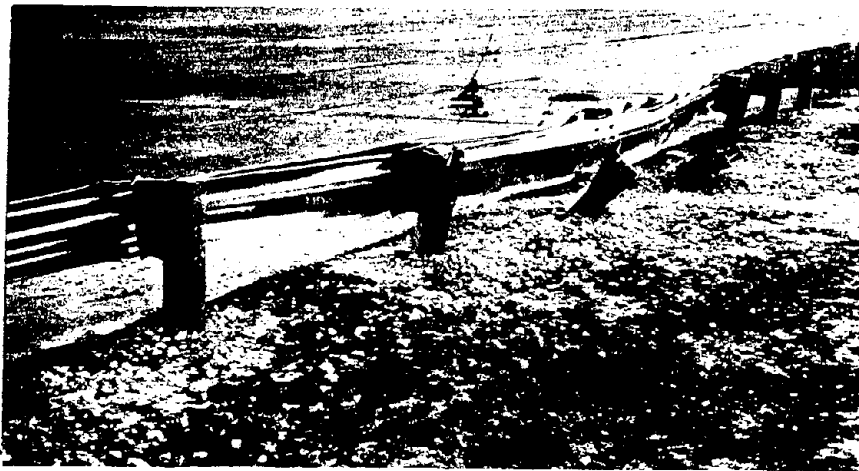
Figure 90. W-beam, steel-post (G4(1S)) guardrail installation after test 471470-27.

As can be seen in figures 90 and 91, the installation received moderate damage. The MELT anchor on the upstream end had pulled up slightly and moved laterally 44.5 mm (1.75 in). The buffered end nose was pulled off the end post (post 1). The bolts were pulled out of the W-beam rail element at posts 15, 16, and 17, and the posts and blockouts were bent. All the steel posts upstream of impact were disturbed, with measurable displacements as shown in table 5.

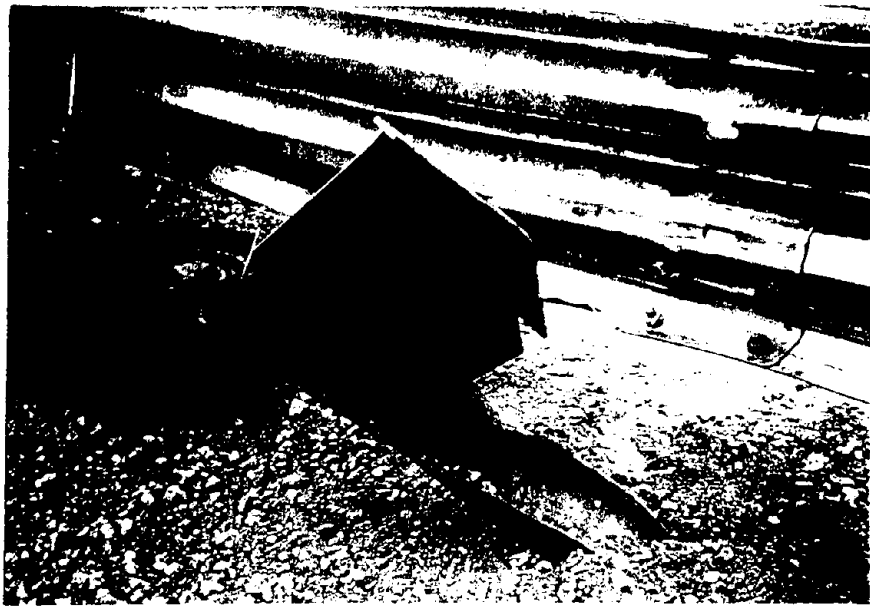
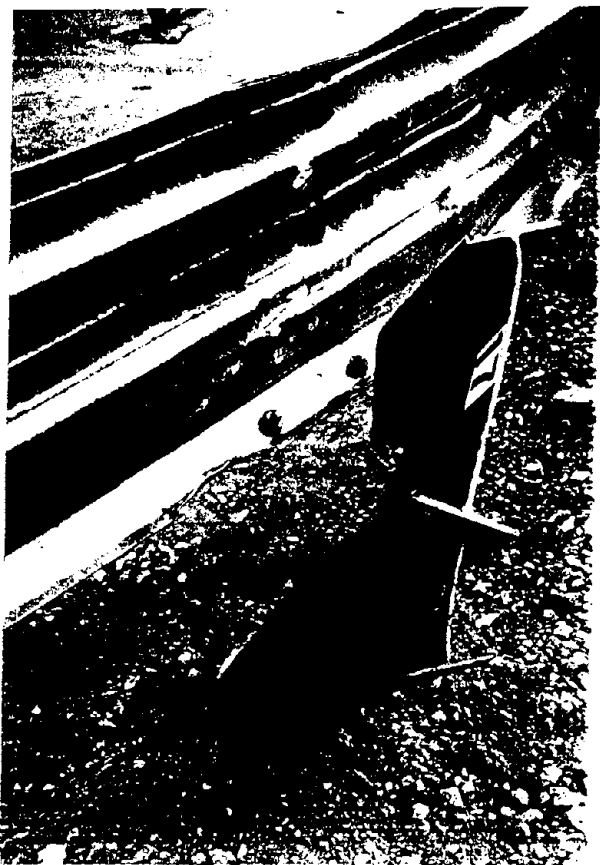
Figure 12c. Damage to truss beam and post flange at post 17.

the face of post 16 and the back side of post 17. The thrie-beam rail element was separated from post 17, and the flanges on post 17 showed evidence of wheel contact. Posts 16, 17, and 18 were twisted severely. The lateral deflections recorded at posts 14 through 20 are noted in table 7.
