DOT HS 813 850

# **Special Crash Investigations: On-Site Child Restraint System Crash Investigation; Vehicle: 2023 Hyundai Palisade; Location: Utah; Crash Date: November 2022**

**Special Crash Investigations**  
**On-Site Child Restraint System Crash Investigation**  
**Case No. DS23004**  
**Vehicle: 2023 Hyundai Palisade**  
**Location: Utah**  
**Crash Date: November 2022**

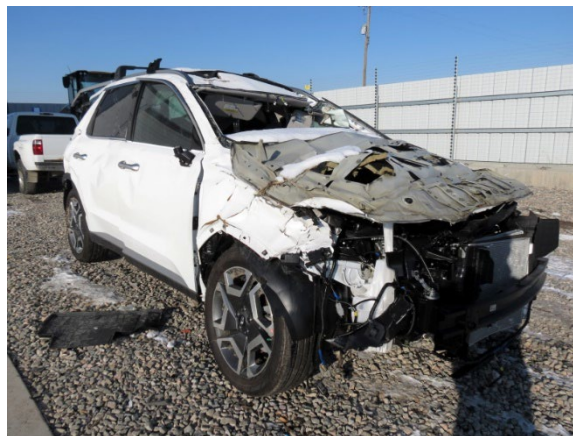
*Figure 1. 2023 Hyundai Palisade*

The Hyundai was traveling northbound in the right lane. The roadway ahead was congested with traffic and, according to police, the Hyundai couldn't slow down to avoid colliding with the vehicle in front. According to the driver who was interviewed by SCI, she had a sudden loss of consciousness causing her to lose control. The Hyundai left the roadway on the right edge, rolled over one and three-quarter times and came to rest on its right side facing east on the roadside.

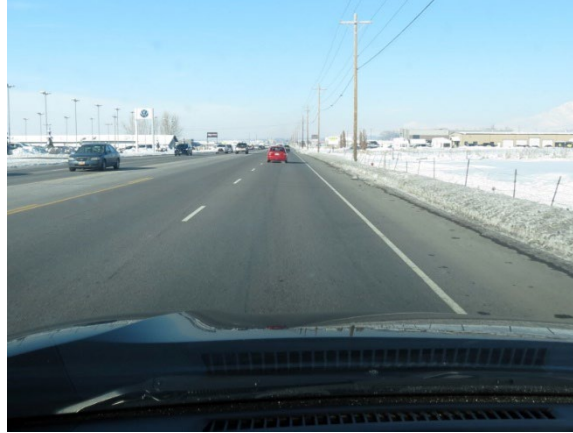
*Figure 2. Crash site looking north*

The crash occurred on a north/south U.S. highway in Utah in November 2022. The asphalt roadway had two lanes for each direction of travel and a center two-way turn lane (Figure 2). The lanes were separated by dashed white painted stripes. The roadway was bordered by raised concrete curbs and unpaved ground on the roadsides. It was straight and level and had a posted speed limit of 72 km/h (45 mph). The crash occurred during daylight under clear and dry conditions. A crash diagram is included at the end of this report.

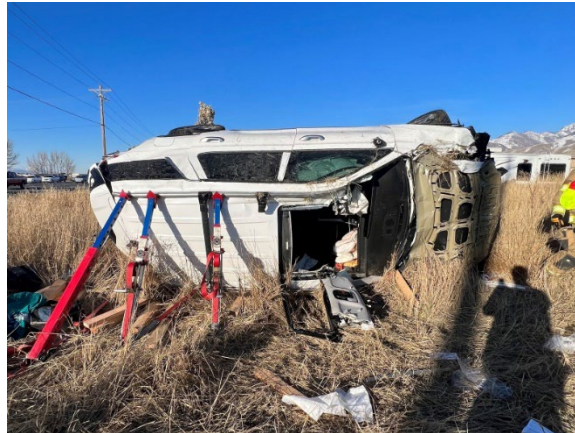
*Figure 3. 2023 Hyundai Palisade at final rest looking north (police photo)*

The crash included one event - the rollover. Following a clockwise rotation, the Hyundai's left side tires tripped on the ground, initiating a left-side-leading rollover. It rolled an estimated seven quarter-turns about its longitudinal axis before coming to rest on its right plane, facing east on the roadside (Figure 3). The estimated roll distance was 54 m (177 ft). It had combination roll-sensing/side-impact inflatable curtain (IC) air bags that deployed during the rollover, in addition to the driver's frontal and knee air bags, and the front and second-row seat-back mounted side-impact air bags. All occupants were belted or secured in CRSs and remained in their seated positions during the rollover.

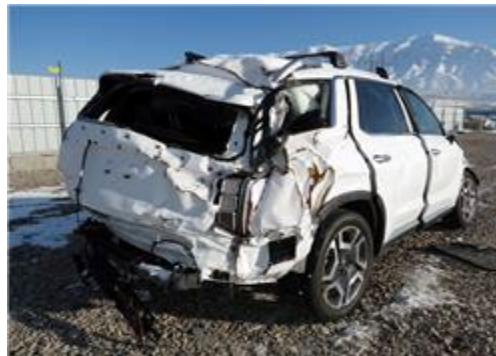
*Figure 4. Greenhouse crush damage 2023 Hyundai Palisade*

The greenhouse was crushed laterally and vertically. The right rear aspect of the greenhouse exhibited the most severe lateral and vertical crush (Figure 4). Maximum lateral crush to the greenhouse was located at the upper aspect of the right D-pillar and measured 15 cm (5.9 in). Maximum vertical crush was located at the right backlight header at 22 cm (8.7 in) aft of the right rear axle and measured 20 cm (7.9 in). The collision deformation classification (CDC) for the Hyundai in Event 1 was 00TDDO3.

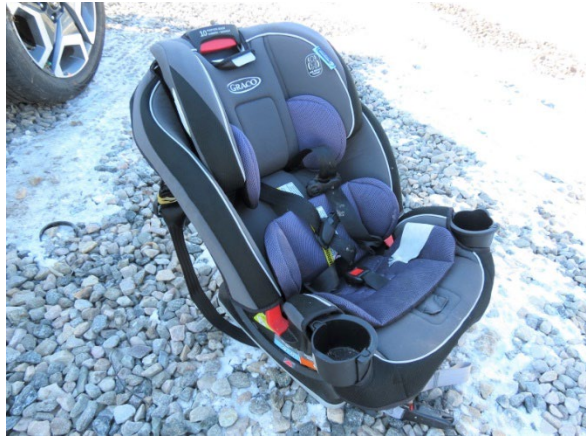
*Figure 5. Graco SlimFit 3-in-1 CRS*

The second-row right position child was using a Graco SlimFit 3-in-1 convertible CRS with a 5-point harness system (Figure 5). It was model number 1999656JJ with a manufacture date of October 9, 2020. It was installed rear-facing using LowerAnchors and Tethers for Children (LATCH) lower anchors. There was no slack at the attachment points and the CRS was held firmly on the vehicle seat. The upper tether was stowed on the back side of the CRS shell. According to the labeling instructions, the upper tether is not required when the seat is used rear-facing. The recline adjustment setting was appropriate for a rear-facing installation. The adjustable headrest was set in the lower position. The harness shoulder straps were in the lower position and the crotch strap was in the forward-most slot. The CRS did not reveal any crash-related damage or evidence of occupant loading. Padded infant inserts were installed at the headrest and seating areas. An aftermarket Safe-Fit seat liner was installed between the CRS and the vehicle seat back and cushion.

Labeling on the seat stated that a child weighing 5 to 40 lb (2.3 to 18 kg) can use this seat rear-facing, and a child weighing less than 22 lb (10 kg) and less than 1 year old must only use it rear-facing. The harness shoulder straps must be at or just below the child's shoulders and the top of the head must be at least 1 in (2.5 cm) below the red handle at the top of the headrest. The occupant using this CRS was a 2-year-old male who weighed 9 kg (20 lb); his height at the time of the crash was unknown. The child had a premature birth and his height and weight were below average. Based on the parameters for using this CRS rear-facing with LATCH installation, it appeared to be appropriate for the occupant.

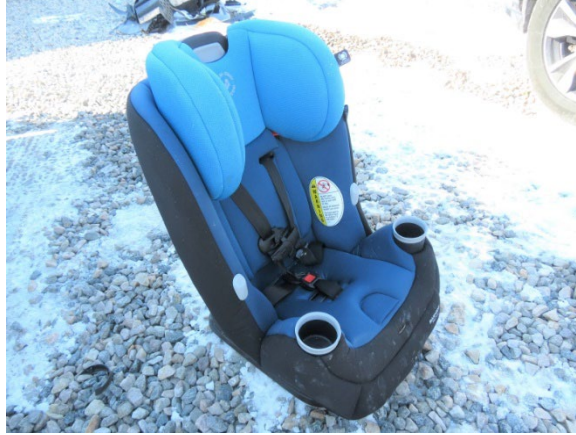
*Figure 6. Maxi-Cosi Pria 3-in-1 CRS*

The child in the third-row left position was using a Maxi-Cosi Pria 3-in-1 convertible CRS with a 5-point harness system (Figure 6). It was model number CC244-FGF with a manufacture date of 12/22/2020. It was installed in a forward-facing orientation using LATCH lower anchors. There was no slack at the attachment points and the CRS was held firmly in the vehicle seat. The upper tether was stowed on the back side of the CRS shell. According to the labeling instructions, the upper tether should be used when the seat is used forward-facing. A tether anchor was available on the vehicle seat back for this position. The adjustable headrest and harness shoulder straps were in a middle position and the crotch strap was in the forward-most slot. The CRS did not reveal any crash-related damage or evidence of occupant loading. An aftermarket Summer vehicle seat liner was installed between the CRS and the vehicle seat back and cushion.

Labeling on the seat stated a forward-facing installation was appropriate for children weighing 22 to 65 lb (10.1 to 29 kg), 29 to 49 in (73.6 to 125 cm) tall, and at least 1 year old. Labeling specified that a LATCH lower anchor installation was intended for children weighing up to 40 lb (18 kg), and a seat belt (lap or lap and shoulder) installation was intended for children weighing up to 65 lb (29 kg). The child using this CRS was a 3-years-old female who weighed 16 kg (35 lb); her height was unknown. Based on the parameters for using this CRS forward-facing with LATCH installation, it appeared to be appropriate for the occupant.
