# **COMPARISON OF THE HAMBURG WHEEL-TRACKING DEVICE AND THE ENVIRONMENTAL CONDITIONING SYSTEM TO PAVEMENTS OF KNOWN STRIPPING PERFORMANCE**

Timothy .Aschenbrener  
Colorado Department of Transportation  
4201 East Arkansas Avenue  
Denver, Colorado 80222

Final Report  
January 1994

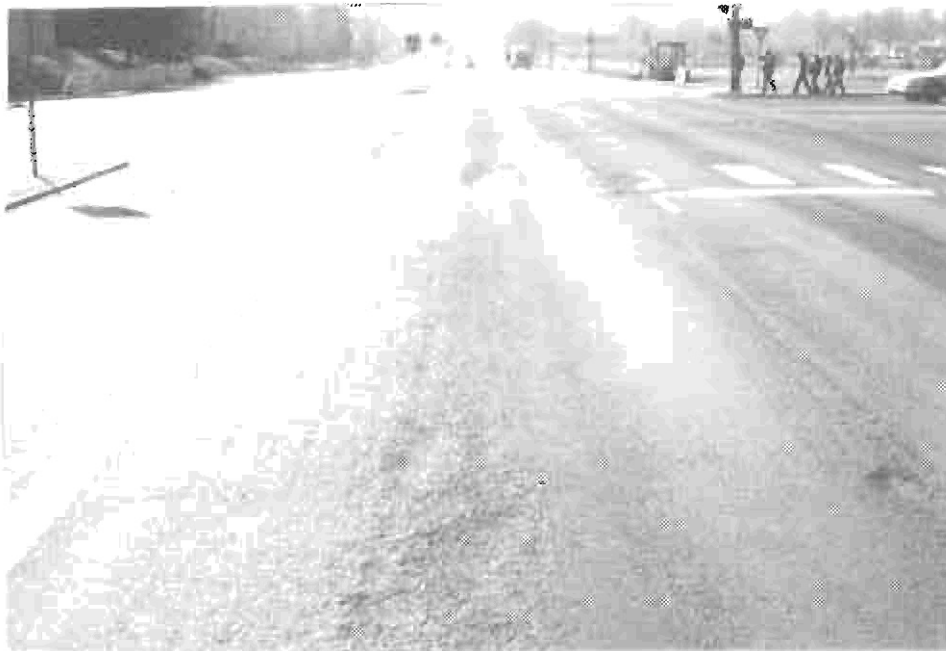
These pavements have received an exceptionally high level of maintenance. Although pavements in this category are still in service after two to five years, their performance is considered unacceptable when compared to their design life. The maintenance required to address problems from moisture damage to the HMA pavements included overlays and significant patching of potholes. A 15-month old pavement that required an overlay on some sections is shown in Fig. 1.

**Fig. 1. A "High Maintenance" Mix Experiencing Ravelling After 15 Months.**

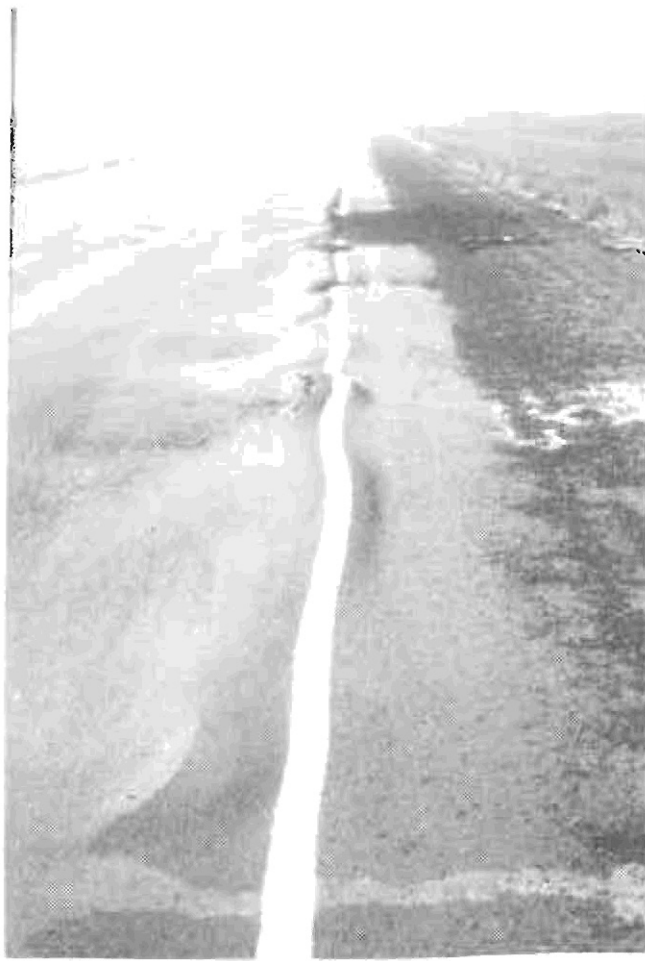
Several pavements in Colorado required complete rehabilitation when less than two years old, and often when less than one year old. The moisture damage was related to a unique pavement design feature, rut-resistant composite pavement, that utilized a plant mixed seal coat (PMSC) as described and evaluated by Harmelink (5). HMA pavements directly below the PMSC exhibited severe moisture damage. The pavement surface (Fig. 2) and a core showing the moisture damage that occurred just below the surface (Fig. 3) are shown for a pavement requiring complete rehabilitation after 12 months. Even though the PMSC was a contributing factor the distress in the underlying HMA, the HMA was still considered to be susceptible to moisture damage since it failed so quickly.

**Fig. 2. The Surface of a Pavement Requiring "Complete Rehabilitation" in 12 Months.**

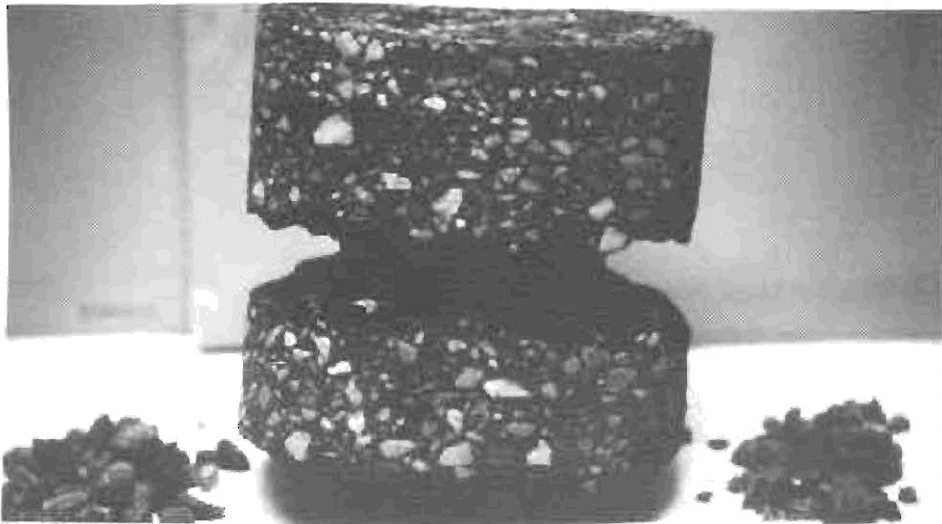
**Fig. 3. A Core Showing Stripping Below the Surface from the Pavement in Figure 2.**

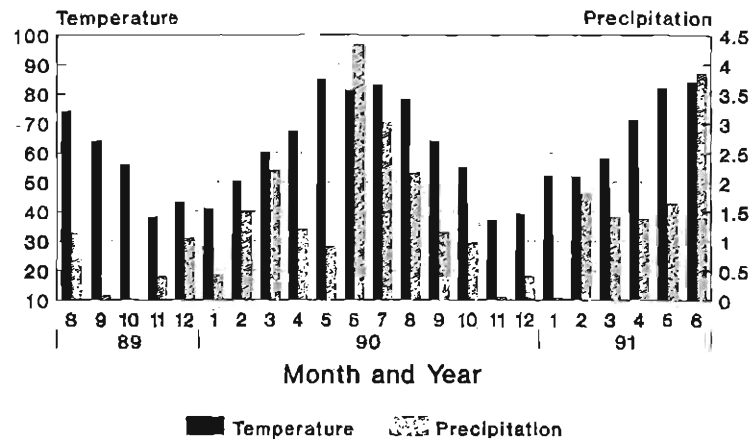
Pavements requiring complete rehabilitation all failed when high levels of precipitation occurred in the hottest part of the summer. The weather conditions were all very similar to that shown in Figure 4. The temperature is the monthly mean maximum temperature, i.e. the average of the daily high temperatures. The precipitation is the total accumulation for the month. The first month and year in each figure represents the end of construction, and the final month and year in each figure represents the time of failure.

Even though all pavements in Colorado are subjected to freeze cycles, the severe moisture damage did not correspond with freezing conditions. The instantaneous failures were directly related to a simultaneous combination of high temperature, high moisture, and high traffic.

**Fig. 4. Environmental Conditions for the Pavement at Arriba Requiring "Complete Rehabilitation" After 24 Months.**

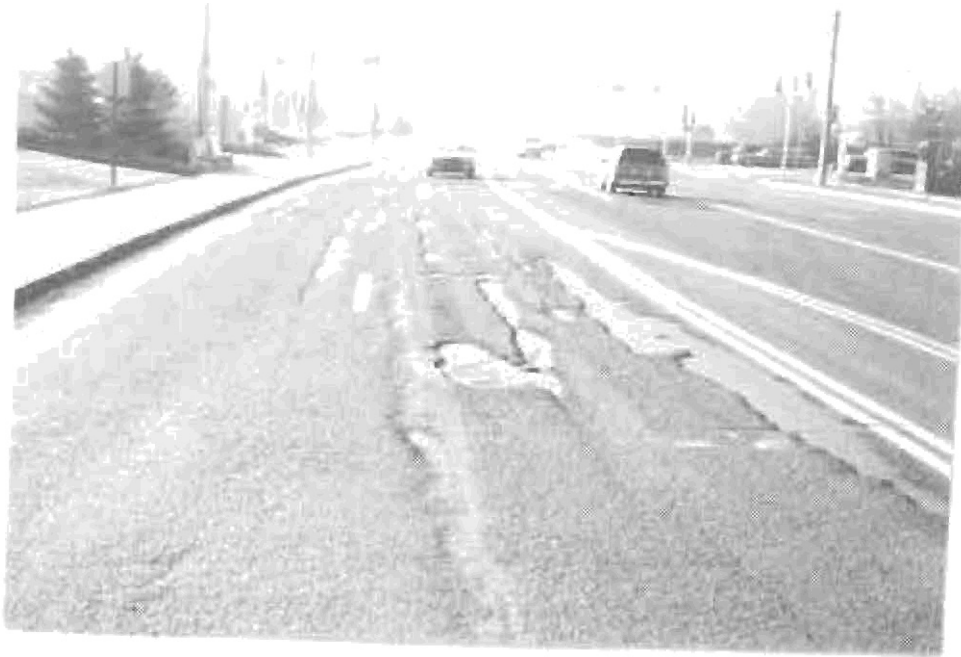
There are several aggregate sources used in HMA pavements that have a notorious history of severe moisture damage. A 6-month old pavement that disintegrated is shown in Fig. 5. Since contractors have not used these aggregate sources on CDOT projects for many years, specific mix designs for the "disintegrators" were difficult to obtain. The mix designs with the aggregate sources thought to be "disintegrators" were reproduced as closely as possible with the help of experienced, long-term employees of the CDOT.

**Fig. 5. A Disintegrator After 6 Months.**
