Report No. CDOT-DTD-R-93-12

# **CURTAIN DRAINS**

Final Report  
December, 1993

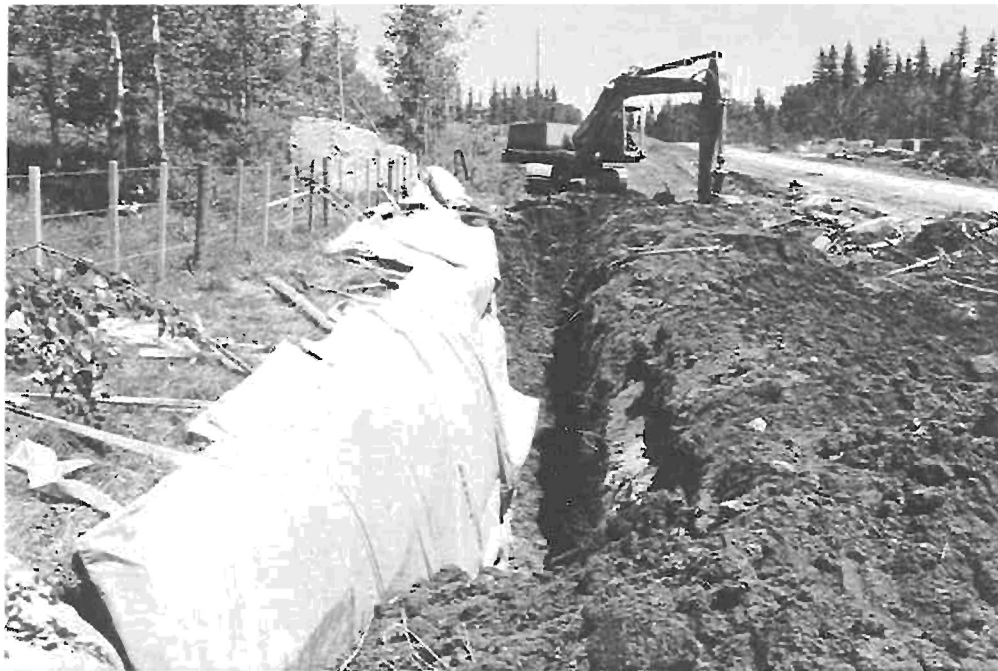
**Figure 4** Pictured here is the installation on the south end of the project. The trench was dug in relatively dry soil which made it easy to hang the curtain drain sections from the fence, place them neatly and backfill the trench.

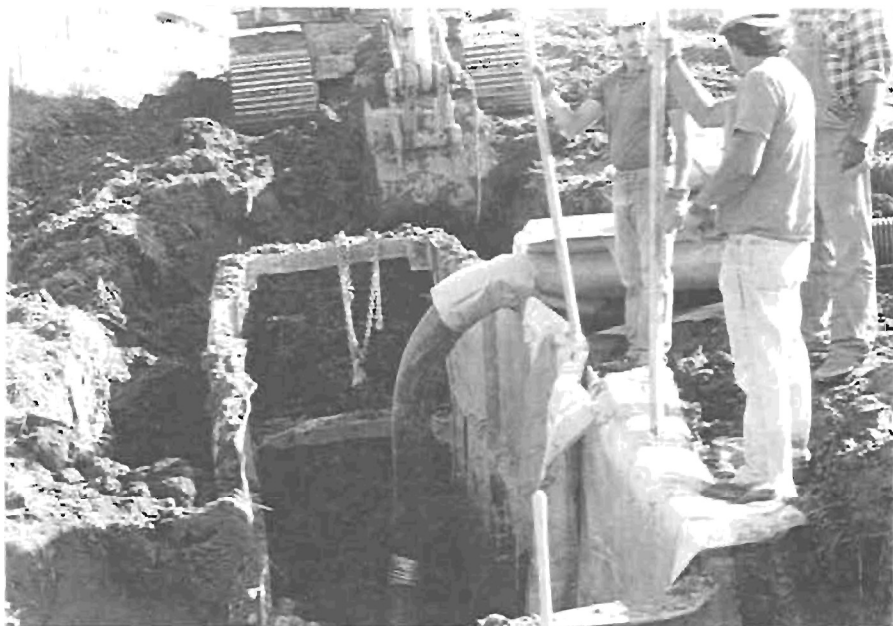
It was during this phase of the installation that the drain sections were buried deeper than they should have been. The drains did not reach near the top of the trench as they should have. Instead, they appeared to be buried about one to one and a half meters (four feet) below the surface. (Upon excavation it was found that the depth was a little more than one and a half meters (five or six feet).)

**Figure 3** On the north side of this project it was necessary to use a trench box to keep the moisture saturated walls of the trench from collapsing. In this photo, the installation operation is progressing away from the camera. The perforated pipe is being fed through the bottom of the next drain section. When the leading backhoe pulls the trenchbox forward, the men on the right side of the photo will use the sticks with hooks to lower the drain sections under the brace and pull them back into place.

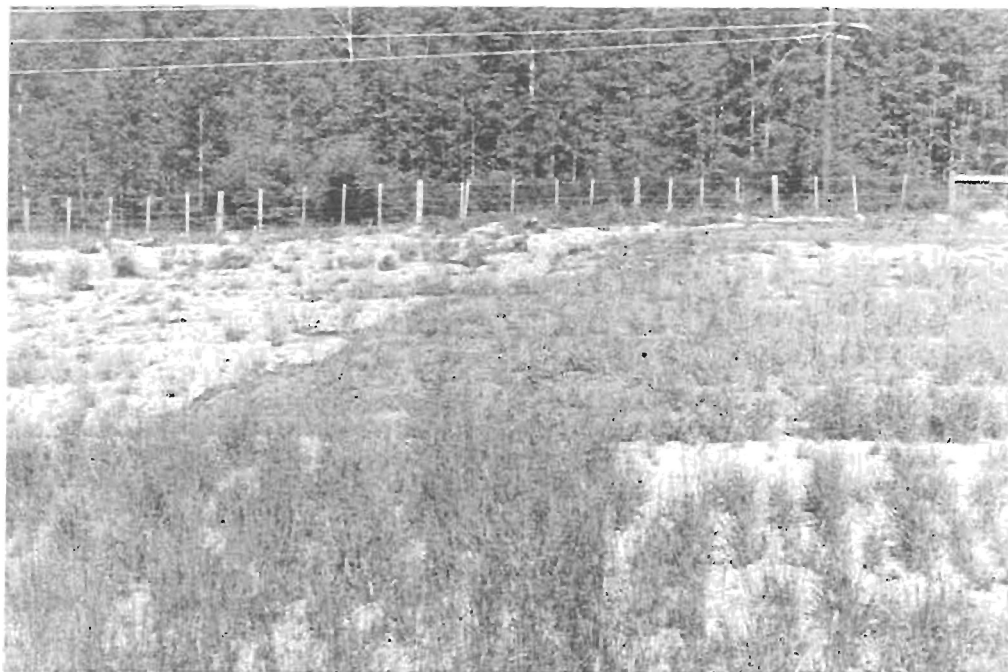
**Figure 10** The dark area in the middle of the photo is where the surface is saturated on the slope below the interceptor ditch and curtain drain. This shows that the system is not completely effective. This photo was taken in July of 1989.

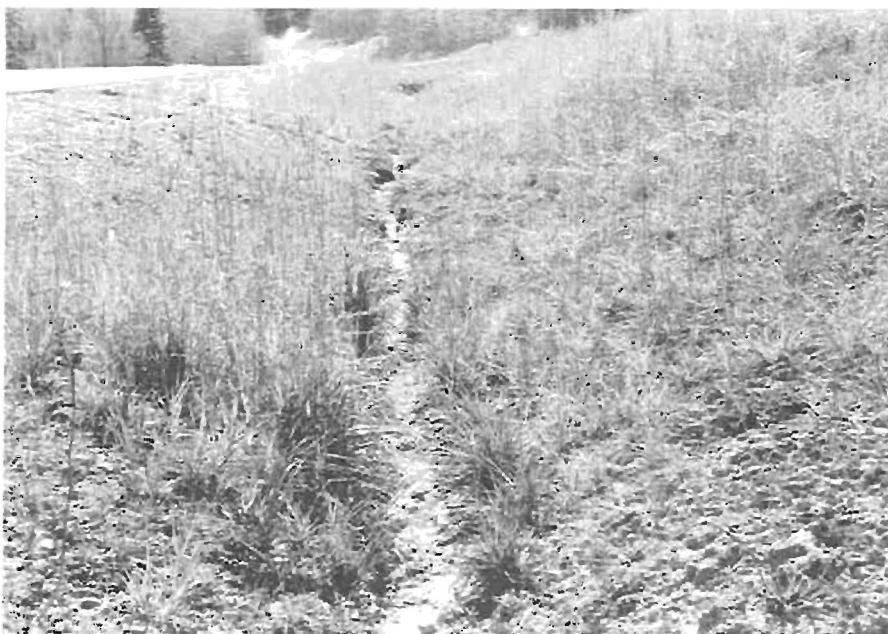
**Figure 11** Water in the ditch at the base of the hill indicated that the ground water level just barely reached the bottom of the ditch in October of 1988.

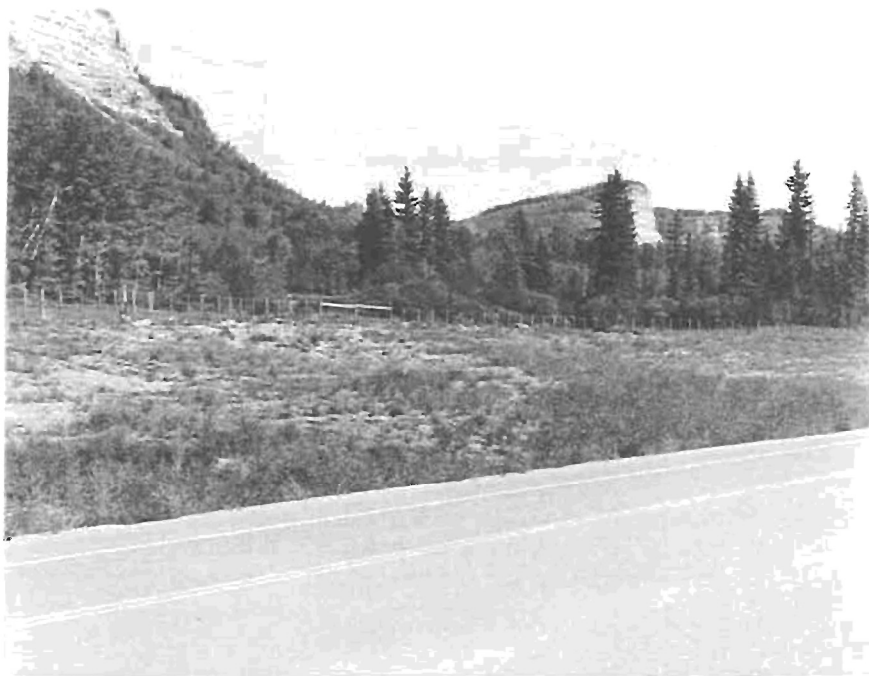
**Figure 12** At the bottom of the hill on the other side of the roadway cattails and other dense wetland vegetation can be seen where the ground water reaches the surface.

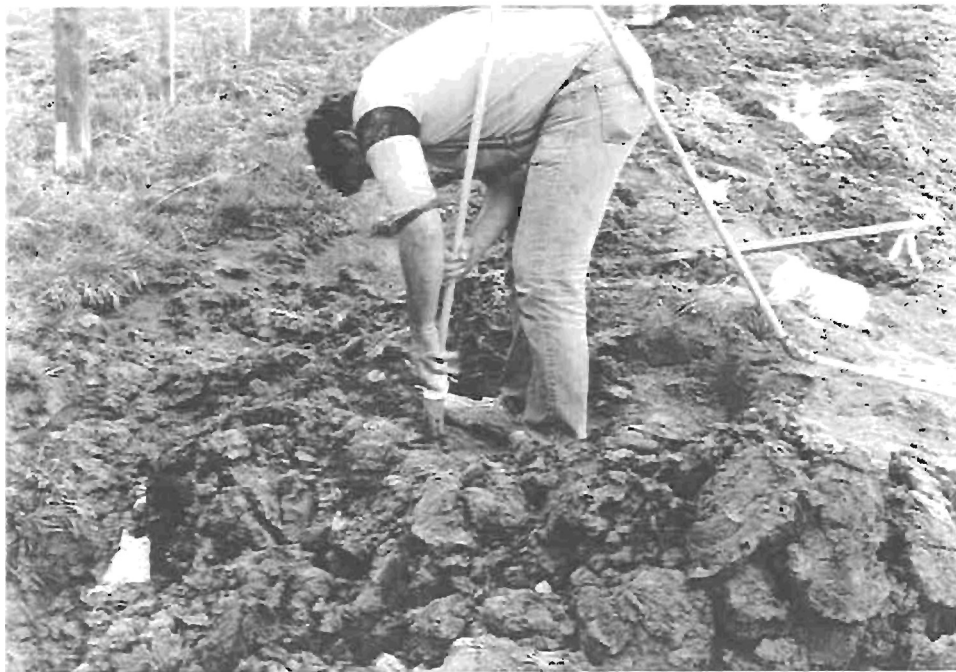
**Figure 16** Water sometimes got into the tube. This made it necessary to extract the water from the tube as is being done in this photo.

When using the nuclear moisture probe method, the moisture tubes can be unreliable and difficult to work with because they can get water in them, which precludes taking readings, and they have a tendency to separate at the couplings.

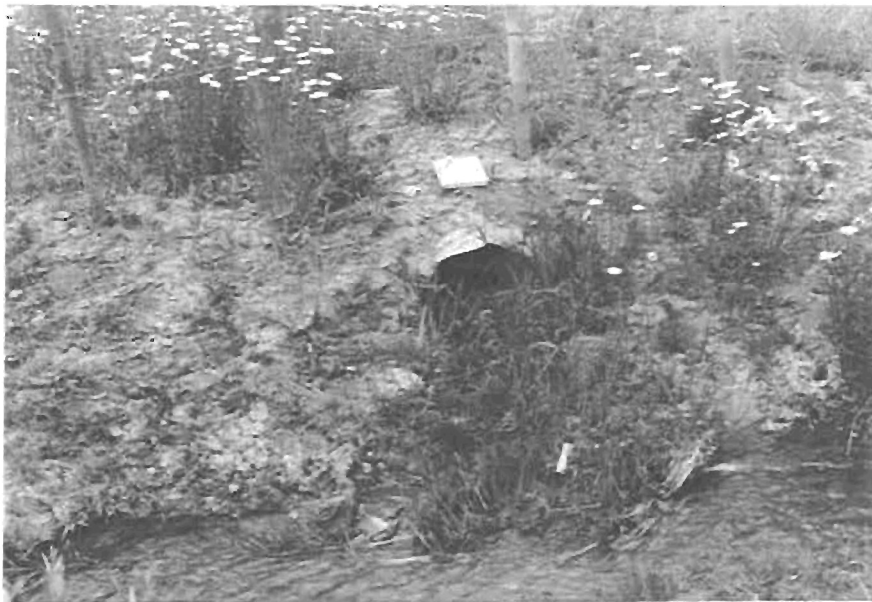
**Figure 20** A relatively small amount of water, as seen coming from this pipe on the east side of the roadway, was collected by the system. The most observed was about 20 liters (5.3 gallons) per minute. The water in the foreground is from the roadside ditches and the channel above the curtain drain.

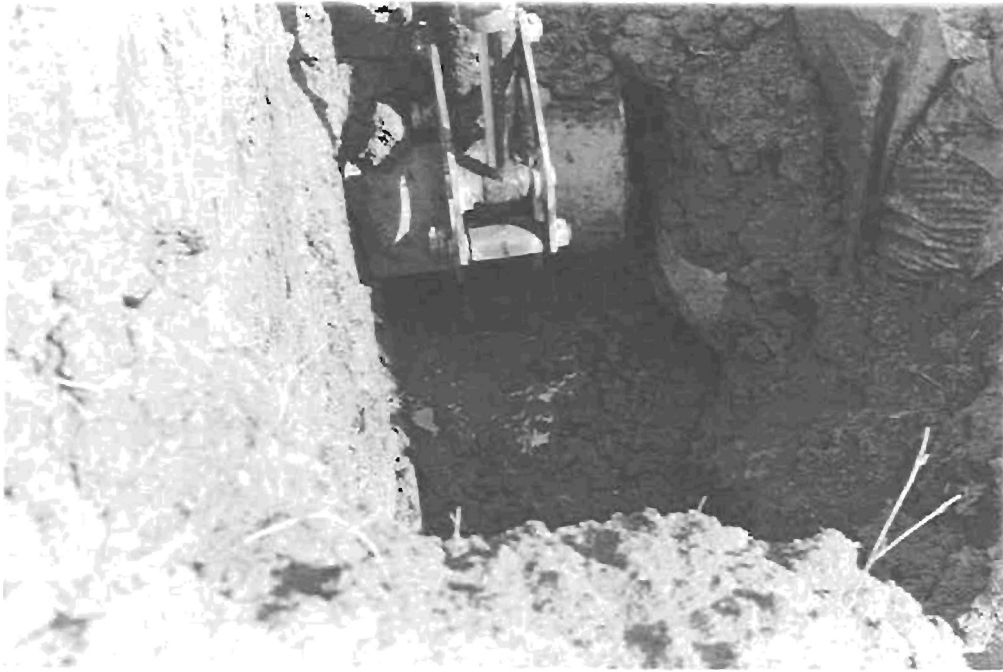
The downhill side was backfilled, and then the uphill side was excavated. When the backhoe reached the bottom of the curtain drain, a section of the drainage pipe at the bottom of the system was accidentally ripped up. Some water from the uphill side of this pipe poured into the hole. This flow seemed to decrease slightly after a short period of time. The hole was widened to provide better access to the damaged pipe. This however cut into some nearby springs and let more water into the hole. The banks began to collapse and fill in the hole again. A two meter section of perforated 8" pipe was finally placed next to the bottom of the uphill side of the curtain drain to hopefully transfer water around the missing pipe section.

The pipe would not have been damaged had it been beneath the curtain drain as expected. Instead it was about 0.6 meters (two feet) off center to the uphill side. No groundwater was encountered flowing next to the curtain drain.

**Figure 22** In September of 1990, a section of the drain was excavated with a backhoe and examined. The top of the curtain drain was found at a depth of almost two meters (six feet). The water in this photo at the bottom of the trench is due to the accidental cutting into the perforated pipe.

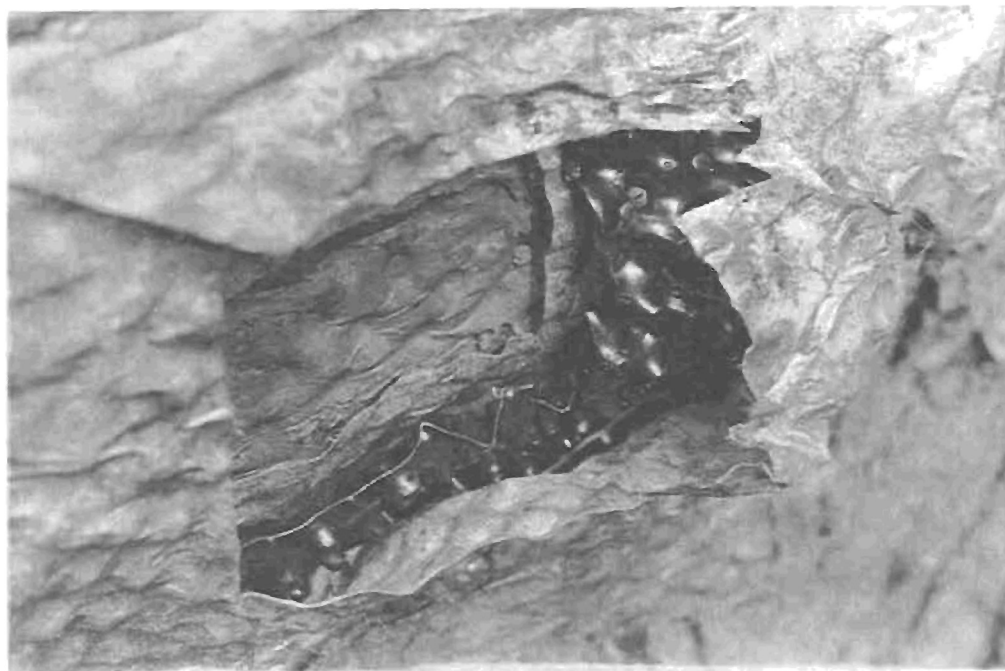
The inside of this piece was completely clean, and the outsides of the filter cloth had only traces of dirt on them. The plastic core of the sample had a few traces of moisture on the uphill side, and was completely dry on the downhill side. The filter fabric was compressed partway into the polyethylene core, but this was probably not a problem since the flow from the soil was slow. At the point where adjacent panels were to overlap, a 20cm (eight inch) gap was found in some places.

**Figure 24** This is a close-up of the area where the curtain drain section was removed. The fabric did not appear to be clogged on either side of the curtain drain. The indentations in the fabric show that the soil was pushing in against the sides and intruding into the open space. There were a few beads of water on the uphill side of the plastic core.

The filter fabric did not appear to be clogged. Though the fabric intruded into the space in the polyethylene core, this did not appear to be a problem in clayey soil. If a great deal of flow were occurring due to fissures or springs, the reduced flow area might cause problems. With the greater soil pressure that occurs at depth, there is a greater chance of the fabric being pushed into the core and the flow impeded.

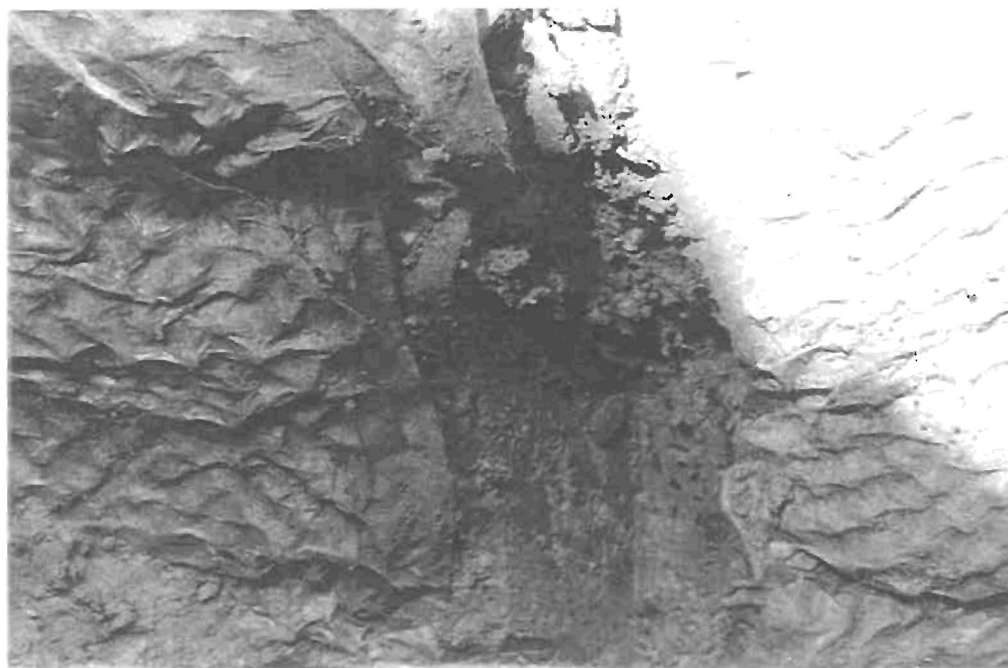
**Figure 25** This photo shows a 20cm (eight inch) gap where adjacent curtain drain sections pulled apart, presumably during construction.
