DOT HS 813 841

**Special Crash Investigations:  
On-Site Child Restraint System  
Crash Investigation;  
Vehicle: 2007 Mitsubishi  
Outlander;  
Location: Indiana;  
Crash Date: January 2023**

**Special Crash Investigations**  
**On-Site Child Restraint System Crash Investigation**  
**Case Number: CR23004**  
**Vehicle: 2007 Mitsubishi Outlander**  
**Location: Indiana**  
**Crash Date: January 2023**

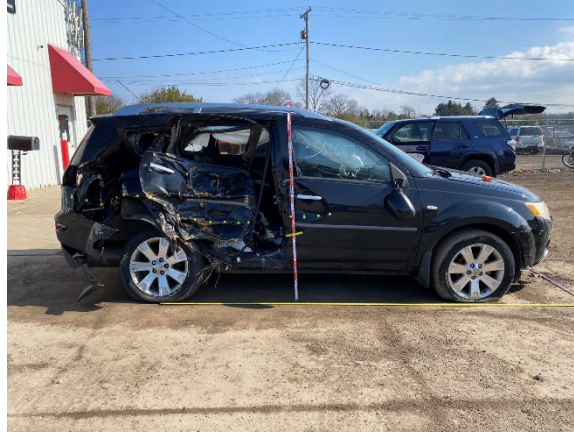
The crash resulted in damage to the Mitsubishi's right side (Figure 6). The direct damage began 145 cm (57.1 in) aft of the right front axle extending rearward 193 cm (75.9 in). The field-L started 127 cm (50.0 in) aft of the right front axle and extended 215 cm (84.6 in) rearward. The crush measurements, taken at mid-door level, were C1 = 9 cm (3.5 in), C2 = 6 cm (2.4 in), C3 = 13 cm (5.1 in), C4 = 13 cm (5.1 in), C5 = 6 cm (2.4 in), and C6 = 0 cm. Maximum crush was 25 cm (9.8 in) located 322 cm (126.8 in) rear of the right front axle. The WinSMASH program's damage algorithm calculated the Mitsubishi's total delta V as 25 km/h (15.5 mph). The longitudinal and lateral velocity changes were -9 km/h (-5.5 mph) and -23 km/h (-14.2 mph). The collision fits model, results appear low. The collision deformation classification (CDC) for this profile was 02RZEW3.

*Figure 6. View of the right-side damage of the 2007 Mitsubishi Outlander*

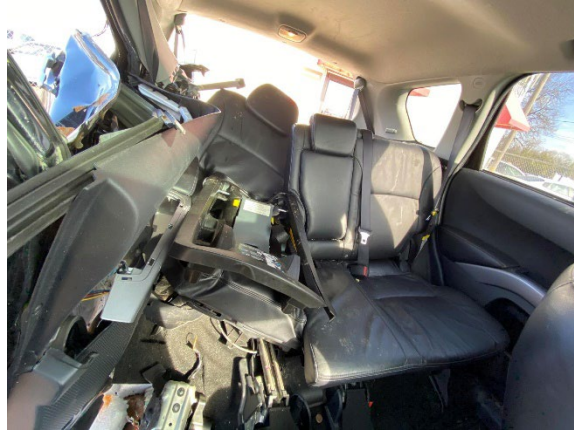
No contact evidence was observed during the SCI inspection of the interior. The Mitsubishi's interior sustained damage that included lateral intrusions (Figure 7) due to impact with the Ford. In the second row, the maximum lateral intrusion was 20 cm (7.8 in) located at the right door rear upper quadrant. Lateral intrusion at the C-pillar was 16 cm (6.2 in). The bottom of the right seat separated from the seat track mount (Figure 8) during the crash sequence. This resulted in the seat cushion deforming 7 cm (2.7 in) laterally and the seatback shifting laterally, to the left, 20 cm (7.8 in). The second-row left floor pan also intruded vertically an estimated 3 to 8 cm (1 to 3 in).

*Figure 7. View of the interior of the Mitsubishi depicting the intrusion of the right rear door and shifting of the right seating position*

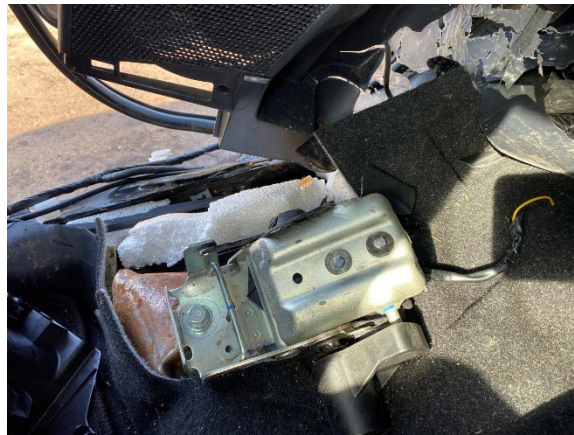
*Figure 8. View of the interior of the Mitsubishi depicting the second-row right seating position track mount*

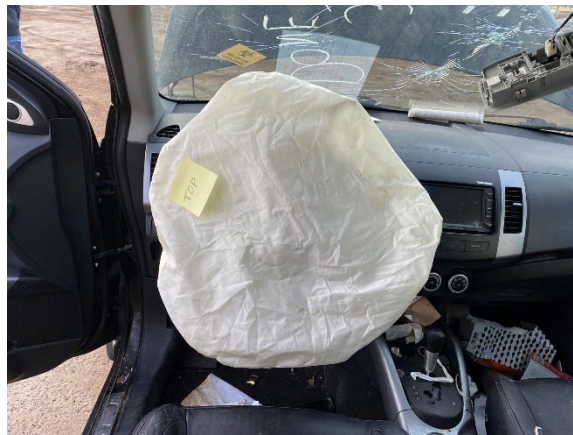
No frontal impact occurred that would result in the deployment of the driver's frontal air bag (Figure 9). The driver's frontal air bag deployment was due to the deceleration from the side impact. No contact evidence was noted on the driver's frontal air bag.

*Figure 9. View of the driver's deployed frontal air bag in the Mitsubishi*

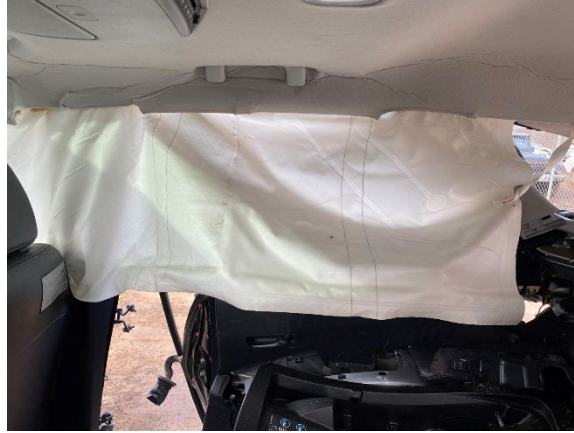
The right IC air bag (Figure 10) deployed during the crash sequence. The right IC air bag extended downward 55 cm (21.7 in) in its deflated state. No contact evidence was noted on the right IC air bag.

*Figure 10. View of the right IC air bag deployed in the Mitsubishi*

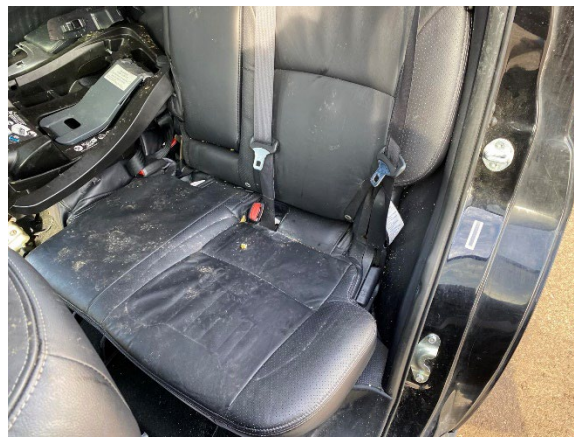
The CRS for the second-row left passenger was a booster seat of unknown manufacture. Evidence on the bottom seat cushion, indicated by the yellow arrow in Figure 11, and seat belt usage indicate that a CRS was in this seating position. There was no booster seat in the vehicle at the time of the SCI inspection. An interview with the Ford driver resulted in confirmation that the child in this seating position was secured to a combination CRS using a 5-point harness.

*Figure 11. View of CRS impressions on the second-row left seating position in the Mitsubishi*

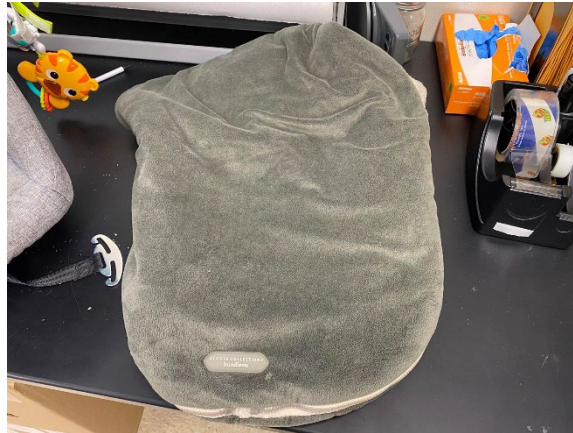
The child was seated within a JJ Cole Collections Bundleme (Figure 14) aftermarket (non-approved) padding. The Bundleme was designed to eliminate blankets in the CRS while allowing the Bundleme padding to not interfere with the belt system of a CRS. At the time of the SCI inspection, there were stains on the Bundleme that were located on the top right and middle right of the interior padding (Figure 15). It should be noted that these were on the opposite side of where the force of the impact initially occurred.

*Figure 14. JJ Cole Collections Bundleme padding that was secured in the CRS located in the second-row right seating position of the Mitsubishi*

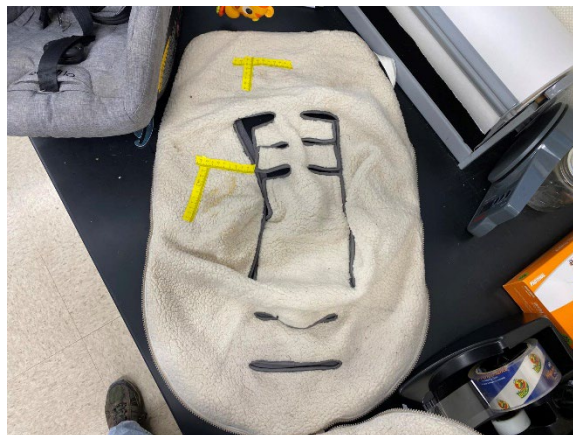
*Figure 15. Stains located within the JJ Cole Collections Bundleme padding at the time of SCI inspection*

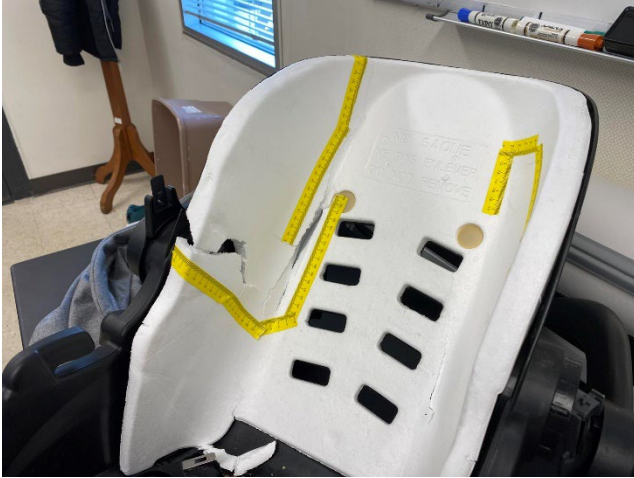
During the SCI inspection, the grey manufacturer padding was removed from the CRS and polystyrene foam (Figure 16) was found to be damaged. The inboard surface of the CRS polystyrene foam was cracked vertically due to the compression of the intruding door. The CRS's left side had two indentions (Figure 17) within the polystyrene foam indicative of an object or occupant contacting the polystyrene foam.

*Figure 16. View of the polystyrene foam padding on the seat back of the CRS*

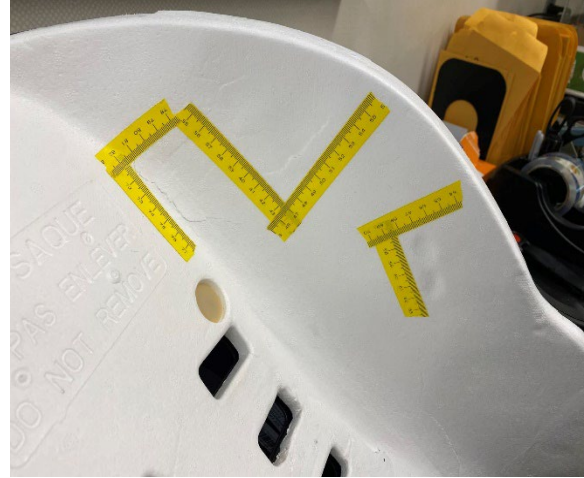
*Figure 17. View of contact points on the left side of the CRS*

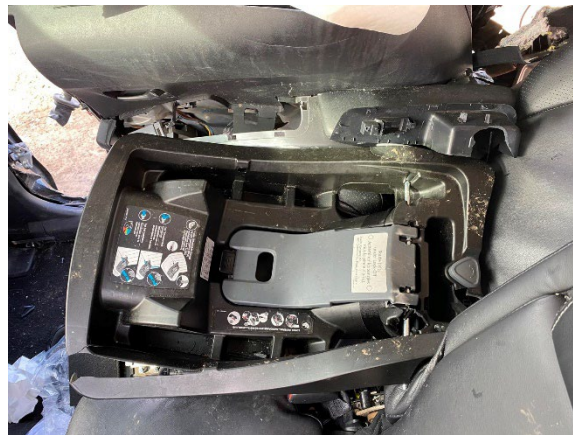
At the time of the inspection, the CRS base (Figure 18) appeared to have been secured properly to the anchor points located in the second-row right seating position. Due to the extent of the damage to the interior, it cannot be determined if the CRS base was level at the time of installation or not. The manufacturer label (Figure 19) stated that it was produced on September 20, 2021, with an expiration date of September 20, 2027.

*Figure 18. CRS base that was secured in the second-row right seat of the Mitsubishi*

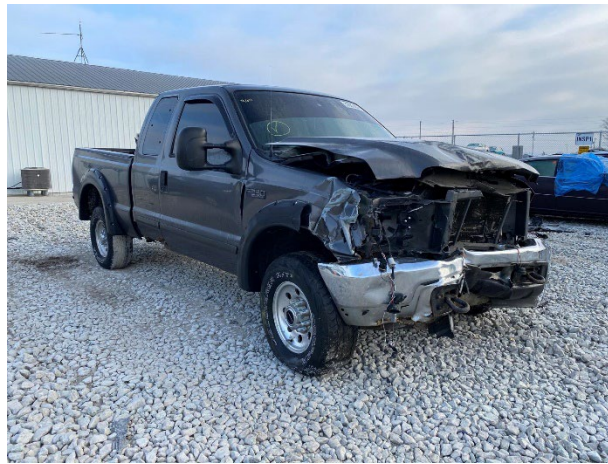
*Figure 20. Front right oblique view of the 2002 Ford F-250*

The Ford sustained direct damage to the front during the crash with the Mitsubishi. The direct damage started 88 cm (34.6 in) left of center extending right 176 cm (69.3 in). The field-L started 88 cm (34.6 in) left of center extending right 176 cm (69.3 in) rearward. The crush measurements, taken at bumper level, were C1= 1 cm (0.4 in), C2 = 8 cm (3.1 in), C3 = 18 cm (7.1 in), C4 = 32 cm (12.6 in), C5 = 19 cm (7.5 in), and C6 = 32 cm (12.6 in). Maximum crush was 32 cm (12.5 in) located 15 cm (5.9 in) right of the front center point. The damage algorithm of the WinSMASH program calculated the Ford's total delta V as 16 km/h (9.9 mph). The longitudinal and lateral velocity changes were -16 km/h (-9.9 mph) and 3 km/h (1.8 mph). The analysis fit the collision model and the results appeared low. The CDC for this damage profile was 12FDEW2.
