Report No. CDOT-DTD-R-91-4

# **RUT-RESISTANT COMPOSITE PAVEMENT DESIGN**

Donna S. Harmelink  
Colorado Department of Transportation  
4201 East Arkansas Avenue  
Denver, Colorado 80222

Final Report  
July 1991

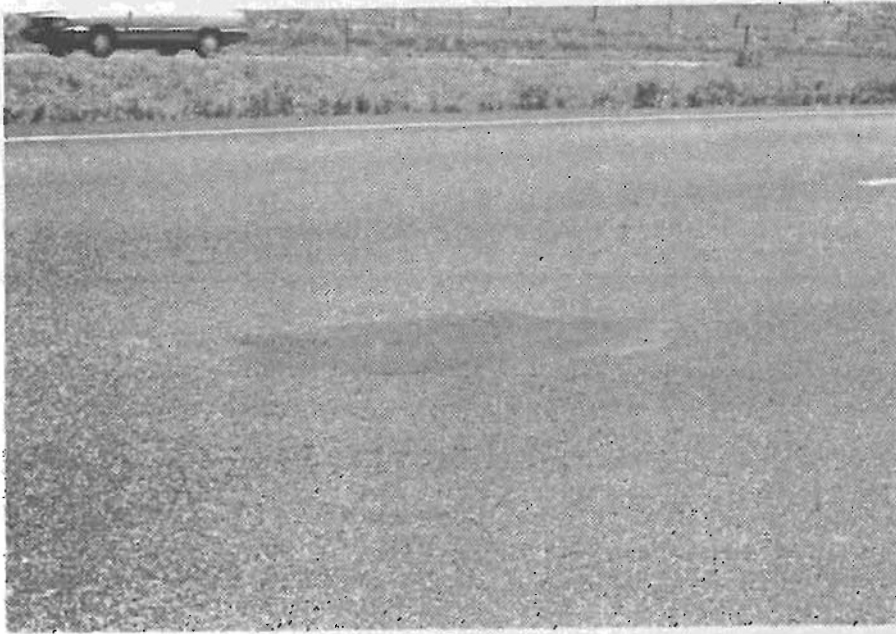
PHOTO 6

Photos 6 through 10 show examples of the failures on the C470, between US 285 and I-70 and on the I-70, east of Agate locations. Photo 9 taken on I-70, east of Agate was taken before this site was added to this study. Photo 10 was taken after the rehabilitation of the RRCP. This pavement was not a high-stability (RRCP) design.

C470, US 285 to I-70  
The first sign of the stripping failure is the appearance of rich spots on the surface. These rich areas are randomly spaced and typically found in the wheel paths.

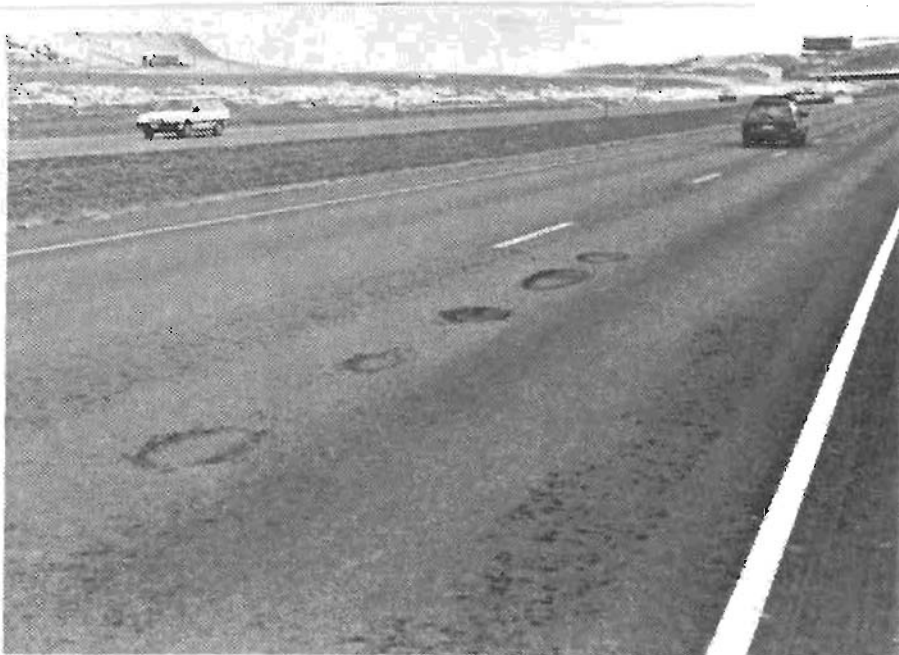
PHOTO 7

C470, US 285 to I-70  
This photo shows areas which have stripped under the PMSC. Evidence of raveling in the right wheel path is a result of extensive stripping in the RRCP layer below the PMSC.

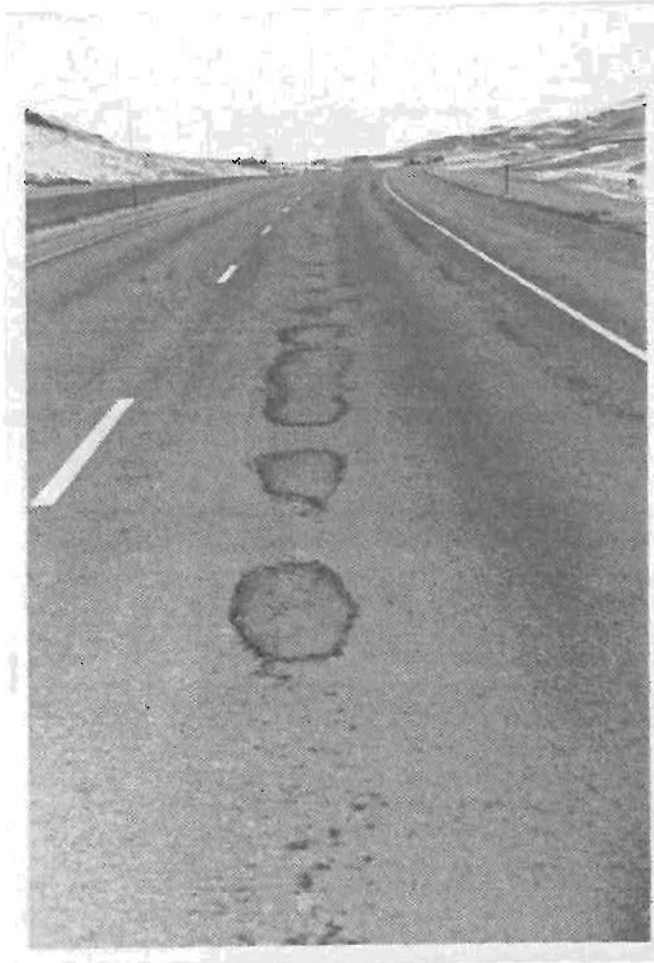
PHOTO 8

C470, US 285 to I-70  
This type of  
distress was found  
throughout the  
project.

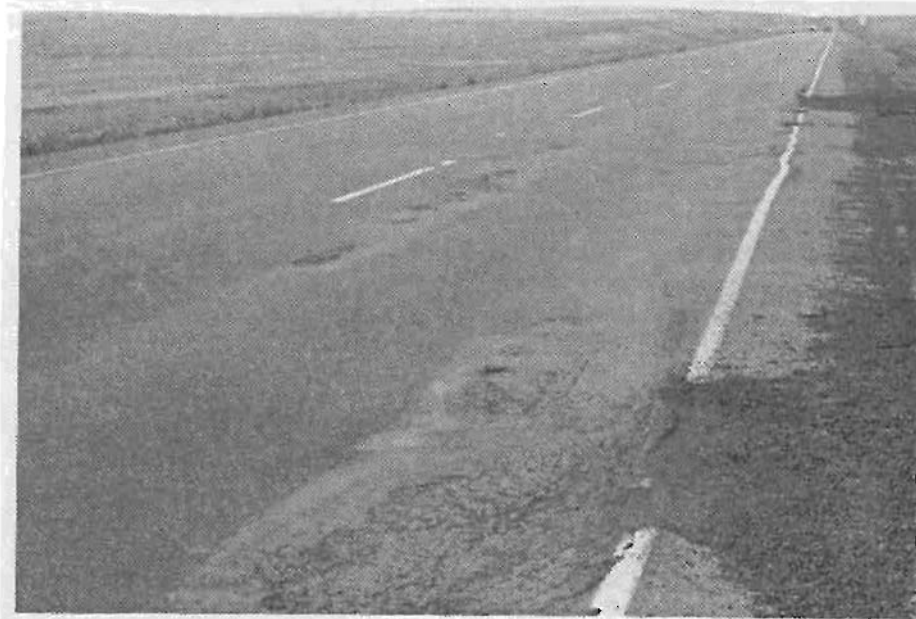
PHOTO 9

This photo was  
taken on I-70, east  
of Agate eight  
months after  
construction using  
the RRCP design.  
This type of  
distress was  
typical throughout  
the project.

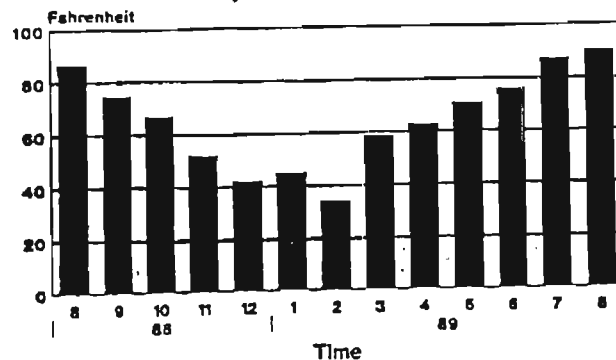
High moisture, moderate moisture susceptibility, high traffic

Failed in 7-89

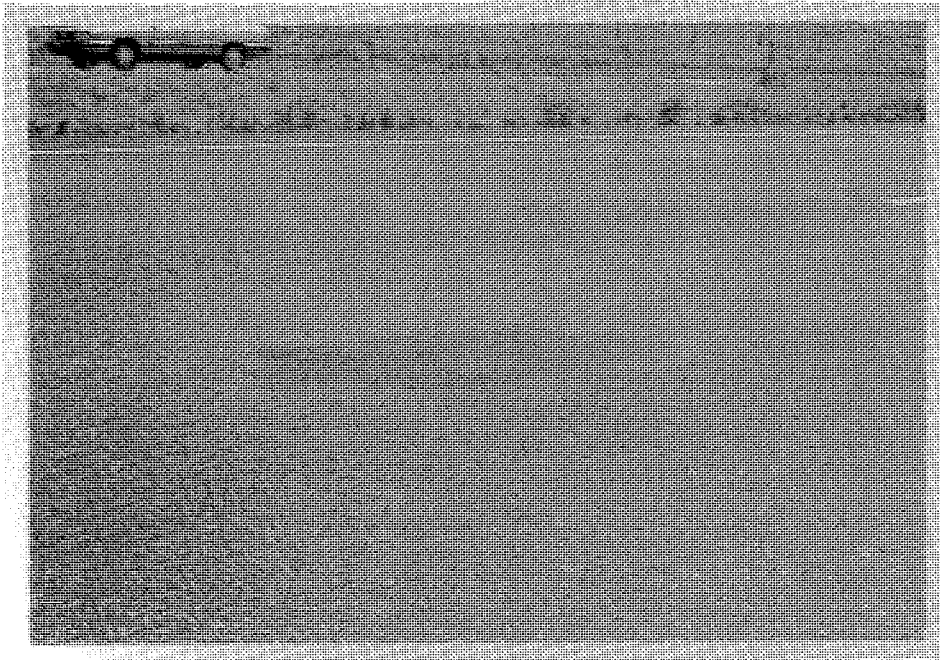
PHOTO 6

C470, US 285 to I-70  
The first sign of the stripping failure is the appearance of rich spots on the surface. These rich areas are randomly spaced and typically found in the wheel paths.

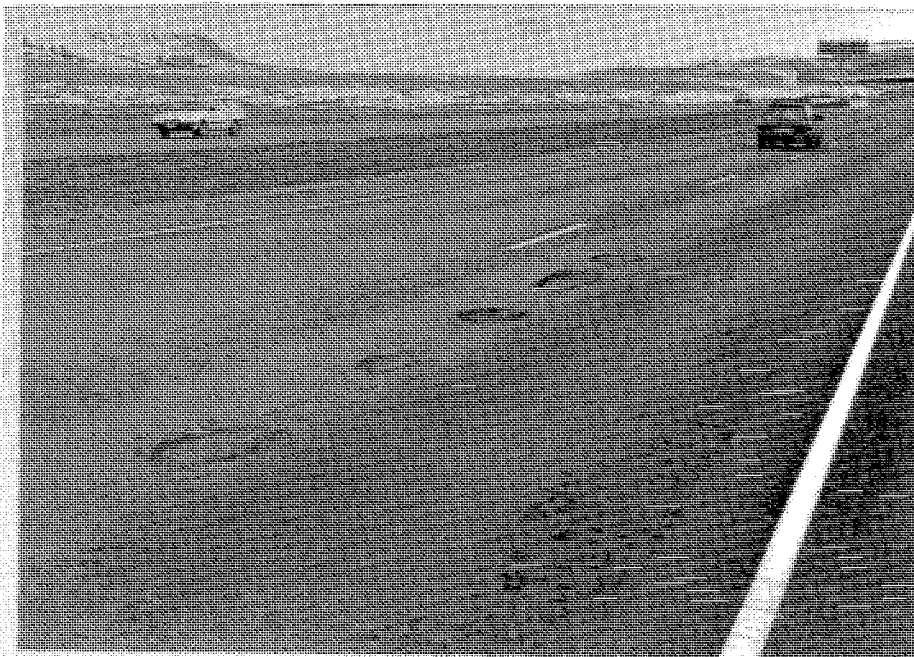
PHOTO 7

C470, US 285 to I-70  
This photo shows areas which have stripped under the PMSC. Evidence of raveling in the right wheel path is a result of extensive stripping in the RRCP layer below the PMSC.

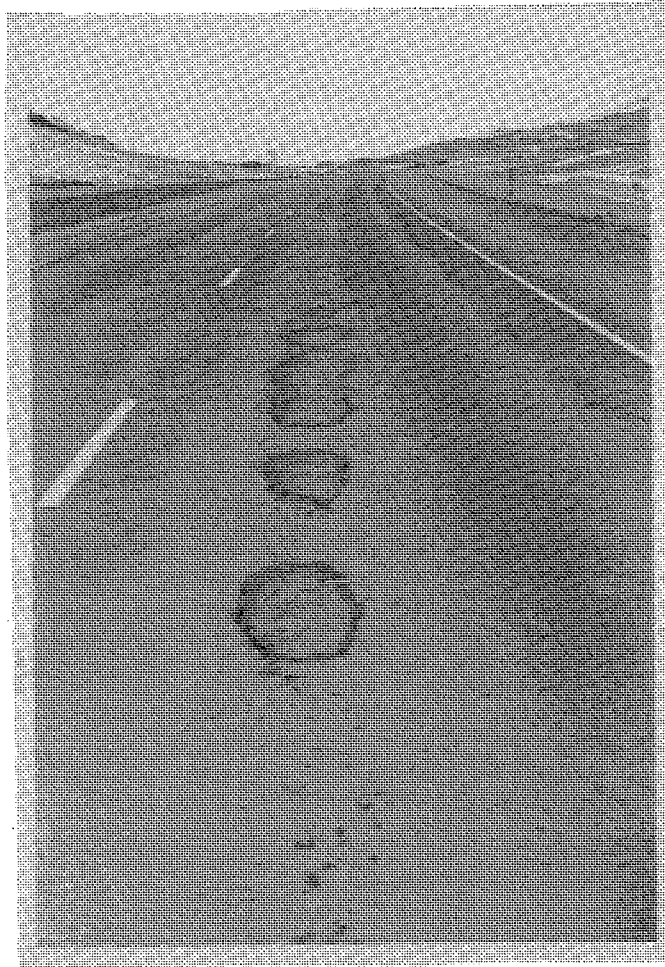
PHOTO 8

C470, US 285 to I-70  
This type of  
distress was found  
throughout the  
project.

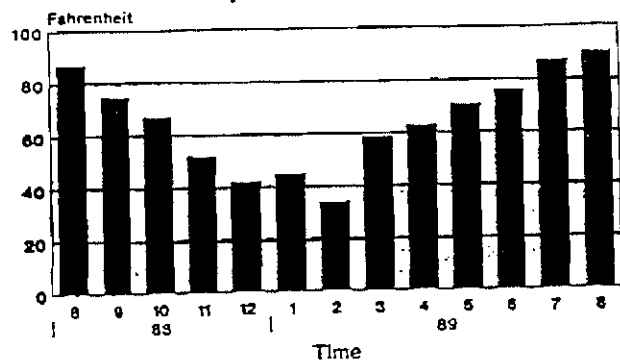
High moisture, moderate moisture susceptibility, high traffic

Failed in 7-89
