# Performance Evaluation of KYTC Bridge Deck Overlays Used for Maintenance Activities

Report Number: KTC-26-01

**September 2025**

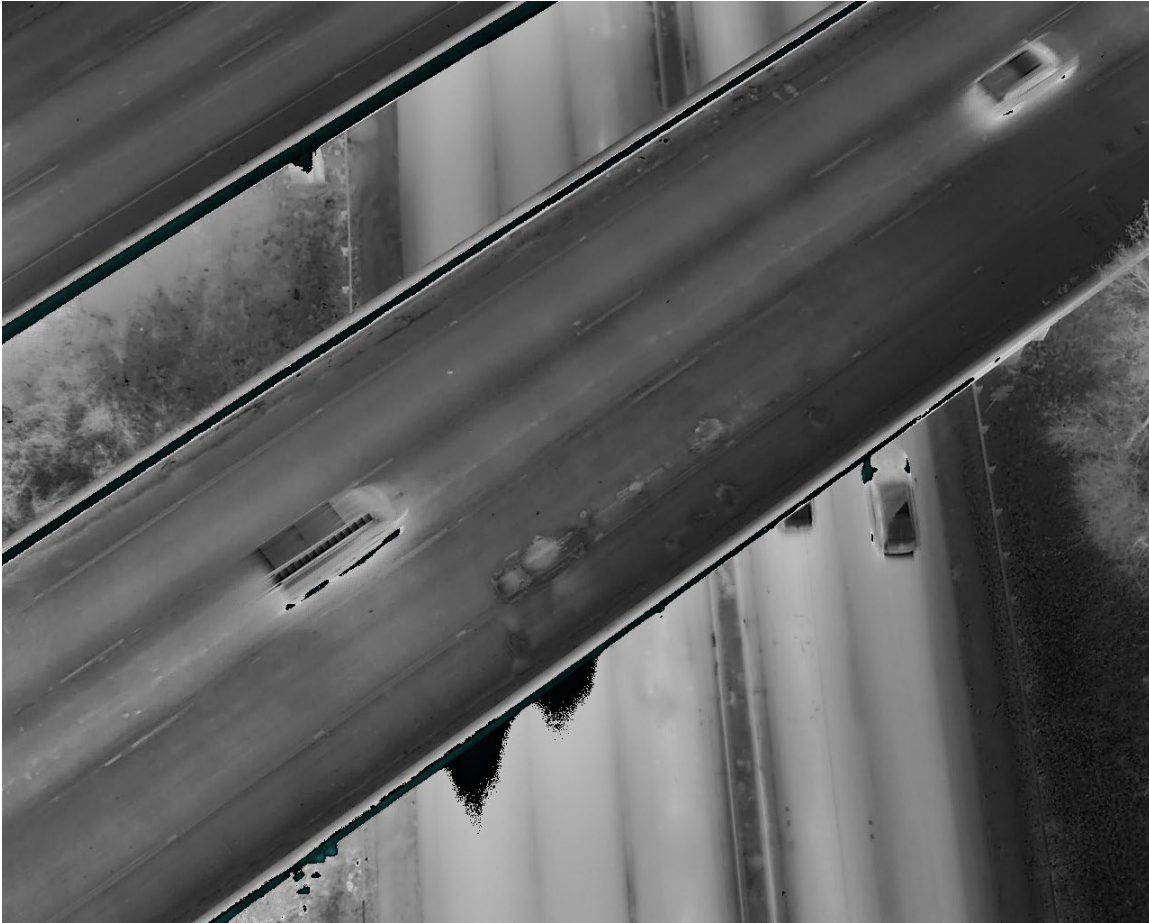
**Figure 3.9** Drone Image of Patched Bridge Deck

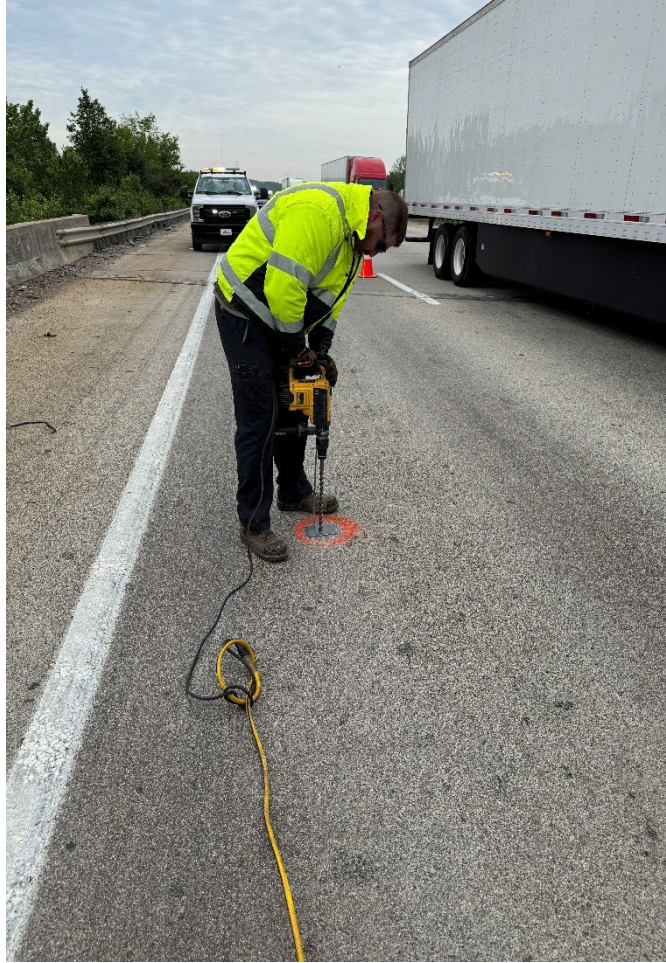
**Figure 3.10** Drilling for Chloride Sample in the Wheel Path

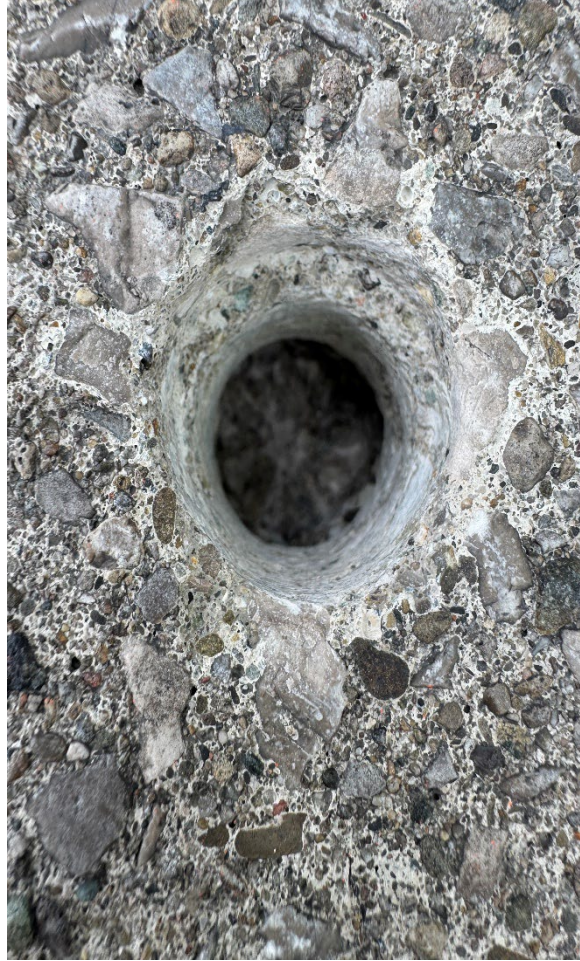
**Figure 3.11** Sampling Hole After Collection of Concrete Deck Dust

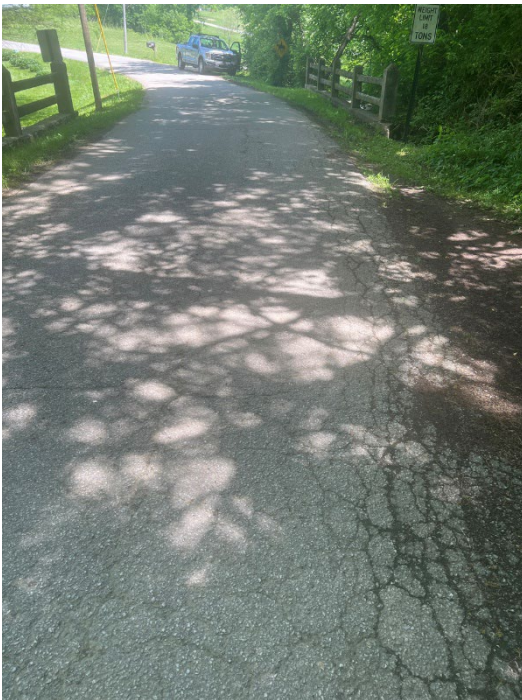
**Figure 3.15** Trees Blocking Sunlight

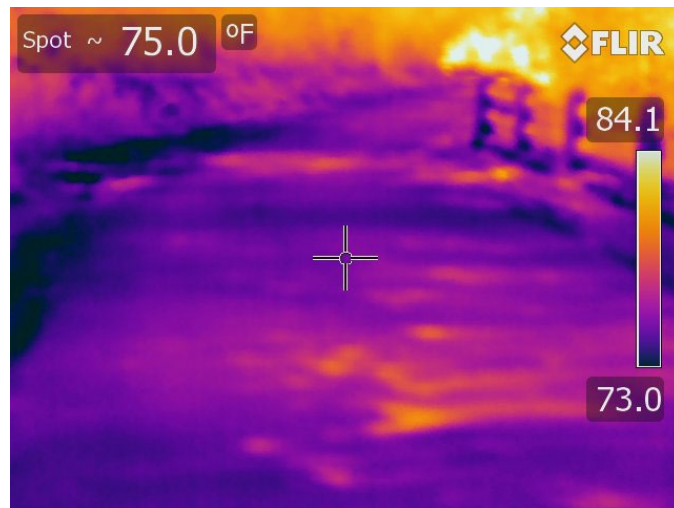
**Figure 3.16** FLIR Image Shows No Pronounced Temperature Difference

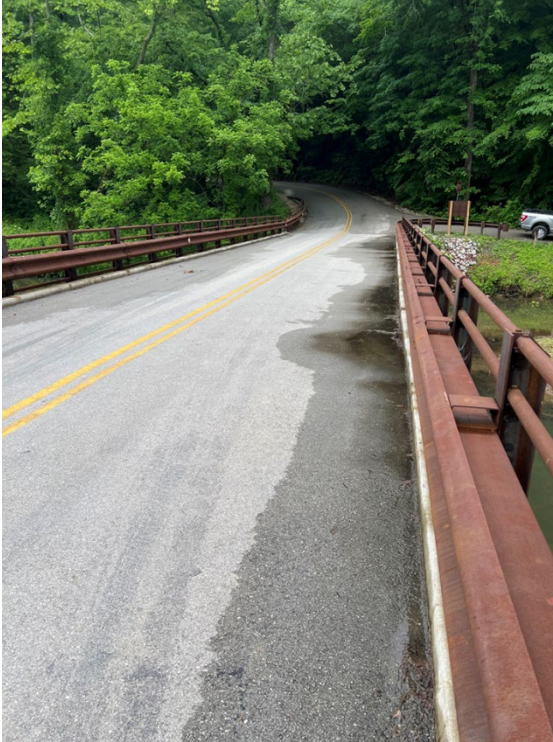
**Figure 3.17** Water Pooling in gutter line Following Cold Rain.

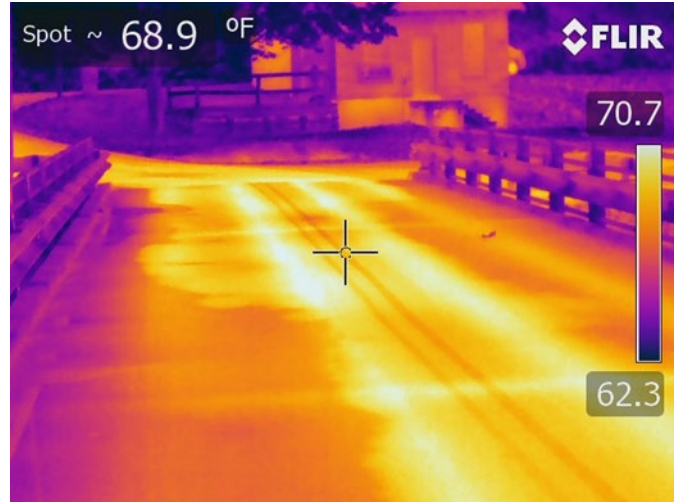
**Figure 3.18** FLIR image of Water Pooling Showing Up as Possible Delamination
