DOT/FAA/CT-93/78
DOT-VNTSC-FAA-93-10

Full-Scale Testing and Analysis of Curved Aircraft Fuselage Panels

December 1993

Final Report

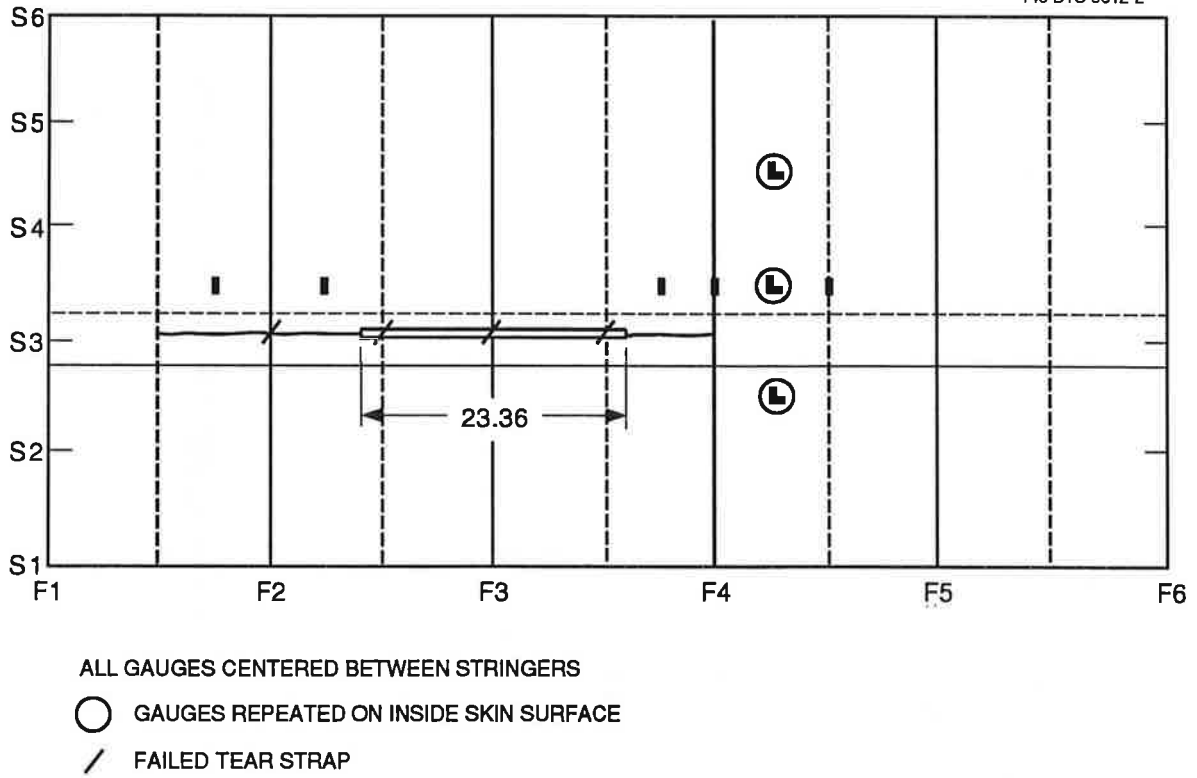
Figure 9. Panel 8 - After Fracture

For the failure tests of Panels 8 and 9, the internal panel pressure was increased at a constant rate of 1 psi per second. Stable crack growth began in Panel No. 8 at approximately 7 psi. The total crack extension reached 0.1 in. at 8.6 psi. The center tear strap at F3 failed at 9.4 psi. From review of the videotape, (referring to the F3 tear strap failure as time zero) the tear strap between F2 and F3 failed at 0.37 sec and the tear strap between F3 and F4 failed at 0.40 sec. The tear strap at F2 then failed at 0.70 sec and pressurization could not be maintained. The final crack is shown in Figure 9. A photograph of the failed panel is shown in Figure 10.

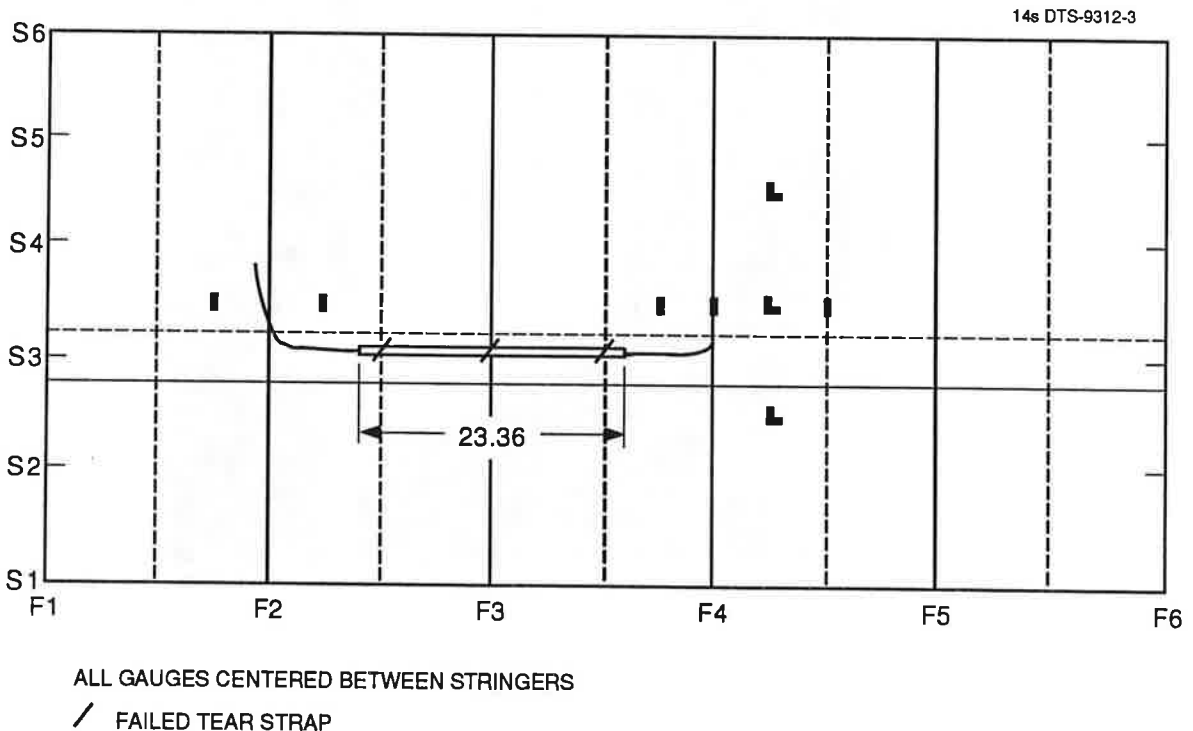
Figure 11. Panel 9 - After Fracture

Stable crack growth began in Panel No. 9 at approximately 6.2 psi. The total crack extension reached 0.1 in. at 7.5 psi. The center tear strap at F3 and the midframe bay tear straps on either side of F3 all failed at 10.5 psi. From the crack

propagation gauges and the close-up videotape, it is evident that the first ligaments past the lead crack tips failed completely approximately 2 sec prior to the tear strap failures. Further from the videotape, the crack turns at F2, resulting in a flapping failure, 0.27 sec after failure of the tear straps. The final crack is shown in Figure 11. A photograph of the failed panel is shown in Figure 12.

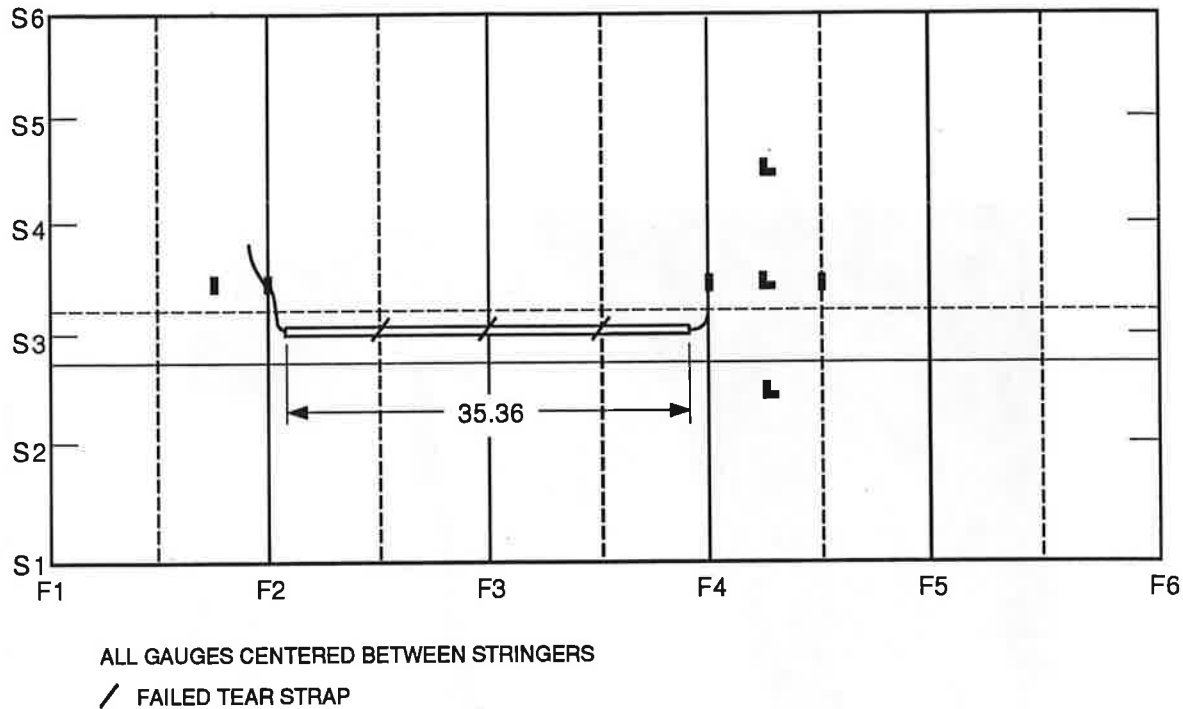
Figure 18. Panel 14 - After Fracture

frame and then turned approximately 1 in. away from the lap splice. From review of the videotape, the turned crack at F2 continued to grow after 1.1 sec and progressed to 7.5 in. away from the lap splice. The tear strap at F2 did not fail. The final crack is shown in Figure 18. A photograph of the failed panel is shown in Figure 19.

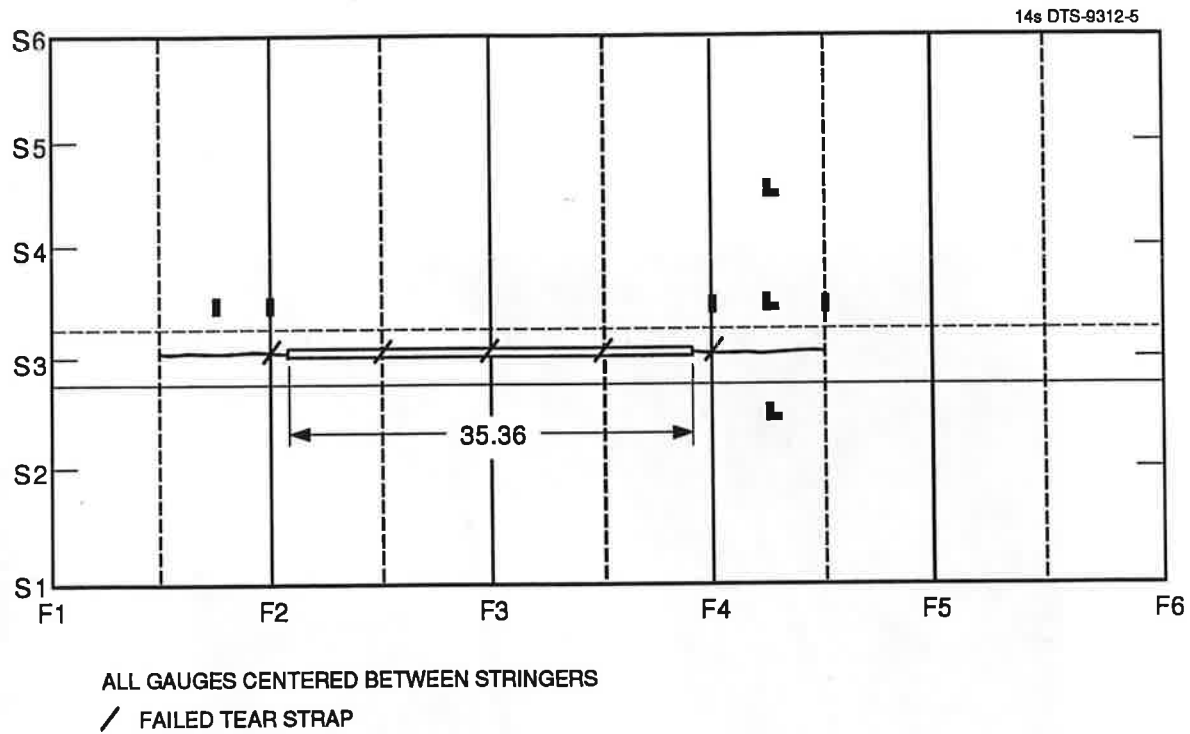
Figure 20. Panel 15 - After Fracture

Stable crack growth was observed in Panel No. 15 at approximately 3.5 psi. The total crack extension reached 0.1 in. at 5.9 psi. Stable crack growth resulted in the failure of the first ligament nearer F4 at 7.2 psi. Further incremental pressure increases were applied and failure of the first ligament nearer F2 was recorded at 7.8 psi. The center three tear straps also failed at this time and the crack grew in both directions to the next frame. The tear strap at F2 failed 0.7 sec later and that crack tip began to grow toward the next tear strap. At 0.9 sec after initial failure, the crack had propagated to the tear strap between F4 and F5. At this same time, the tear strap at F2 failed, the crack grew immediately to the next tear strap, and pressure could not be maintained. The final crack is shown in Figure 20. A photograph of the failed panel is shown in Figure 21.

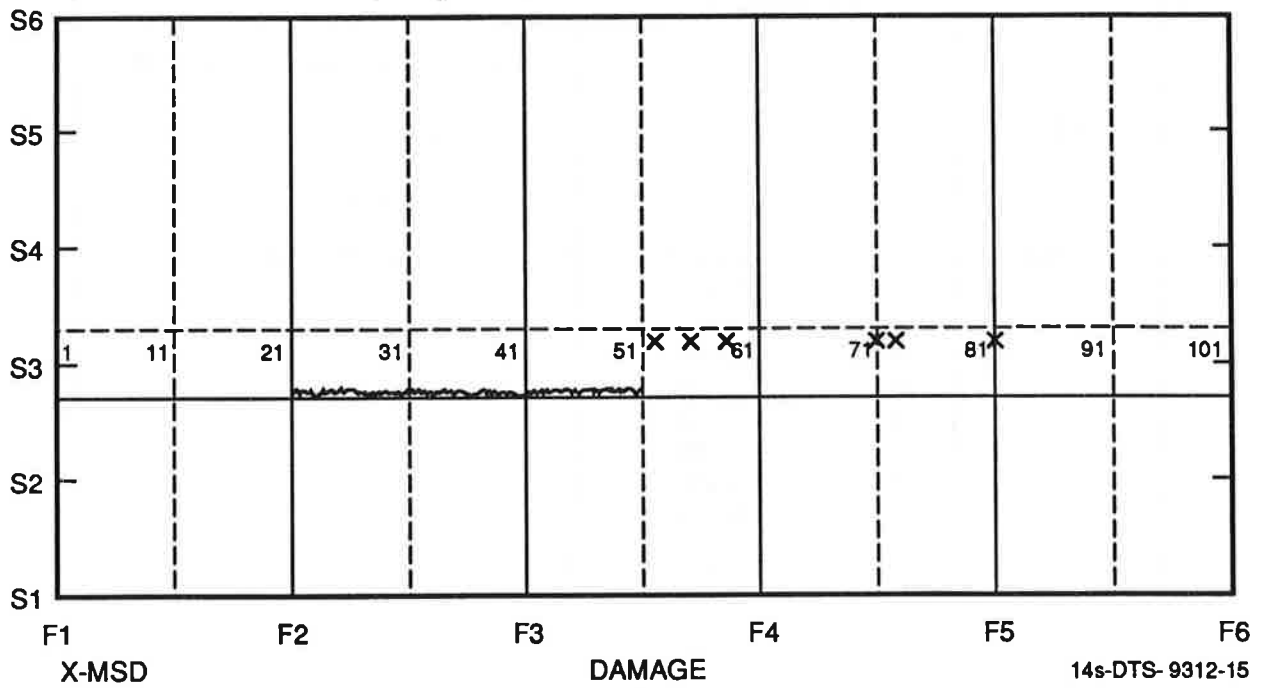
Figure 38. Test Panel No. 12 After Fracture

visible along the upper rivet row. At 114,571 cycles, lap joint leakage became pronounced. Upon inspection, link-up had occurred between rivets 35-37 on the lower rivet row. The panel fractured at 115,755 cycles. The failure occurred from rivets 22 through 51 on the lower rivet row, which ruptured the lower skin, as shown in Figures 38 through 40. No tear straps were broken.
