FRA-76-7-II
REPORT NO. FRA/ORD-76/303,II

TRAIN-TO-TRAIN REAR END
IMPACT TESTS
Volume II - Impact Test Summaries

MARCH 1977

FINAL REPORT

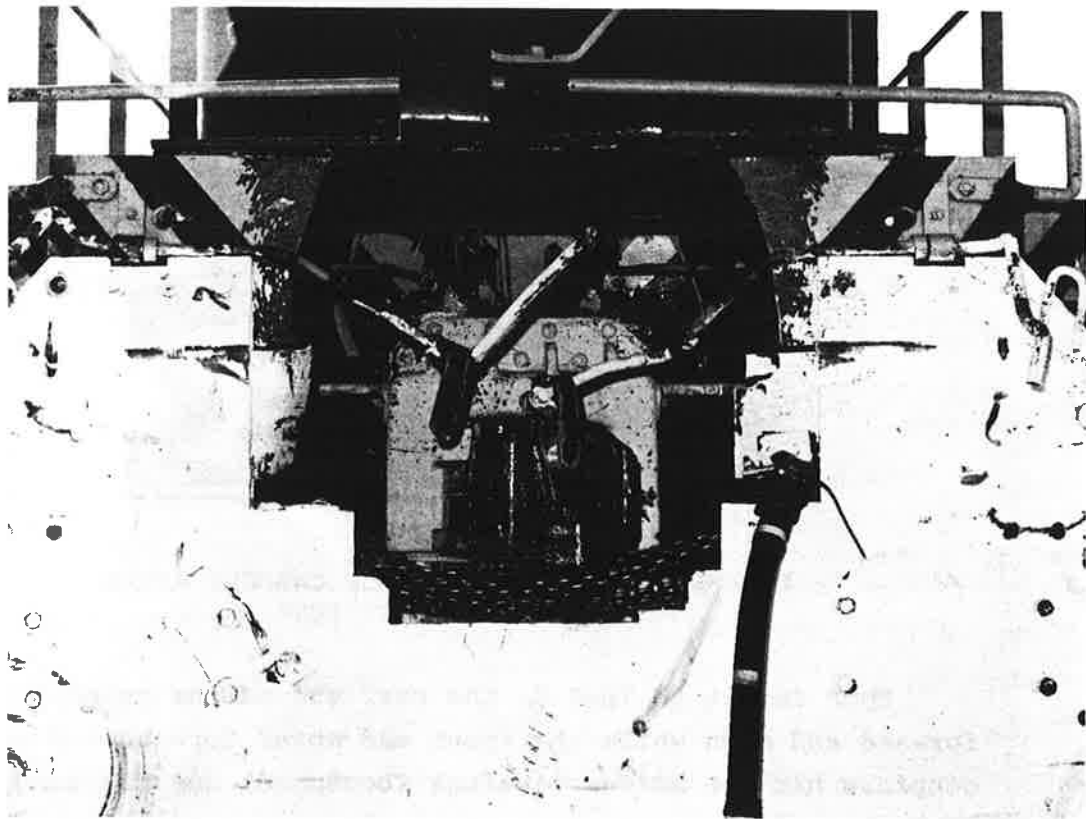
these impact tests. Figures 20, 21, and 22 show the locomotive draft gear, the caboose crushed end platform, and the sheared rivets from the locomotive. To avoid this problem in Test 8, the draft gear assembly on the impacting locomotive was reinforced by welding thick plates from the frame rails to the draft gear. This reinforcement brought the draft gear strength to a higher level that is more representative of modern locomotives.

FIGURE 20. SHEARED DRAFT GEAR AFTER 10-MPH IMPACT TEST.

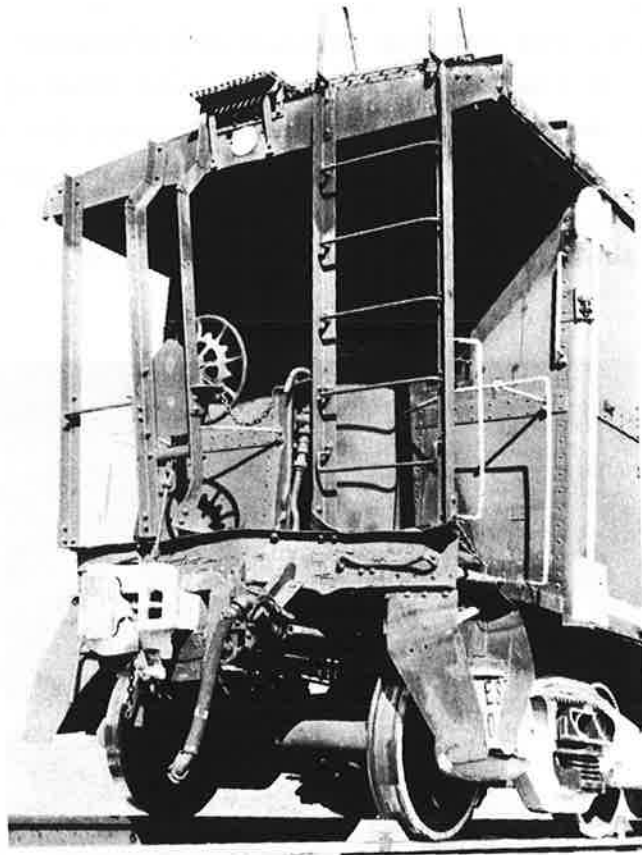
FIGURE 21. CRUSHED END OF CABOOSE AFTER 10-MPH IMPACT TEST.

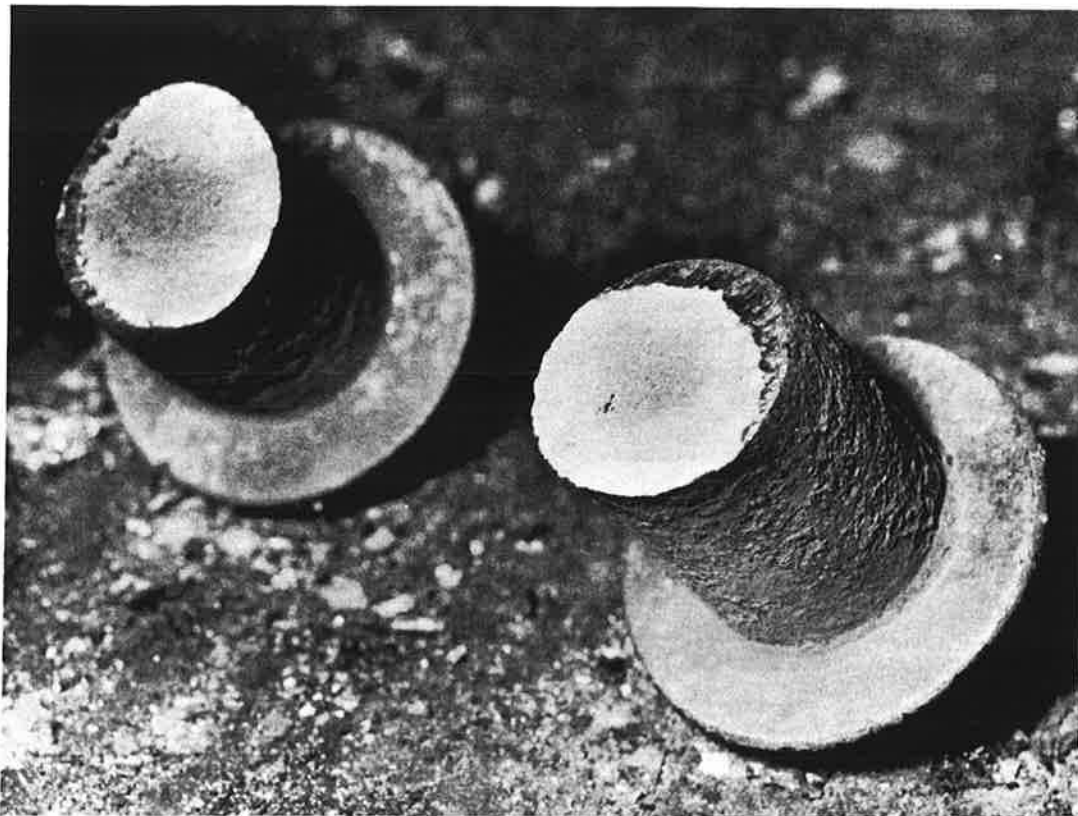
FIGURE 22. SHEARED DRAFT GEAR ASSEMBLY RIVETS
AFTER 10-MPH IMPACT TEST.

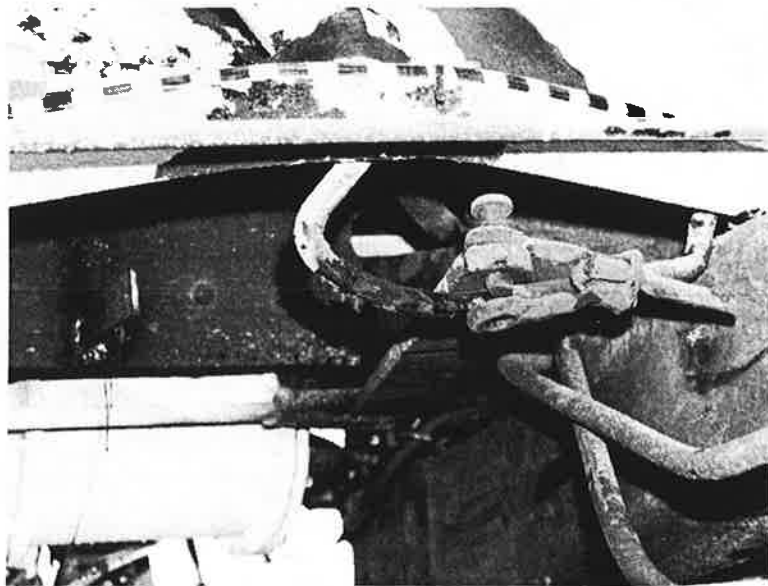
The time at which these buckles occurred and the magnitude of the buckle are important in determining the subsequent course of events. For Test 8, the caboose had time to rotate until the couplers between the caboose and hopper were beginning to disengage vertically, before the forces built up enough to buckle the sills. The speed was slow enough that the couplers bent and completely disengaged before the sill buckles could progress further. As will be seen in the higher speed impact (Test 9), the caboose did not have time to rotate before forces built up

FIGURE 23. POST-TEST BUCKLE OF CABOOSE CENTER SILL - TEST 3.

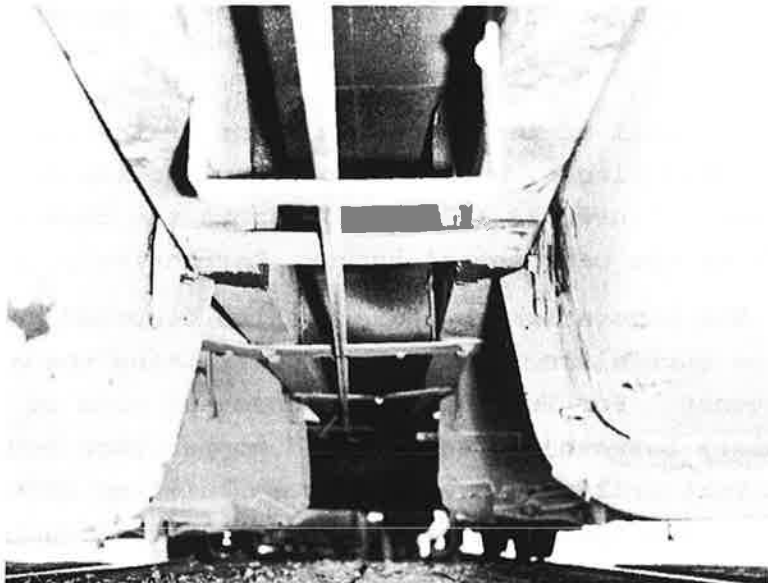
FIGURE 24. POST-TEST BUCKLE OF HOPPER CENTER SILL - TEST 3.

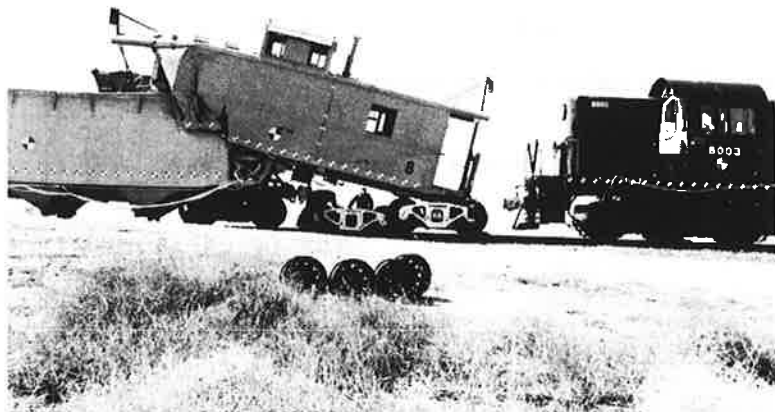
The 18.1-mph impact caused extensive damage to a caboose and one hopper. Table 2 is a list of the significant damage observed after the test. Also associated with the damage is a list (Table 3) of debris near the track as a result of the impact. All measurements were taken laterally from the south rail. Note that anything to the north and less than 4 feet 8 inches was between the rails.

FIGURE 26. POST-TEST CABOOSE AND HOPPER - TEST 8.

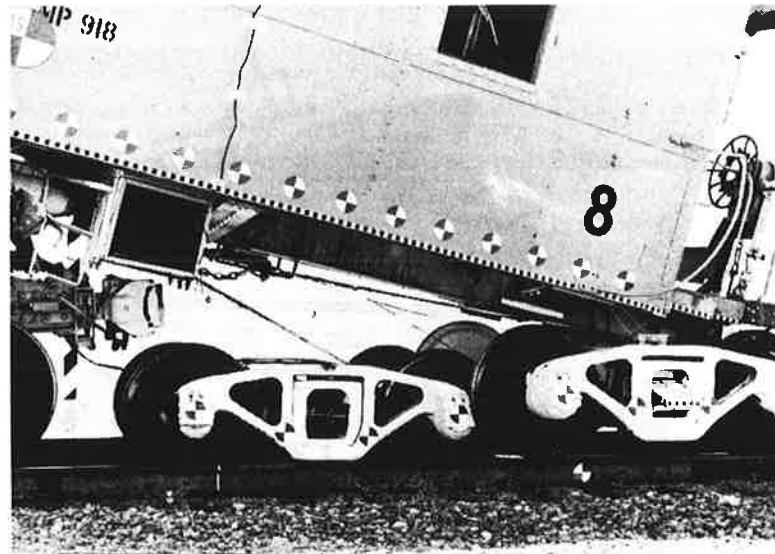
FIGURE 27. POST-TEST REAR END OF CABOOSE - TEST 8.

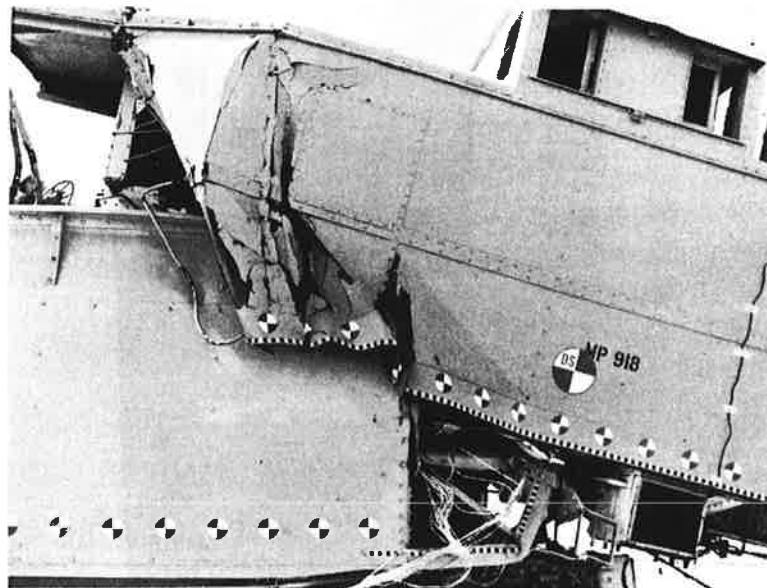
FIGURE 28. POST-TEST FRONT END OF CABOOSE - TEST 8.

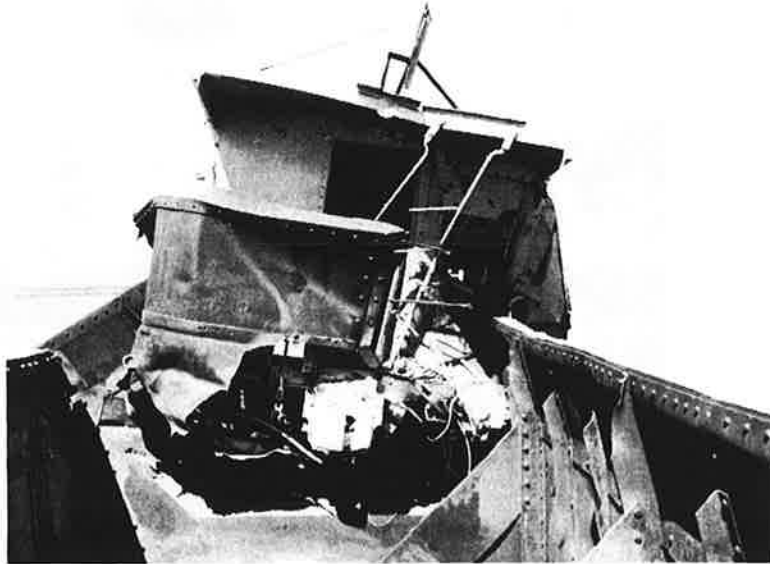
FIGURE 29. POST-TEST CABOOSE INTRUSION INTO HOPPER - TEST 8.

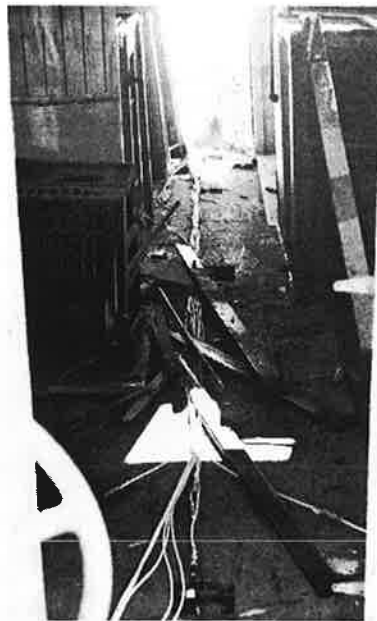
FIGURE 30. POST-TEST CABOOSE INTERIOR - TEST 8.

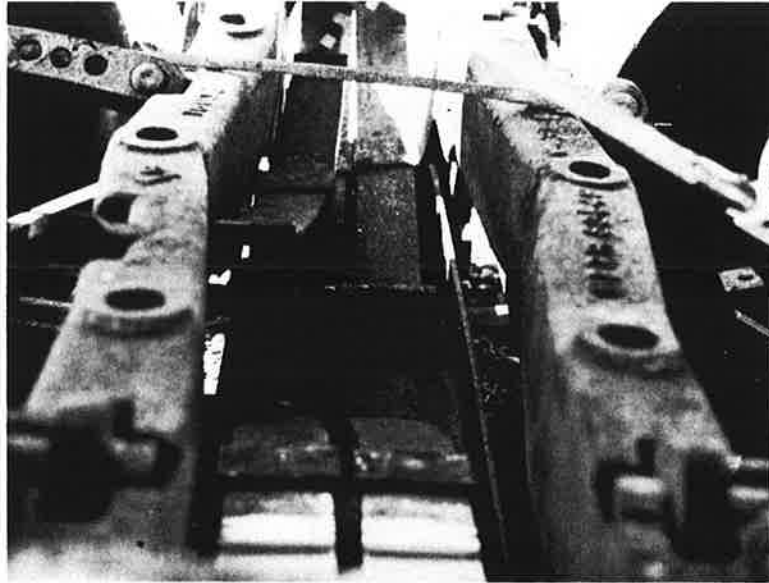
The caboose front truck was derailed under the caboose, but suffered no permanent damage.

FIGURE 31. POST-TEST CABOOSE FRONT TRUCK - TEST 8.

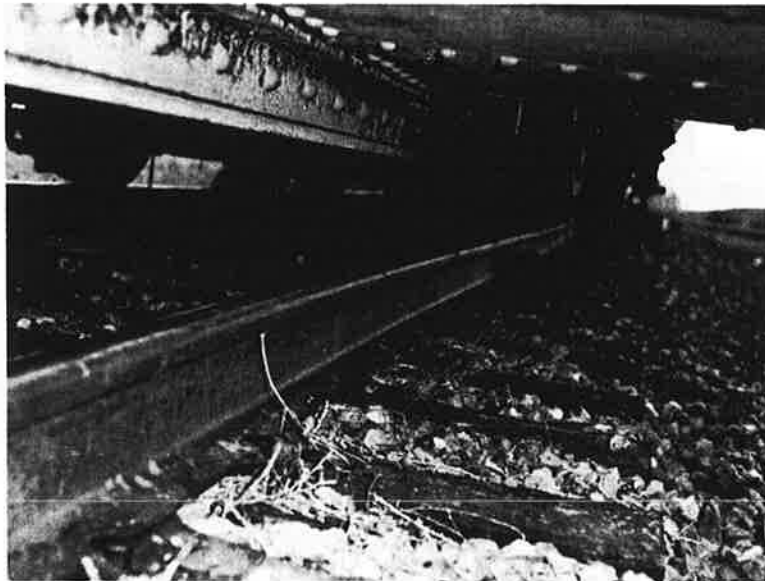
FIGURE 32. POST-TEST LATERAL RAIL DEFLECTION - TEST 8.

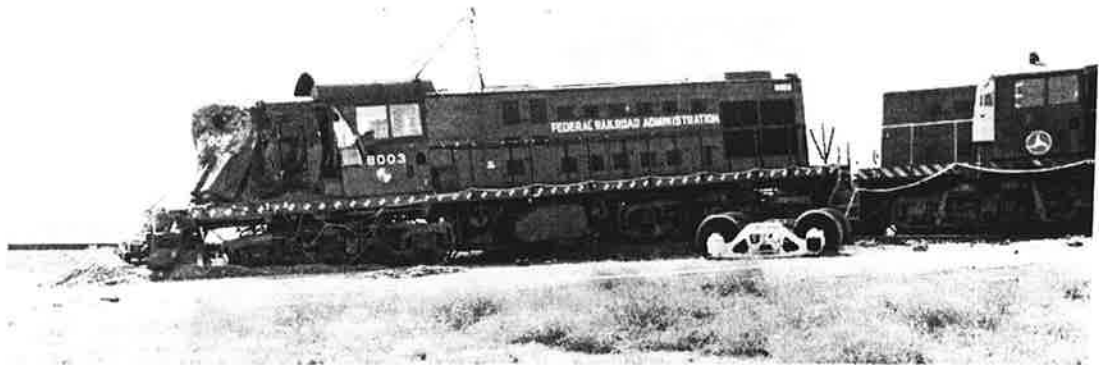
Figures 47, 48, and 49 show the damage incurred by the impacting locomotive. The intrusion into the side of the cab was caused as the crushed caboose was pushed off to one side.

FIGURE 47. POST-TEST IMPACTING LOCOMOTIVE SOUTH SIDE - TEST 9.

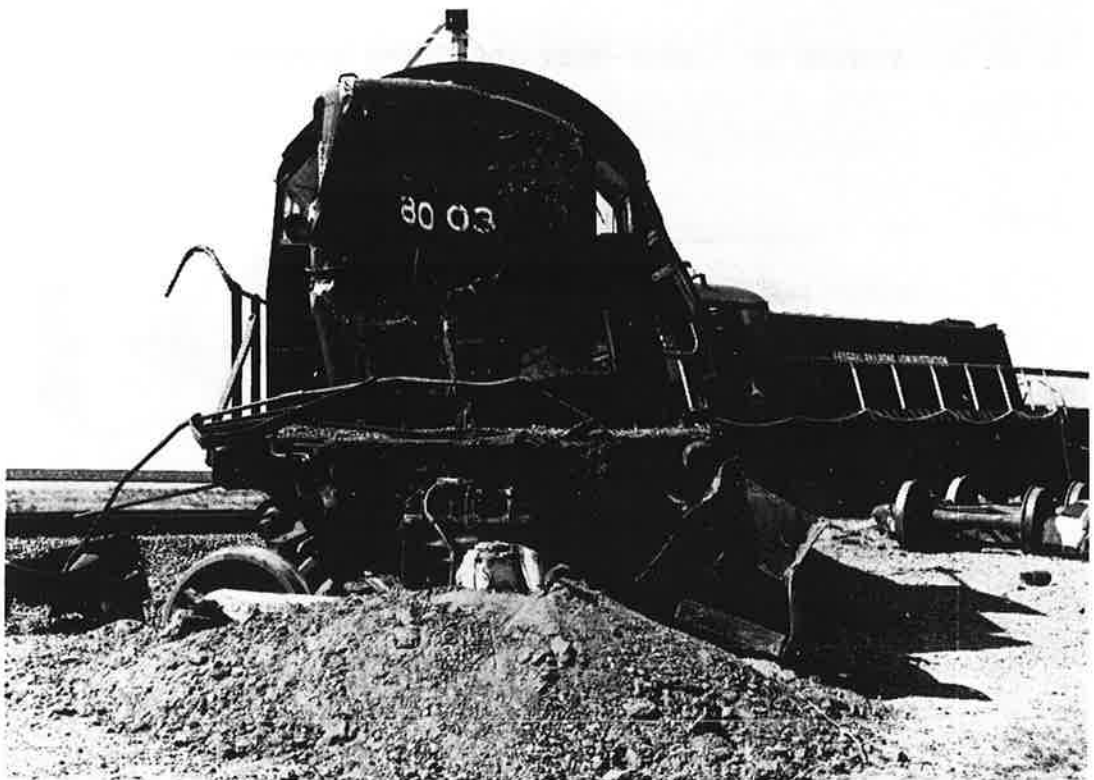
FIGURE 48. POST-TEST IMPACTING LOCOMOTIVE REAR END - TEST 9.

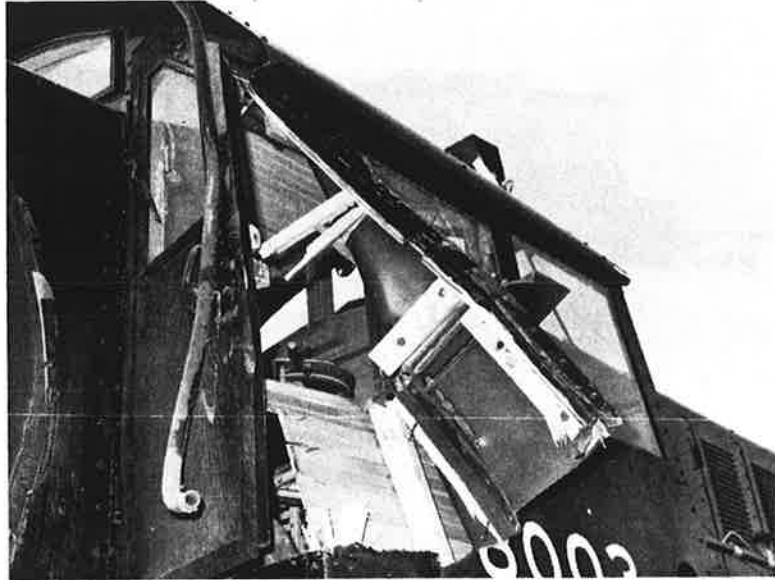
FIGURE 49. POST-TEST IMPACTING LOCOMOTIVE CAB - TEST 9.

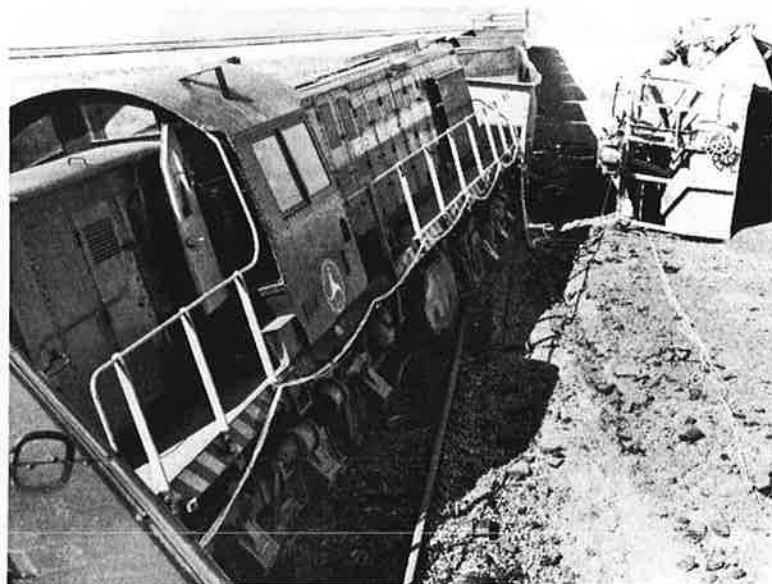
FIGURE 50. POST-TEST SECOND LOCOMOTIVE - TEST 9.

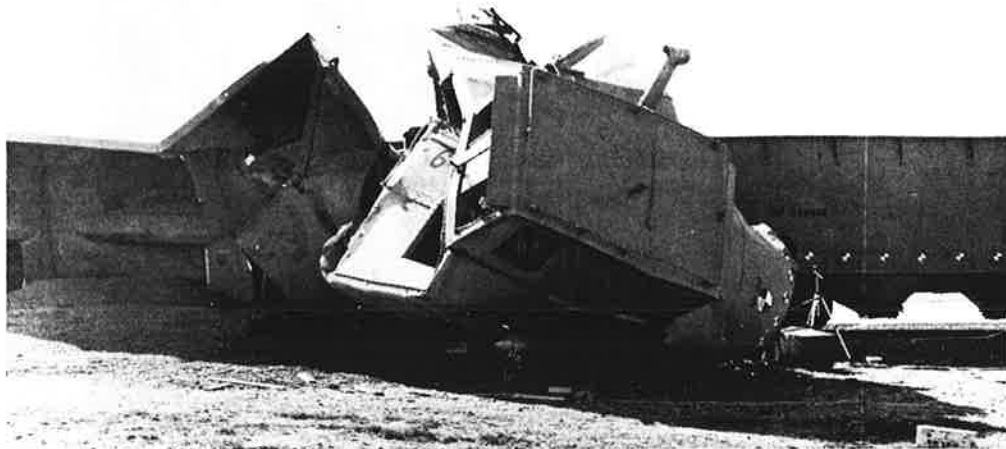
FIGURE 51. POST-TEST CABOOSE - TEST 9.

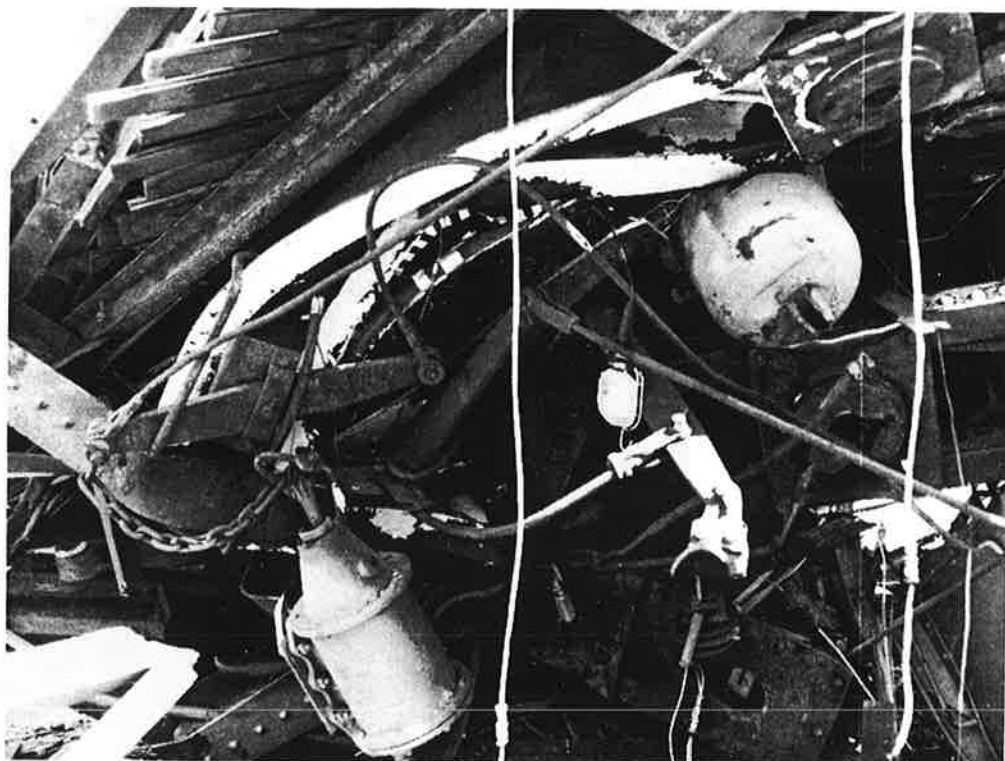
Figure 52 the bottom, showing the "U" shaped center sill. Figure 53 depicts the impact coupler of the caboose with its shank bent down. Figures 54 and 55 show the top and bottom of the first hopper. Only the rear end section of the hopper sill was crushed. Figure 56, taken from on top of the impacting locomotive, shows how far the struck train continued before coming to rest.

FIGURE 52. POST-TEST CABOOSE CENTER SILL - TEST 9.

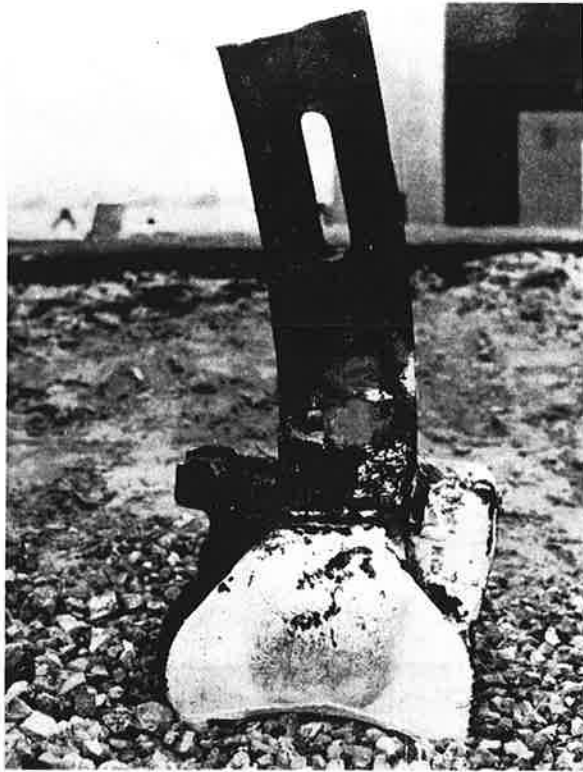
FIGURE 53. POST-TEST CABOOSE REAR COUPLER - TEST 9.

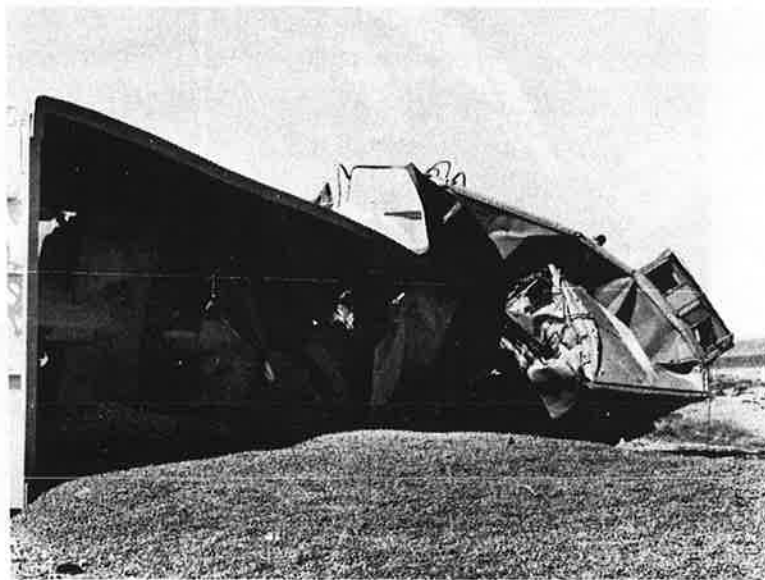
FIGURE 54. POST-TEST HOPPER AND CABOOSE - TEST 9.

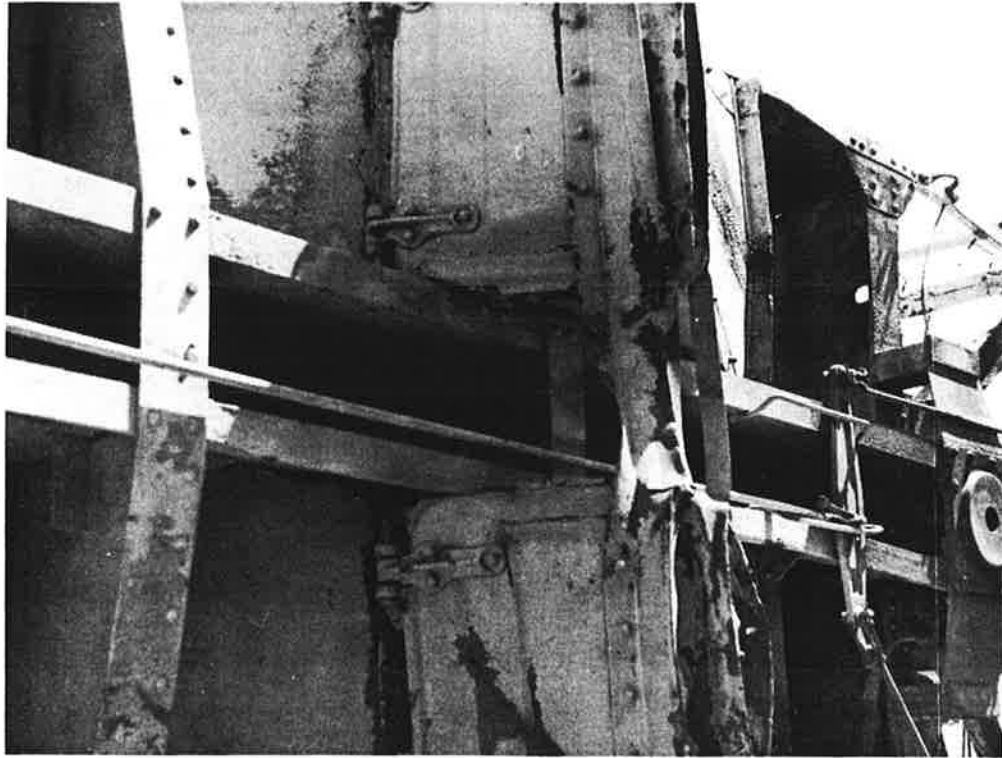
FIGURE 55. POST-TEST HOPPER CENTER SILL - TEST 9.

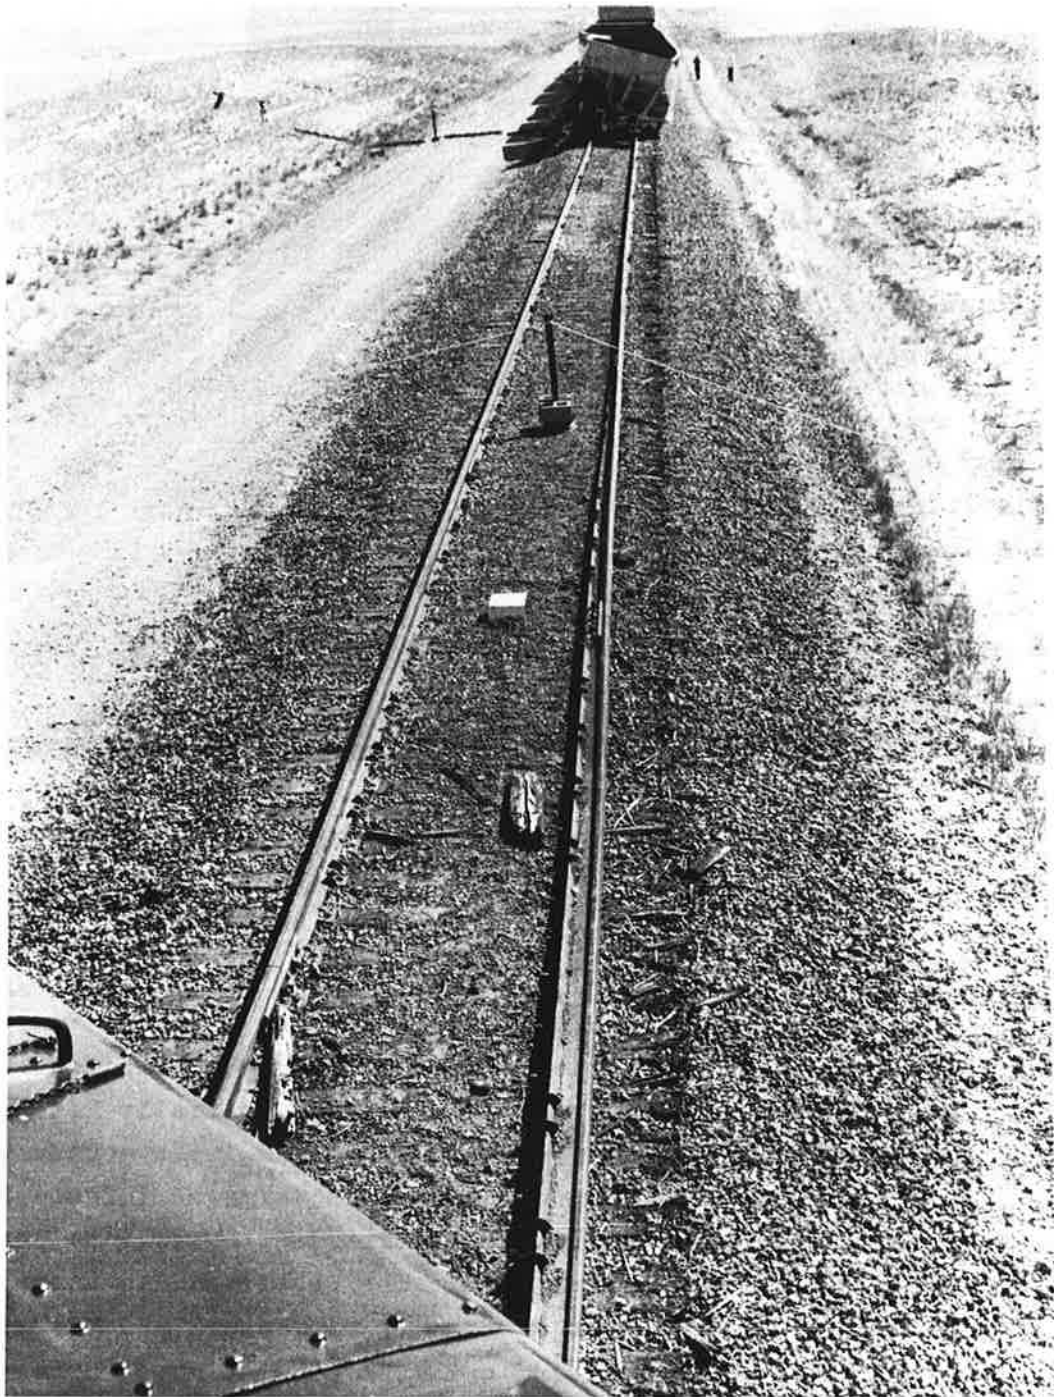
FIGURE 56. POST-TEST BENT RAIL AND SECOND HOPPER - TEST 9.

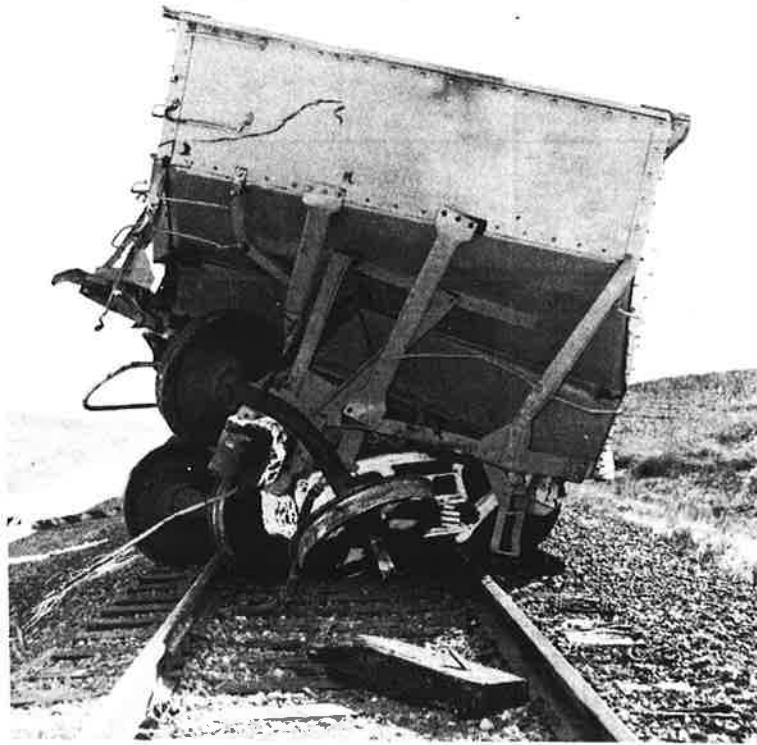
FIGURE 57. POST-TEST SECOND HOPPER - TEST 9.

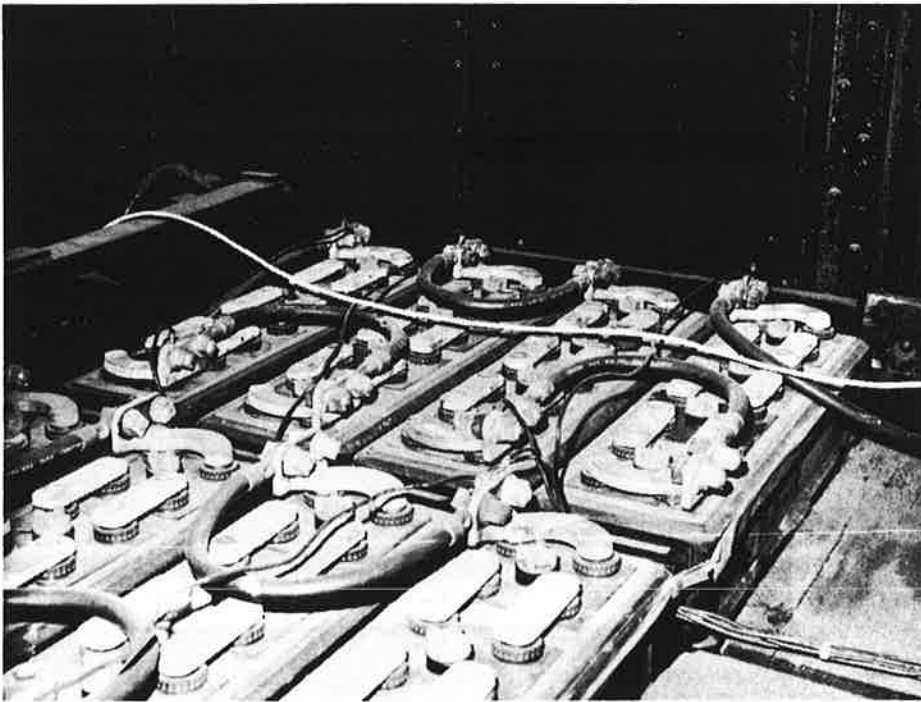
FIGURE 69. LOCOMOTIVE BATTERY COMPARTMENT - REAR END.

Both locomotives were derailed during the impact. The battery compartment of the lead locomotive was heavily damaged.

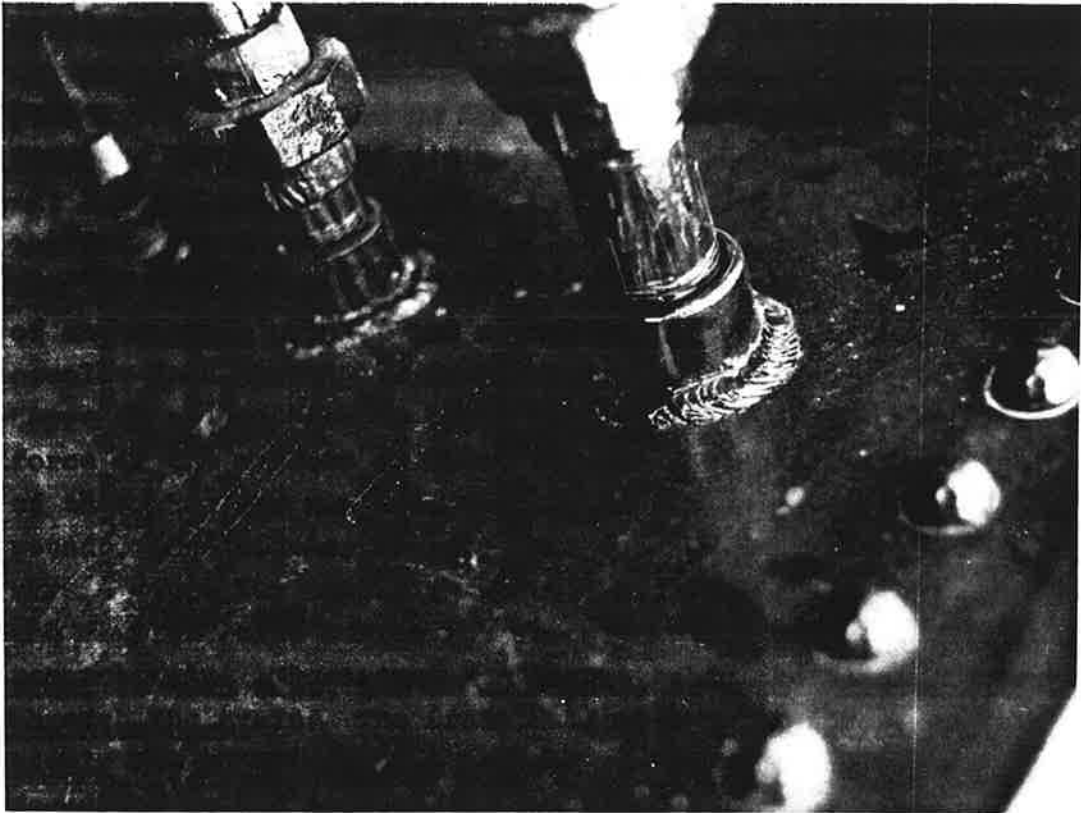
FIGURE 70. LOCOMOTIVE FUEL TANK LEAK - TEST 8.

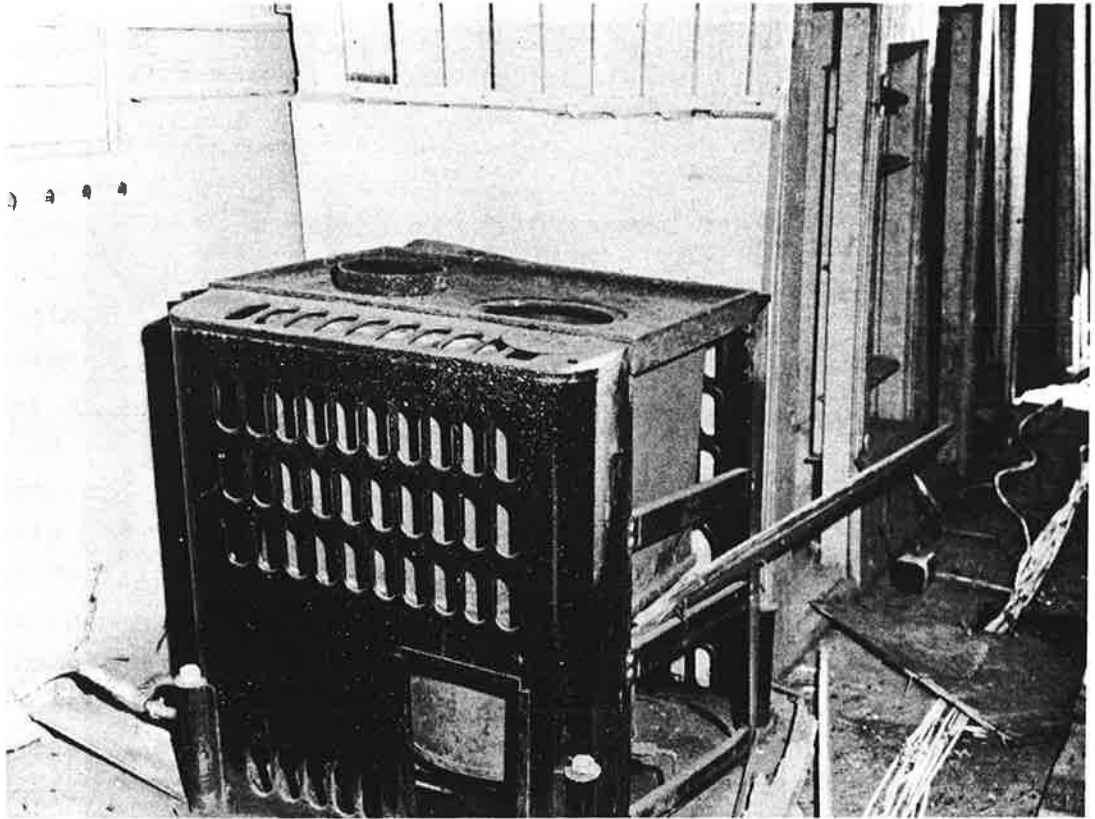
There could have been a fire hazard in connection with the caboose, however. Although the fuel oil heater in the rear of the caboose did not tear loose, it had been bent rearward on its

FIGURE 71. POST-TEST VIEW OF CABOOSE HEATER - TEST 8.
