Publication No. FHWA-RD-93-119

July 1994

Testing of Small and Large Sign Support Systems FOIL Test Number: 92F038

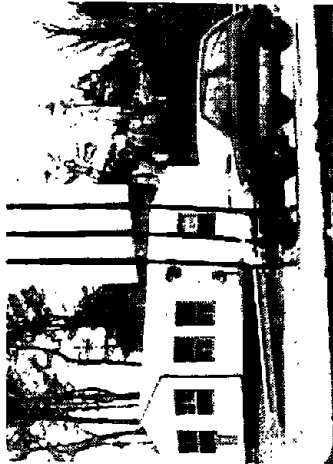
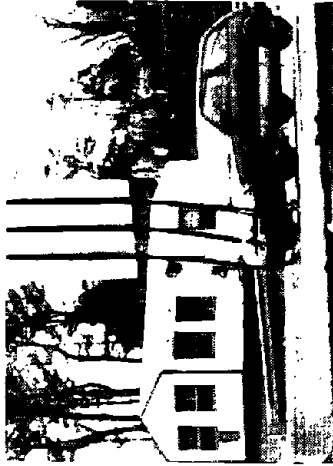
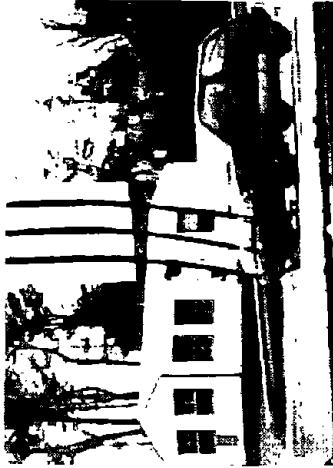
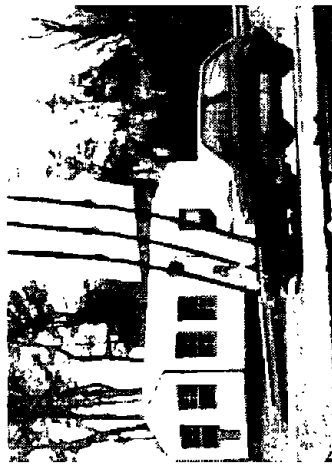
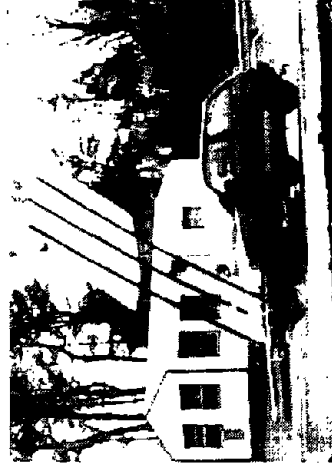
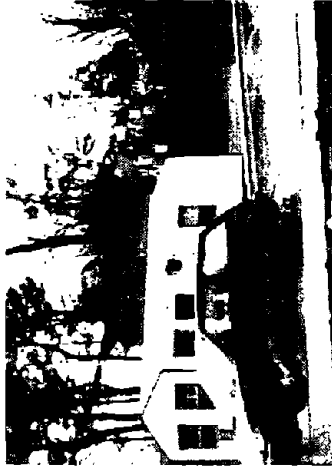
Figure 3. Test photographs during impact, test 92F038.

The bumper made contact with all three sign posts and began to collapse. The center and left post fail 0.004 s after initial contact. The three splice joints began to fail 0.002 s after the two posts failed. The last post failed 0.008 s into the event. Each of the posts failed at bumper height where initial contact was made. By 0.014 s all the splices had failed and the vehicle continued to pass through the sign system vaulting the sign upwards. The vehicle passed underneath the sign. The vehicle did not make further contact with the sign. The u-posts began to plow through the strong soil; however, the resistive force of the soil did not allow the posts to continue to plow through it. In addition, the speed and energy of the vehicle does not allow sufficient time for the posts to plow through the strong soil.

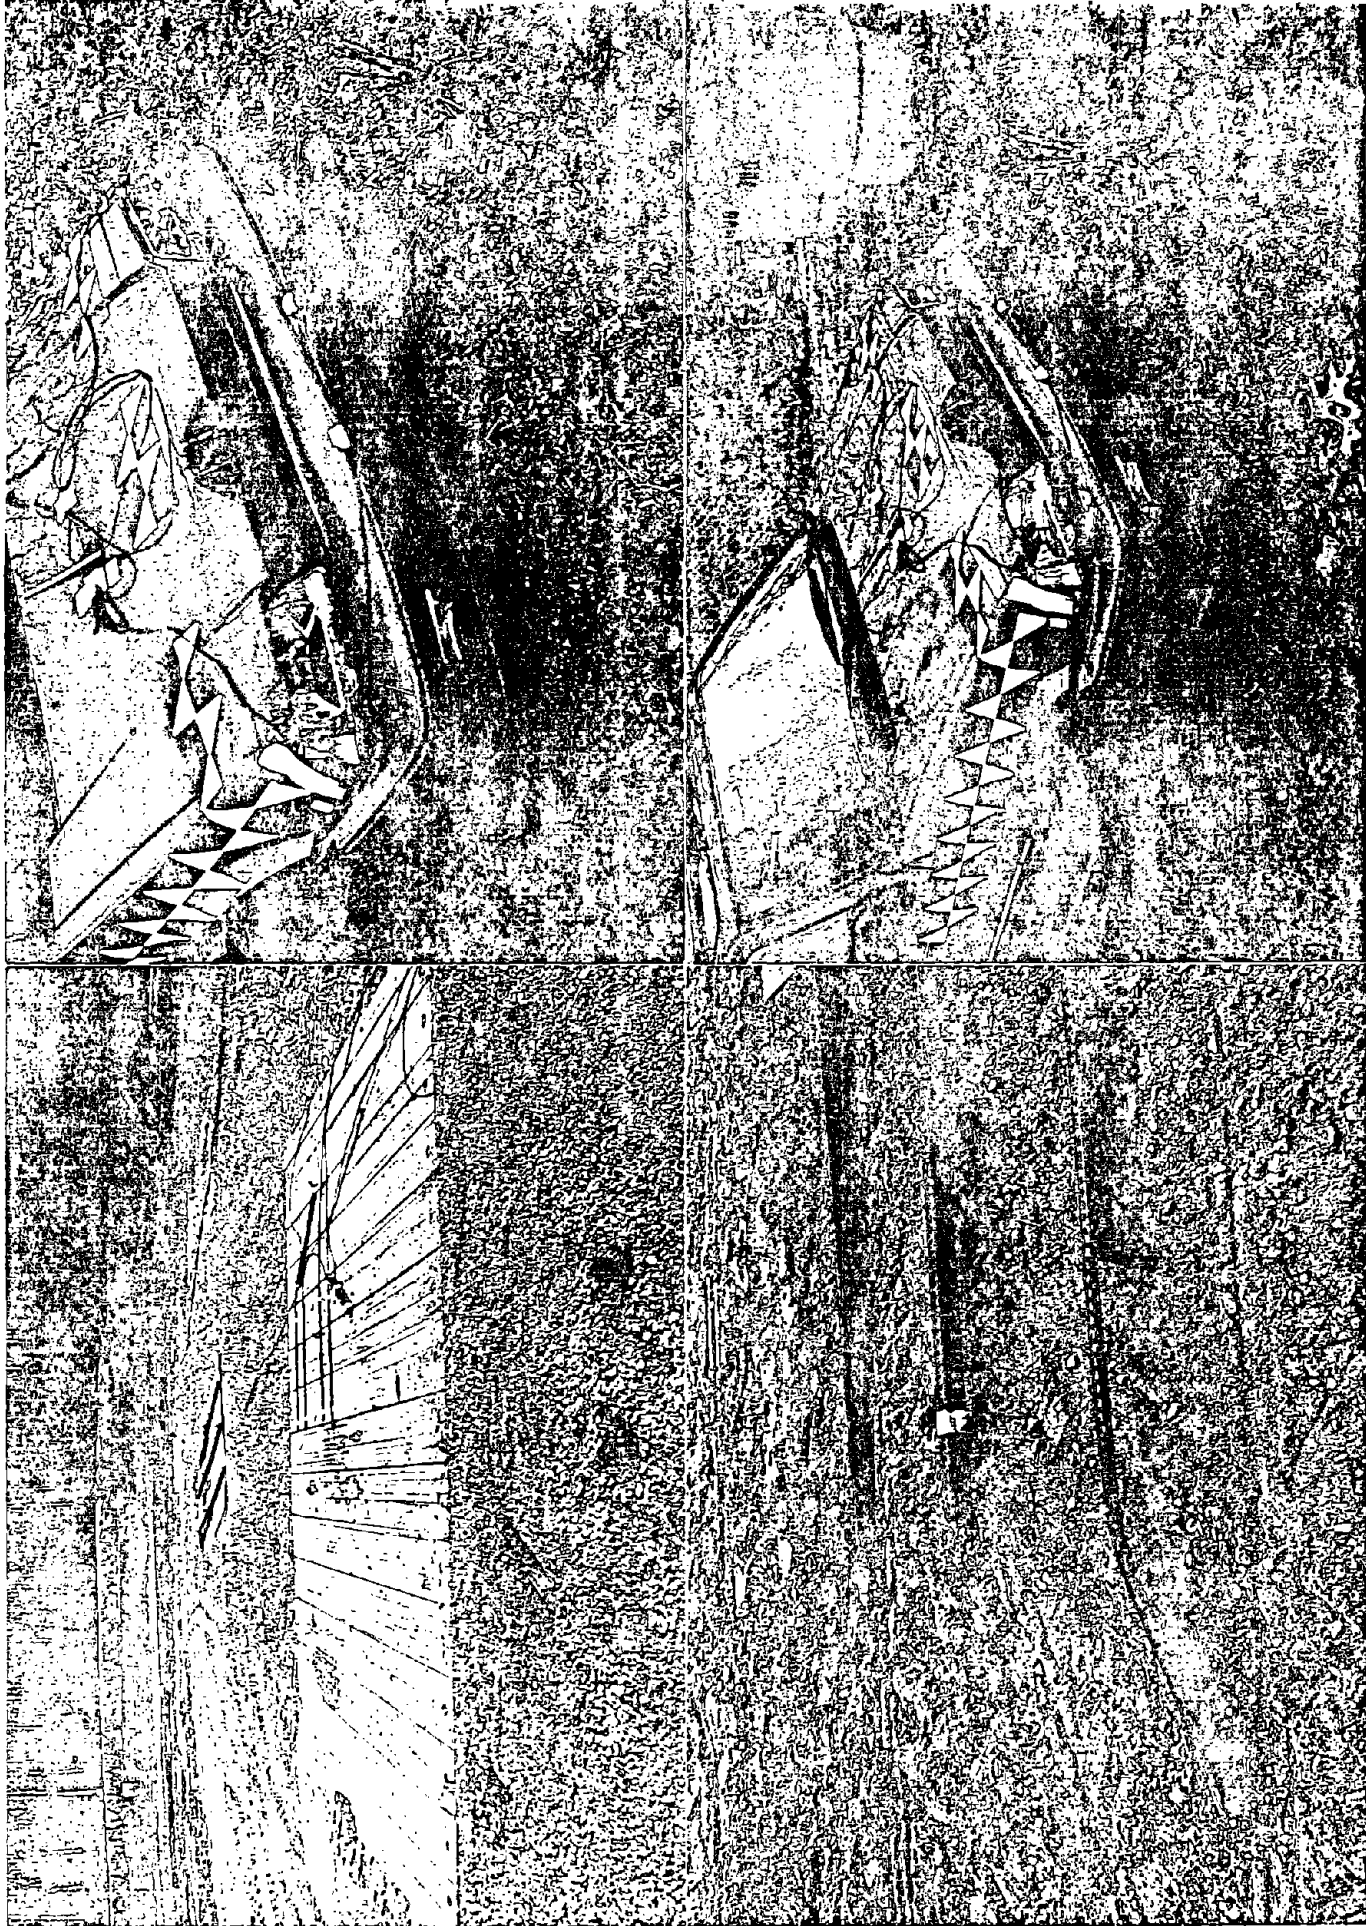
Figure 11. Post-test photographs of test 92F038.

Damage to the vehicle consisted of minor damage to the bumper and grill and one broken head lamp. The center of the vehicle sustained the maximum crush because it is the softest area on the front end. There was little damage to the bumper, the recorded crush was inflicted on the header panel above the bumper. The center of the vehicle sustained a maximum crush of 1-in (25.2 mm). The occupant compartment was intact after the test.

Damage to the sign system consisted of three broken u-channel posts and six fractured grade-2 bolts. The sign panel and stubs were in usable condition after the test. No sign components impaled the occupant compartment.
