Publication No. FHWA-RD-93-116

Testing of Small and Large Sign Support Systems FOIL Test Number: 92F035

7. Author(s) Christopher M. Brown		8. Performing Organization Report No.	
9. Performing Organization Name and Address Advanced Technology & Research Corp. 14900 Sweitzer Lane Laurel, MD 20707		10. Work Unit No. (TRIS) 3A5F3142	11. Contract or Grant No. DTFH61-91-Z-00002

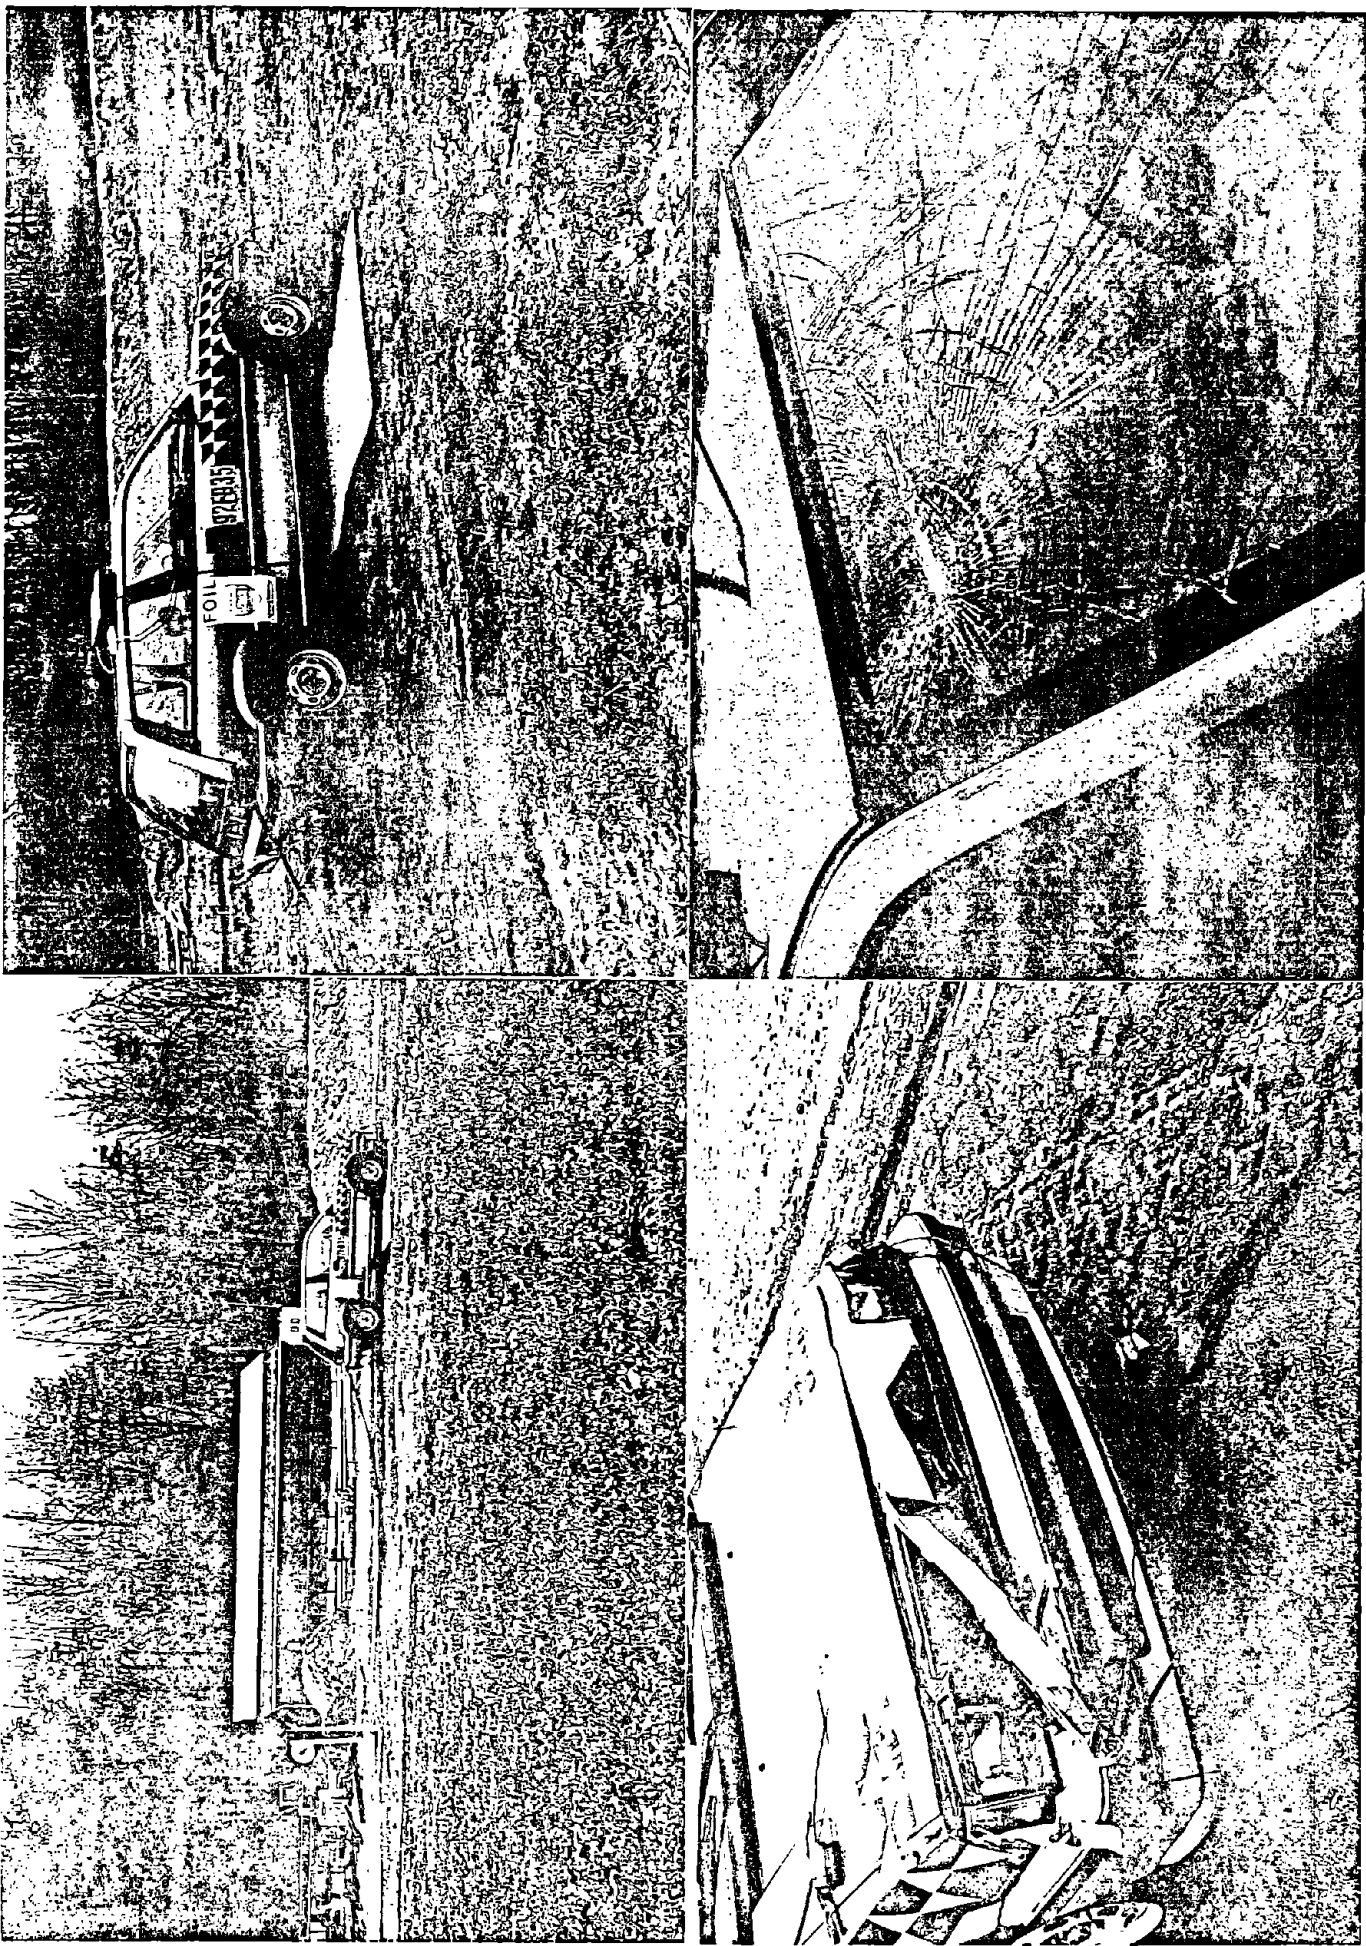
Figure 10. Post-test photographs of test 92F035.

Damage to the vehicle consisted of minor damage to the bumper and header panel. The damage was to plastic bumper parts and not to any structural members. The windshield was cracked in one upper corner. The maximum crush measured after the test was recorded to be 3 in (76.2 mm). None of the sign components impaled the occupant compartment.

Damage to the sign consisted of two ripped and frayed fiberglass posts. The sign panel and all hardware were in usable condition after the test. The concrete foundations did not move during the impact event. New posts could be installed in the foundations with no complication.
