Publication No. FHWA-RD-93-097
July 1994

Testing of Small and Large Sign Support Systems FOIL Test Numbers: 92F009 and 92F010

U.S. Department of Transportation
Federal Highway Administration

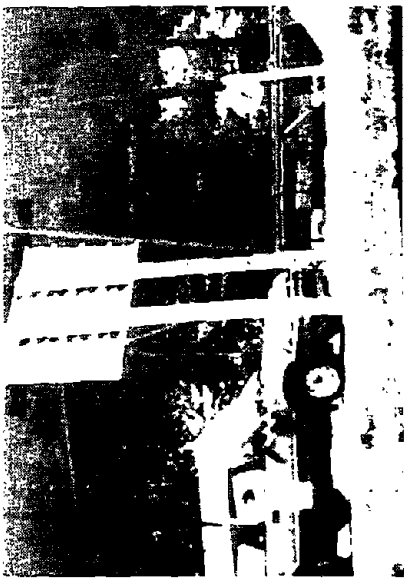
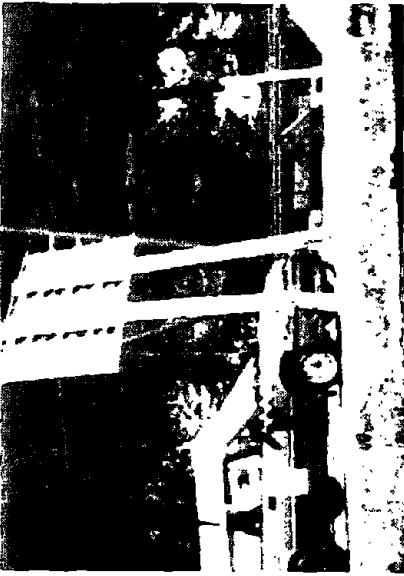
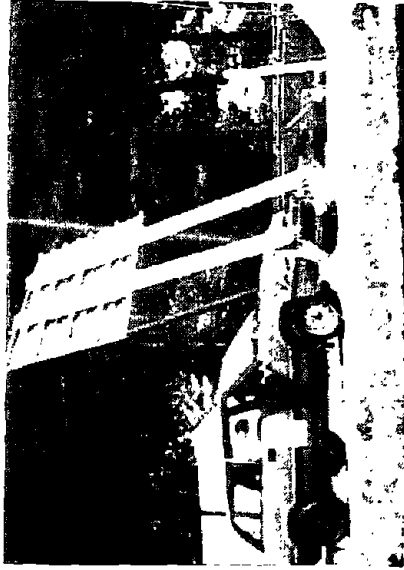
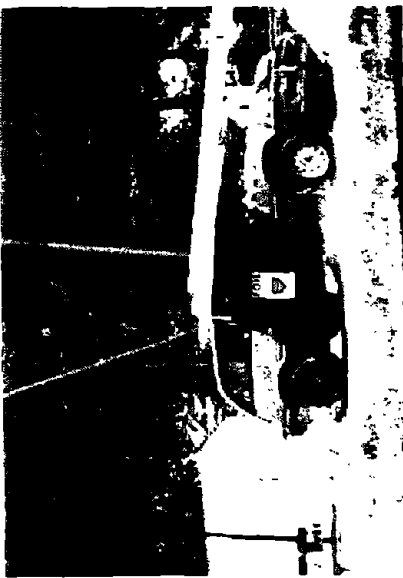
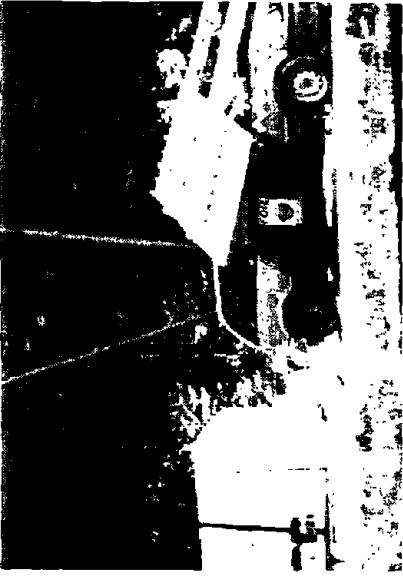
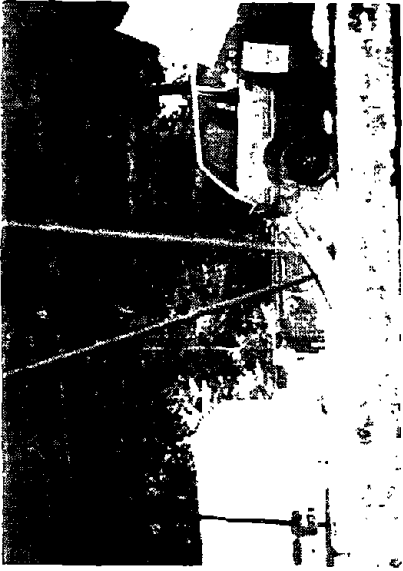
Figure 3. Test photographs during impact, test 92F009.

The bumper made contact with both sign legs and began to collapse. The bumper did not crush significantly during the impact event. The breakaway force was low enough not to cause severe damage to the front end of the vehicle. The left leg of the sign fractured at the hole 4 in (0.102 m) above ground 0.016 s after initial contact. The left leg never fractured at the hole 18 in (0.457 m) above ground level. The right leg fractured 0.036 s after impact. The fracture occurred at the upper hole and not the lower hole. Because the right leg took longer to fracture than the left leg, the vehicle yawed clockwise approximately 15 degrees. The vehicle continued to pass over the remaining section of the right leg. The remaining piece broke 12 in (0.305 m) below ground level as the vehicle passed over. A second significant impact occurred at 0.412 s, as the sign fell on top of the vehicle with the center of the panel striking the roof/windshield sill. The impact was enough to dent the roof and cause the windshield to crack. The sign panel with the broken legs attached remained on the hood of the vehicle for the remainder of the runout time. The brakes were applied and the sign slid off the vehicle as the vehicle came to rest.

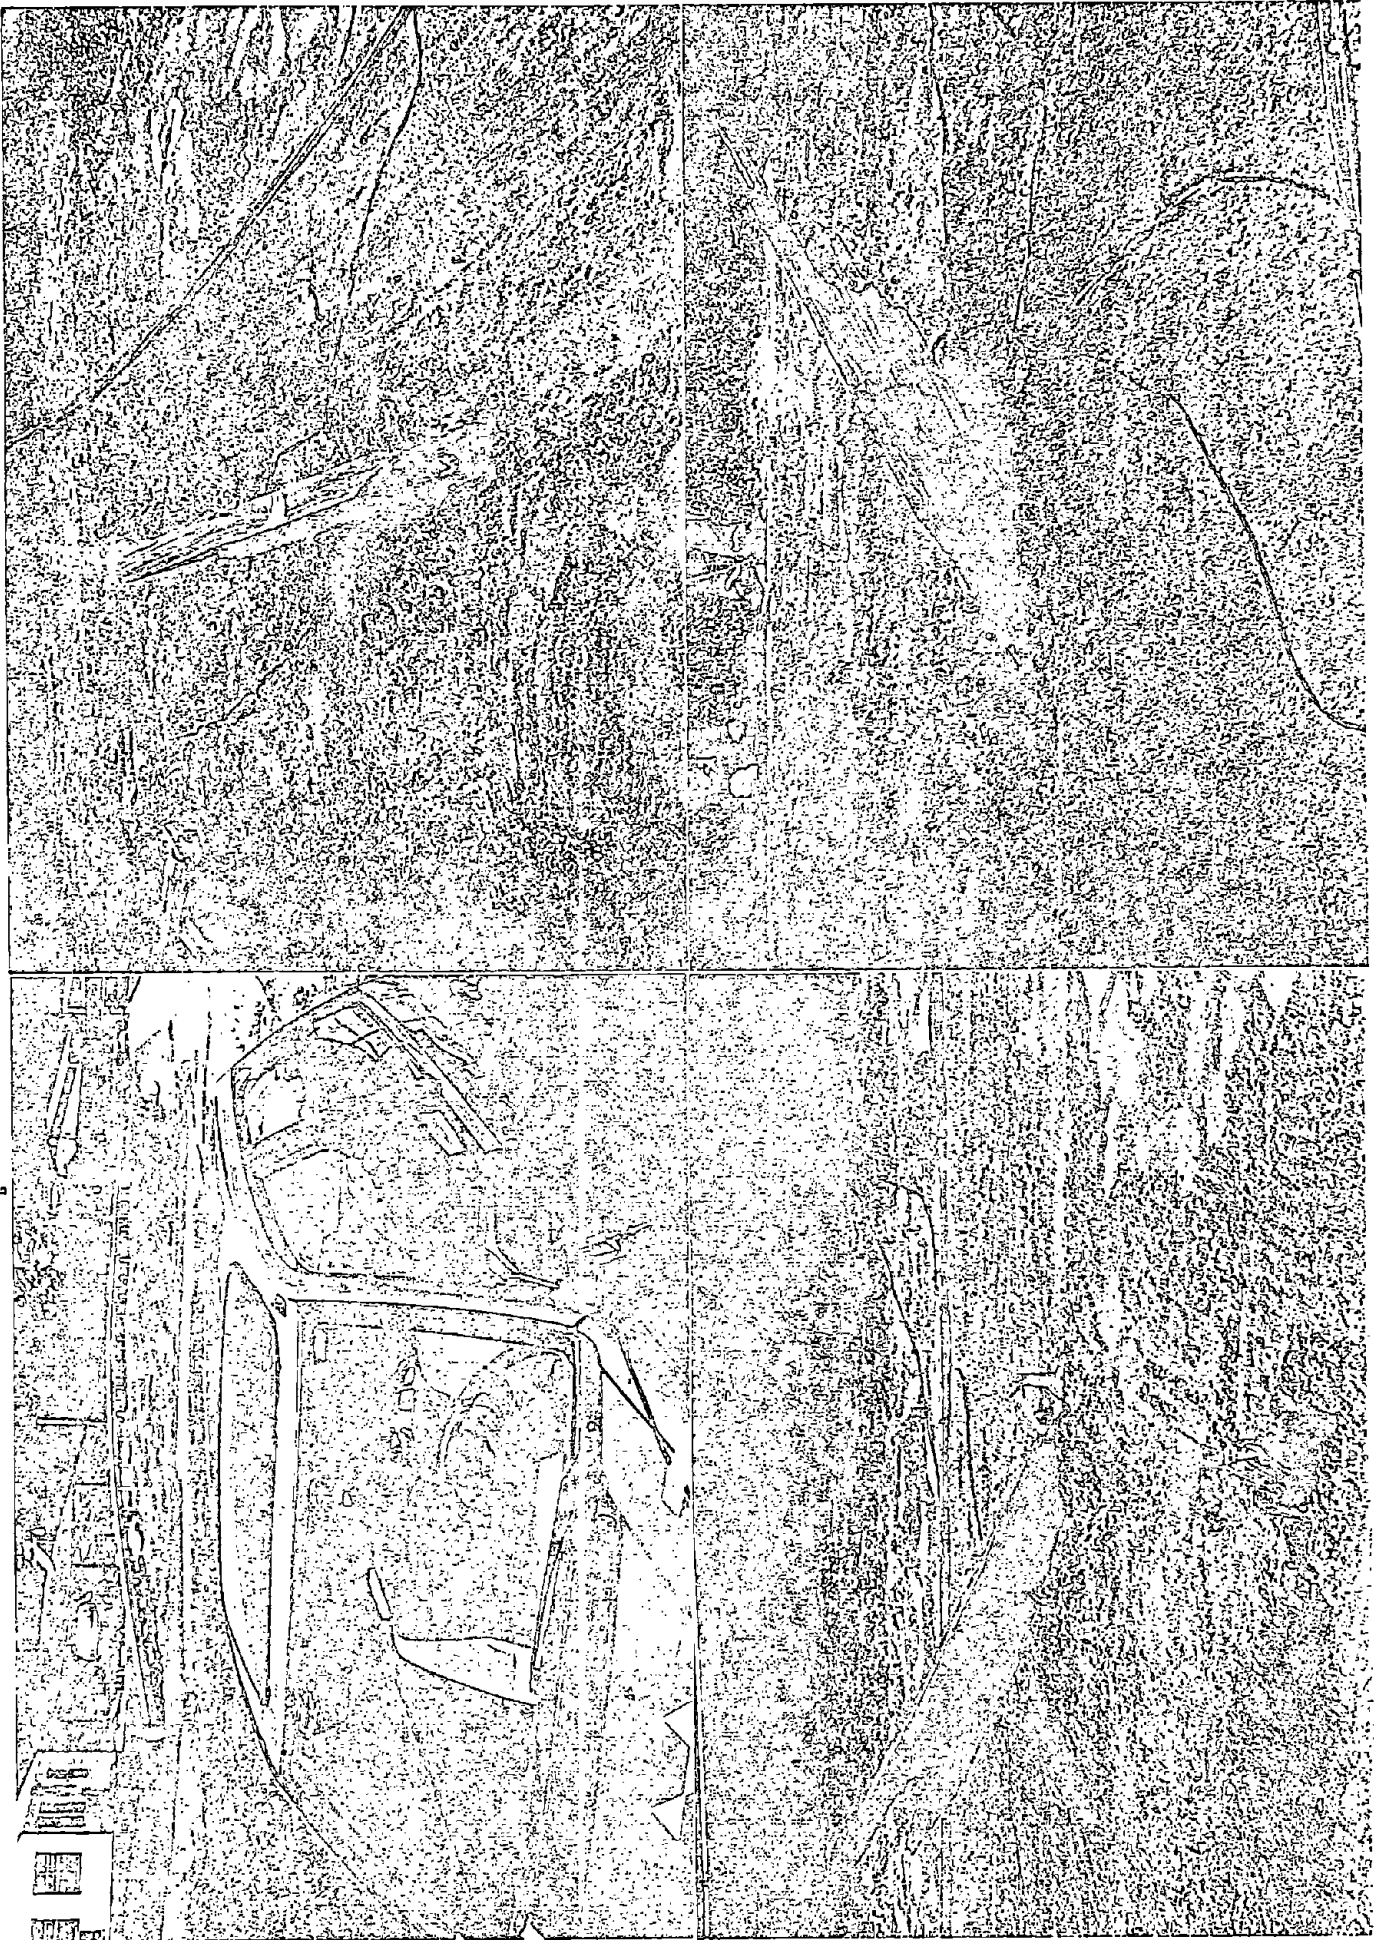
Figure 10. Post-test photographs of test 92F009.

Damage to the vehicle consisted of minor damage to the bumper and a dent approximately 0.5 in (13 mm) deep along the roof/windshield sill. Since no considerable damage was inflicted on the front end of the vehicle no crush measurements were recorded. The damage to the roof was slight and the windshield was cracked but did not shatter. None of the sign components impaled the occupant compartment.

Damage to the sign support consisted of two fractured wooden legs. The upper portions remained attached to the sign panel. The embedded 3-ft (0.9-m) sections of the sign legs remained buried in the weak soil. Strands of wood fibers remained intact on the right leg between the buried section and length of leg up to the upper hole. The panel was in good condition after the test.

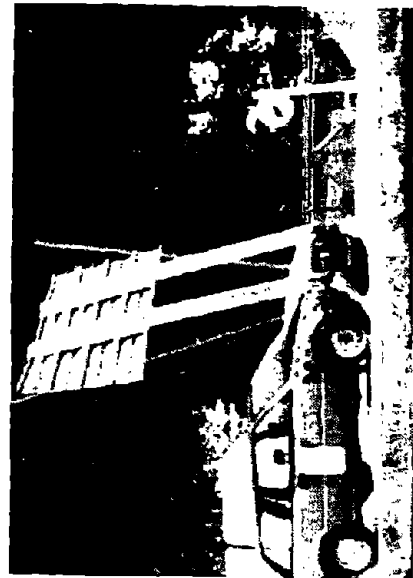
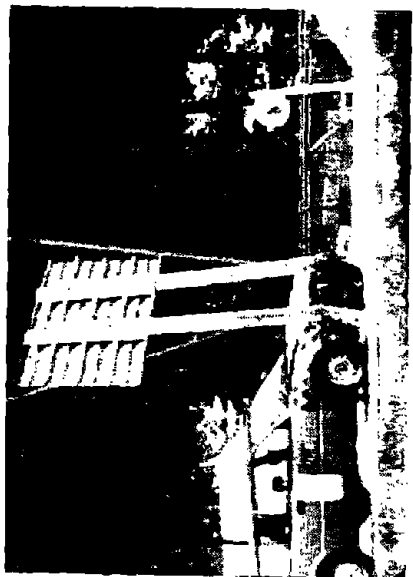
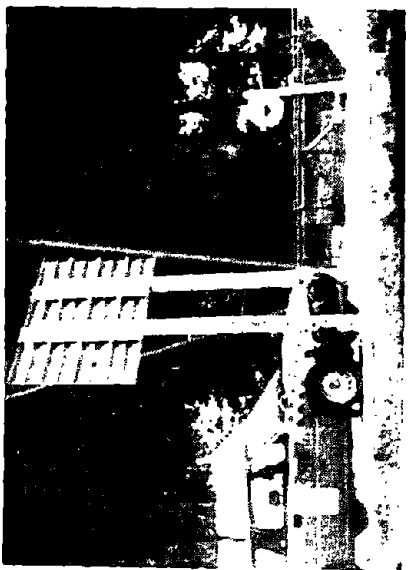
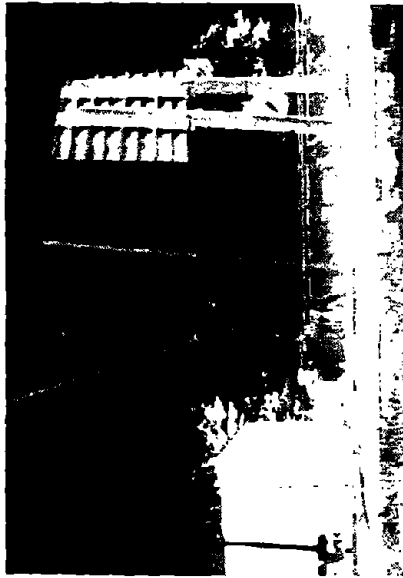
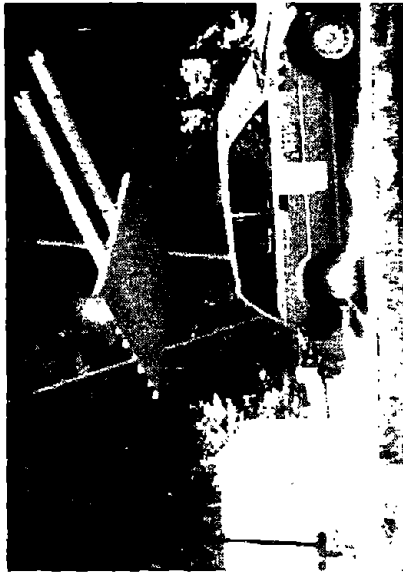
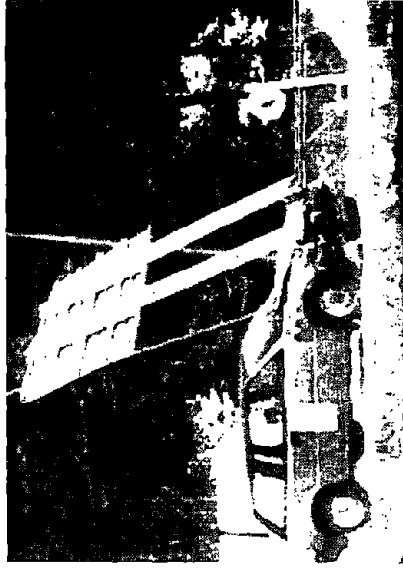
Figure 11. Test photographs during impact, test 92F010.

The bumper made contact with both sign legs and began to collapse. The contact between bumper and sign legs occurred to the outside edge of each bumper support. Damage was significant to the bumper and headlights only, the majority of the front end elements remained in good condition. The vehicle contacted both sign legs simultaneously and the legs fractured at the hole 18 in (0.457 m) above ground 0.016 s after initial contact. Both legs never fractured at the lower hole 4 in (0.102 m) above ground level. Instead each leg fractured 12 in (0.305 m) below ground level while the vehicle rolled over the remnants of each leg. The vehicle continued underneath the sign support, inducing a rotation in the sign support and vaulting the sign support upward. The vehicle passed underneath the sign support without making secondary contact. The sign support rotated 360 degrees and re-impaled itself in the weak soil briefly then fell backward with the sign panel facing up. The brakes were applied and the vehicle came to rest before making contact with the FOIL catch fence.
