Publication No. FHWA-RD-93-103

July 1994

# Testing of Small and Large Sign Support Systems FOIL Test Number: 92F015

7. Author(s) Christopher M. Brown		8. Performing Organization Report No.	
9. Performing Organization Name and Address Advanced Technology & Research Corp. 15210 Dino Drive Burtonsville, MD 20866		10. Work Unit No. (FRAIS) 3A5f3142	11. Contract or Grant No. DTFH61-91-Z-00002

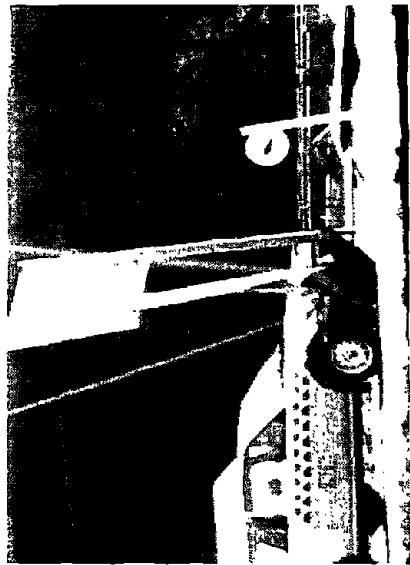
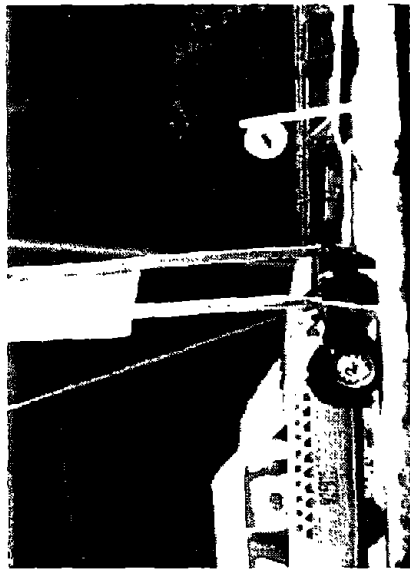
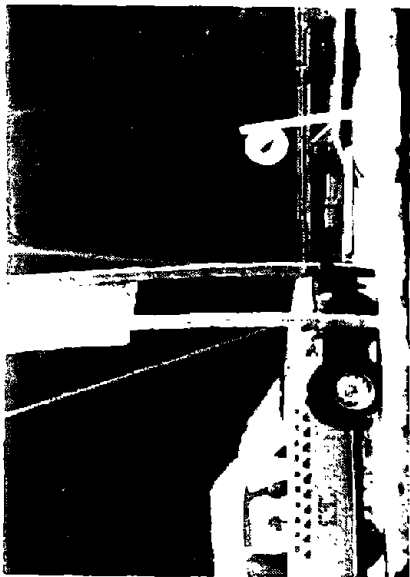
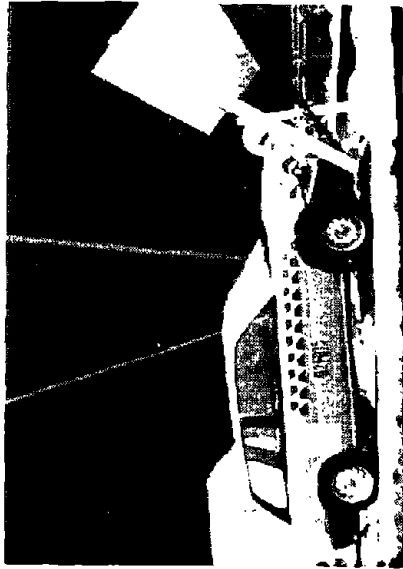
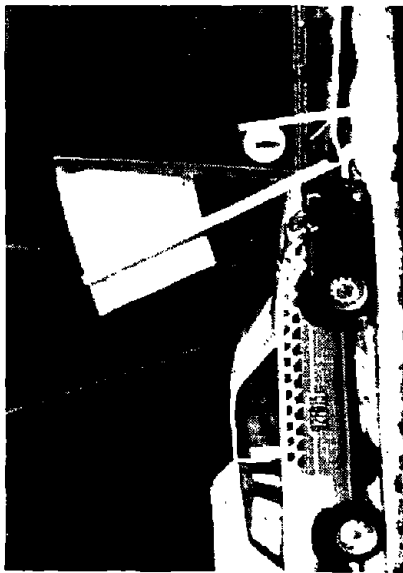
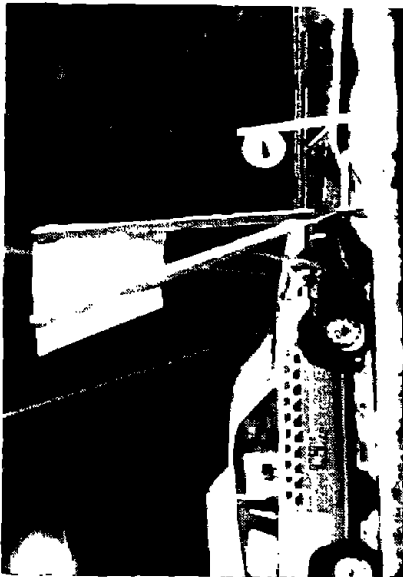
Figure 3. Test photographs during impact, test 92F015.

The bumper made contact with both sign legs and began to collapse. The brunt of the impact occurs to outside edge of the bumper supports on either side of the test vehicle. The bumper had collapsed to the headlight socket 0.034 s into the event. During the collapse of the bumper, the wooden legs were bowed outward away from the vehicle. At 0.036 s the wooden legs began to fracture. The right leg fractured approximately 3 ft (0.9 m) above ground. The left leg began to fracture 6 in (0.152 m) above ground. Neither leg broke completely. Each leg split vertically in the center. Seventy four milliseconds into the event, the right leg had split vertically approximately 4 ft (1.2 m) above ground. Wood fibers held together throughout the event never completely tearing apart. The same action occurred on the left leg. The leg split vertically for approximately 5 ft (1.5 m). The wood never yielded completely. The vehicle continued to push the remaining wood fibers of the left leg and eventually bent the leg backwards to the ground. The left leg took longer to bend backward thus causing the vehicle to yaw counter-clockwise approximately 20 degrees. No secondary impact occurred between the vehicle and the sign support. The remainder of the wood legs with the panel attached fell backwards away from the vehicle.

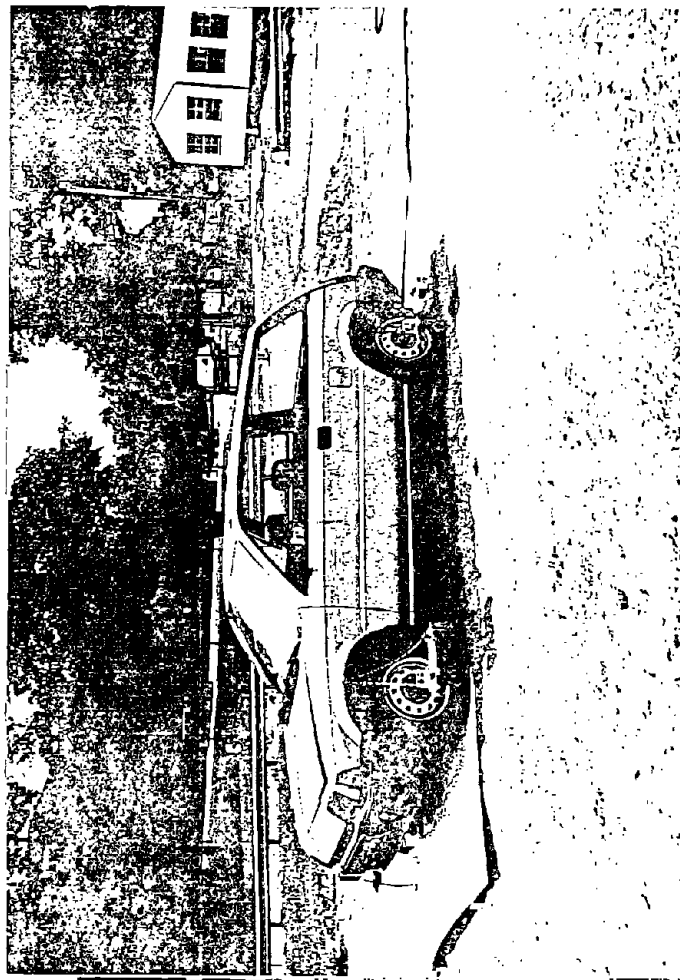
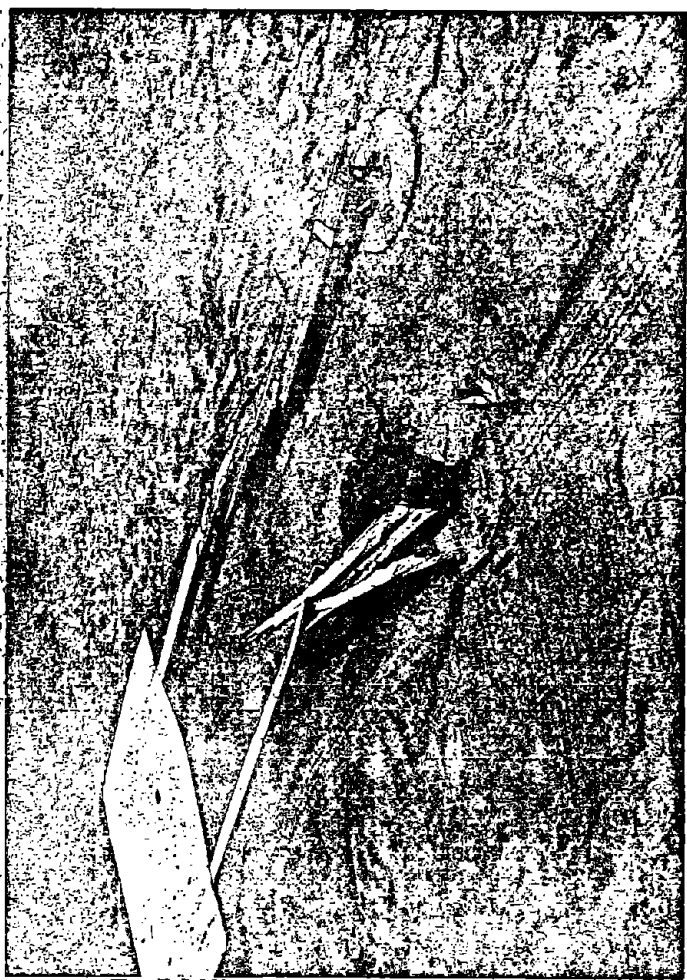
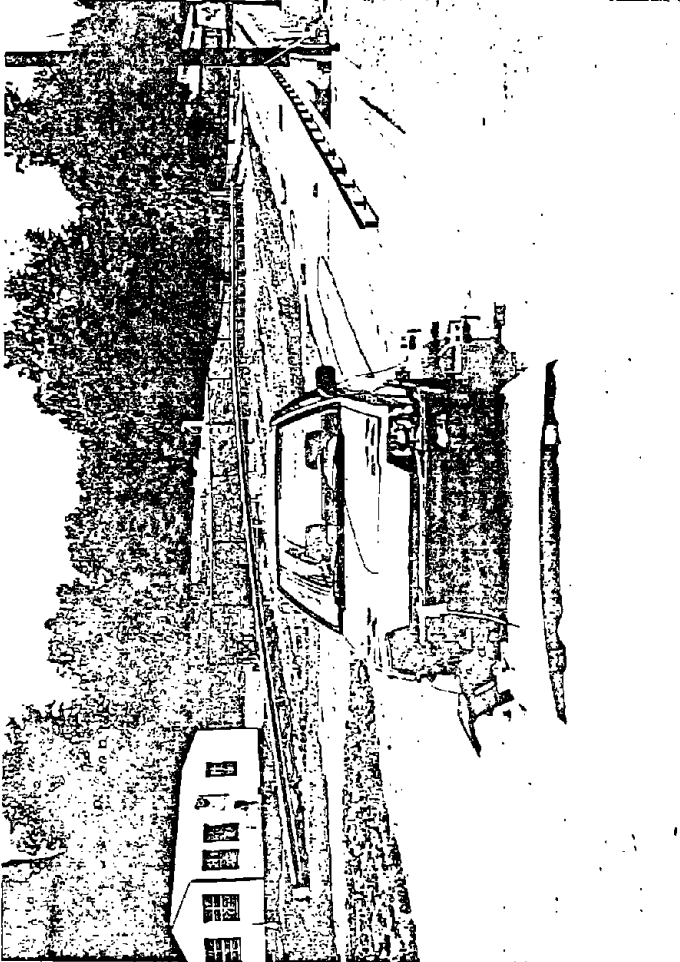
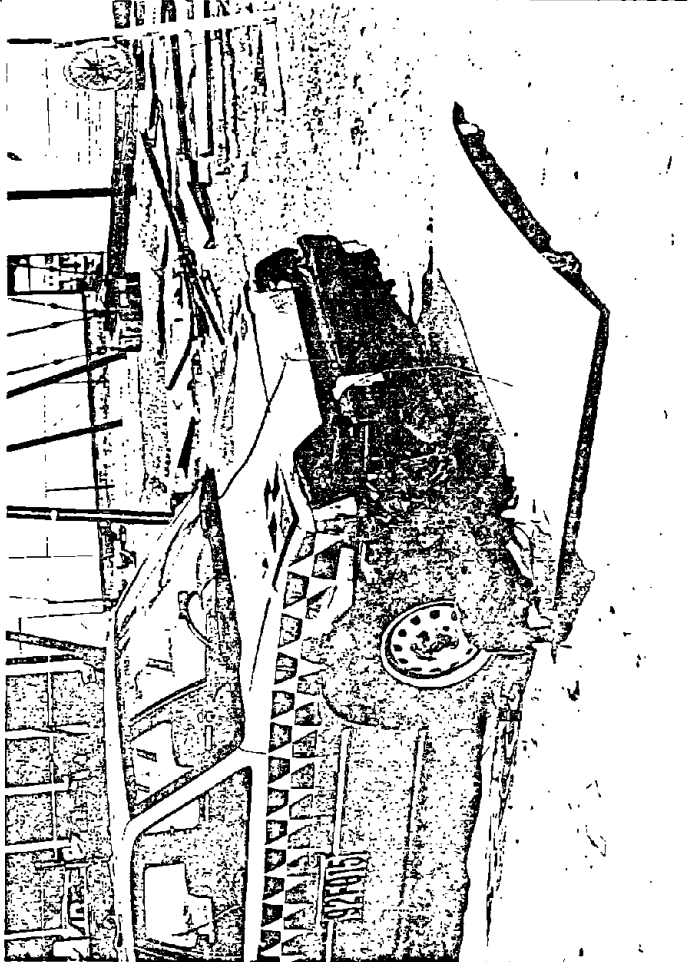
Figure 11. Post-test photographs of test 92F015.

Damage to the vehicle consisted of damage to the bumper and headlights. The damage was to plastic bumper parts and not to any structural members. The sign legs did penetrate the bumper into the headlight sockets which is where the maximum crush occurred. The maximum crush measured after the test was recorded to be 10.5 in (0.267 m). None of the sign components impaled the occupant compartment.

Damage to the sign consisted of two fractured wooden legs. The legs were split vertically with wood fiber holding the wood inside the footers to the upper sections of the legs. The upper sections of the legs remained attached to the sign panel. Two feet (0.6 m) of each leg remained inside the concrete footers. The sign panel was in good condition after the test.

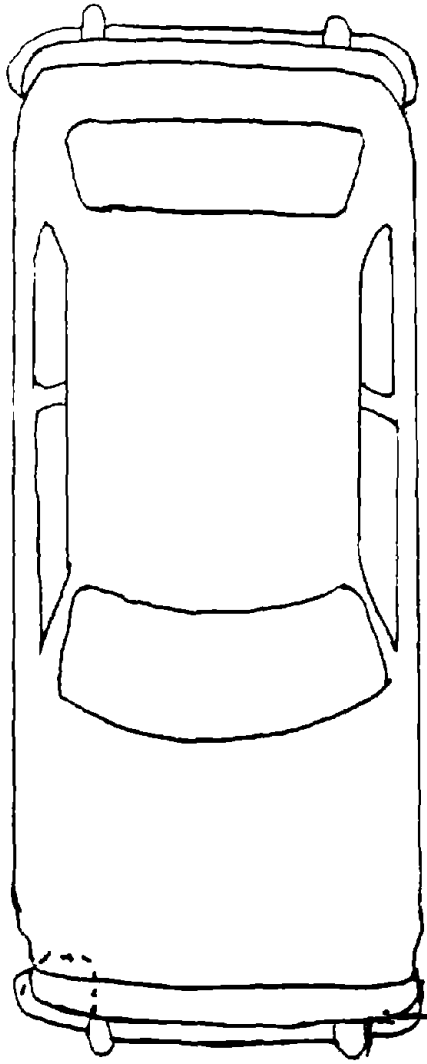
Figure 13. Sketch of vehicle crush, test 92F015.

Max = 10.5"
