Publication No. FHWA-RD-93-107

July 1994

Testing of Small and Large Sign Support Systems FOIL Test Number: 92F019

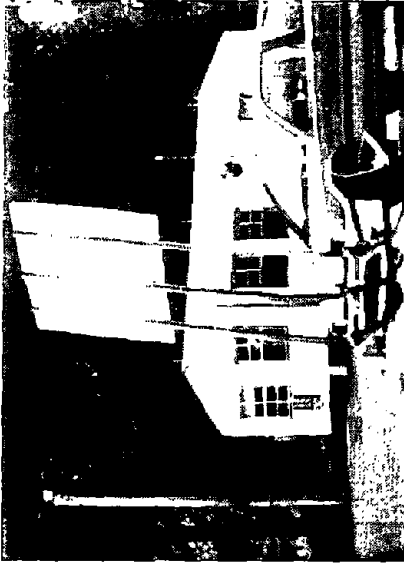
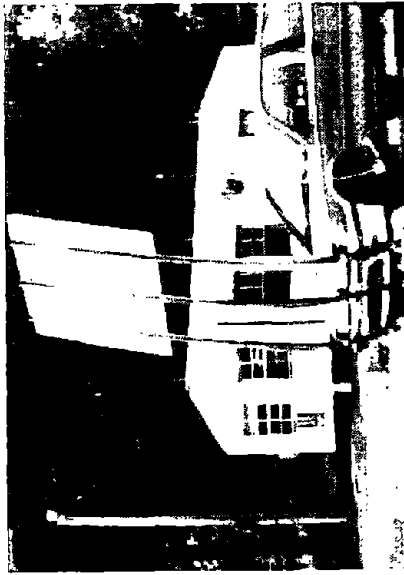
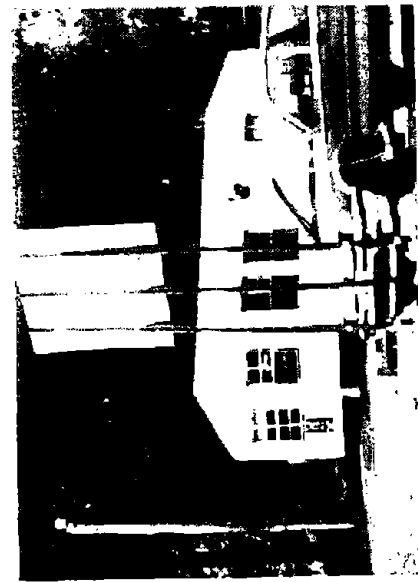
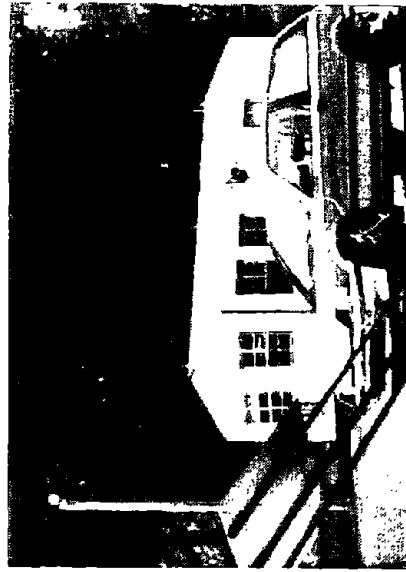
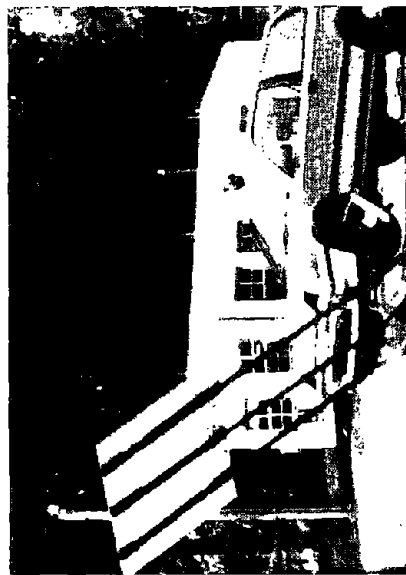
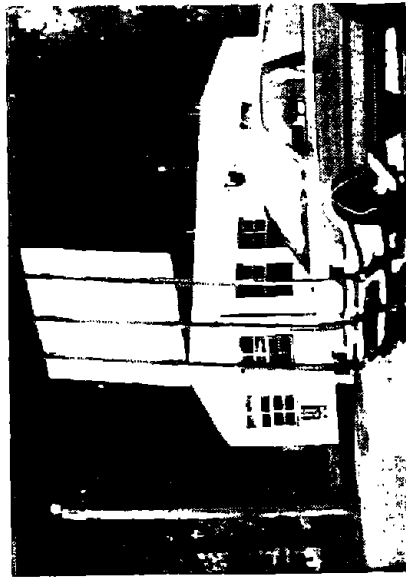
Figure 2. Test photographs during impact, test 92F019.

The bumper made contact with all three sign legs and began to collapse. The sign posts made contact with the bumper to the outside edge of each bumper support and at the bumper center. The u-channel legs began to bow away from the vehicle and wrap around the front end of the vehicle. The vehicle continued forward, pushing the u-channel legs through the weak soil. The required force to break or flatten the u-channel was higher than the resisting force of the weak soil therefore the weak soil gave way before the u-channel and the vehicle forced the u-channel to plow through the sand. Once the u-channel had pushed through the sand as far as possible the flattening or breakaway force required still could not be obtained because too much energy was consumed plowing through the weak soil. The u-channel bent backwards but never flattened. The u-channel legs pushed through the sand approximately 18 in (457.2 mm). The u-channel began pushing through the weak soil upon impact and continued to push through the weak until the vehicle had come to a stop. The sign system remained in the weak soil leaning back 60 degrees. The u-channel was later pulled from the ground and a bend in each u-channel post was recorded 12 in (304.8 mm) below the ground line.

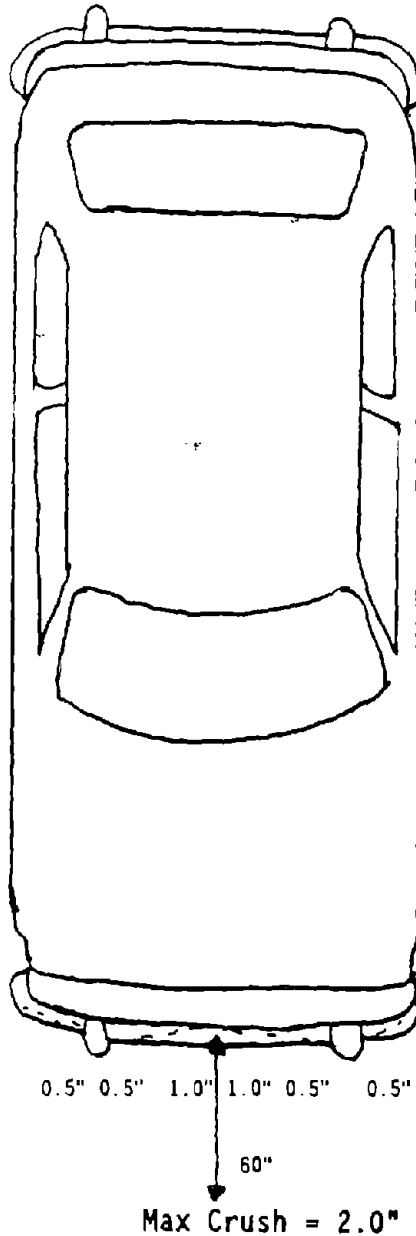
Figure 12. Sketch of vehicle crush, test 92F019.

Damage to the vehicle consisted of minor damage to the bumper and grill. The majority of the damage occurred in the center of the bumper. The occupant compartment was intact after the test.

Max Crush = 2.0"
