CIVIL AERONAUTICS BOARD

ACCIDENT INVESTIGATION REPORT

**CONTINENTAL CHARTERS, INC., NEAR LITTLE VALLEY, NEW YORK
DECEMBER 29, 1951****THE ACCIDENT**

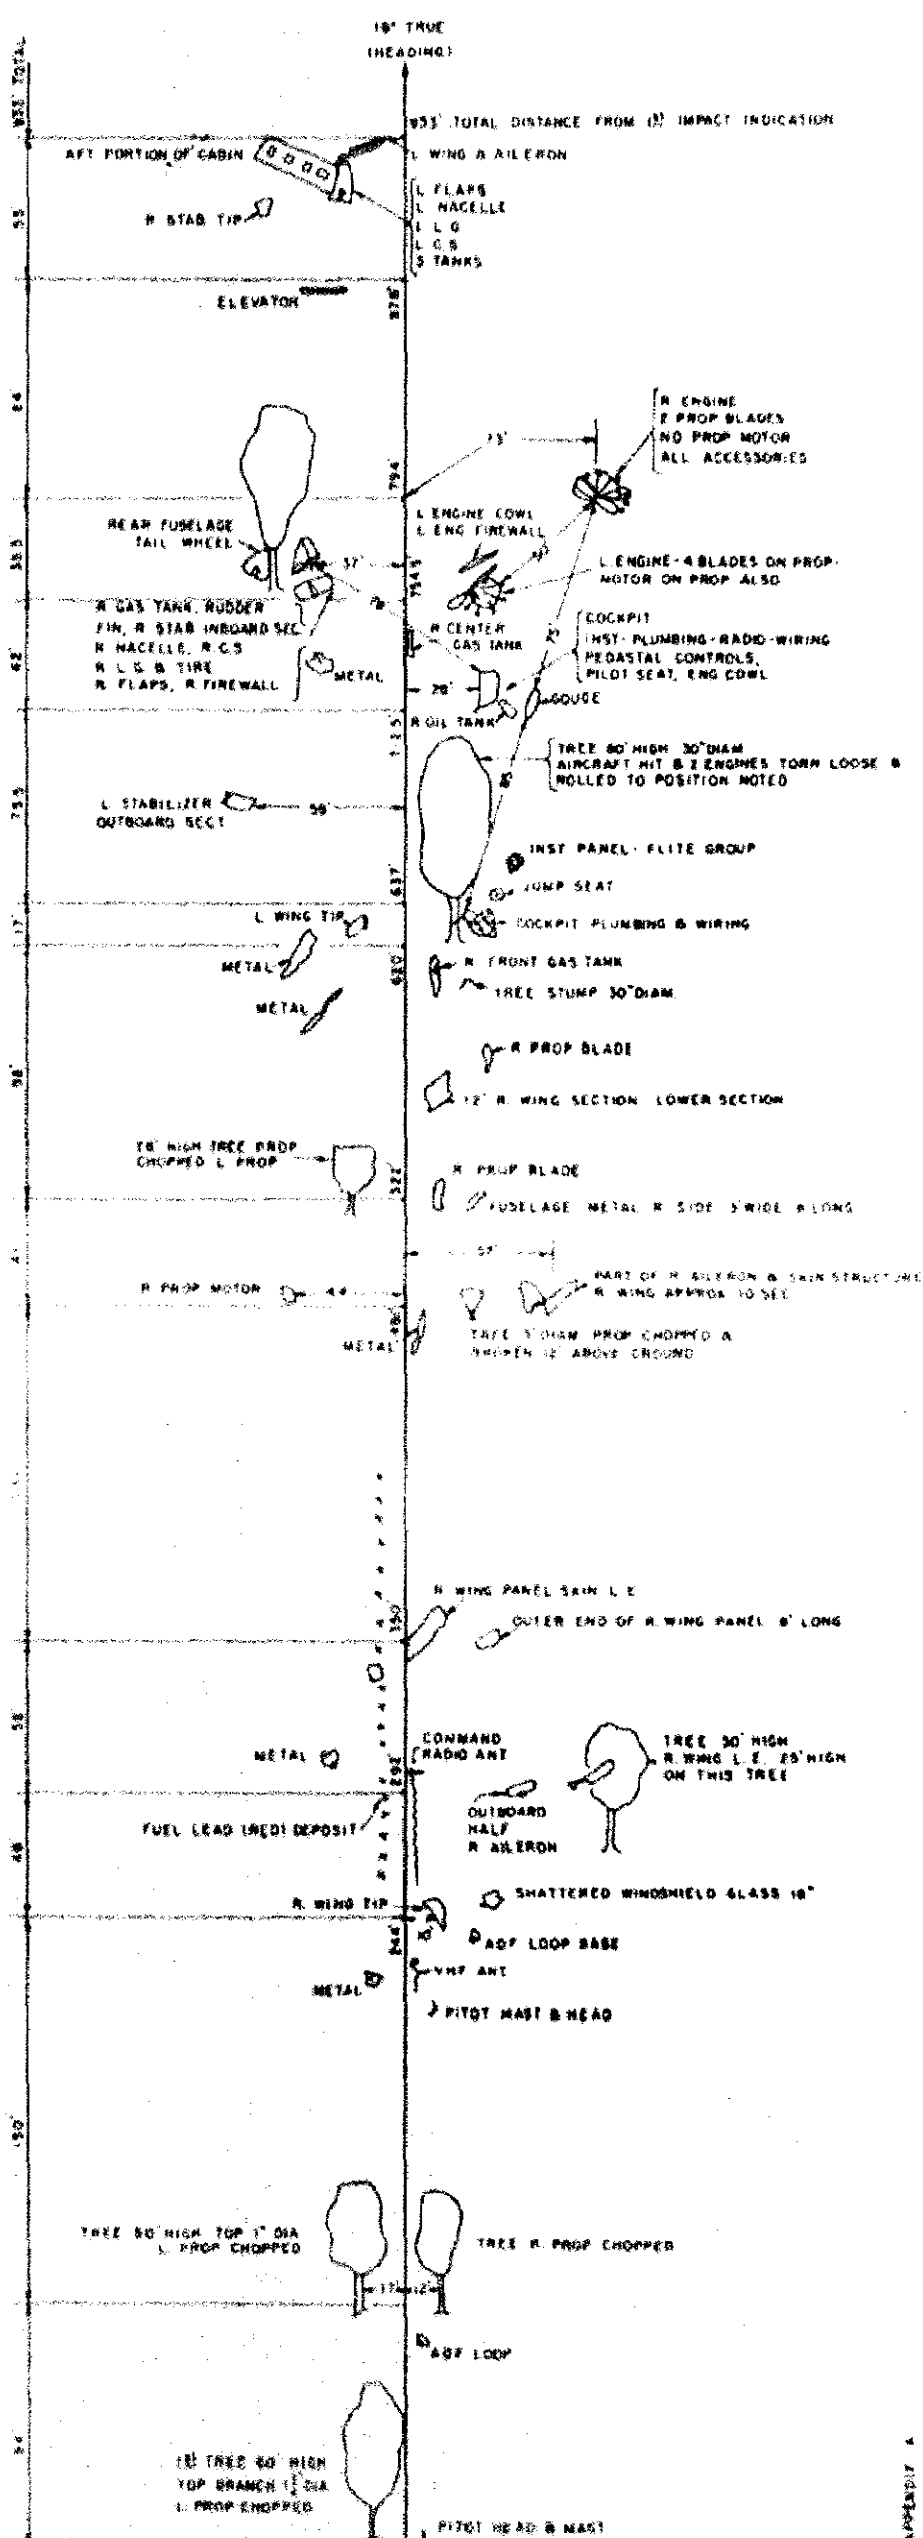
APPENDIX 1

Investigation at the scene indicated that the accident occurred about 100 feet below the crest of a hill, at an altitude of 2375 feet MSL, while the aircraft was in level flight and on a true heading of approximately 18°. Indications were that first contact was with small branches of a tree 60 feet above the ground. From this point on, as forward travel continued, disintegration of the aircraft progressed along a path 933 feet beyond the point of initial impact. All major components were accounted for along this path. Disintegration of the aircraft was complete with the exception of the aft part of the passenger compartment which came to rest at the most distant end of the line of travel.² It was in this section that

DISTRIBUTION OF AIRCRAFT WRECKAGE
 ALL WRECKAGE SHOWN IS IN DENSE WOODED AREA
 "DRAWING NOT TO SCALE"

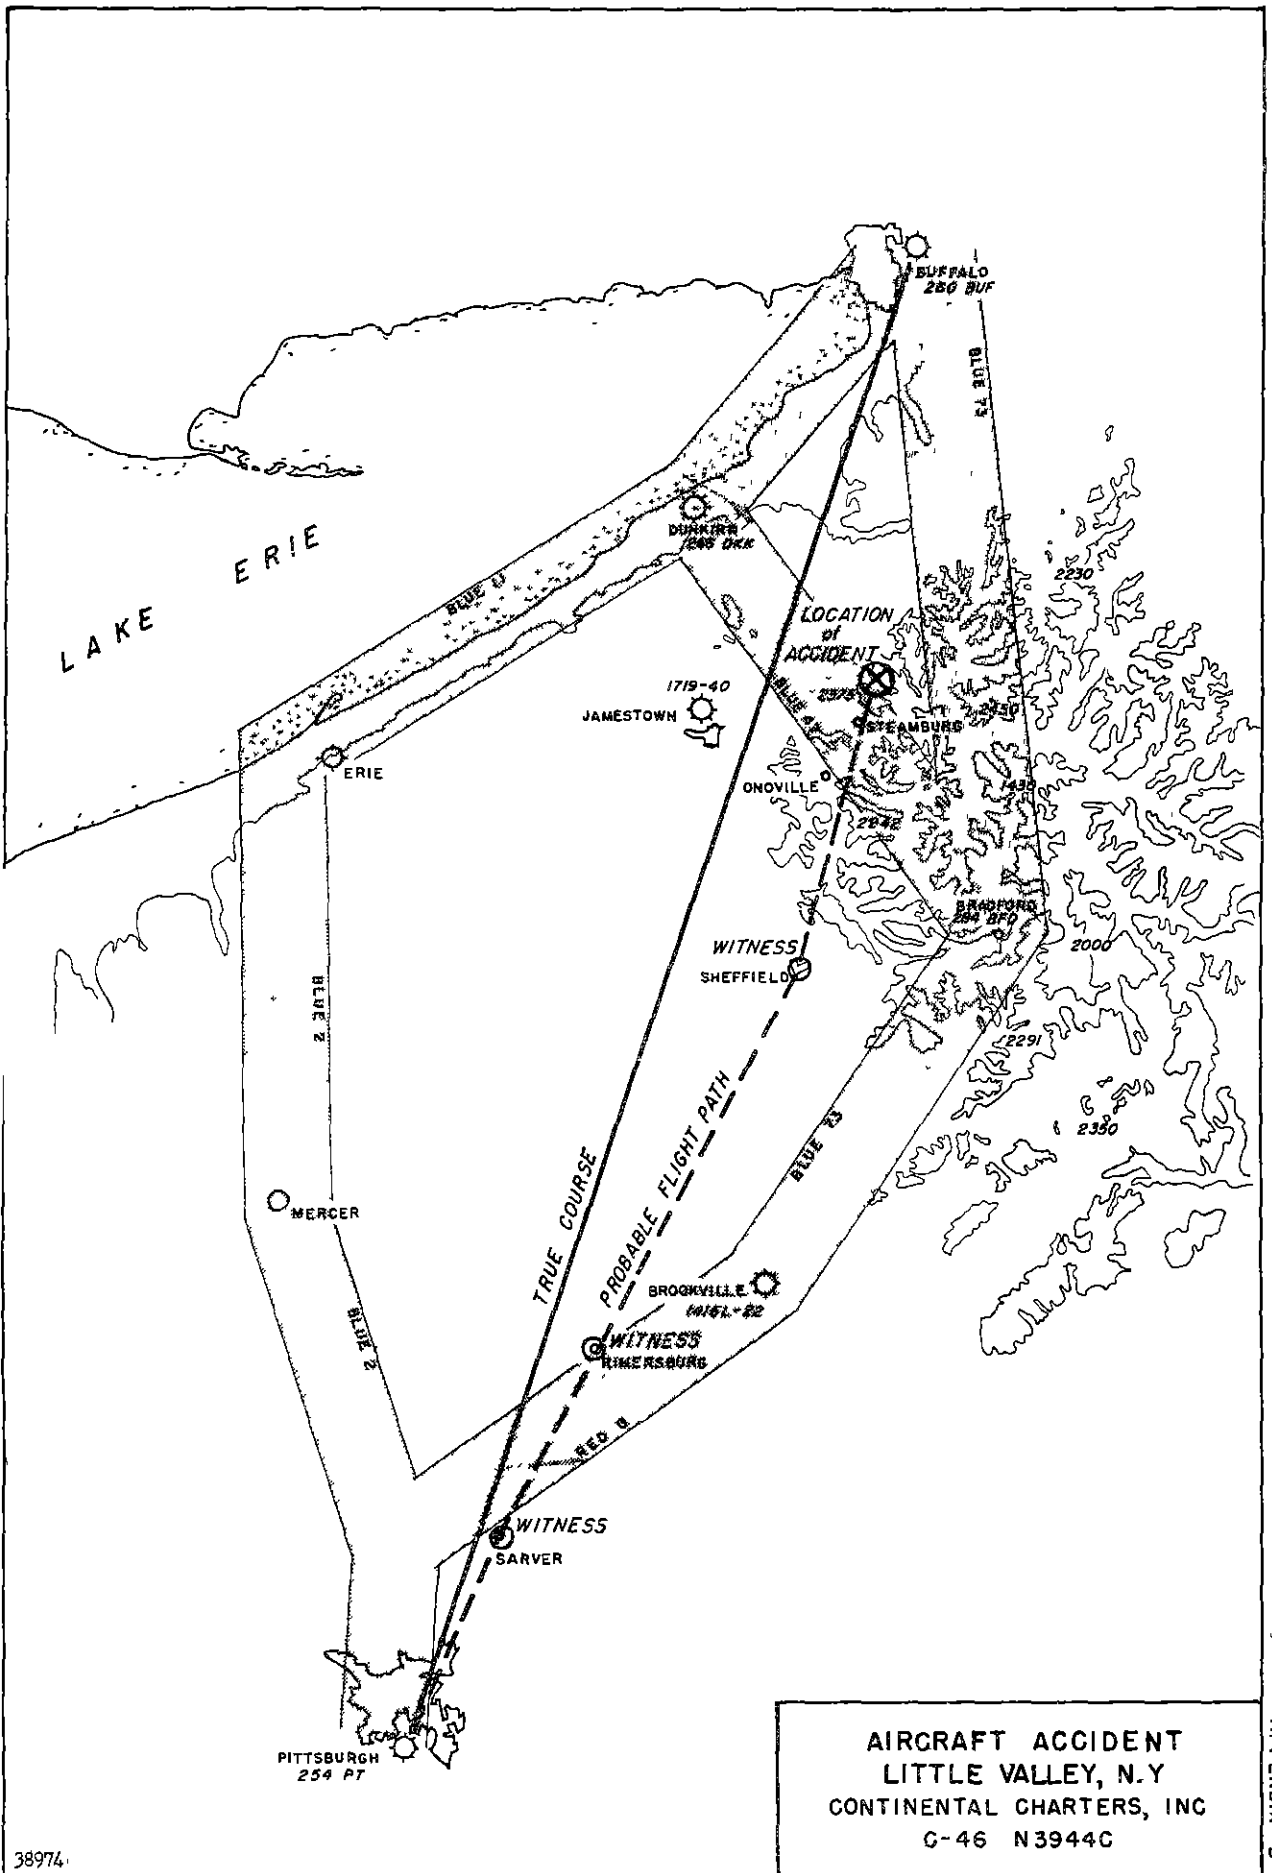
APPENDIX 2

The direct course from Pittsburgh to Buffalo is 18° true. In its Flight Information Manual which was effective on December 29 1951, the Civil Aeronautics Administration classifies this area as mountainous terrain, requiring a VFR night flight to maintain an altitude of not less than 2,000 feet above the highest point within a horizontal distance of 5 miles either side of the center of a direct course. In non-mountainous terrain, an altitude of not less than 1,000 feet above the highest point is required for VFR night flight. The airport at Jamestown, New York, which lies at the extreme western edge of this area, has an elevation of 1,719 feet; the accident occurred about 12 miles east of the direct course in terrain which is considerably higher than that at

Jamestown.⁴ Continental Charters' operations over this route were being conducted on the premise that the terrain is not considered mountainous, further, the company had been so advised by the CAA Aviation Safety District Office, Miami, and the agent assigned to supervise Continental Charters' operations so testified at the public hearing on this accident.

Reports of ground observers and testimony of surviving passengers indicated that Flight 44-2 was conducted at a low altitude all the way from Pittsburgh to the accident scene. The first reliable indication of the flight's position after departing Pittsburgh was "very low" over Sarver, Pennsylvania, approximately 28 miles north-northeast of the Pittsburgh-Allegheny Airport and three miles east of the true course, Pittsburgh to Buffalo. The next position, Cowansville, Pennsylvania, approximately 40 miles north-northeast of Pittsburgh and eight miles east of the true course, was reported by ground observers who heard but did not see a low-flying aircraft. Following this a low-flying aircraft was reported to have been heard at Rumersburg, Pennsylvania, approximately 52 miles north-northeast of Pittsburgh and eight miles east of the true course. At Sheffield, Pennsylvania, approximately 104 miles north-northeast of Pittsburgh and 15 miles east of the true course, it was reported that an aircraft had been seen entering a fog bank. The next point along the intended course to Buffalo which provided reliable information as to the possible passage of Flight 44-2 was at Onoville, New York, about 13 miles south-southwest of the crash site and 11 miles east of the true course. Witnesses here, who stated that an aircraft flew over very low, described the weather as "foggy." Witnesses at Steamburg, New York, approximately seven miles south-southeast of where the accident occurred and on a direct course from Onoville to the crash site, stated that the aircraft flew over there exceptionally low, and three reported they could distinguish the lighted passenger compartment windows. They stated further that the weather was very foggy and estimated visibility as less than one-half mile. Steamburg is located in a valley 1,410 feet above
