**AIRCRAFT ACCIDENT REPORT**

**JAPAN AIR LINES, LTD.,  
DOUGLAS DC-8-33, JA-8006  
San Francisco, California  
December 25, 1965**

**Department of Transportation  
NATIONAL TRANSPORTATION SAFETY BOARD**

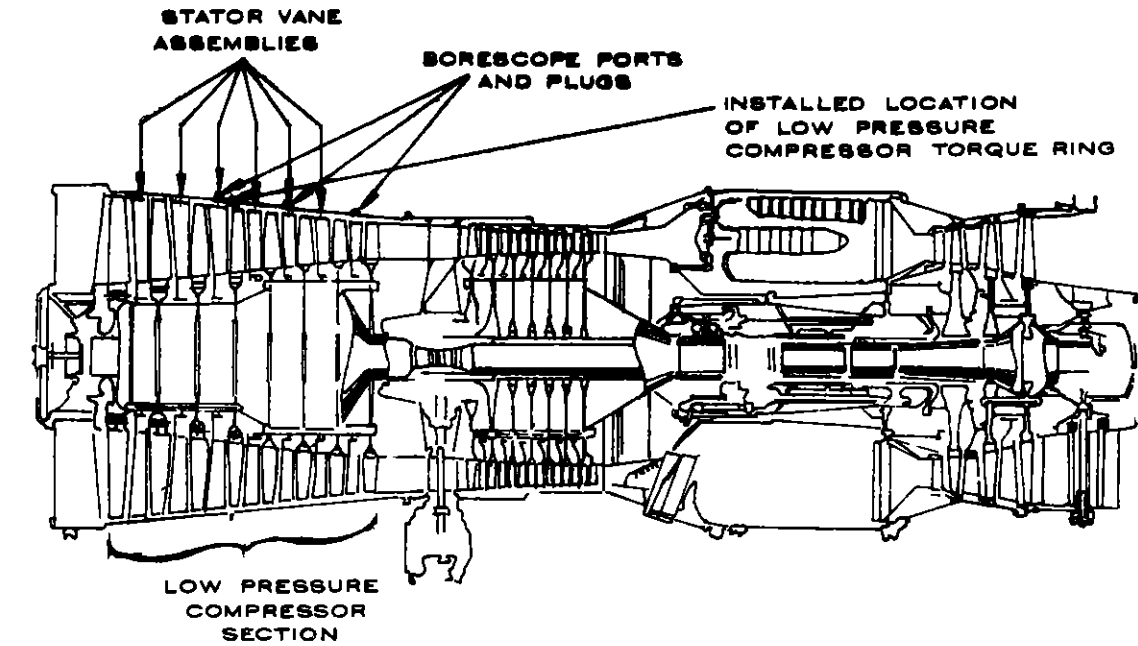
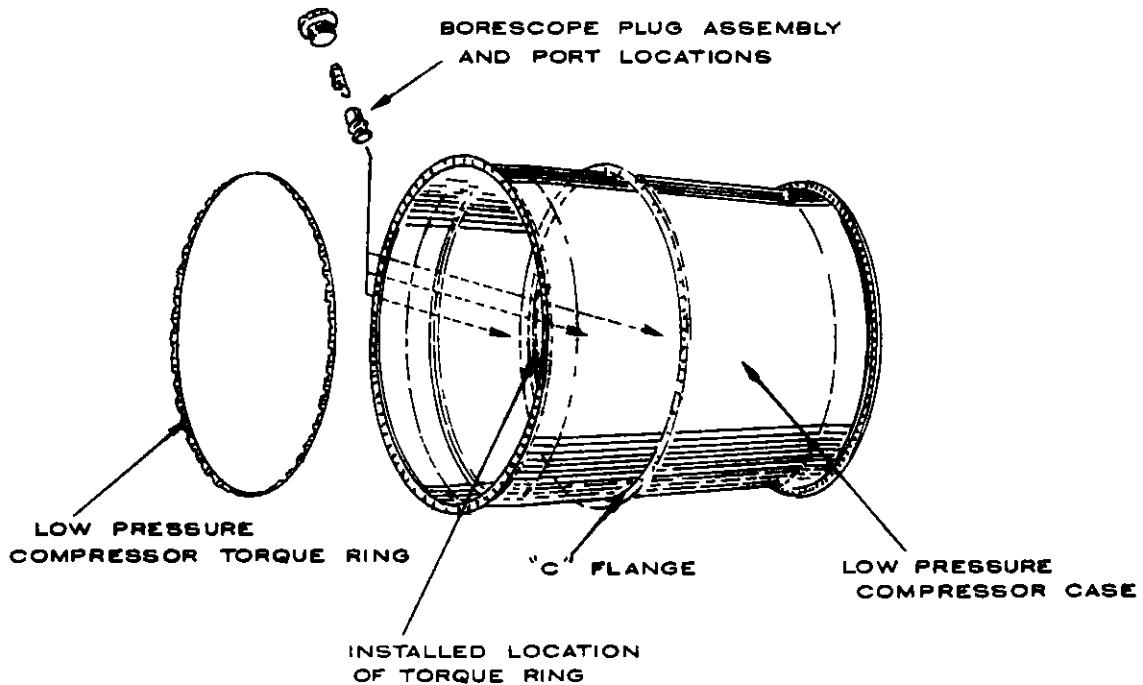
# EXPLANATORY DIAGRAM

Engine overhaul records showed that during the course of the engine overhaul the low pressure compressor torque ring, P/N 310172, was found cracked and therefore replaced. The torque ring is located in the low pressure compressor at the area of the compressor case "C" flange adjacent to the fourth stage compressor stator assembly. <sup>5/</sup> It serves to prevent rotation of the compressor stators. In position, the ring is tightly fitted and a series of slots on the ring mate with a series of lugs on the outer diameter of the fourth stage stator shroud. By design the torque ring is secured in place by 90 rivets, P/N AN 13340, made of AMS 7232, a nickel base alloy. The design shear strength of each rivet is 16,000 p.s.i. at 350 degrees, C. The ring is riveted to the compressor case "C" flange.

There are three borescope inspection ports in the outer compressor case and stator outer shroud. Each of the ports is closed by a threaded plug. Though not designed for the purpose, the ports and plugs tend to impede rotation of the compressor stator assembly.

Since no rivet material was found and the rivet holes in the area of damage were not elongated, the Board concludes that the low pressure compressor torque ring designed to prevent rotation of the low pressure compressor stator assembly was not secured in place by riveting during overhaul of the engine. As a result, when the restraining effect of the tight fit of the ring and the three borescope inspection port plugs was overcome by the normal rotational forces within the compressor, the stator assembly and torque ring began to turn.

At high rotational speed the torque ring bearing on the low pressure compressor case literally ground through the case until the case was so weakened that it disintegrated with explosive force. This is clearly sustained by the extreme abrasive and heat damage found on the recovered pieces of compressor case and stator vane assembly which came from the precise location where the torque ring would make contact.
