# NATIONAL TRANSPORTATION SAFETY BOARD

## RAILROAD ACCIDENT REPORT

HEAD-END COLLISION OF  
AMTRAK TRAIN NO. 392 AND  
ICG TRAIN NO. 51  
HARVEY, ILLINOIS  
OCTOBER 12, 1979

NTSB-RAR-80-3

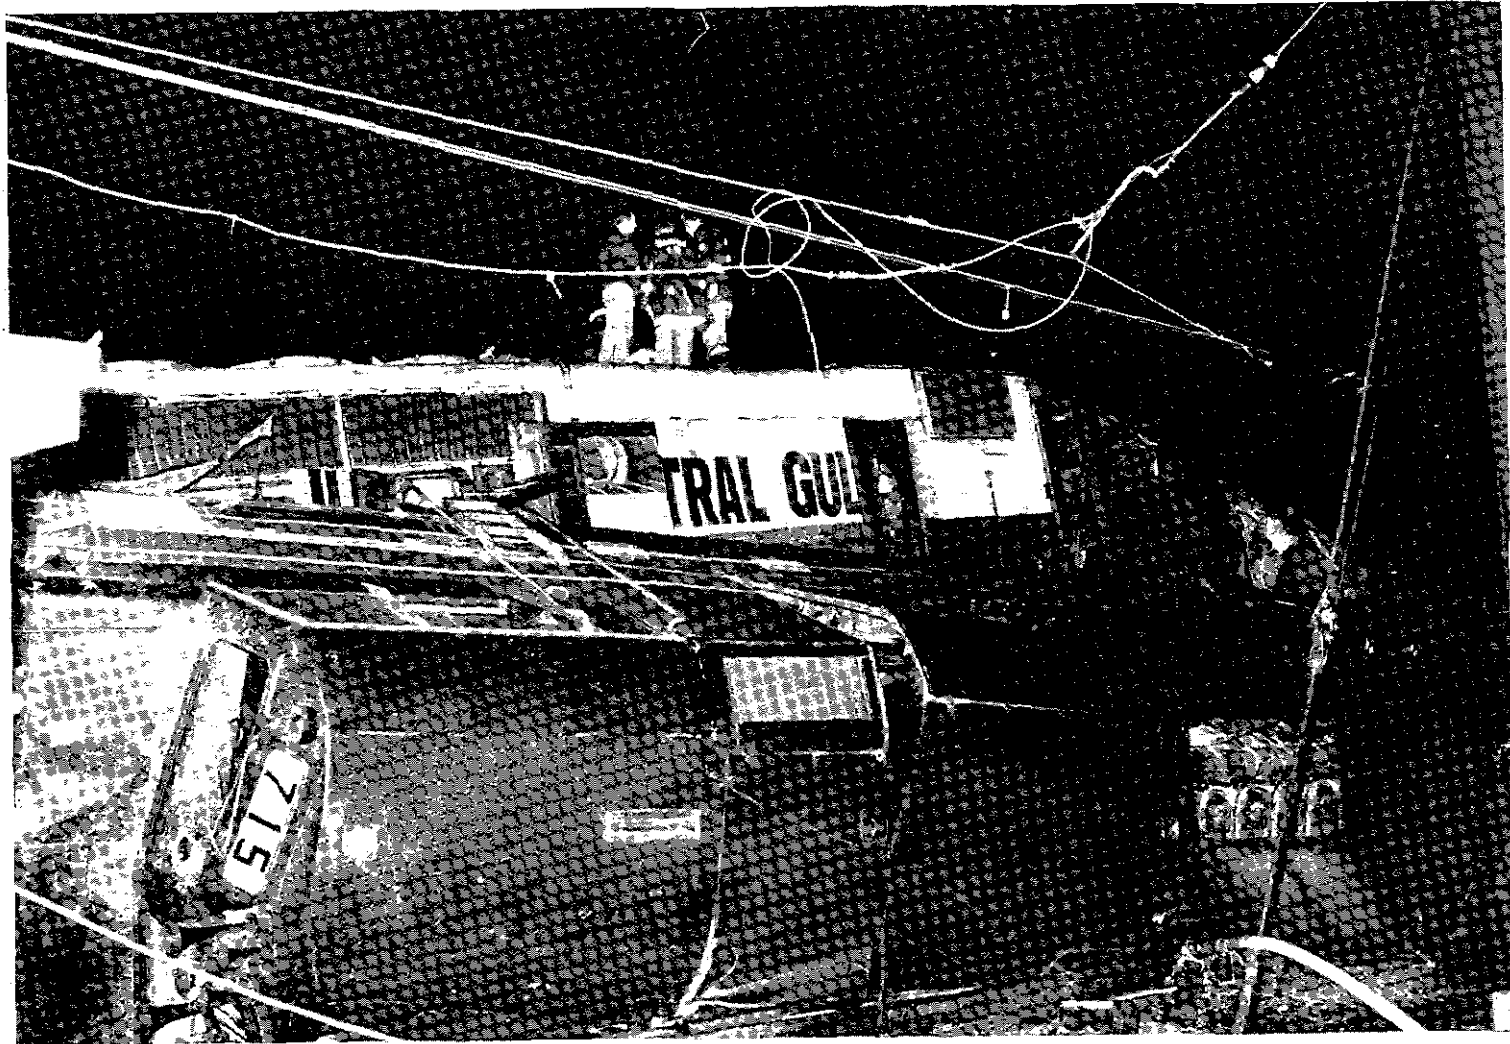
On impact, the locomotive of train No. 392 pushed the lead locomotive unit of train No. 51 34 ft under the second locomotive unit, struck and overrode the front end of the second locomotive unit, and struck and tore down the overhead catenary wires. The Amtrak locomotive and first coach of train No. 392 were overturned onto their sides. The locomotive traveled 134 feet before coming to rest on its left side adjacent to and west of the second locomotive unit of train No. 51. (See figure 1.)

Figure 1.—Amtrak locomotive unit of train No. 392  
and second locomotive unit of train No. 51.

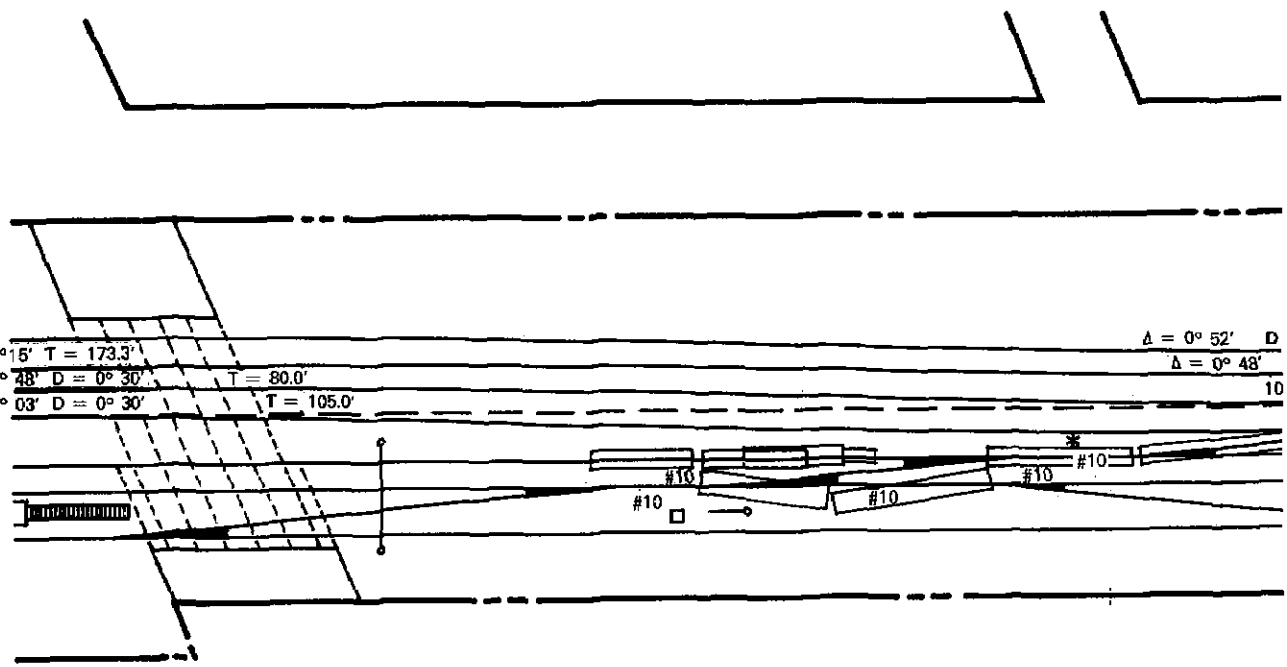
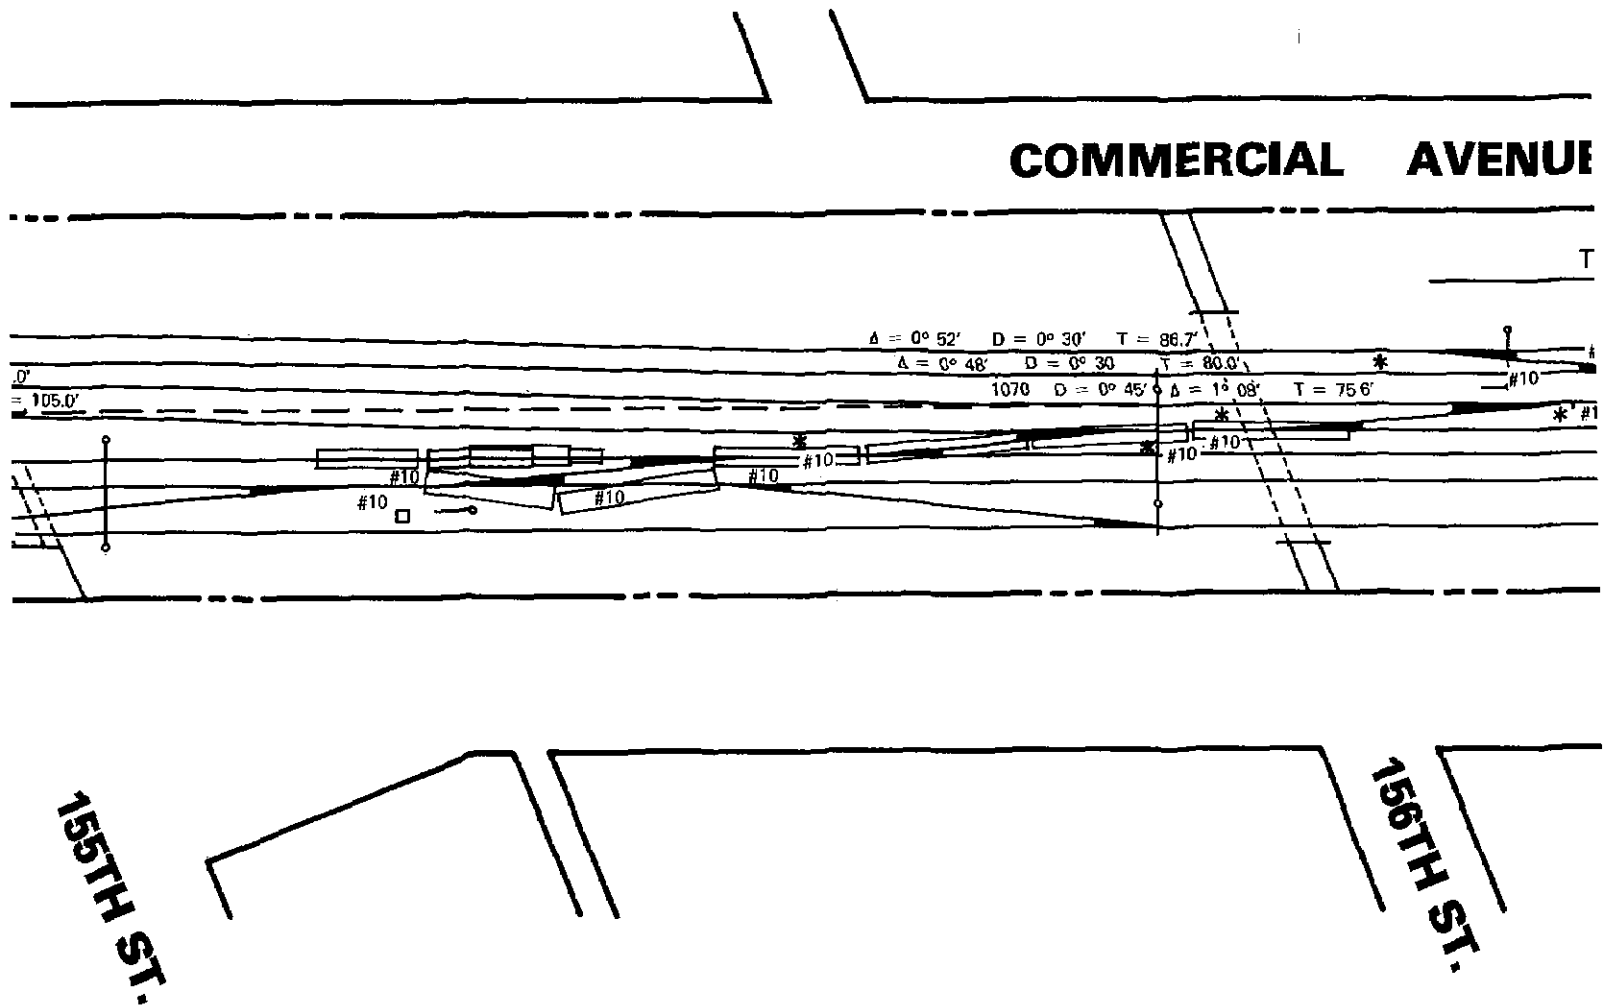
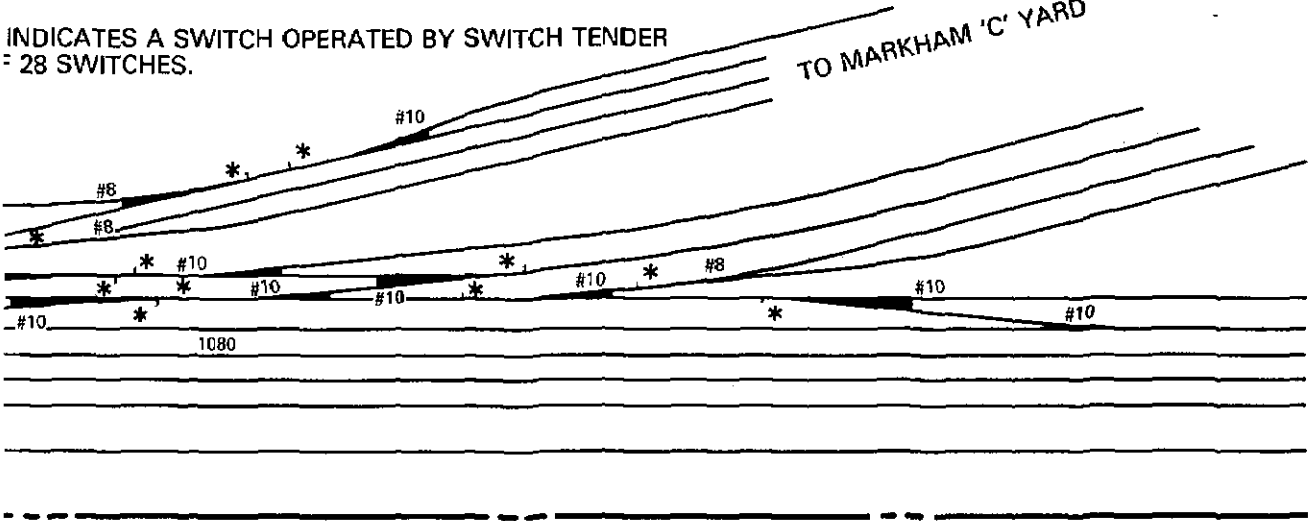
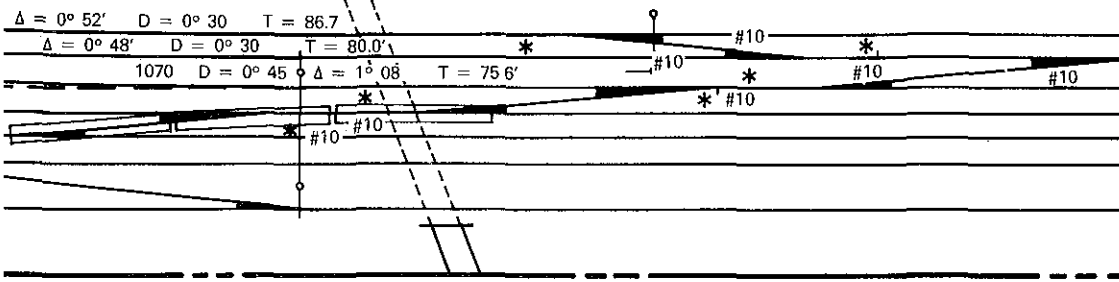
Figure 2. Plan view

Seven crossovers permitted trains to cross over from one track to another and to enter and leave Harvey yard. (See figure 2.)

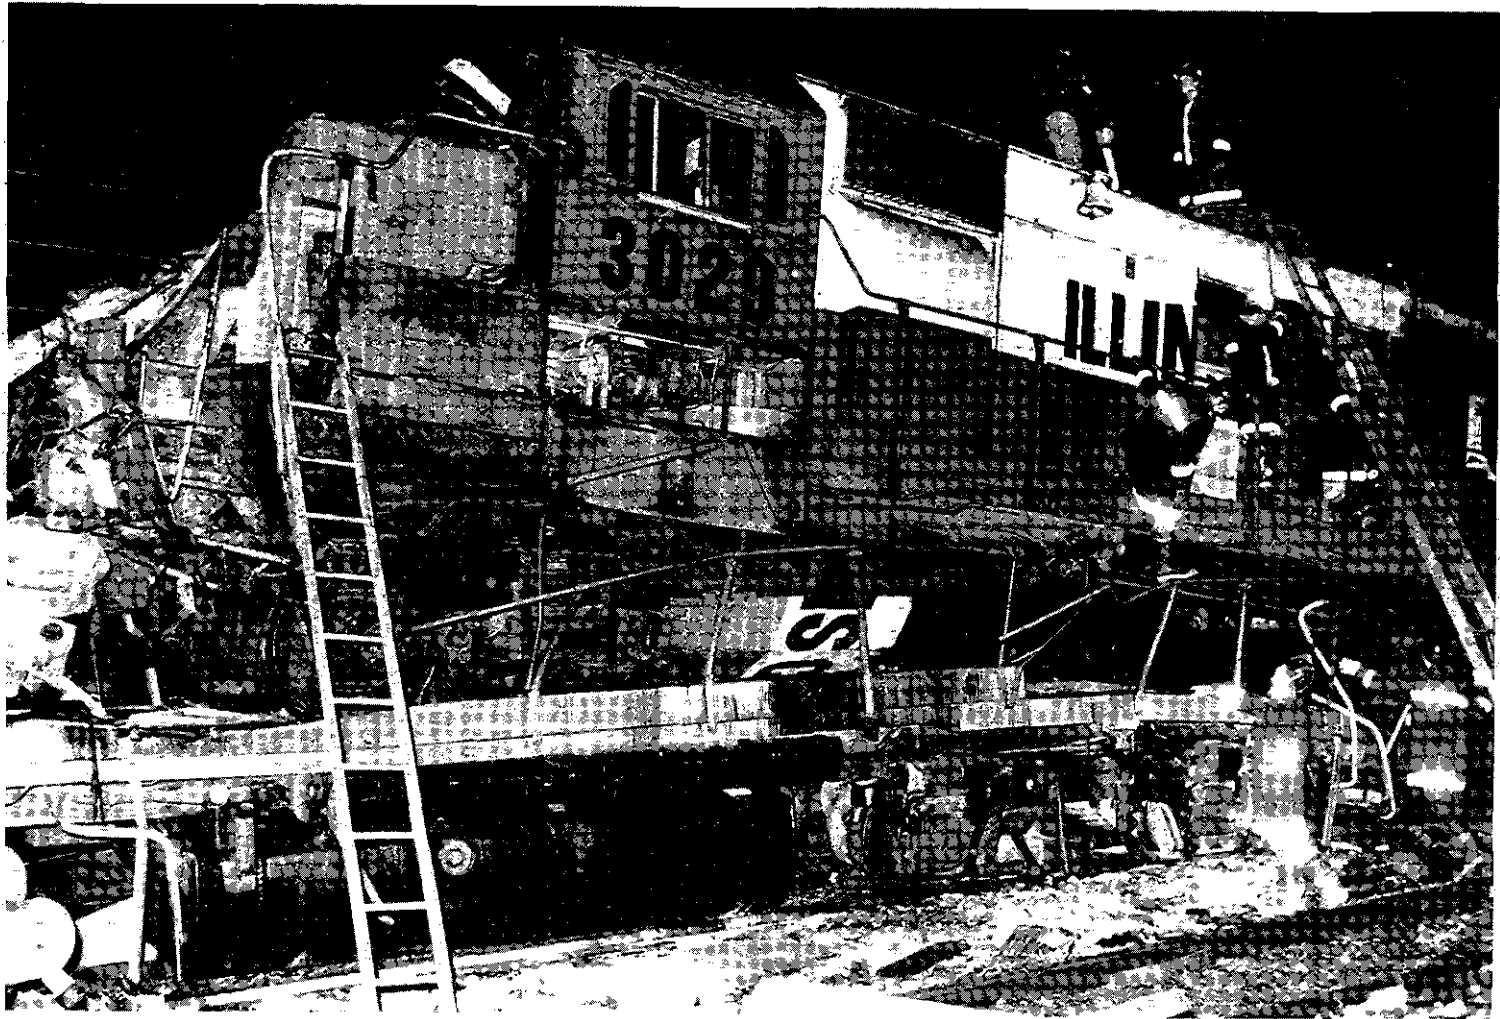
The first locomotive unit of train No. 51 was destroyed. The entire superstructure, including the cab, was sheared from the underframe. The second locomotive unit was damaged extensively. (See figure 3.) The third locomotive unit and cars were not derailed or damaged.

Figure 3.—Second locomotive unit of train No. 57.

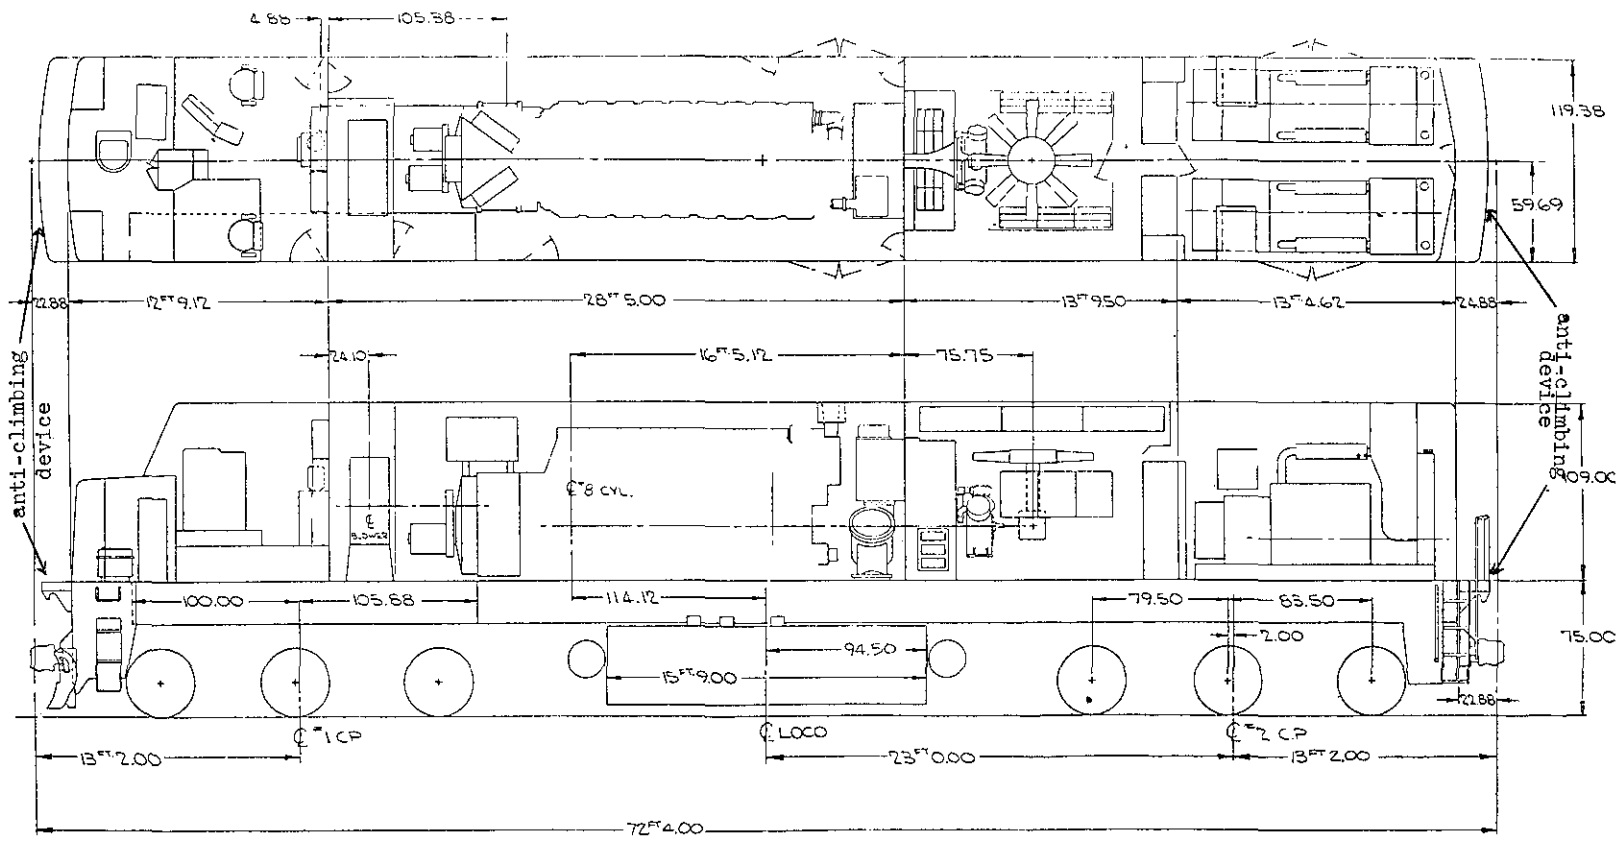
Train No. 392 consisted of one General Electric Model P30CH diesel-electric locomotive unit and five superliner coaches. The locomotive unit was equipped with a dual sealed-beam headlight, speed indicator and recorder, overspeed control, alertor safety device, and cab signals with an acknowledging switch. On this class of locomotive, a steel constructed anticlimbing device at each end of the platform extends 20 inches outward from the underframe and is 6 feet 3 inches above the top of the rail. The device is strengthened by two steel supports on the underside, which are an extension of the center sill of the underframe and are tapered on the leading end. (See figure 4.)

Figure 4.--General Electric Model P30CH diesel-electric locomotive.
