NATIONAL TRANSPORTATION SAFETY BOARD

RAILROAD/HIGHWAY ACCIDENT REPORT

COLLISION OF A
BALTIMORE AND OHIO FREIGHT
TRAIN WITH A PICKUP TRUCK

BECKEMEYER, ILLINOIS
FEBRUARY 7, 1976

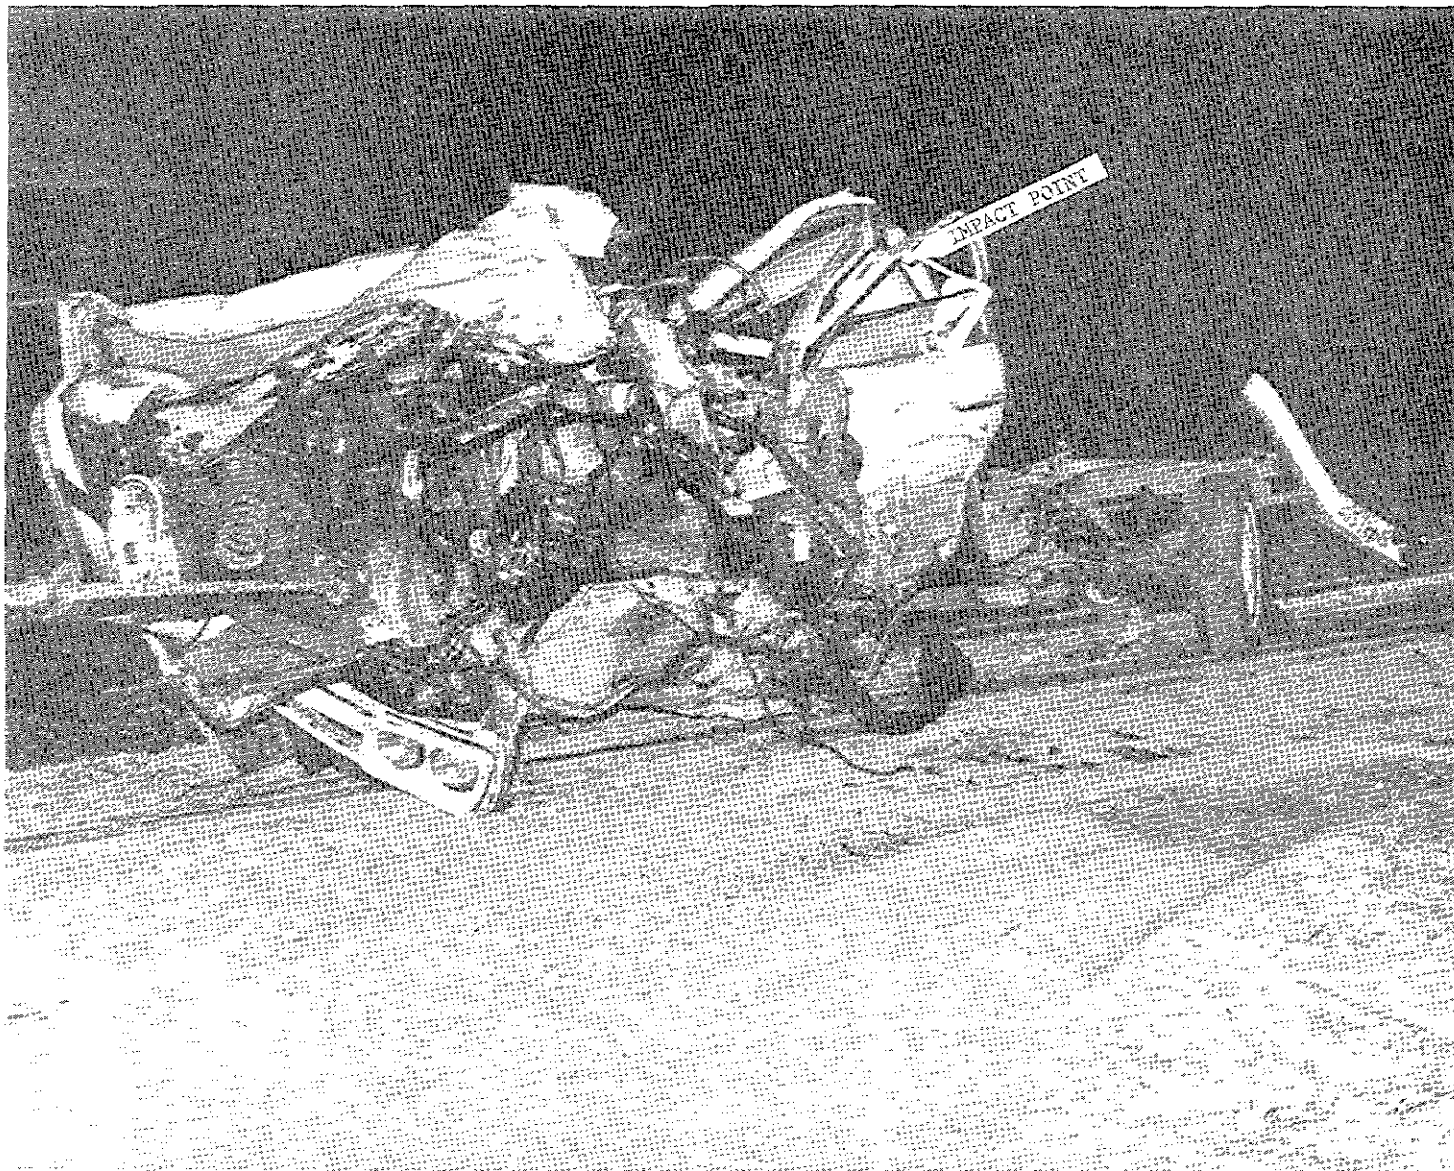
The engineer placed the train control in emergency braking as the lead unit hit the truck. The coupler on the front of the locomotive penetrated the truck cab in the door area, immediately behind the front door post on the driver's side. (See Figure 1.) The truck body was torn off and thrown to the right of the train. The cab and chassis of the truck were wrapped around the lead unit. The train stopped about 2,500 feet west of the impact point.

Figure 1. Damage to truck.

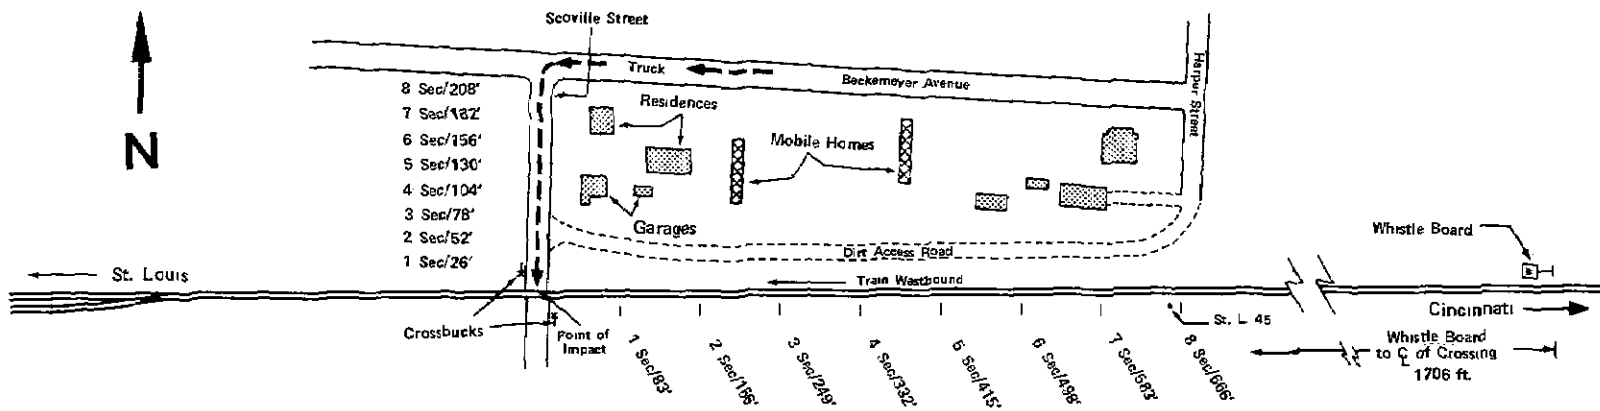
Scoville Street is a north-south-two-lane, asphalt-surfaced road that runs between Beckemeyer and First Streets and crosses the railroad tracks 218 feet south of Beckemeyer Street. (See Figure 2.) The 20-foot-wide street narrows slightly as it approaches the grade crossing. The grade increases 3 percent, beginning about 90 feet from the crossing; near the crossing, the grade increases sharply. The posted speed limit on Scoville Street is 25 mph.

As the truckdriver approached the railroad track from the north, his view east along the track was obscured by dwellings. Thirty-five feet south of Beckemeyer Street, he could have seen the upper portion of the engine, including the headlights, over the garage which was behind the dwellings. One hundred feet from the track, his view of the train and the track became unobstructed, and remained so up to the track.

FIGURE 2. PLAN VIEW OF ACCIDENT SITE,
BECKEMEYER, ILLINOIS.
