RAILROAD - HIGHWAY ACCIDENT REPORT

BOSTON AND MAINE CORPORATION
SINGLE DIESEL-POWERED PASSENGER CAR 563
COLLISION WITH OXBOW TRANSPORT COMPANY TANK TRUCK
AT SECOND STREET RAILROAD-HIGHWAY GRADE CROSSING
EVERETT, MASSACHUSETTS
DECEMBER 28, 1966,

U.S. NATIONAL TRANSPORTATION SAFETY BOARD

BOSTON AND MAINE CORPORATION
SINGLE DIESEL-POWERED PASSENGER CAR 563
COLLISION WITH OXBOW TRANSPORT COMPANY TANK TRUCK
AT SECOND STREET RAILROAD-HIGHWAY GRADE CROSSING
EVERETT, MASSACHUSETTS
DECEMBER 28, 1966

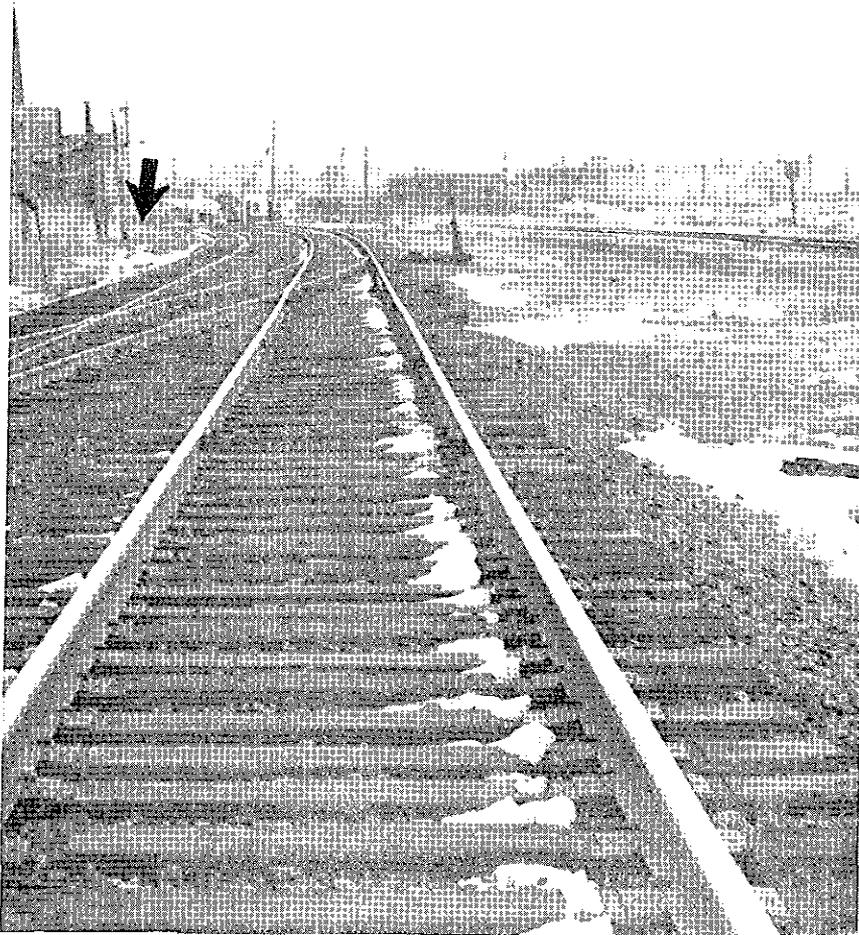
Photo No. 1

View of crossing from a point 840 feet westward on the outbound track. Arrow points to collision point.

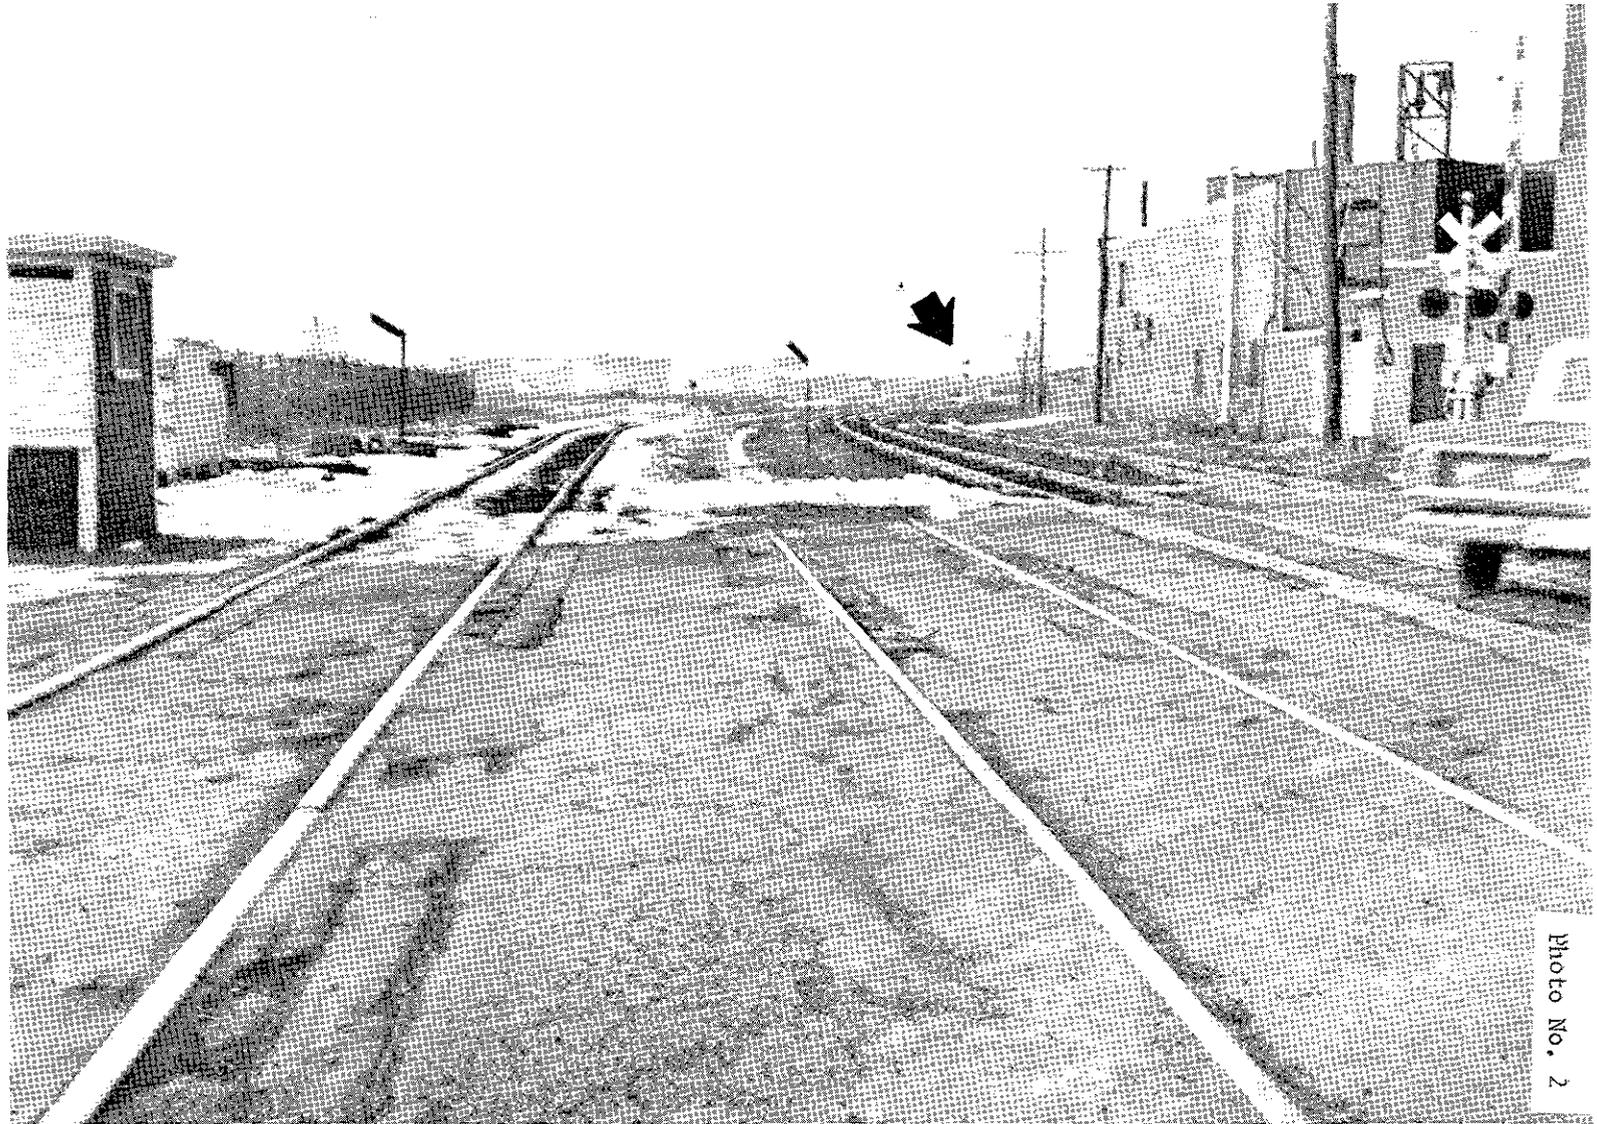
View westward from Second St. Crossing. B&A tracks in foreground, and crossing-watchman's shanty at left. Rear end of vehicle at right is on the B&M outbound track at point of collision. Arrow points to signal P-37.

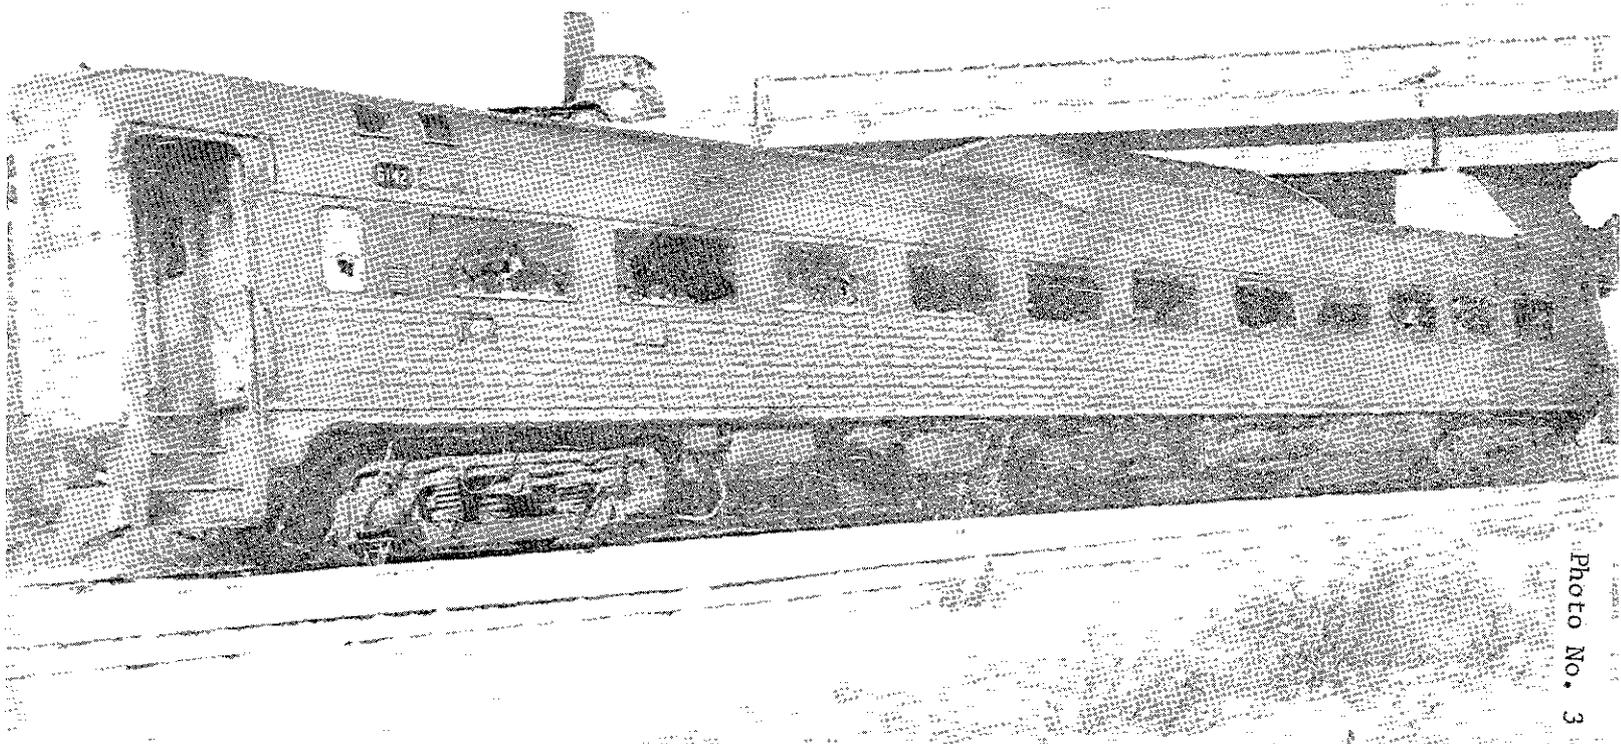
Train No. 563. Rear of train at left.
