✓
REPORT NO. 4170

PENN CENTRAL TRANSPORTATION COMPANY

MASSILLON, OHIO

JUNE 14, 1970

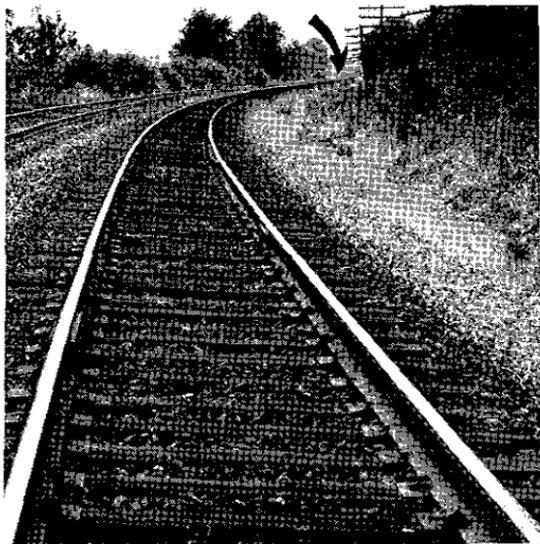
Because of track curvature and trees alongside the railroad, a caboose standing on track No 2 at the collision point cannot be seen from an approaching westbound train at a distance greater than about 2400 feet (see photo below).

Westward view from point on track No. 2 about 2400 feet from collision point (arrow).
